Pit, Below-Grade Tank, or Proposed Alternative Method Permit or Closure Plan Application

1.
Operator: LOGOS Operating, LLC OGRID #: 289408
Address: 2010 Afton Place, Farmington, NM 87401
Facility or well name: ROSA UNIT 008 BGT 1
API Number: 30-039-07944 OCD Permit Number:
U/L or Qtr/Qtr M Section 26 Township 31N Range 6W County: Rio Arriba
Center of Proposed Design: Latitude 36.8664055 Longitude -107.4381256 NAD83
Surface Owner: ☒ Federal ☐ State ☐ Private ☐ Tribal Trust or Indian Allotment

Rosa Unit # 008 BGT#001 Sampling Photos

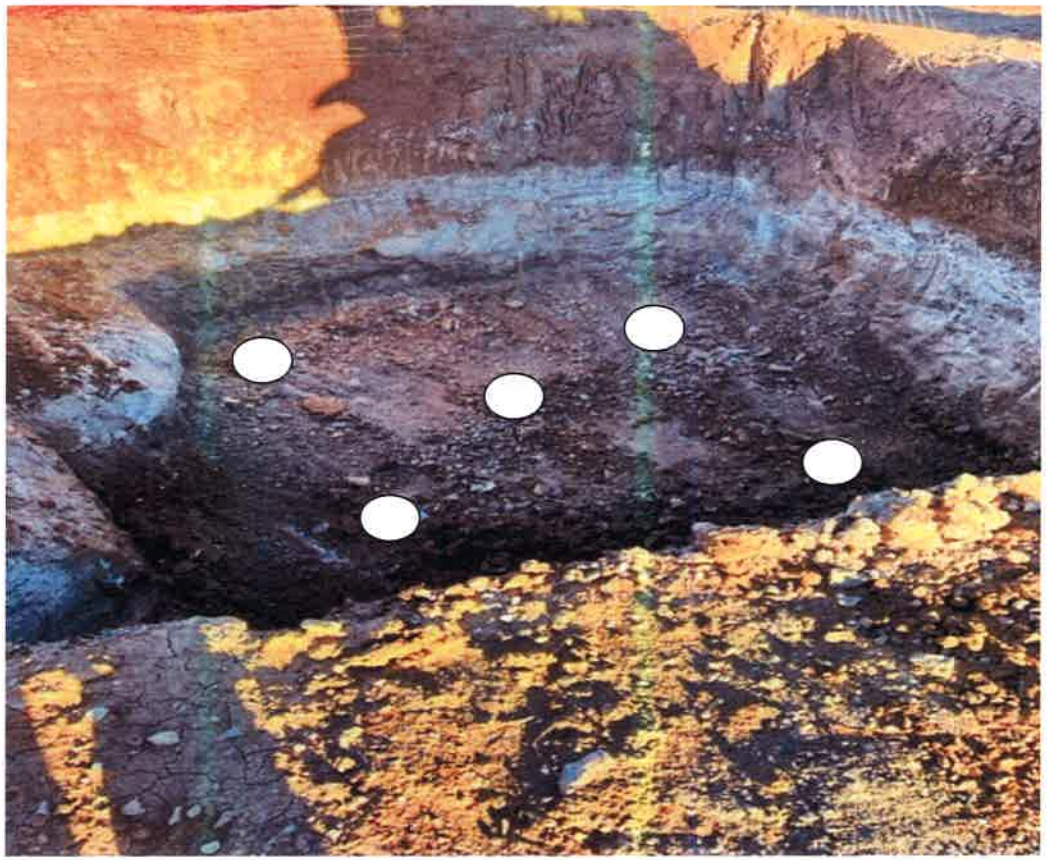
Base Confirmation sampling (1) 5-point confirmation sampling 140 sqft)

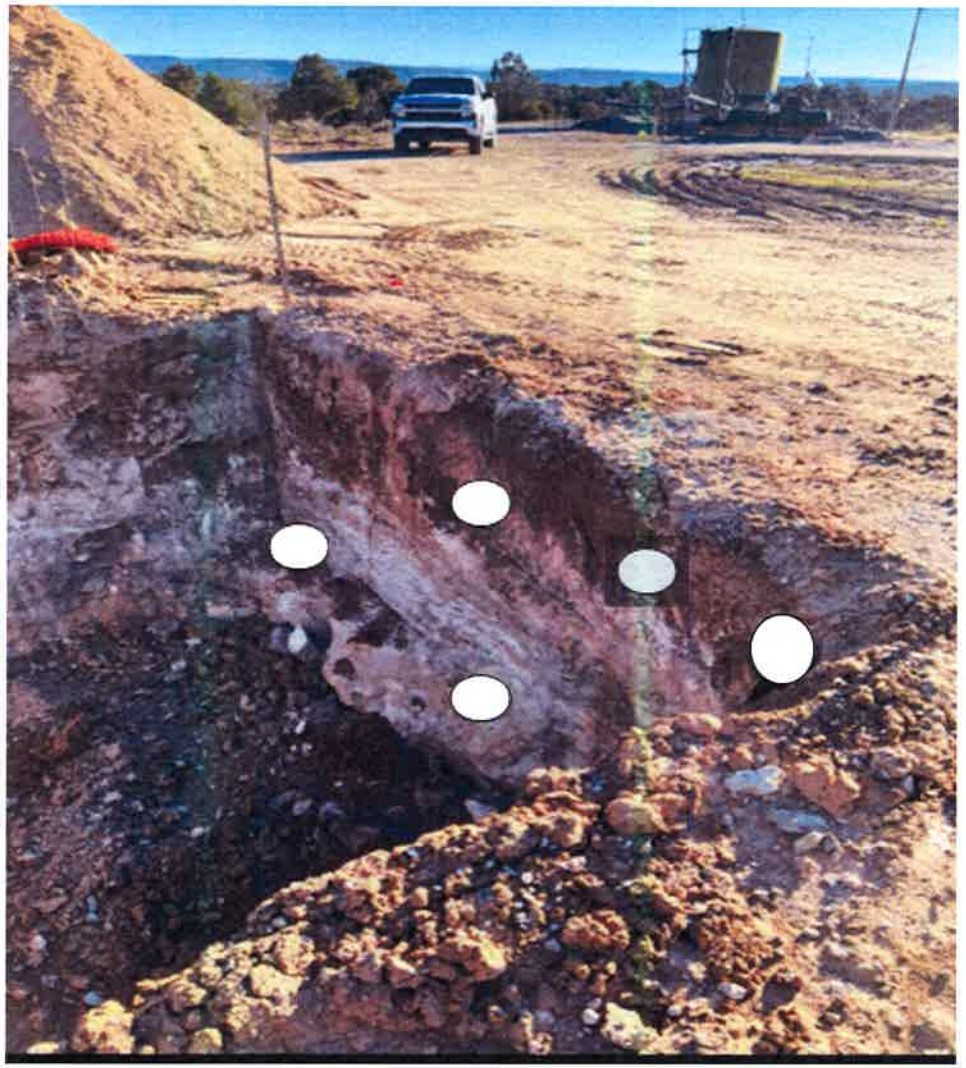
Rosa Unit # 008 BGT 001 Sampling Photos

East Confirmation sampling (1) 5-point confirmation sampling 111 sqf

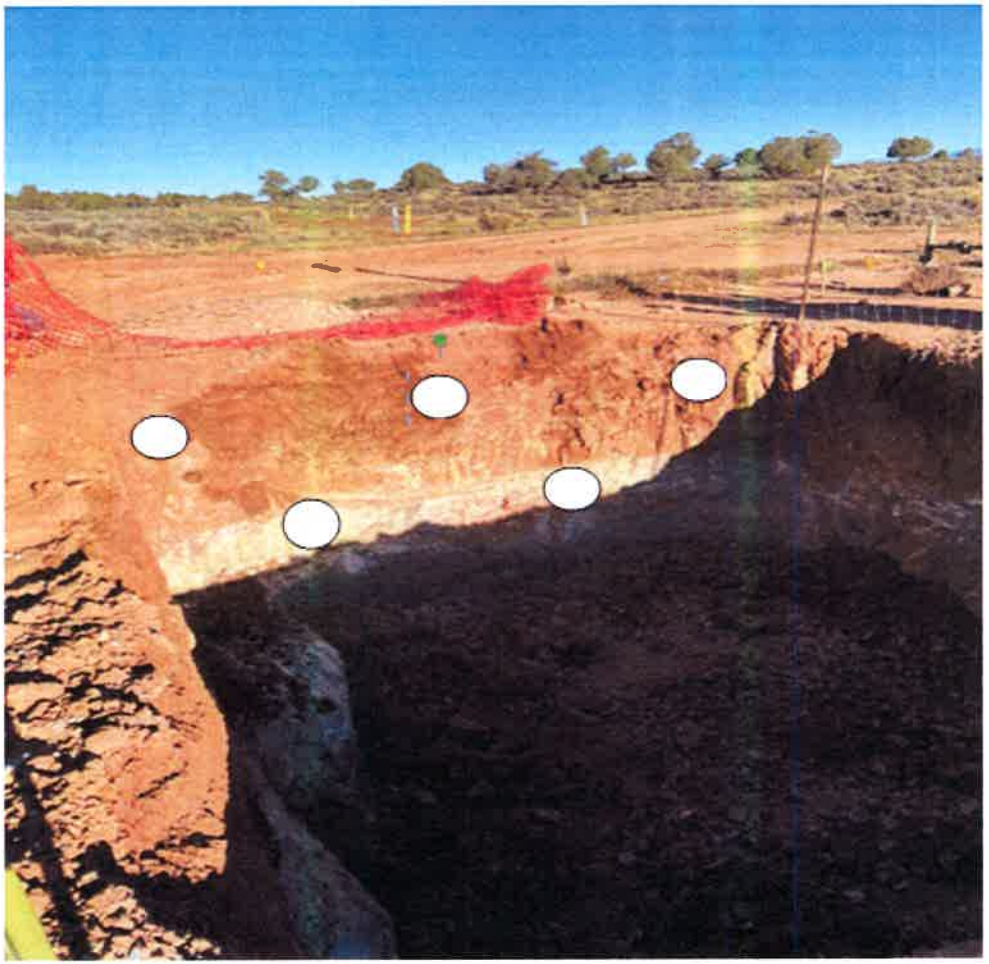
Rosa Unit # 008 BGT 001 Sampling Photos

South Confirmation sampling (1) 5-point confirmation sampling 118 sqf

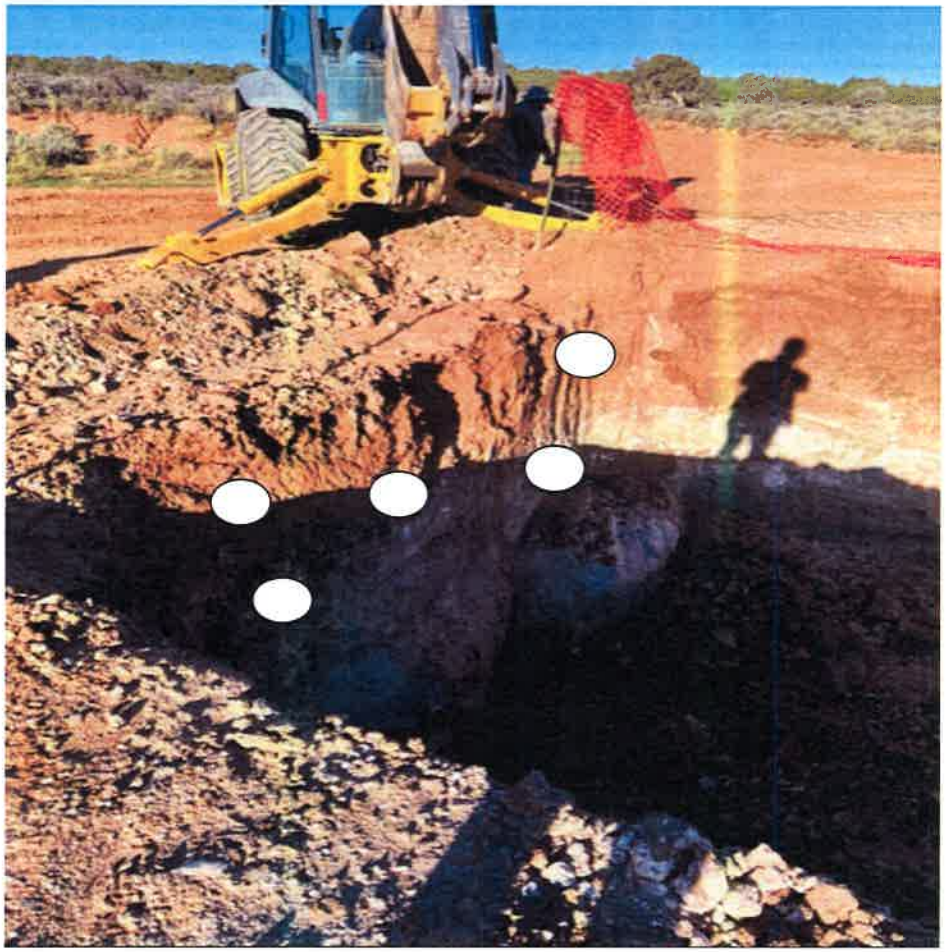
Rosa Unit # 008 BGT 001 Sampling Photos

West Confirmation sampling (1) 5-point confirmation sampling 132 sqf
