Pit, Below-Grade Tank, or Proposed Alternative Method Permit or Closure Plan Application

BGT1 Closure Report
Incident# nAPP2313243978

Facility or well name: Abrams L 1

Hilcorp Energy Company
San Juan Basin: New Mexico Assets
Below Grade Tank Closure Report

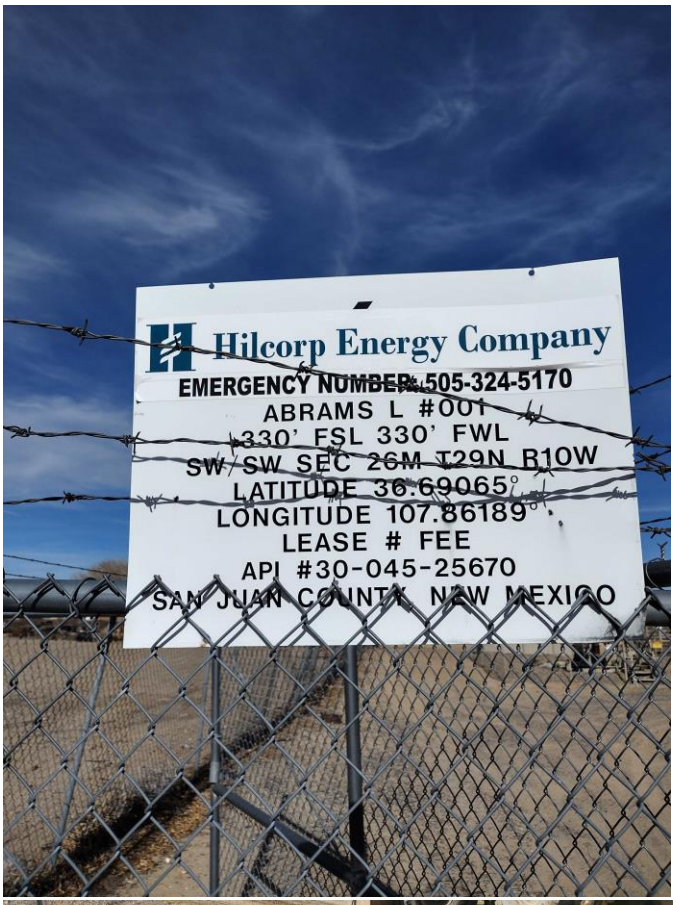
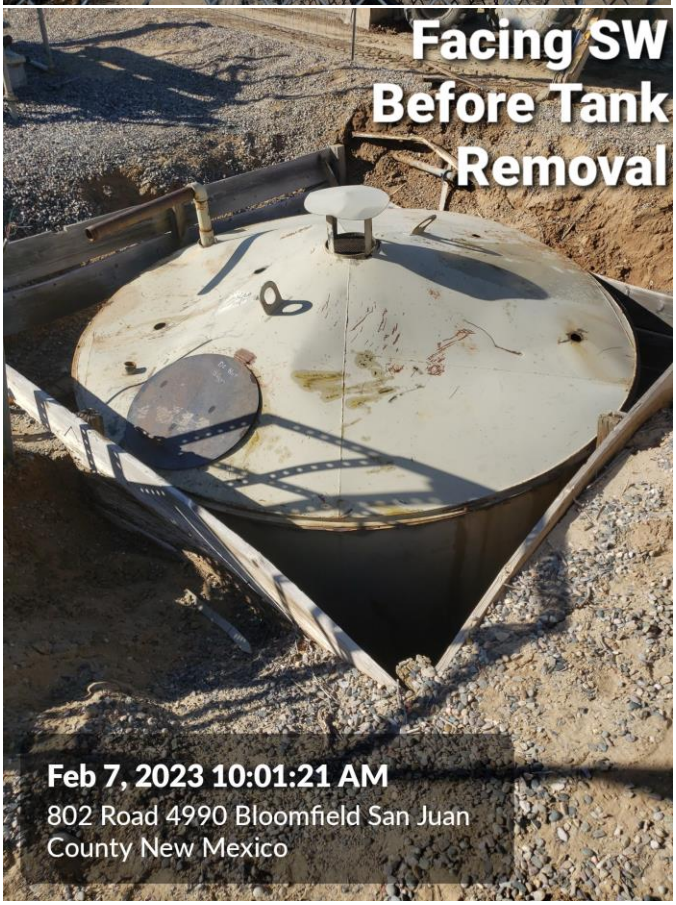
Abrams L 1
30-045-25670
BGT Closure Pictures

Historical release was discovered. Final backfill photo will be included in Final C-141 submittal.
