Pit, Below-Grade Tank, or Proposed Alternative Method Permit or Closure Plan Application

1.
Operator: Hilcorp Energy Company OGRID #: 372171
Address: 382 Road 3100 Aztec, NM 87410
Facility or well name: SAN JUAN 29-5 UNIT 102
API Number: 30-039-22468 OCD Permit Number:
U/L or Qtr/Qtr A Section 9 Township 29N Range 5W County: Rio Arriba
Center of Proposed Design: Latitude 36.7445107 Longitude -107.3562012 NAD27
Surface Owner: ☒ Federal ☐ State ☐ Private ☐ Tribal Trust or Indian Allotment

Hilcorp Energy Company
San Juan Basin
Below Grade Tank Closure Report

Lease Name: SAN JUAN 29-5 UNIT 102
API No.: 30-039-22468

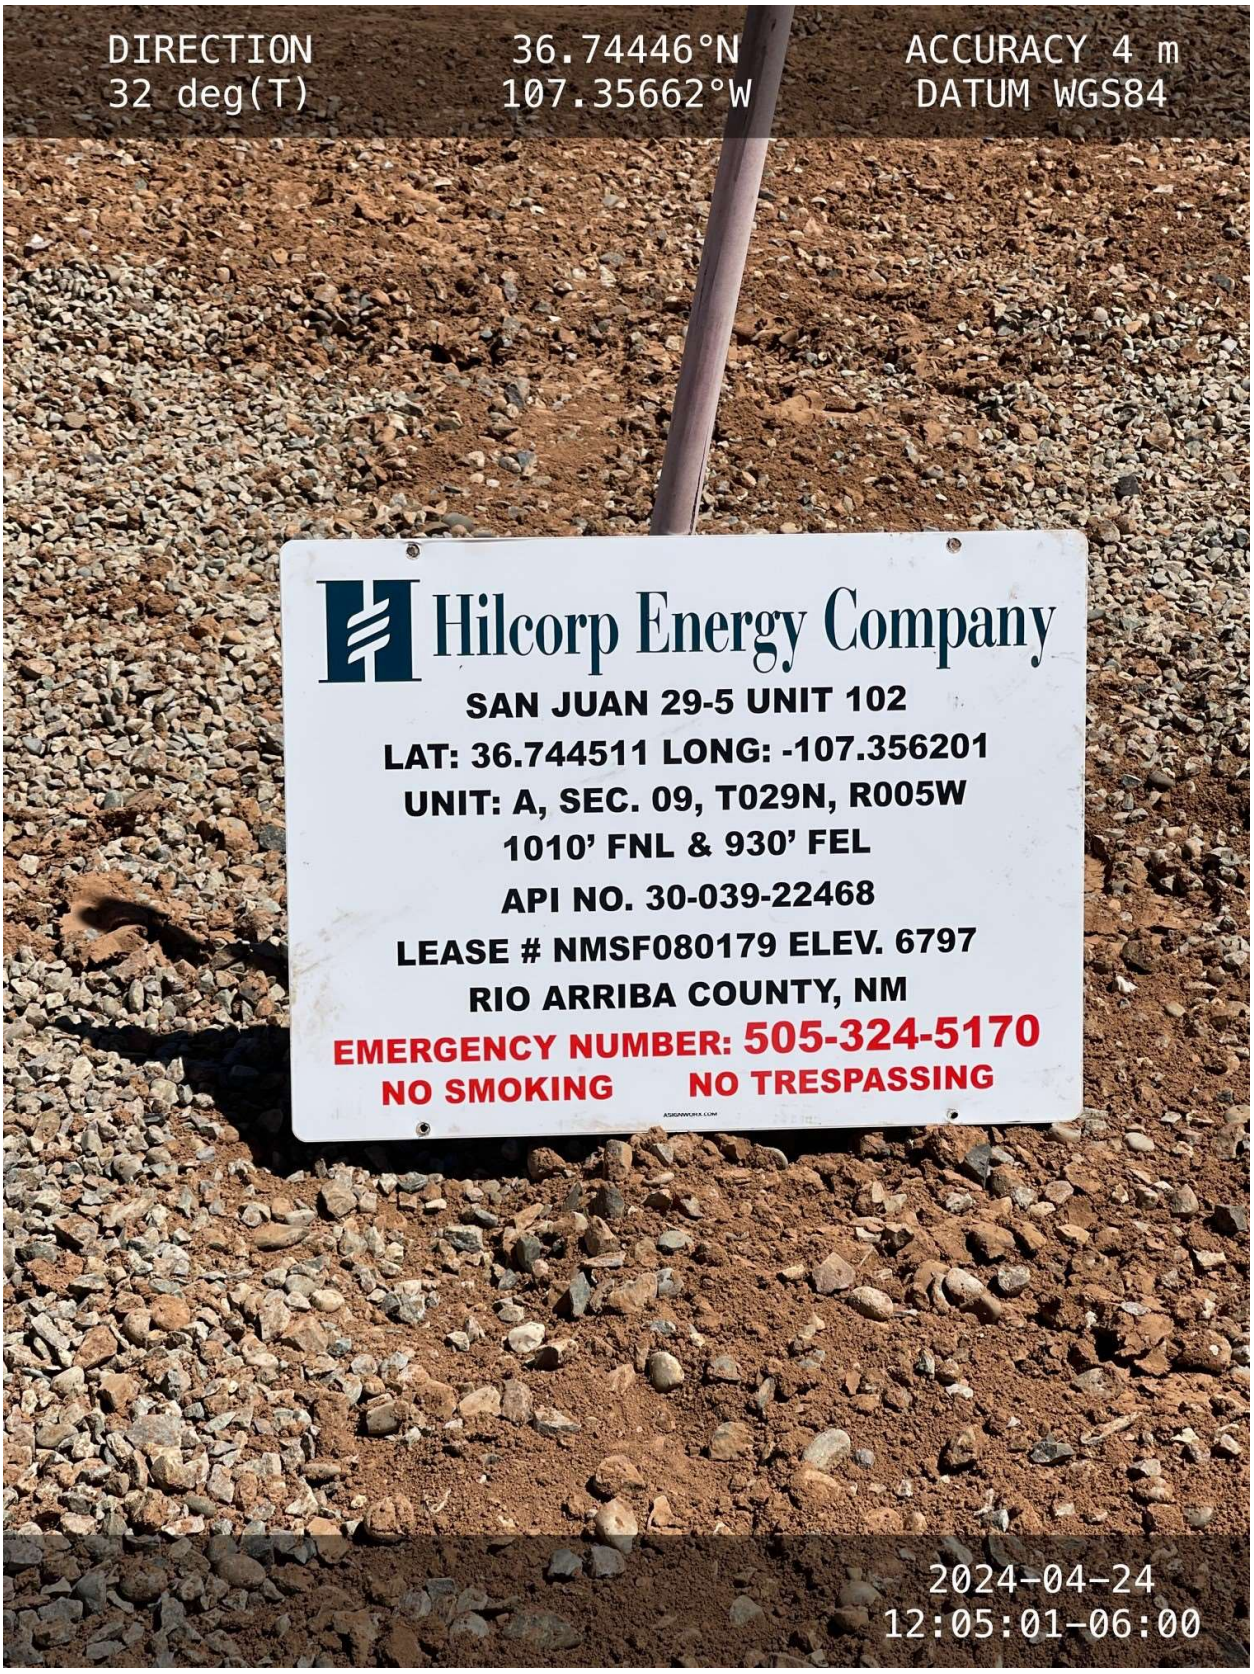
DIRECTION
32 deg(T)
36.74446°N
107.35662°W
ACCURACY 4 m
DATUM WGS84
Hilcorp Energy Company
SAN JUAN 29-5 UNIT 102
LAT: 36.744511 LONG: -107.356201
UNIT: A, SEC. 09, T029N, R005W
1010' FNL & 930' FEL
API NO. 30-039-22468
LEASE # NMSF080179 ELEV. 6797
RIO ARRIBA COUNTY, NM
EMERGENCY NUMBER: 505-324-5170
NO SMOKING
NO TRESPASSING
2024-04-24
12:05:01-06:00

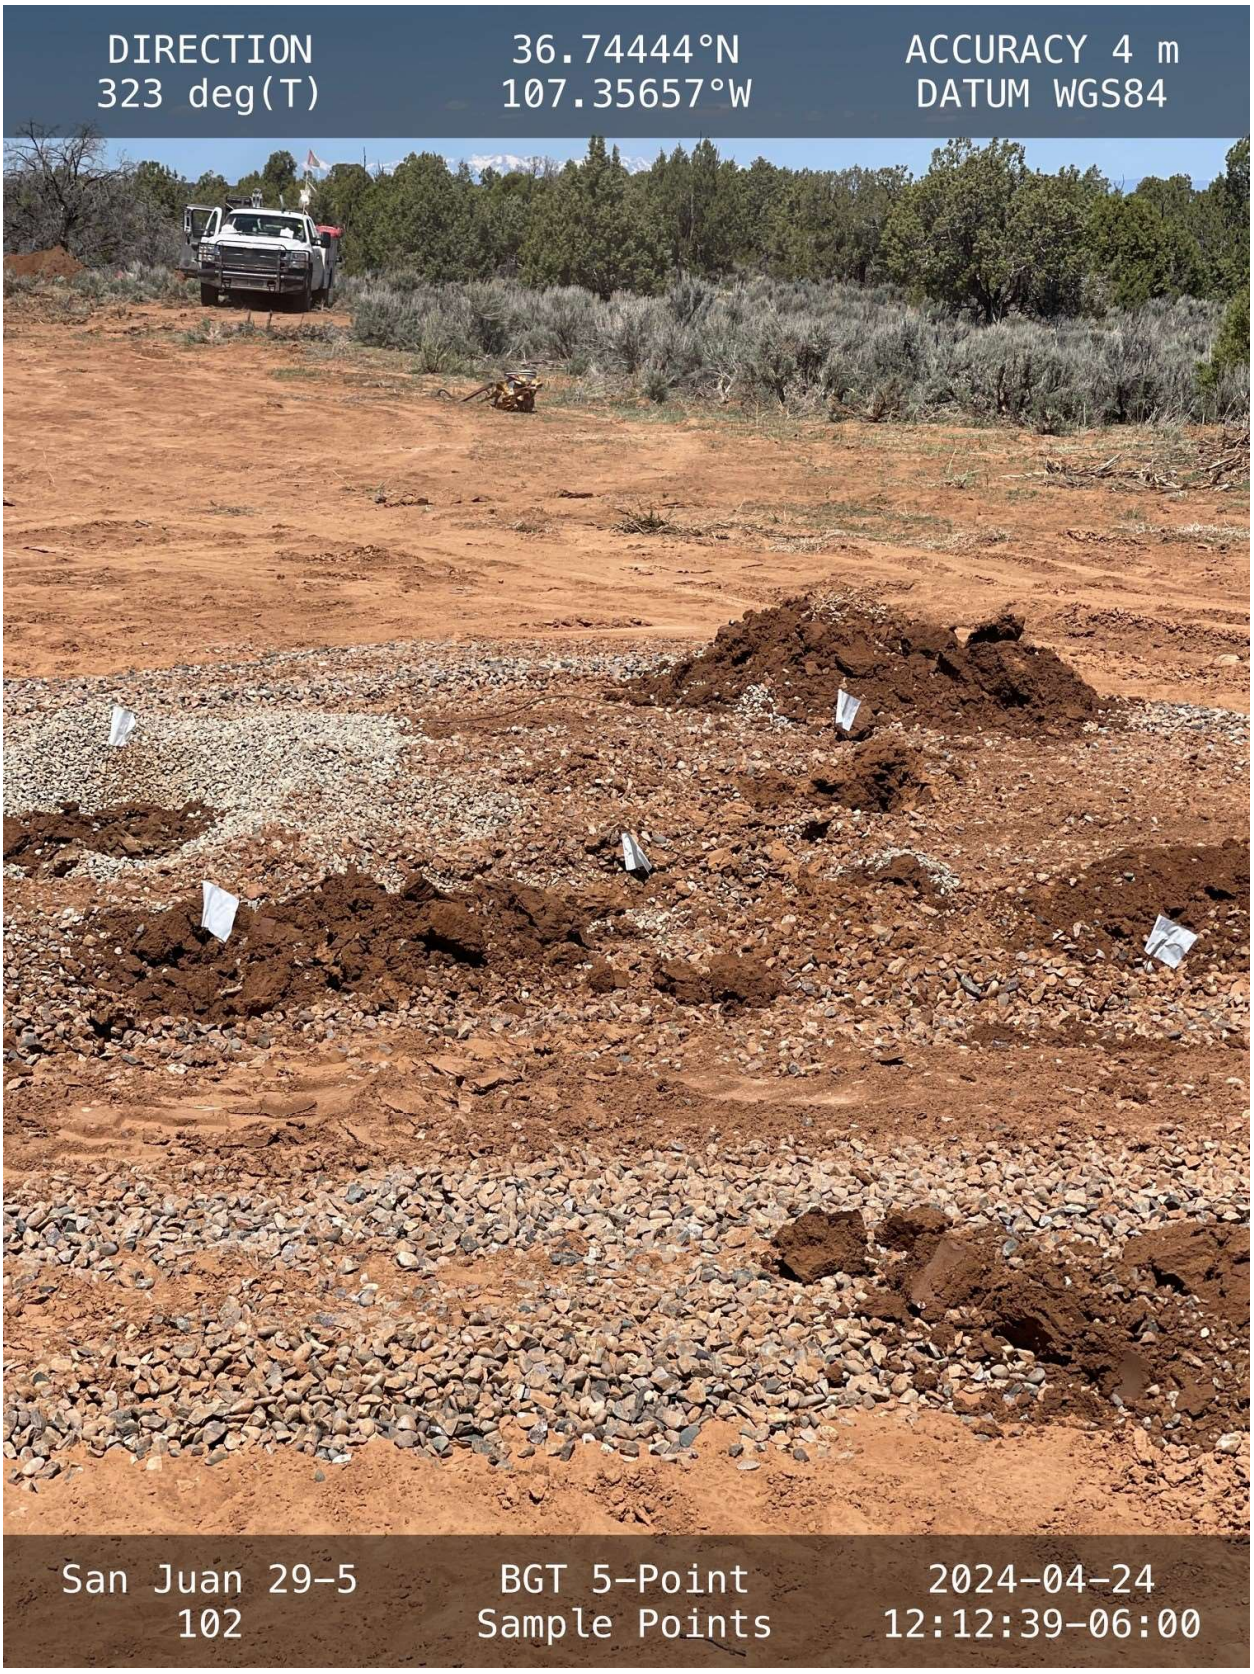
A five point composite sample was taken of the below-grade tank using sampling tools and all samples tested per Subsection B of 19.15.17.1 3(B)(1)(b). (Sample results attached). Form C-141 is attached.

DIRECTION
323 deg(T)
36.74444°N
107.35657°W
ACCURACY 4 m
DATUM WGS84
San Juan 29-5
102
BGT 5-Point
Sample Points
2024-04-24
12:12:39-06:00

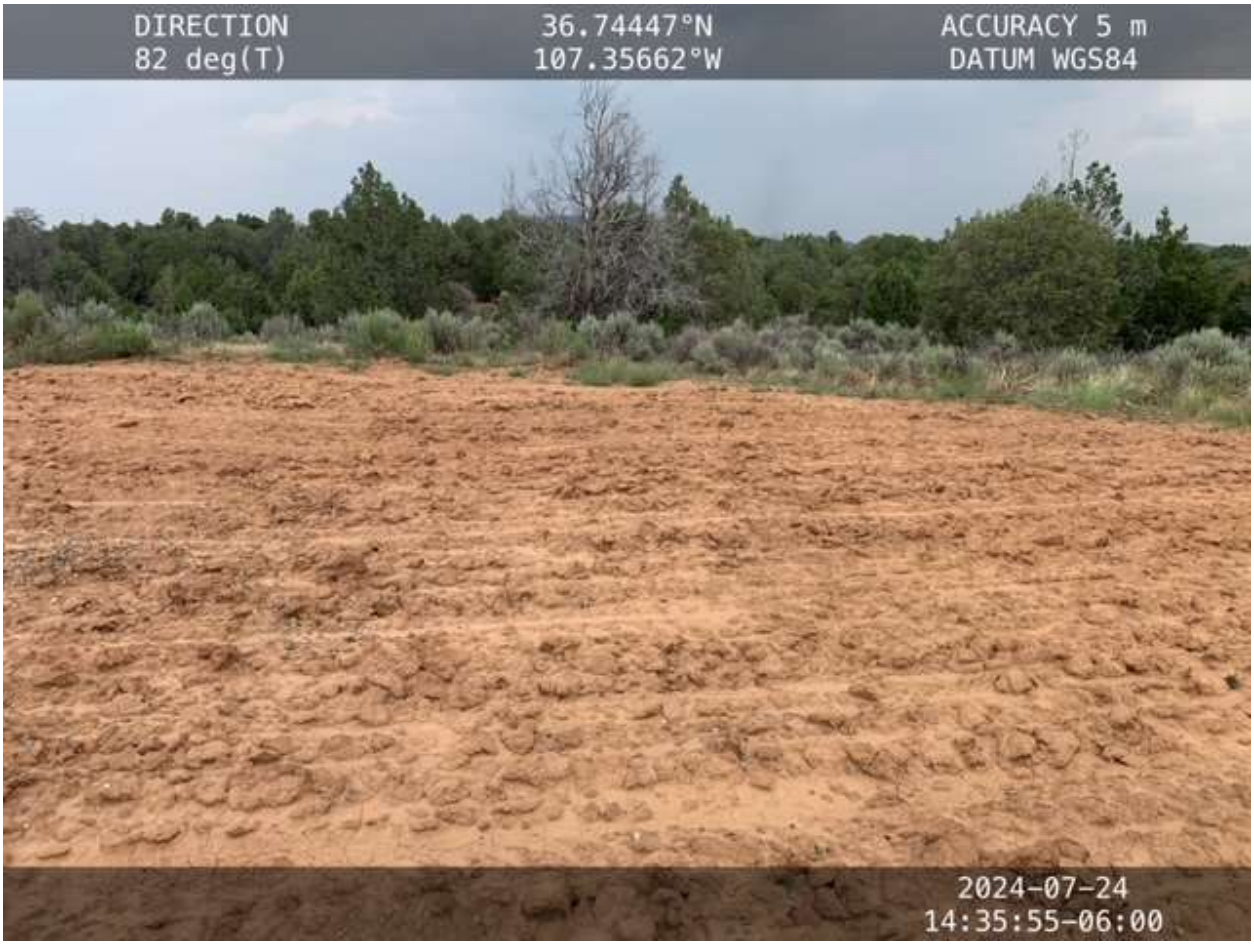
The below-grade tank area was re-contoured to match fit, shape, line, form and texture of the surrounding area. Re-shaping including drainage control, to prevent ponding and erosion. Natural drainages were unimpeded and water bars and/or silt traps were placed in areas where needed to prevent erosion on a large scale. Final recontour has a uniform appearance with smooth surface, fitting the natural landscape.

DIRECTION
82 deg(T)
36.74447°N
107.35662°W
ACCURACY 5 m
DATUM WGS84
2024-07-24
14:35:55-06:00
