Pit, Below-Grade Tank, or Proposed Alternative Method Permit or Closure Plan Application

Hilcorp Energy Company
San Juan Basin
Below Grade Tank Closure Report

Lease Name: HANCOCK B 3
API No.: 30-045-13257

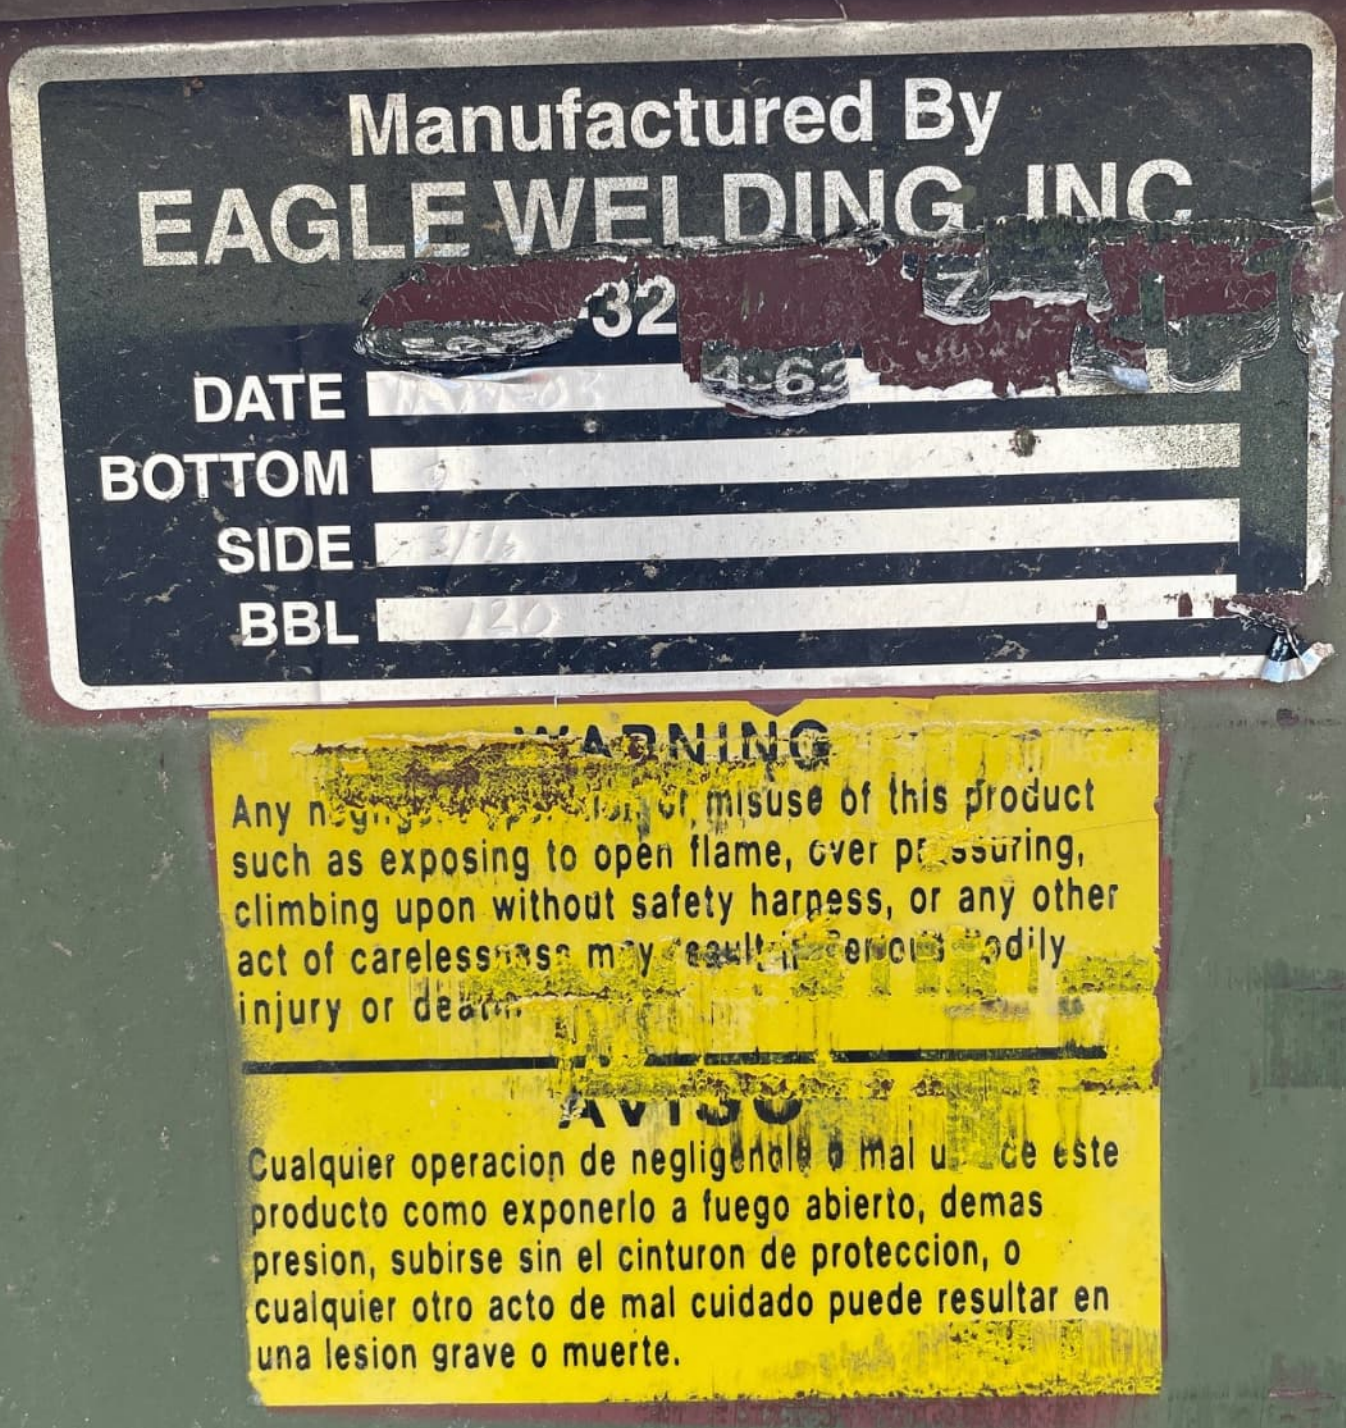
Manufactured By
EAGLE WELDING INC
32
DATE
BOTTOM
SIDE
BBL
WARNING
Any n
or misuse of this product
such as exposing to open flame, over pressuring,
climbing upon without safety harness, or any other
act of carelessness may result in serious bodily
injury or death.
Cualquier operacion de negligencia o mal u
de este
producto como exponerlo a fuego abierto, demas
presion, subirse sin el cinturon de proteccion, o
cualquier otro acto de mal cuidado puede resultar en
una lesion grave o muerte.

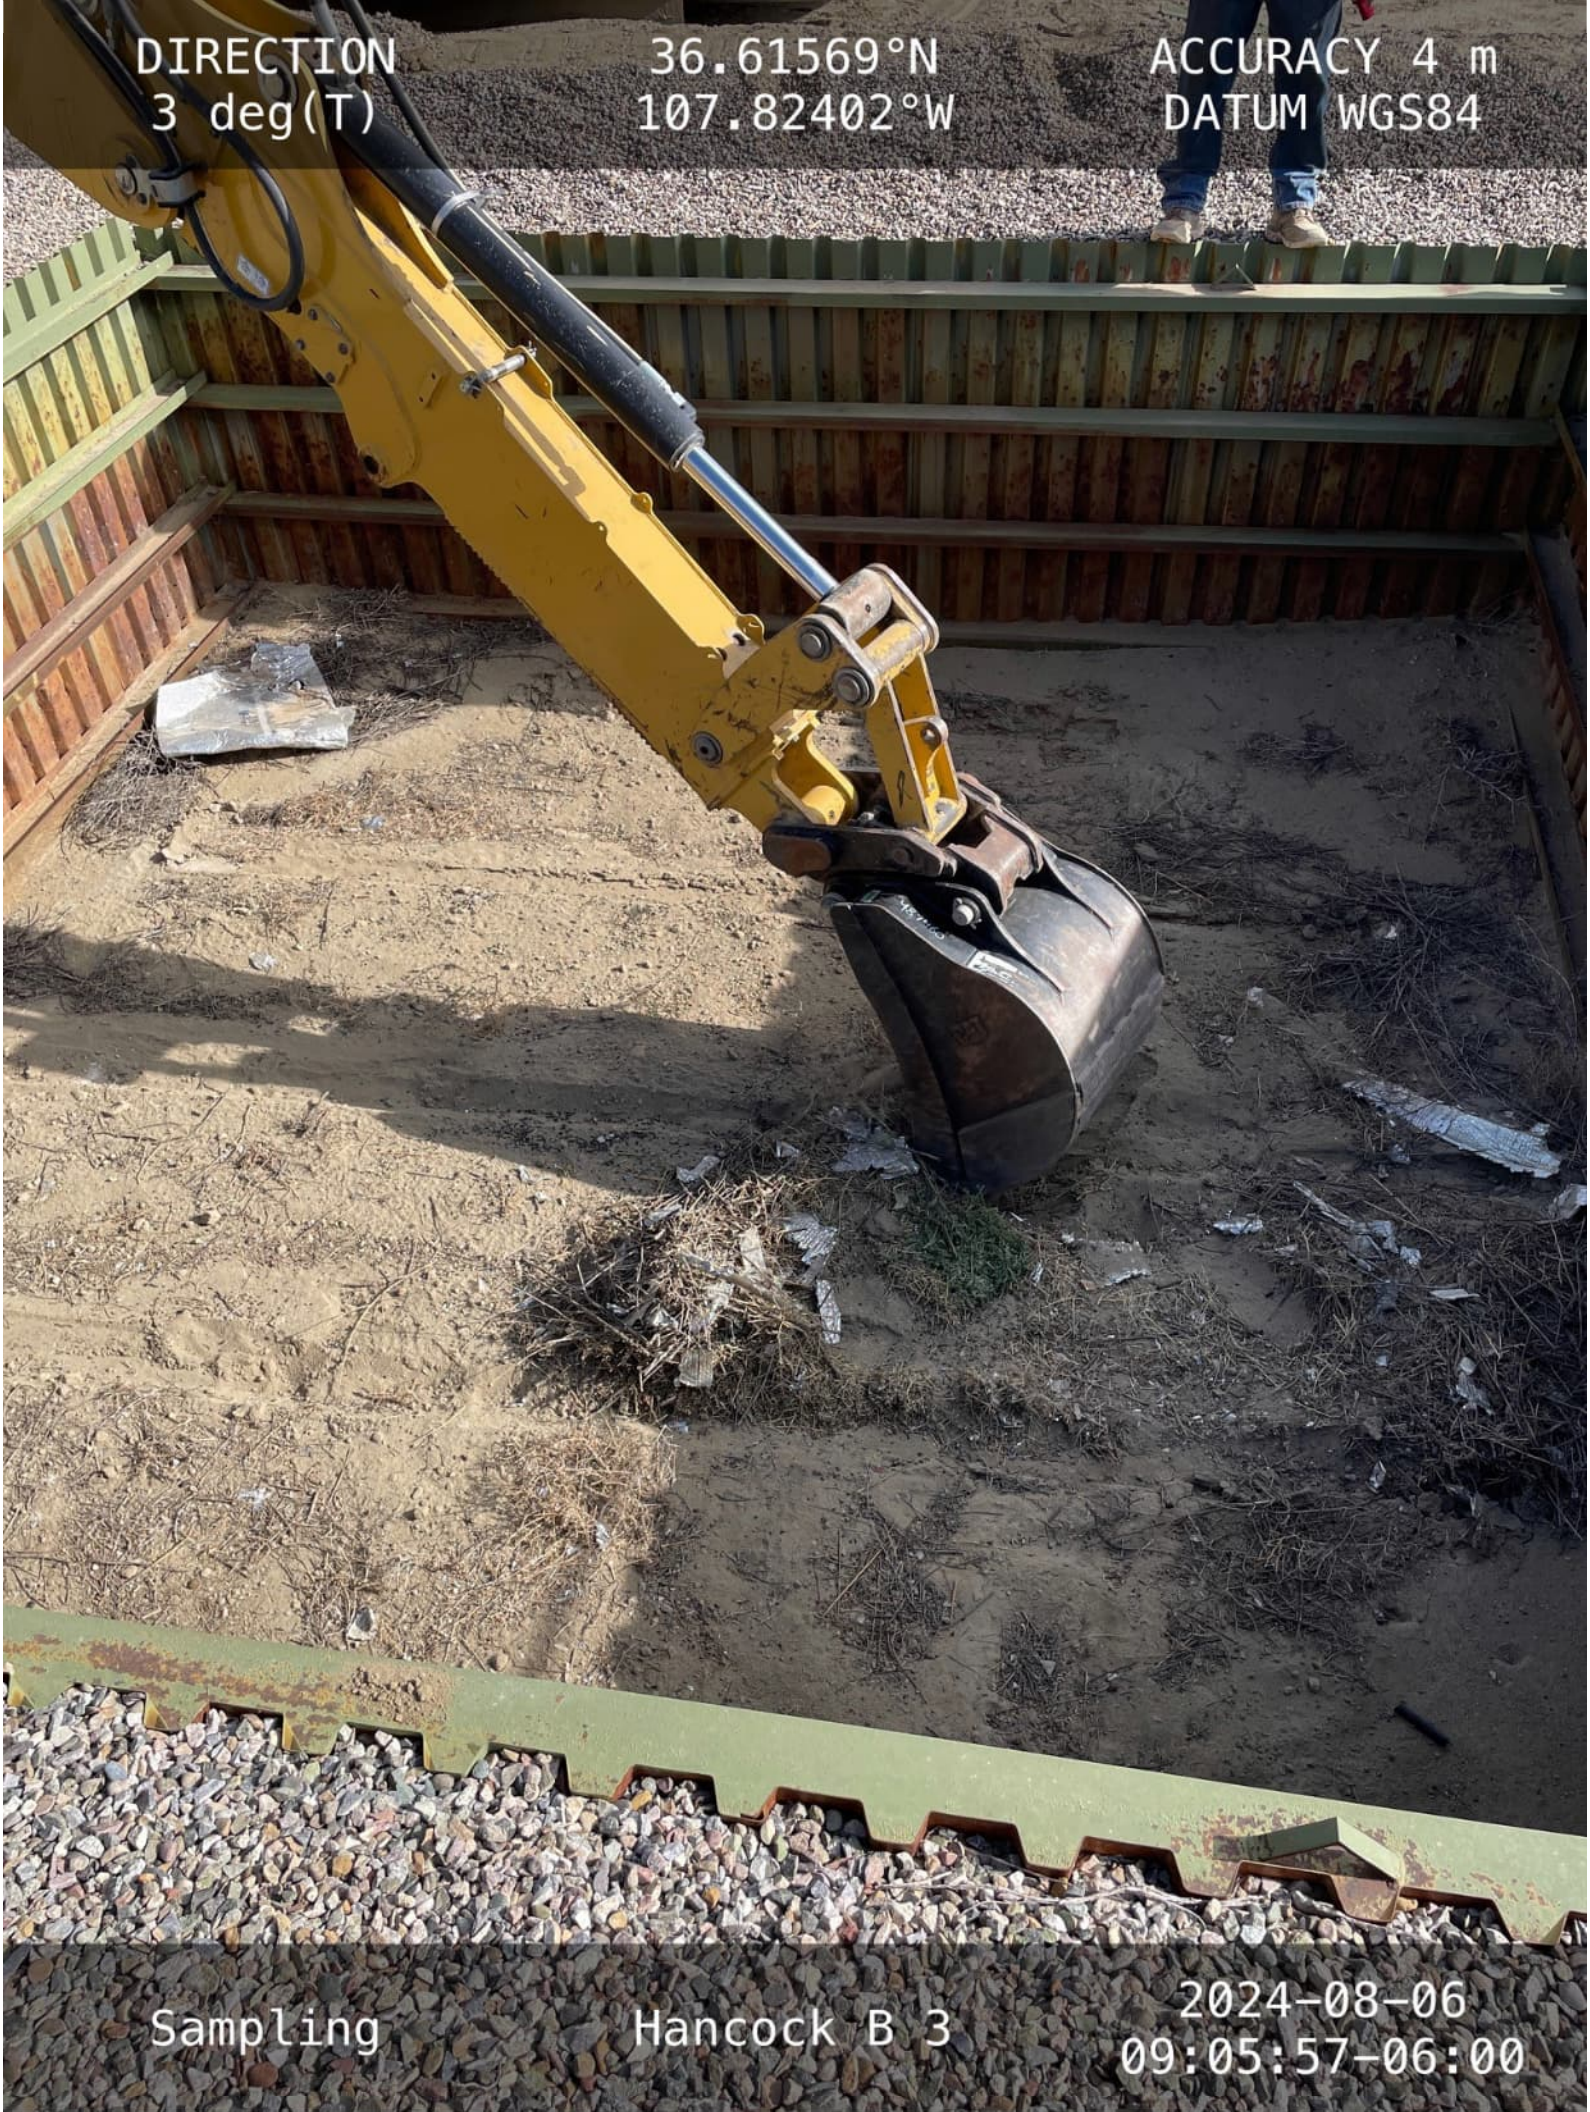
DIRECTION
3 deg(T)
36.61569°N
107.82402°W
ACCURACY 4 m
DATUM WGS84
Sampling
Hancock B 3
2024-08-06
09:05:57-06:00

A five point composite sample was taken of the below-grade tank using sampling tools and all samples tested per Subsection B of 19.15.17.1 3(B)(1)(b). (Sample results attached). Form C-141 is attached.

A release was not determined for the above referenced well.
