From: Hansen, Edward J., EMNRD
Sent: Wednesday, May 02, 2012 2:25 PM
To: Hack Conder (hconder@riceswd.com)
Cc: Leking, Geoffrey R, EMNRD; Katie Jones <kjones@riceswd.com> (kjones@riceswd.com); Laura Pena (lpena@riceswd.com); Scott Curtis (scurtis@riceswd.com)
Subject: Remediation Plan (1R425-29) Termination - ROC Vacuum F-30-1 Vent Site

RE: Termination Request
Vacuum F-30-1 vent (1R425-29): UL/F, Sec. 30, T17S, R35E
RICE Operating Company – Vacuum SWD System

RICE OPERATING COMPANY
JUNCTION BOX FINAL REPORT

Vacuum F-30-1 vent

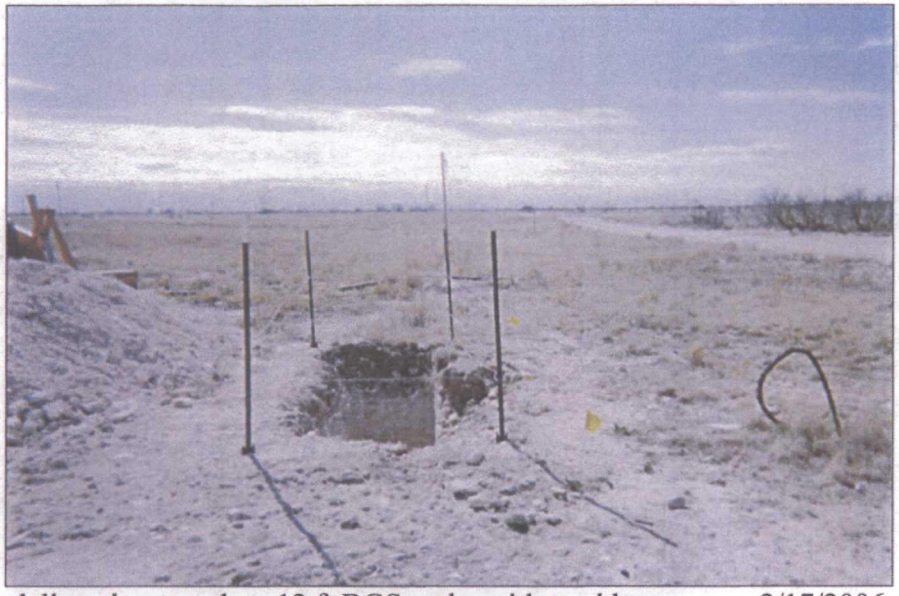
undisturbed junction box 7/11/2005

delineation trench to 12 ft BGS make with trackhoe 2/17/2006

backfilling delineation trench 2/17/2006

seeding backfilled location 3/21/2006
