Pit, Closed-Loop System, Below-Grade Tank, or Proposed Alternative Method Permit or Closure Plan Application

REMEDIATION SUMMARY &

SITE CLOSURE REQUEST

SOUTHERN UNION GAS SERVICES
TRUNK "O" TANK BATTERY (1RP-1800)
HISTORICAL RELEASE SITE
Lea County, New Mexico
Unit Letter "H" (SE/NE), Section 28, Township 20 South, Range 37 East
Latitude 32° 32.326' North, Longitude 103° 17.689' West
NMOCD Reference # 1RP-1800

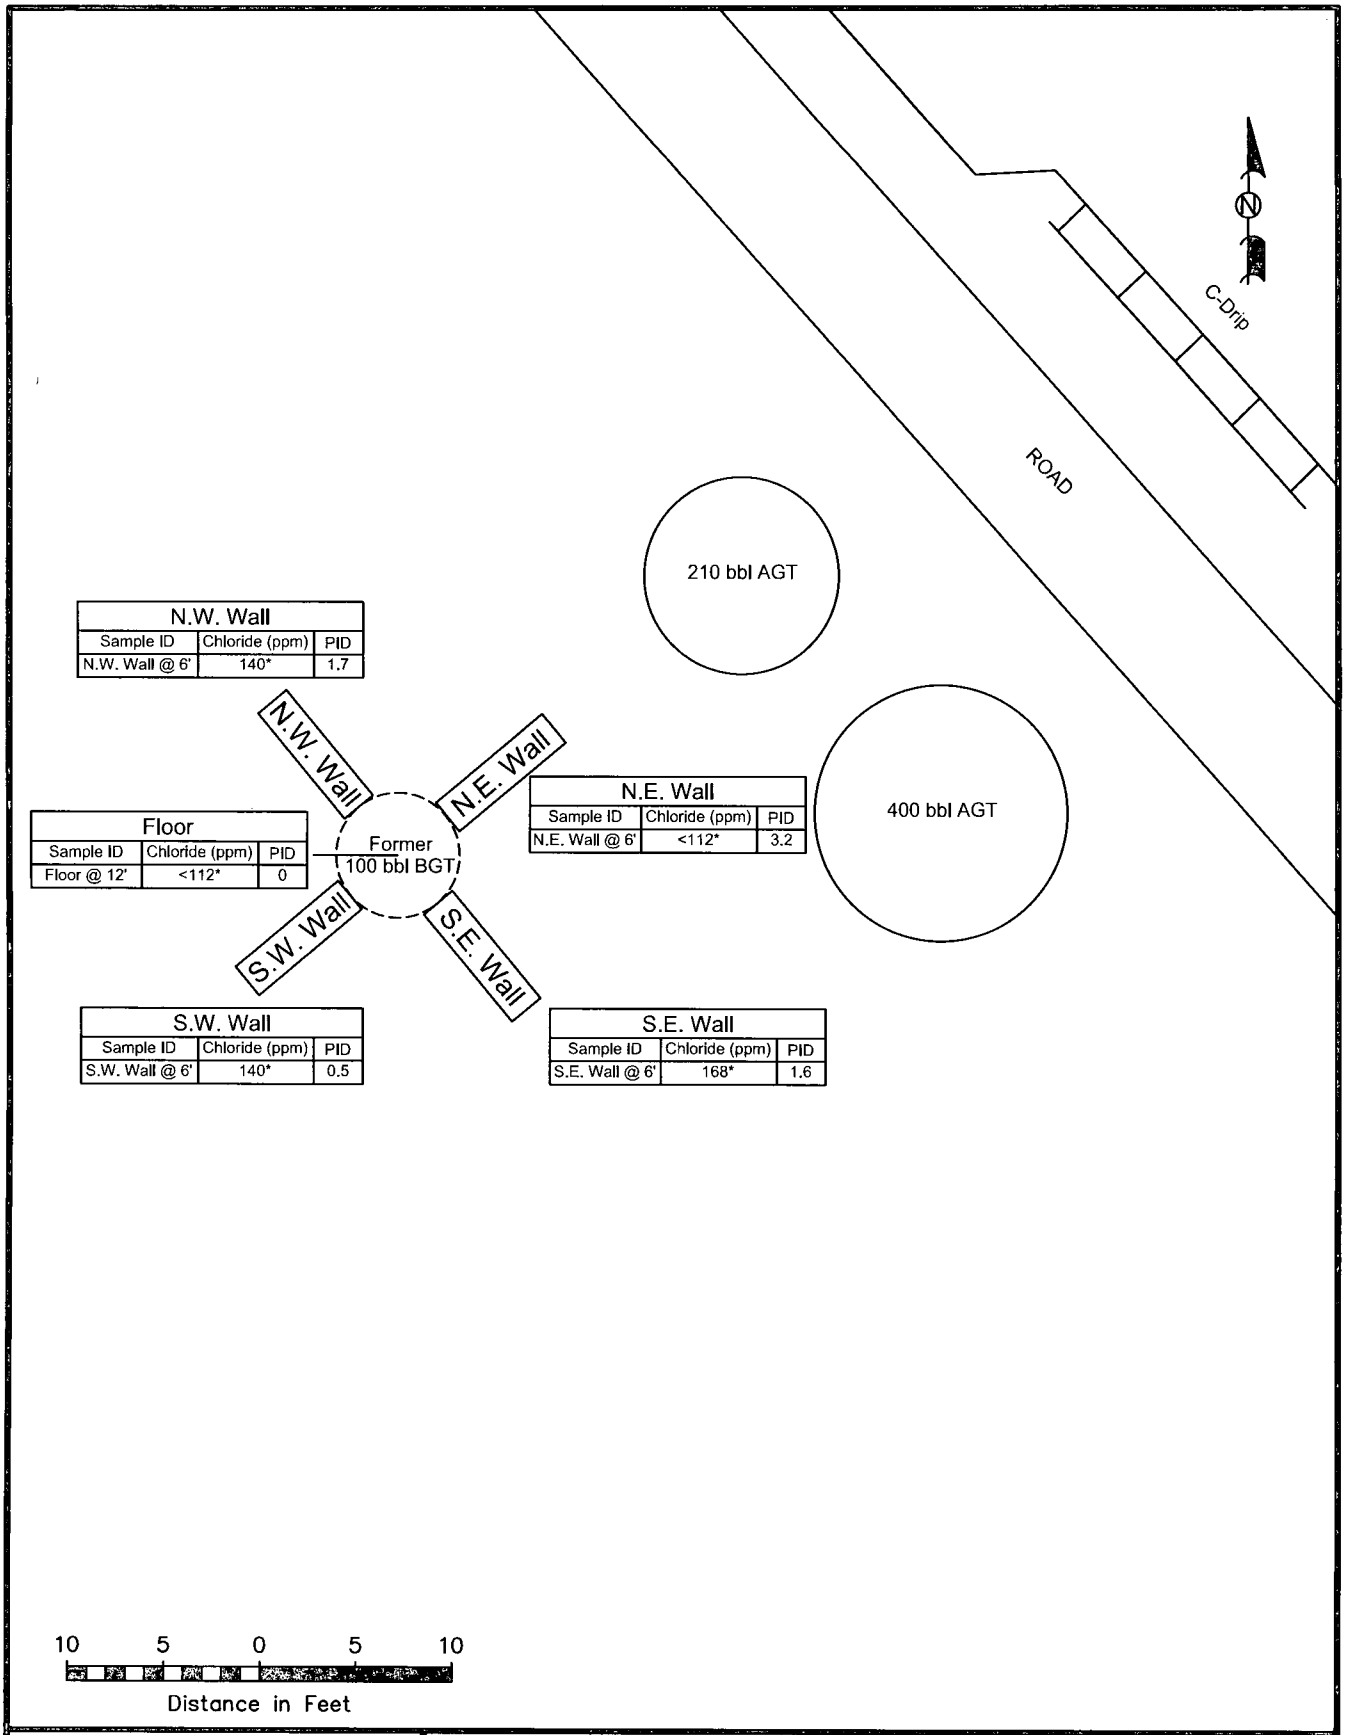
Figure 2
Site & Sample Location Map
Southern Union Gas Services
Trunk "O" Tank Battery (1RP-1800)
Lea County, NM

Prior to excavating the former BGT location, one (1) surface soil sample (Surface) was collected from the inferred center of the former BGT location and submitted to Permian Basin Environmental Lab, LP, of Midland, Texas for determination of BTEX, TPH and chloride concentrations in accordance with EPA Methods SW 846-8021B, SW 846-8015M and 300.0. Laboratory analytical results indicated benzene and BTEX concentrations were less than the appropriate laboratory method detection limit (MDL). Analytical results indicated the TPH concentration was less than the laboratory MDL. The chloride concentration was 31.6 mg/Kg. Table 1 summarizes the "Concentrations of Benzene, BTEX, TPH & Chloride in Soil". Soil sample locations are depicted in Figure 2, "Site & Sample Location Map". Laboratory analytical reports are provided as Appendix B.

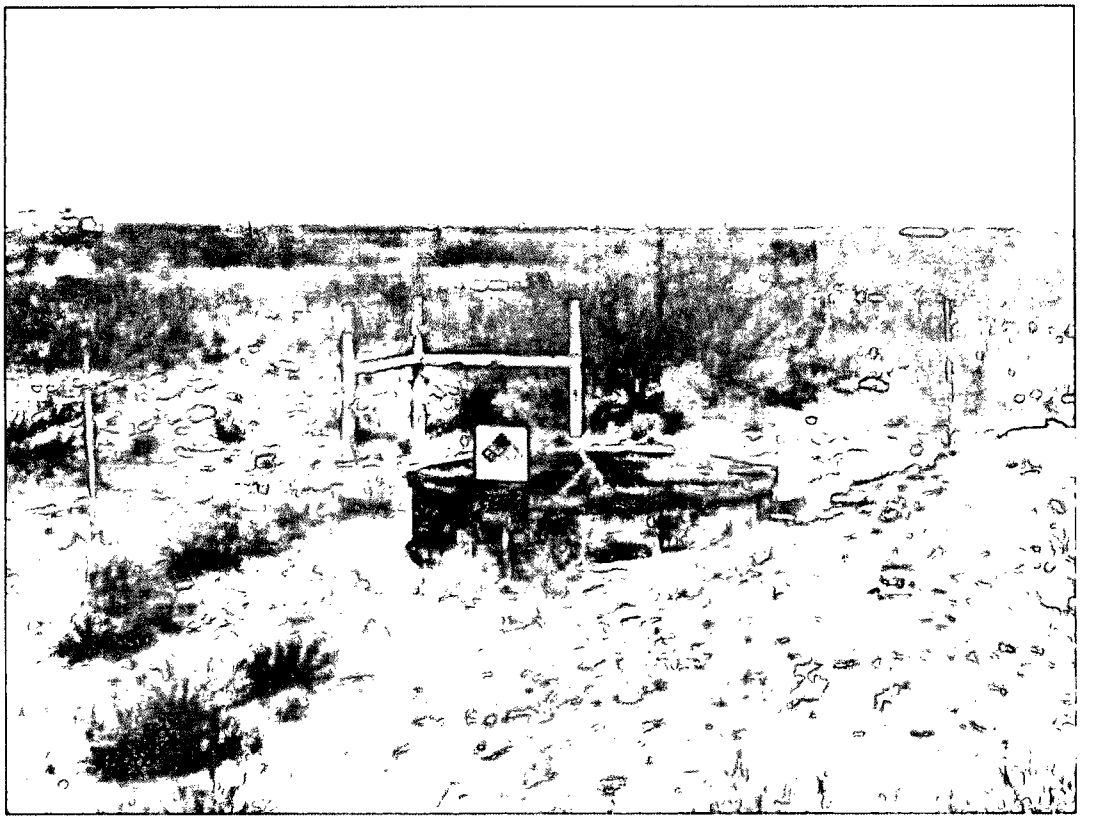
Photograph of Below Grade Tank prior to removal at the Trunk "O" Tank Battery.

Photograph of exhumed Below Grade Tank at the Trunk "O" Tank Battery.

Photograph of the area excavated during Below Grade Tank removal at the Trunk "O" Tank Battery.

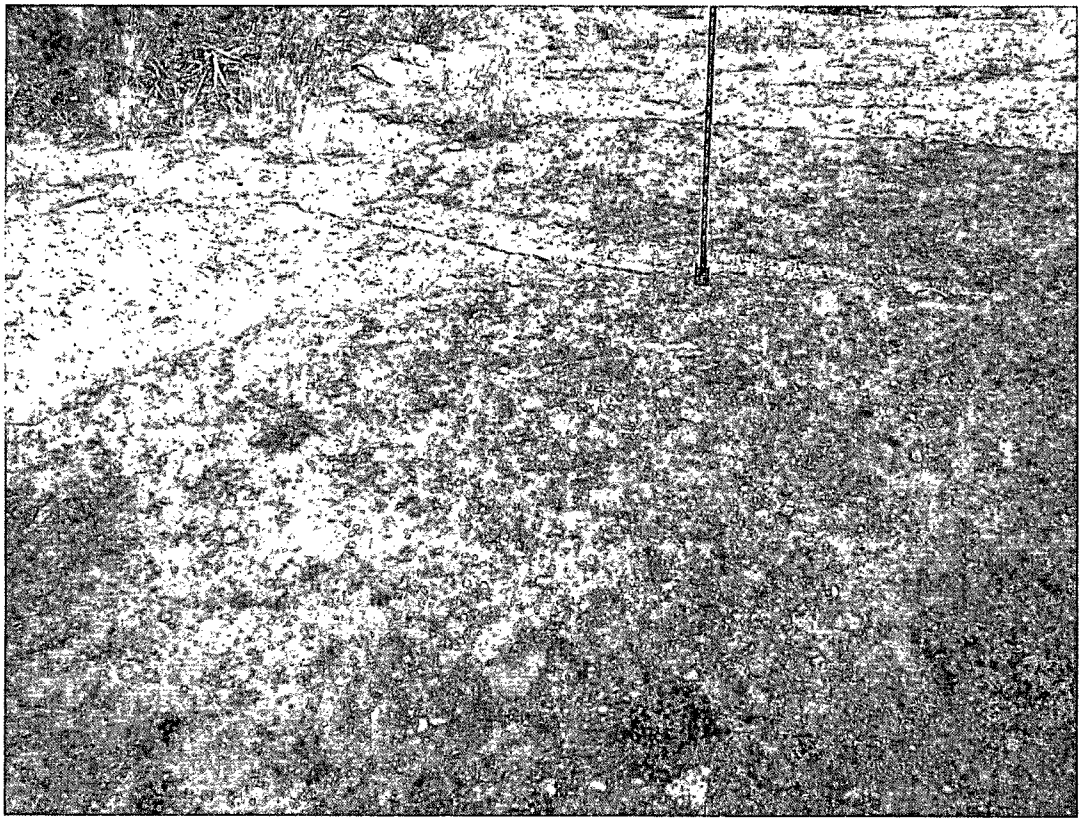
Photograph of Former Below Grade Tank Location prior to Initial Investigation
at the Trunk "O" Tank Battery

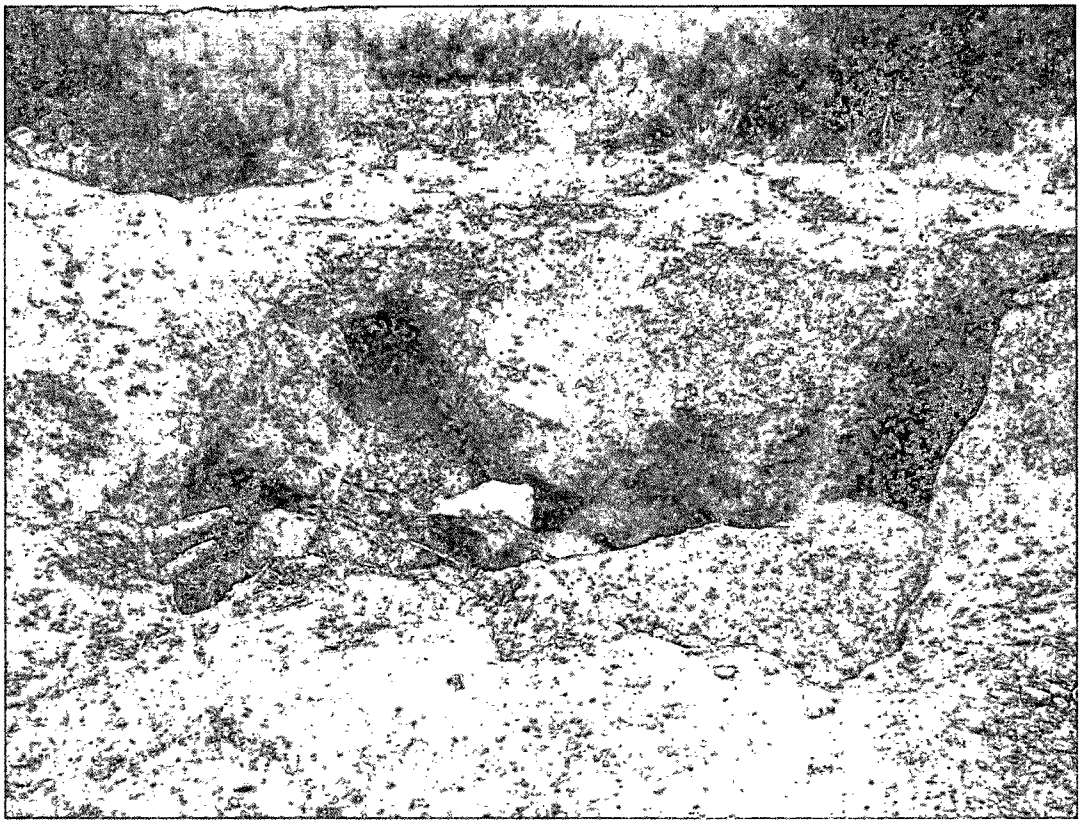
Photograph of excavation and delineation trenches advanced during initial investigation at the Trunk "O" Tank Battery.

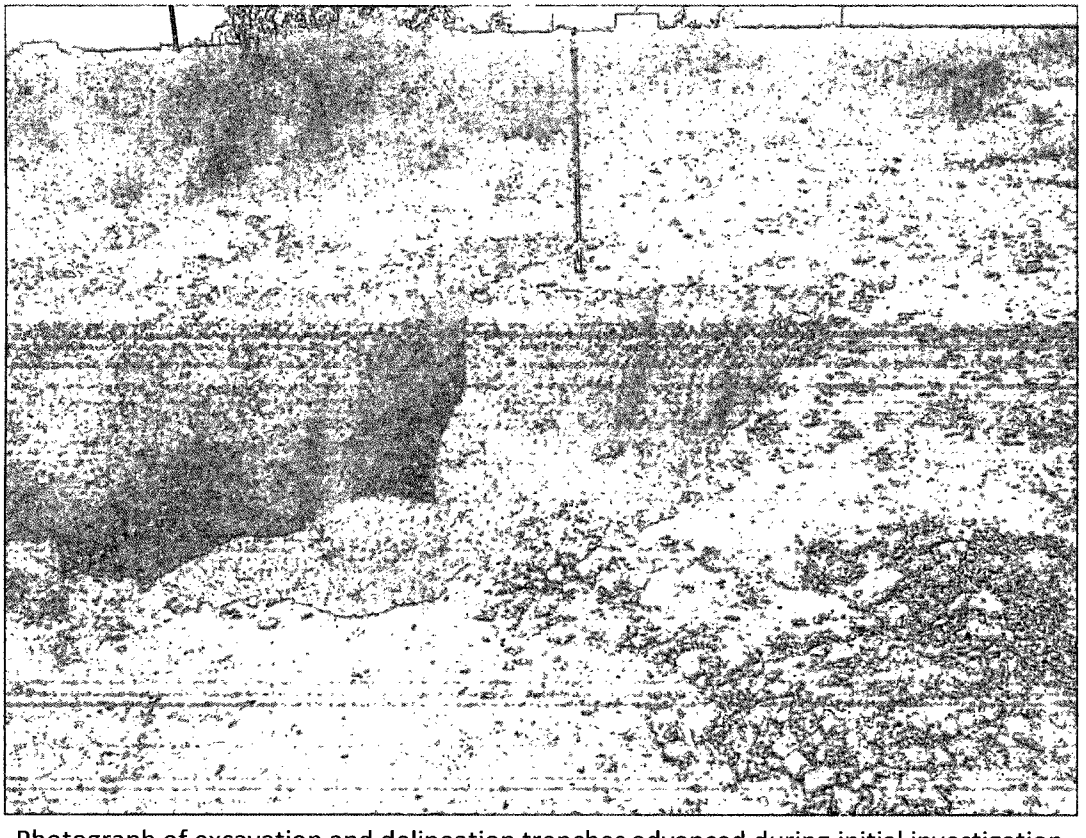
Photograph of excavation and delineation trenches advanced during initial investigation at the Trunk "O" Tank Battery.

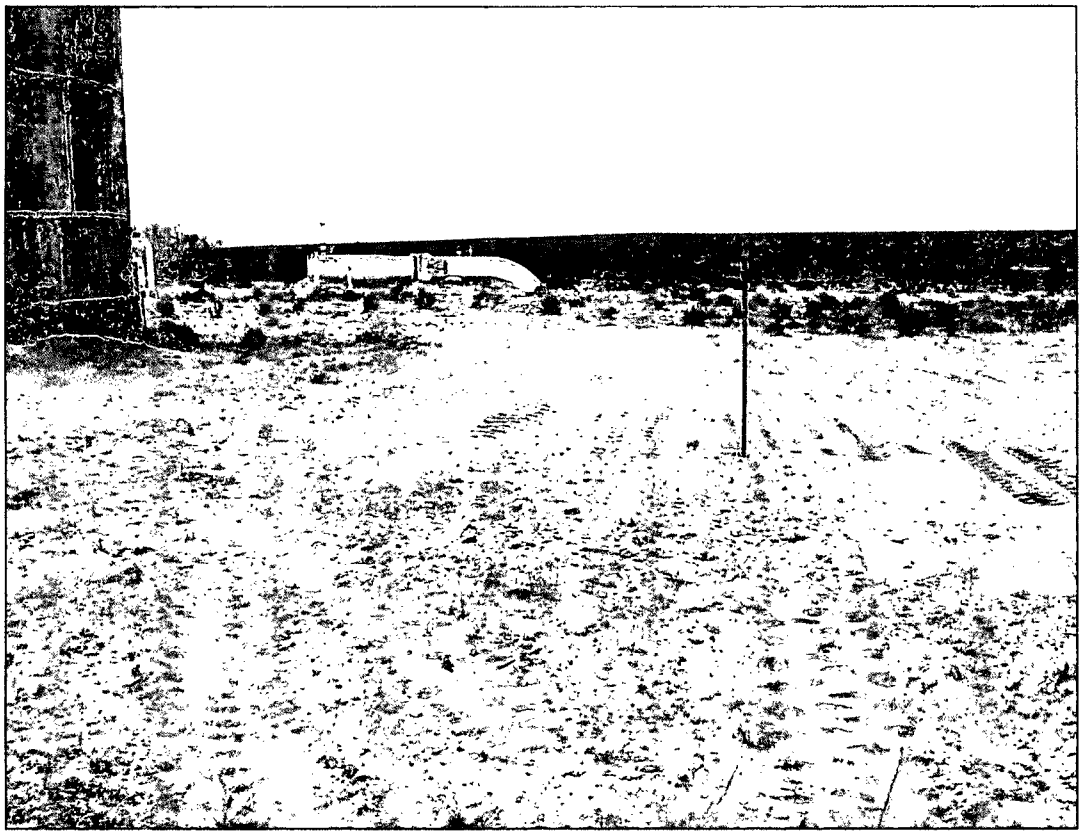
Photograph of backfilled excavation at the Trunk "O" Tank Battery.

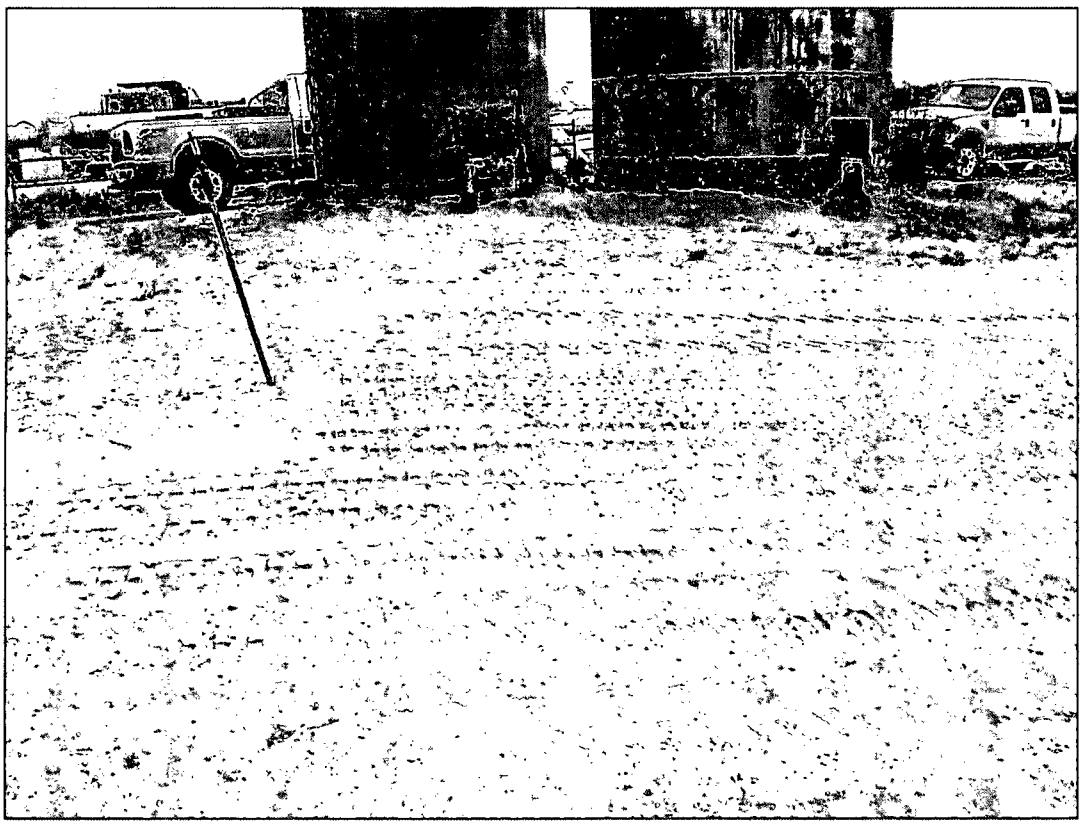
Photograph of backfilled excavation at the Trunk "O" Tank Battery.
