Pit, Below-Grade Tank, or Proposed Alternative Method Permit or Closure Plan Application

1.
Operator: Williams Four Corners LLC OGRID #:
Address: 1755 Arroyo Drive, Bloomfield, NM 87413
Facility or well name: Kernaghan Compressor Station (BGT 1)
API Number: C-144B 16232 OCD Permit Number: 16232
U/L or Qtr/Qtr SW/NW (E) Section 29 Township 31N Range 8W County: San Juan
Center of Proposed Design: Latitude 36.869783 Longitude -107.707055 NAD: ☐1927 ■1983
Surface Owner: ■ Federal ☐ State ☐ Private ☐ Tribal Trust or Indian Allotment

Williams Four Corners LLC
Below Grade Tank Closure Report
Facility Name: Kernaghan Compressor Station (BGT 1)
API Number: C-144B 16232
Permit Number: 16232

Remediation Excavation and Sampling Form

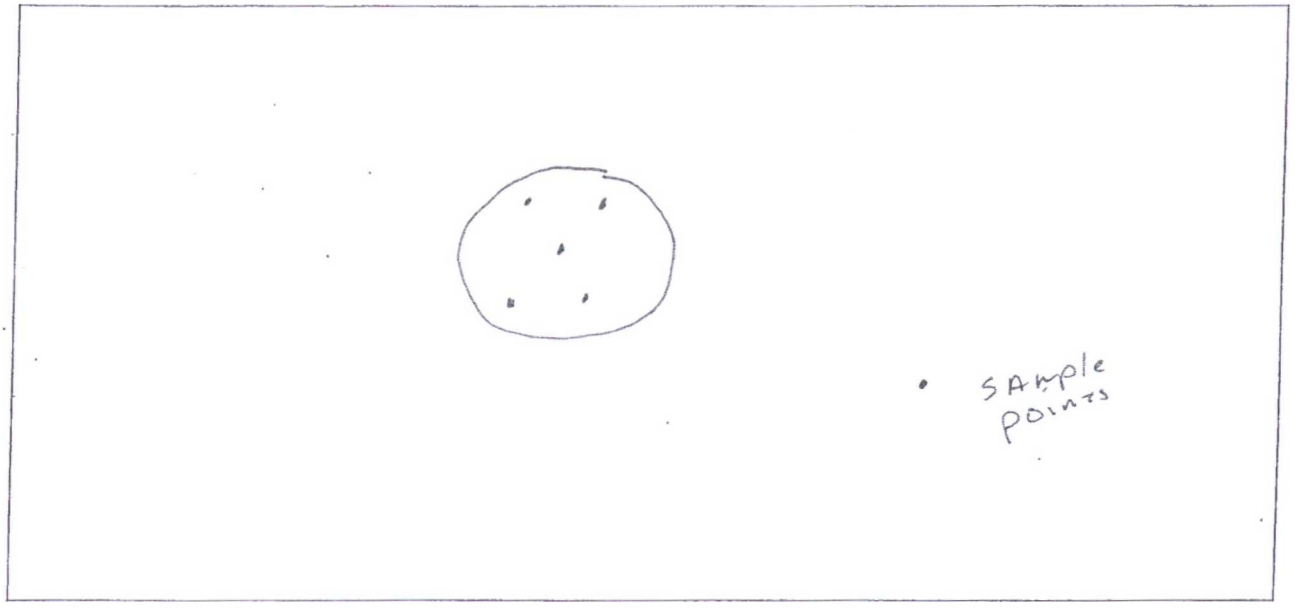
Excavation Diagram and Sample Locations

10' Length 10' Width 6' Depth

Sample ID	Sample Date	Type (Composite, Grab)	Location (Floor, Sidewall)	Comments
Ker-1-comp	3-1-18	comp.	Floor	no stain or odor
