Investigation and Characterization Report and Termination Request
Rice Operating Company – EME SWD System
O-19 Jct
UL O Sec 19 T 20S R 37E
NMOCD Case Number: 1R427-06

July 27th, 2009
(updated from April 7th, 2009 report)

O-19 Jct
UL O Sec 19 T 20S R 37E
NMOCD Case Number: 1R427-06

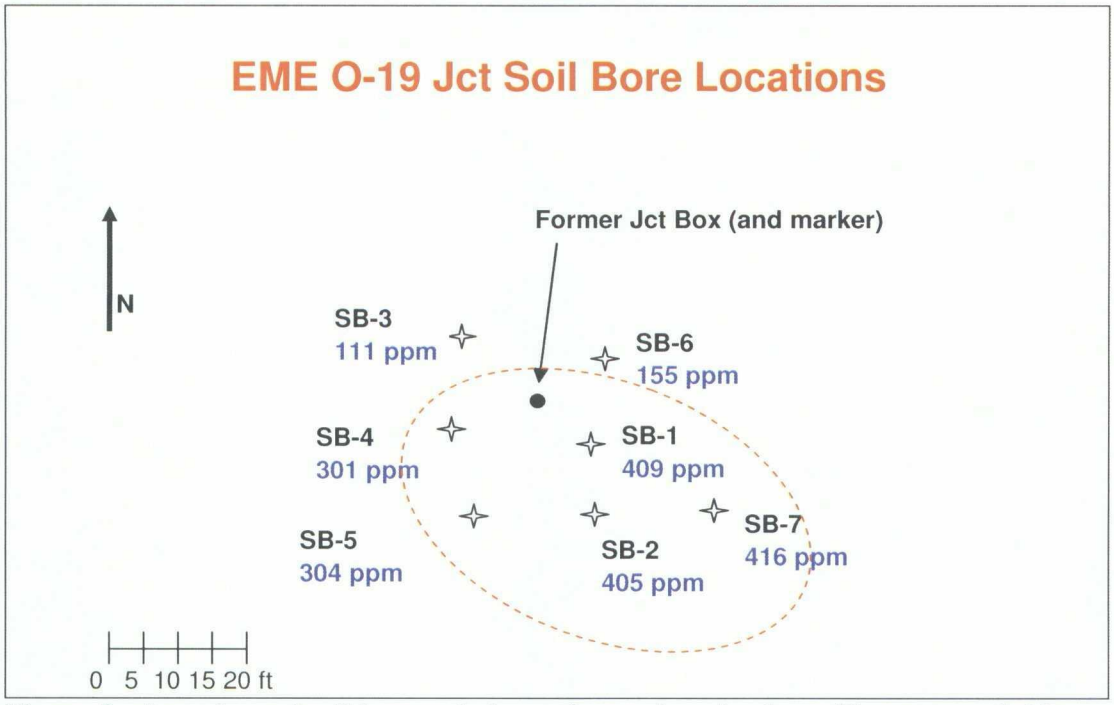
Seven soil borings were advanced near and around the location of the former junction box to depths of 20 ft bgs where the water table capillary fringe was encountered (Figure 3). The average soil chloride concentration from the sample points within the affected area is 367 ppm. It assumed that the natural background depth-averaged soil chloride concentration is 100 ppm We thus calculate the increase in depth-averaged residual soil chlorides from the former junction box to be 267 ppm (367 ppm – 100 ppm; Figures 3 & 4). The total mass of residual soil chlorides believed to be contributed by the former junction box was estimated to be 1,258 lbs (Figure 5). Soil petroleum hydrocarbons were insignificant (below 1.0 ppm by PID and below laboratory detection; Appendices B & C).

Figure 3 – Locations of soil bores relative to former junction box. The average field-measured, depth-averaged soil chloride concentrations are given for depths 0 to 20 ft bgs (at the water table capillary fringe). The dashed, red ellipse approximates the area (of 2,120 sq ft) encompassing average soil chloride concentrations greater than 250 ppm. The average soil chloride concentration from the sample points within this affected area is 367 ppm. It assumed that the natural background depth-averaged soil chloride concentration is 100 ppm.. We thus calculate the increase in depth-averaged residual soil chlorides due to the former junction box to be 267 ppm (367 ppm – 100 ppm).

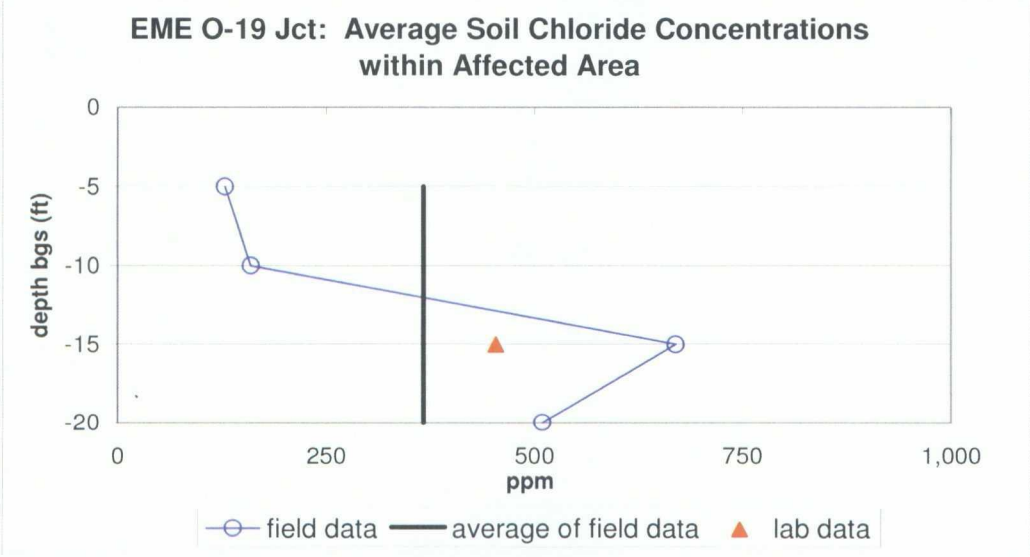
Depth (ft below ground surface)	Field Chloride Test (ppm)	Lab Chloride Test (ppm)	Field PID test (ppm)	Lab GRO test (ppm)	Lab DRO test (ppm)	Cutting Description
0						
-5	129		14			pale brown fine sand
-10	160		6			"
-15	670	454	1	< 25.0	< 25.0	light brownish gray silt
-20	509		6			light brownish gray sand, moist
avg	367		7

Figure 4 – Average soil chloride and petroleum hydrocarbon concentrations from five soil borings taken at/near the former junction box location within the affected area.

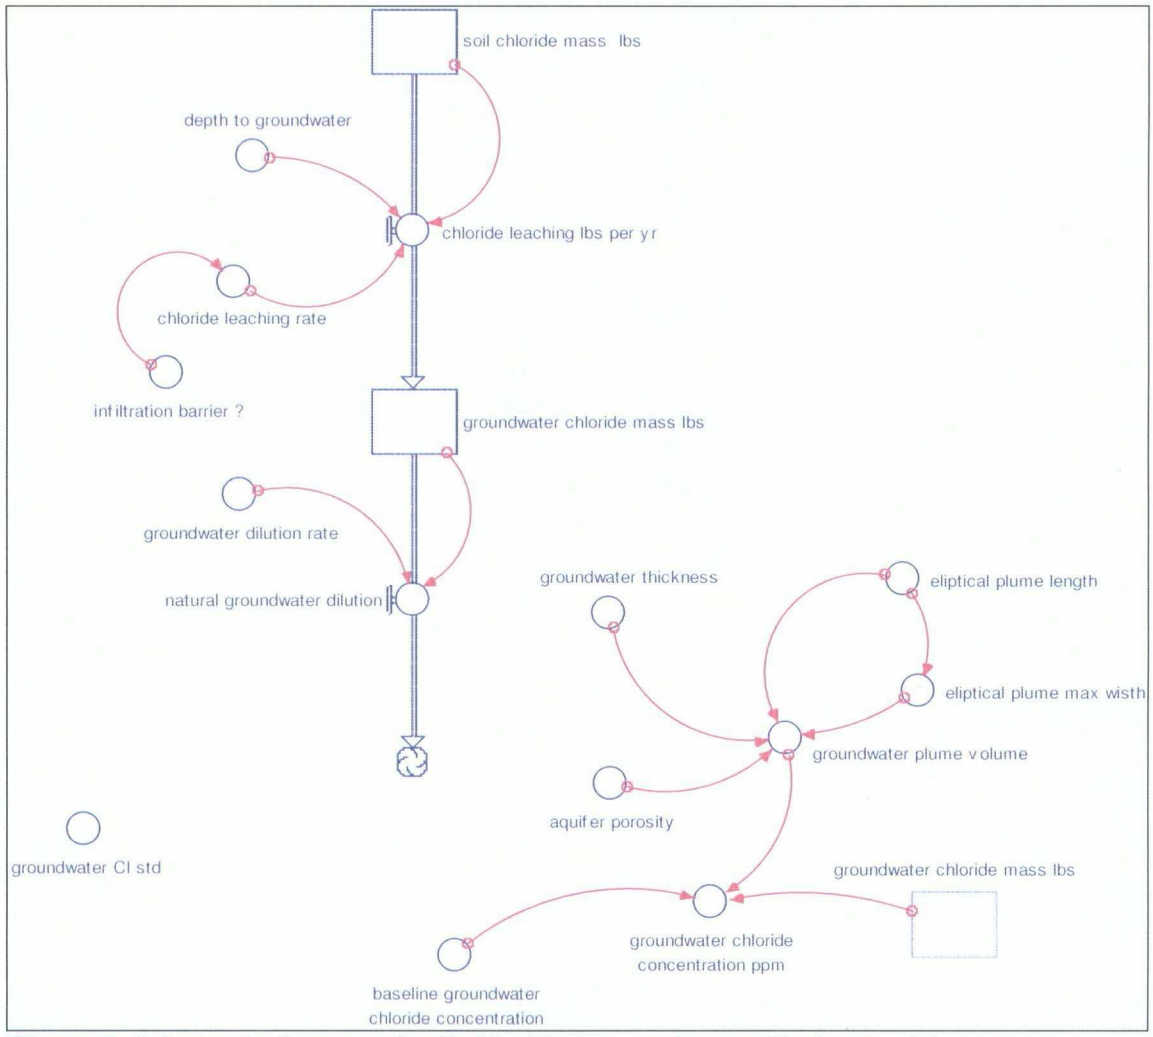
In order to determine if the residual soil chlorides represent a potential hazard to down gradient groundwater, a simple soil chloride transport and groundwater dilution model (Figures 6 & 7) was developed to estimate the potential effects on groundwater quality given the following assumptions:

1. The center of mass of residual chlorides moves downward at a rate of 2.0 ft/yr.
2. It is assumed that these chlorides mix uniformly within an elliptical groundwater plume of dimensions 250 ft maximum length by 100 ft maximum width through a depth of 10 ft of the water table aquifer.
3. Natural dilution of the plume occurs at a rate of 10% per year.

Figure 6- Schematic diagram of soil chloride – groundwater dilution model.

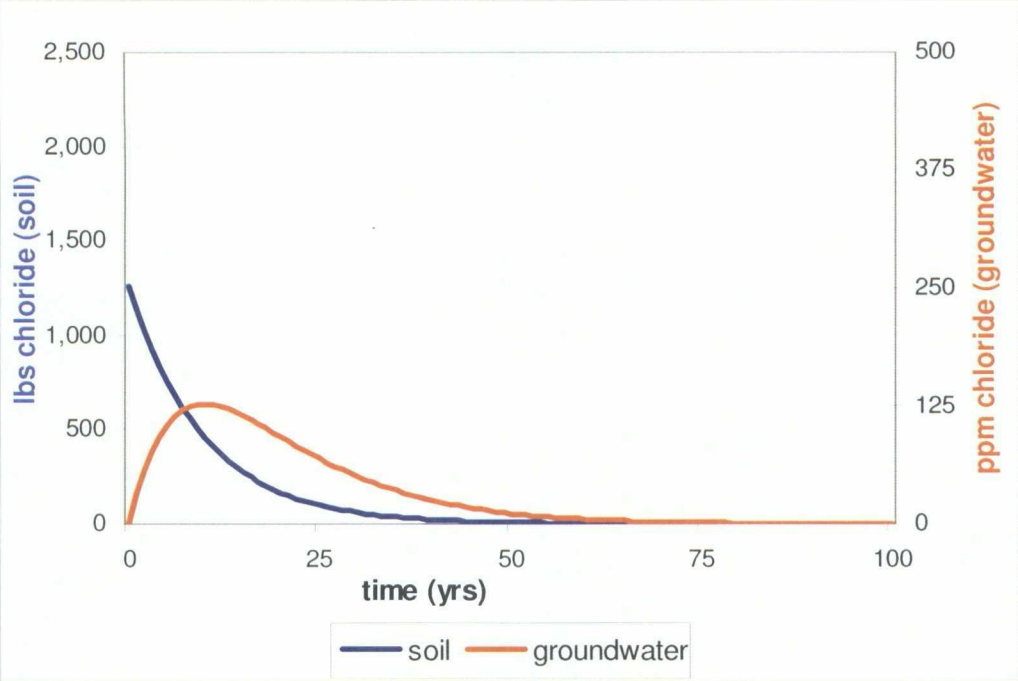
The model predicted that maximum anticipated elevation of groundwater chlorides caused by the movement of residual soil chlorides is under 150 ppm (Figure 8), indicating that residual soil chlorides should not represent a hazard to groundwater quality.

Figure 8 – Estimated change in baseline groundwater chloride concentrations (right axes) over time within a hypothetical plume originating at the former junction box and extending down-gradient for 250 ft and having a maximum width of 100 ft. The maximum anticipated elevation in groundwater chlorides in a reference plume of 250 ft in length by 100 ft in width due to the former junction box is less than 150 ppm.

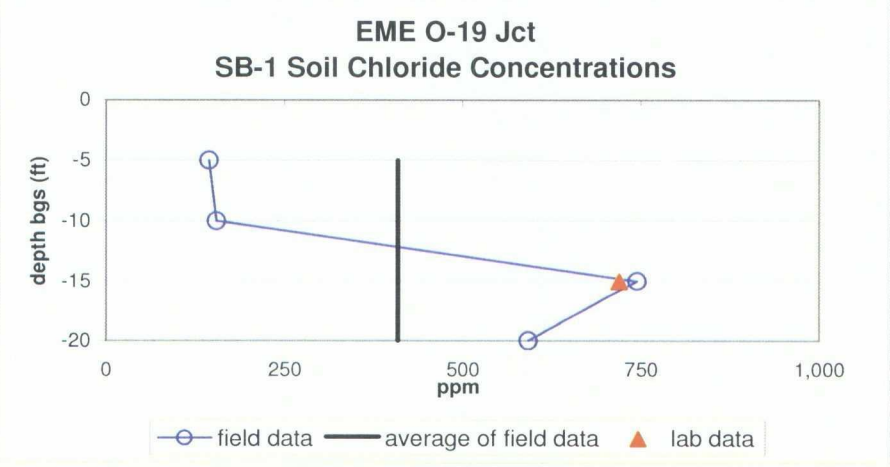
Depth (ft below ground surface)	Field Chloride Test (ppm)	Lab Chloride Test (ppm)	Field PID test (ppm)	Lab GRO test (ppm)	Lab DRO test (ppm)	Cutting Description
0						
-5	145		45.2			pale brown fine sand
-10	155		19.8			"
-15	745	720	4.8	< 25.0	< 25.0	light brownish gray silt
-20	592		3.7			light brownish gray sand, moist
avg	409		18

Appendix B1 – Soil boring SB-1 cuttings descriptions and analytical data.

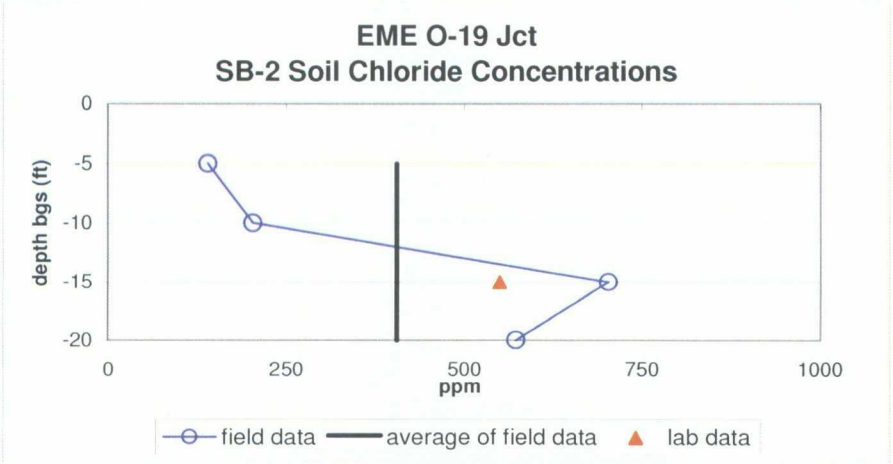
Depth (ft below ground surface)	Field Chloride Test (ppm)	Lab Chloride Test (ppm)	Field PID test (ppm)	Lab GRO test (ppm)	Lab DRO test (ppm)	Cutting Description
0						
-5	140		3.0			pale brown fine sand
-10	203		0.0			pale brown sand
-15	703	550	0.2	< 25.0	< 25.0	variegated white & very pale prown silt
-20	573		33.3			variegated light gray and brown fine sandy loam, moist
avg	405		9

Appendix B2 – Soil boring SB-2 cuttings descriptions and analytical data.

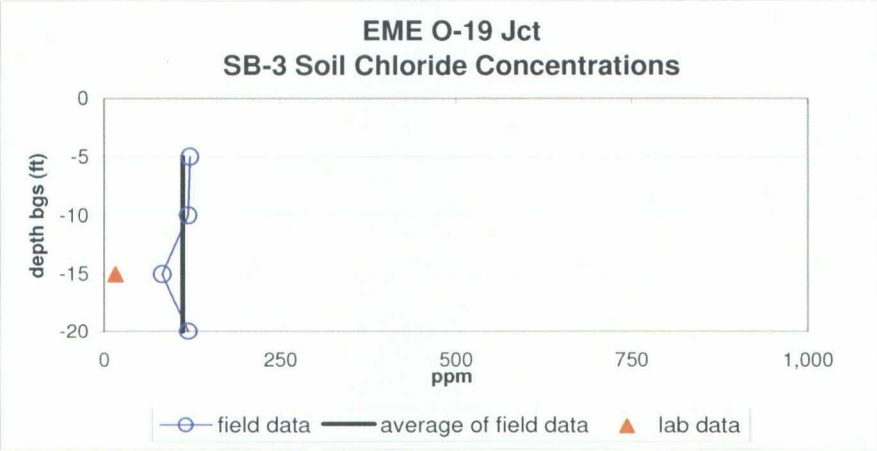
Depth (ft below ground surface)	Field Chloride Test (ppm)	Lab Chloride Test (ppm)	Field PID test (ppm)	Lab GRO test (ppm)	Lab DRO test (ppm)	Cutting Description
0						
-5	122		3.9			pale olive brown fine sand
-10	120		0.0			"
-15	83	16	0.0	< 25.0	< 25.0	variegated white & very pale brown silt
-20	120		0.0			variegated light gray and brown fine sandy loam, moist
avg	111		1

Appendix B3 – Soil boring SB-3 cuttings descriptions and analytical data.

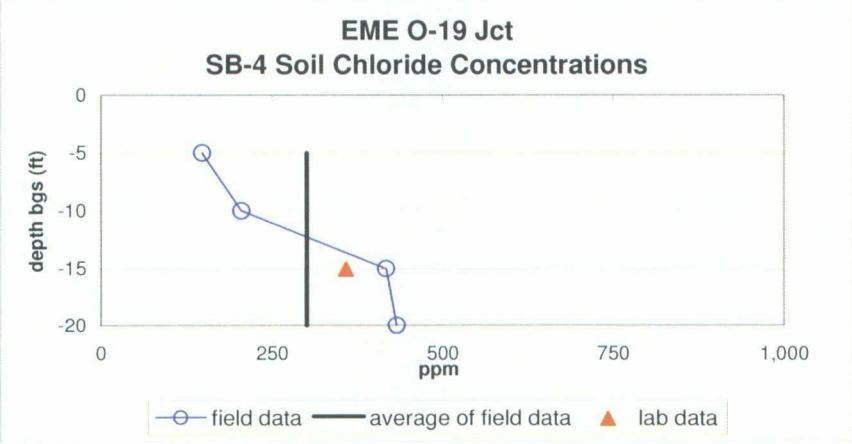
Depth (ft below ground surface)	Field Chloride Test (ppm)	Lab Chloride Test (ppm)	Field PID test (ppm)	Lab GRO test (ppm)	Lab DRO test (ppm)	Cutting Description
0						
-5	148		0.0			pale brownish gray fine sand
-10	205		0.7			pale brownish gray fine sandy loam
-15	417	358	0.0	< 25.0	< 25.0	pale brownish gray fine sand
-20	433		0.0			light olive gray sandy loam
avg	**301**		**0**

Appendix B4 – Soil boring SB-4 cuttings descriptions and analytical data.

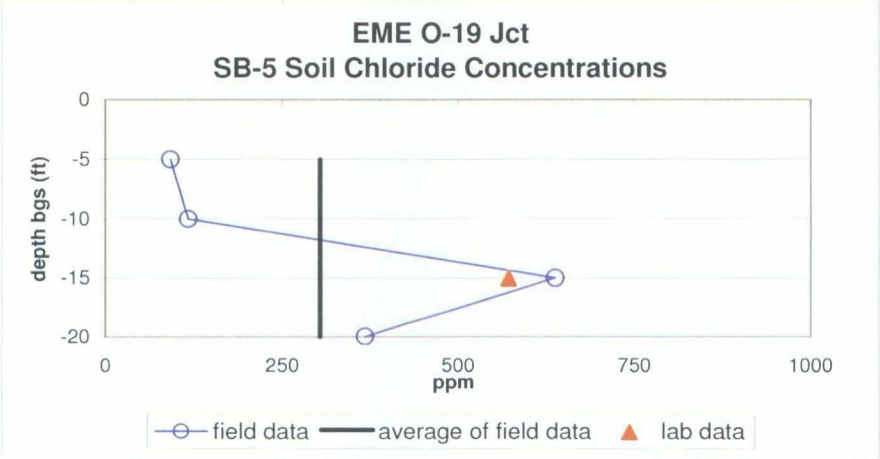
Depth (ft below ground surface)	Field Chloride Test (ppm)	Lab Chloride Test (ppm)	Field PID test (ppm)	Lab GRO test (ppm)	Lab DRO test (ppm)	Cutting Description
0						
-5	92		0.0			pale brown fine sand
-10	118		0.0			very pale brown fine sand
-15	638	572	0.0	< 25.0	< 25.0	"
-20	368		0.0			light olive brown fine gravelly fine sandy loam
avg	**304**		**0**

Appendix B5 – Soil boring SB-5 cuttings descriptions and analytical data.

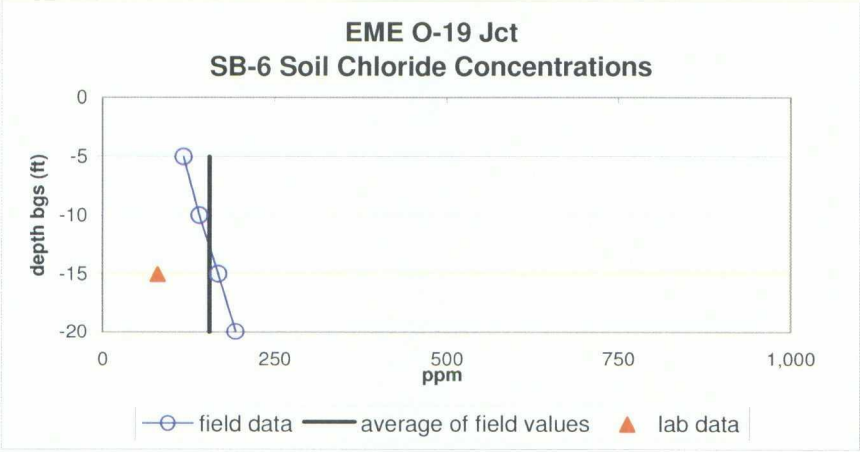
Depth (ft below ground surface)	Field Chloride Test (ppm)	Lab Chloride Test (ppm)	Field PID test (ppm)	Lab GRO test (ppm)	Lab DRO test (ppm)	Cutting Description
0						
-5	118		0.0			pale brown fine sand
-10	141		0.0			"
-15	168	80	0.0	< 25.0	< 25.0	light olive brown fine loamy sand
-20	193		0.0			light olive brown fine sandy loam w/ iron concretions
avg	155		0

Appendix B6 – Soil boring SB-6 cuttings descriptions and analytical data.

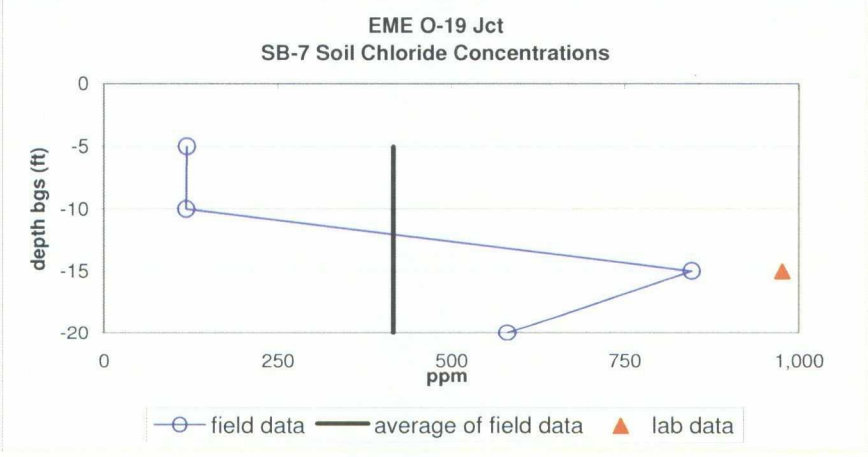
Depth (ft below ground surface)	Field Chloride Test (ppm)	Lab Chloride Test (ppm)	Field PID test (ppm)	Lab GRO test (ppm)	Lab DRO test (ppm)	Cutting Description
0						
-5	120		45.2			pale brown fine sand
-10	118		19.8			very pale brown fine sand
-15	846	976	4.8	< 25.0	< 25.0	light olive brown fine sandy loam w/ iron concretions
-20	581		3.7			"
avg	416		18

Appendix B7 – Soil boring SB-7 cuttings descriptions and analytical data.
