2013 STIPULATED ORDER REPORT

RE: Investigation Report
Transwestern Compressor Station No. 9
Transwestern Pipeline Company, LLC
Roswell, Chavez County, New Mexico
NMOCD Case #GW-052/EPA ID NO. NMD986676955

INVESTIGATION REPORT
TRANSWESTERN COMPRESSOR STATION NO. 9
(ROSWELL COMPRESSOR STATION)
6381 NORTH MAIN STREET
ROSWELL, CHAVES COUNTY, NEW MEXICO
EPA ID NO. NMD986676955

Investigation Report
Transwestern Compressor Station No. 9
(Roswell Compressor Station)
6381 North Main Street
Roswell, Chaves County, New Mexico
EPA ID No. NMD986676955

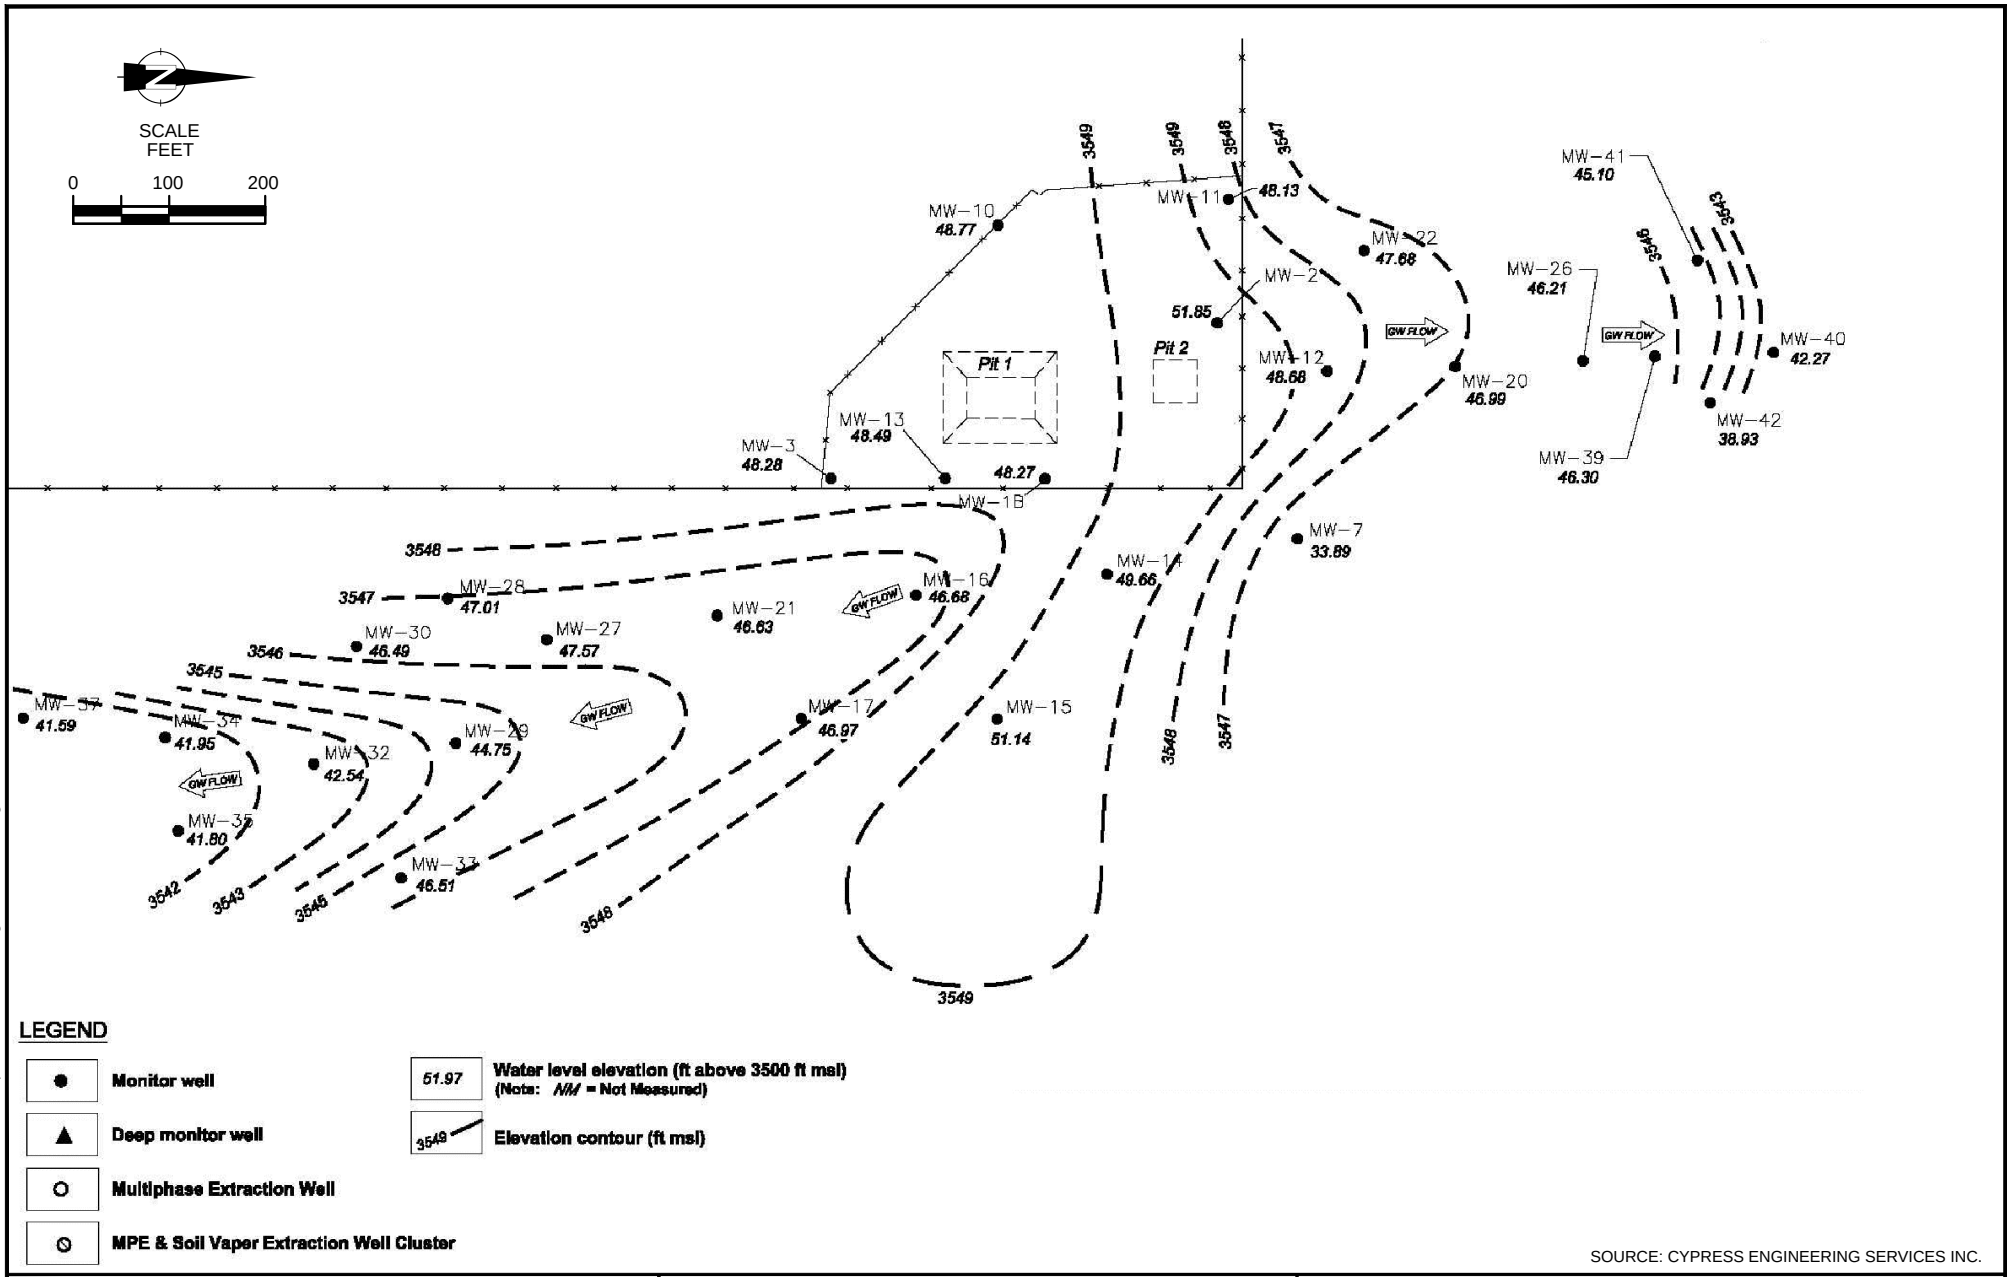
DRAWN:	CHECKED:	DATE:	FIGURE:
LDG	GPF	12/13	4-1

The principal water-bearing zones of sands and gravels are separated by less permeable lenses of silt and clay. According to Welder (1983), one to five water-bearing zones exist within the valley fill, and in many areas the alluvium is hydraulically connected to the upper bedrock units of the Artesia Group. The perimeter of the shallow alluvial aquifer is generally bounded by a margin of less permeable alluvium. Shallow groundwater conditions in the alluvium at the Project Area are shown on the groundwater surface elevation map of the Uppermost Aquifer, as measured on November 3, 2013 (see **Figure 4-1**).

Depth to water measurements collected on August 16, 2013 in preparation for well development indicate that groundwater was found at depths ranging from 51.64 feet below top of casing (TOC; at MW-39) to 56.57 feet TOC (at MW-41). These values are in line with recent gauging data from neighboring monitoring well MW-26 (51.95 feet TOC in January 2013 and 51.70 feet TOC in April 2013). A summary of groundwater elevations is presented in **Table 4-1** and an updated groundwater potentiometric map for the project area including the new monitoring wells is presented in **Figure 4-1**.
