R. T. HICKS CONSULTANTS, LTD.

September 7, 2016

RE: Temporary Pit Closure Report
Convoy "BUC" State No. 1H
API 30-025-41647 Ut P, Section 28, T24 R33E
Lea County

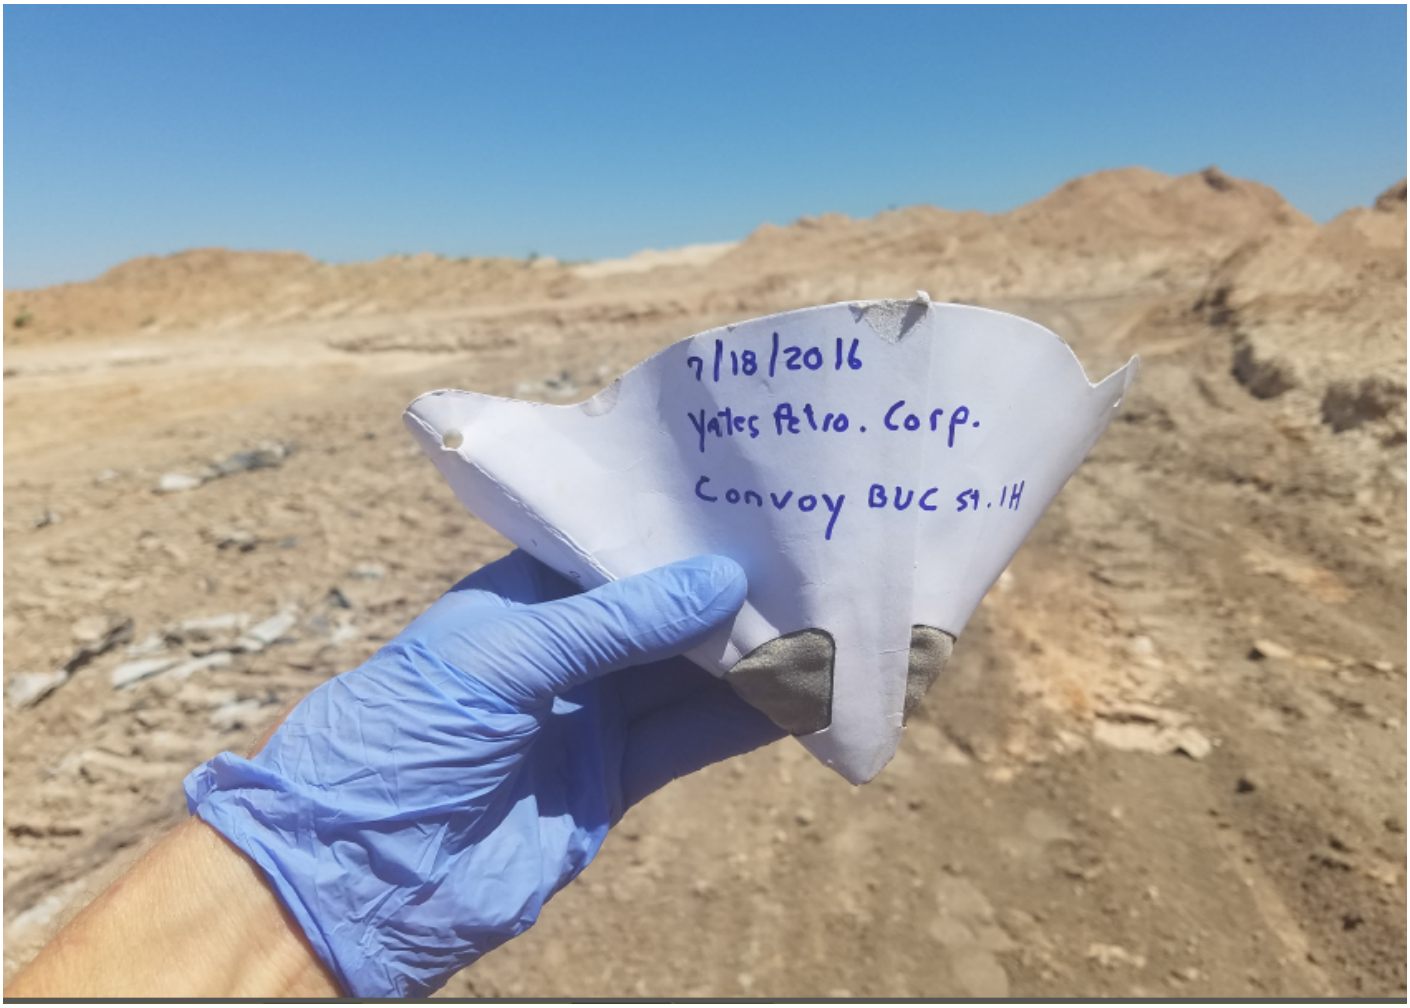
5. Following the July 18, 2016 inspection, having achieved all applicable stabilization requirements associated with in-place burial, a 20 Mil. geomembrane liner was installed to completely cover the stabilized cuttings on July 22, 2016. The pit contents and liner were shaped to shed infiltrating water, sloping from East to West.

Viewing West 20 Mil. liner installation

Paint filter test on 7/18/2016

Liner Installation completed on 7/22/2016.

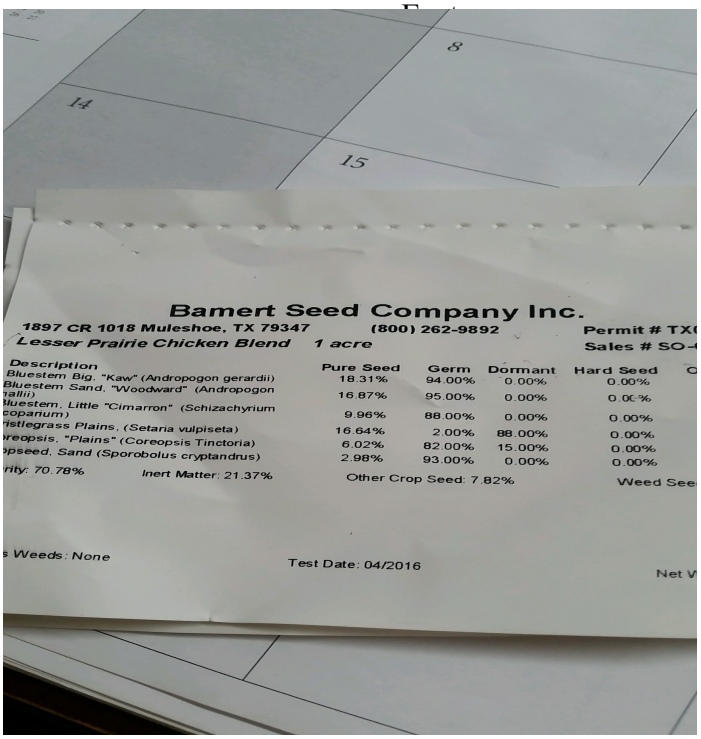
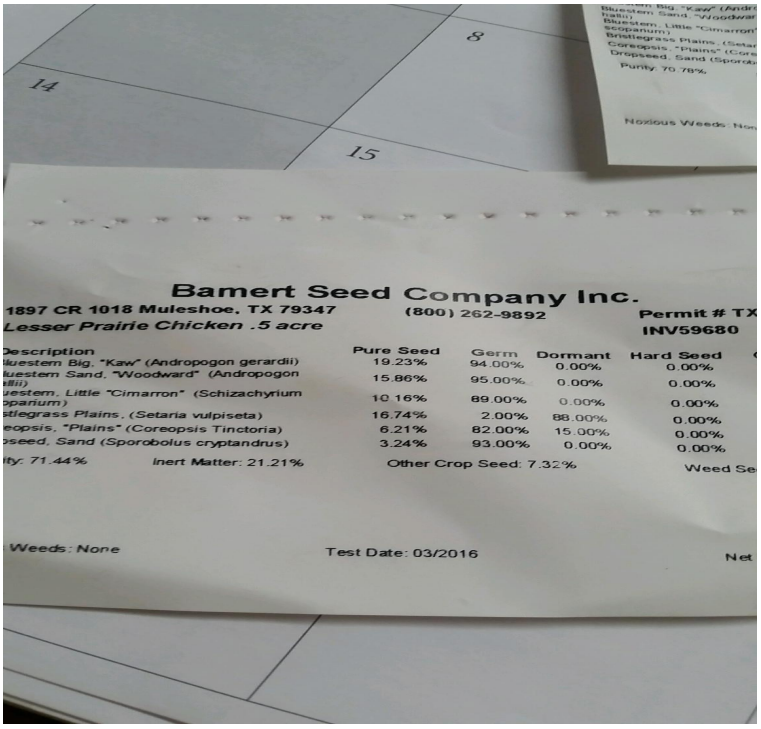
2. Approximately 70 pounds of a seed mixture consisting of lesser parie chicken seed mix was applied in accordance with the supplier's instructions to approximately 1 acre of the former temporary pit area. Species constituents of lesser parie chicken seed blend are listed below and are appropriate for the soil type and conditions at this site.

Labels on seed sacks describing composition species

Completed drilling pit – viewing to
