Rice Environmental Consulting & Safety

RE: Corrective Action Plan Burnett Oil Gissler B-3-1 UL/B sec. 11 T17S R30E API No. 3001504120

Corrective Action Plan

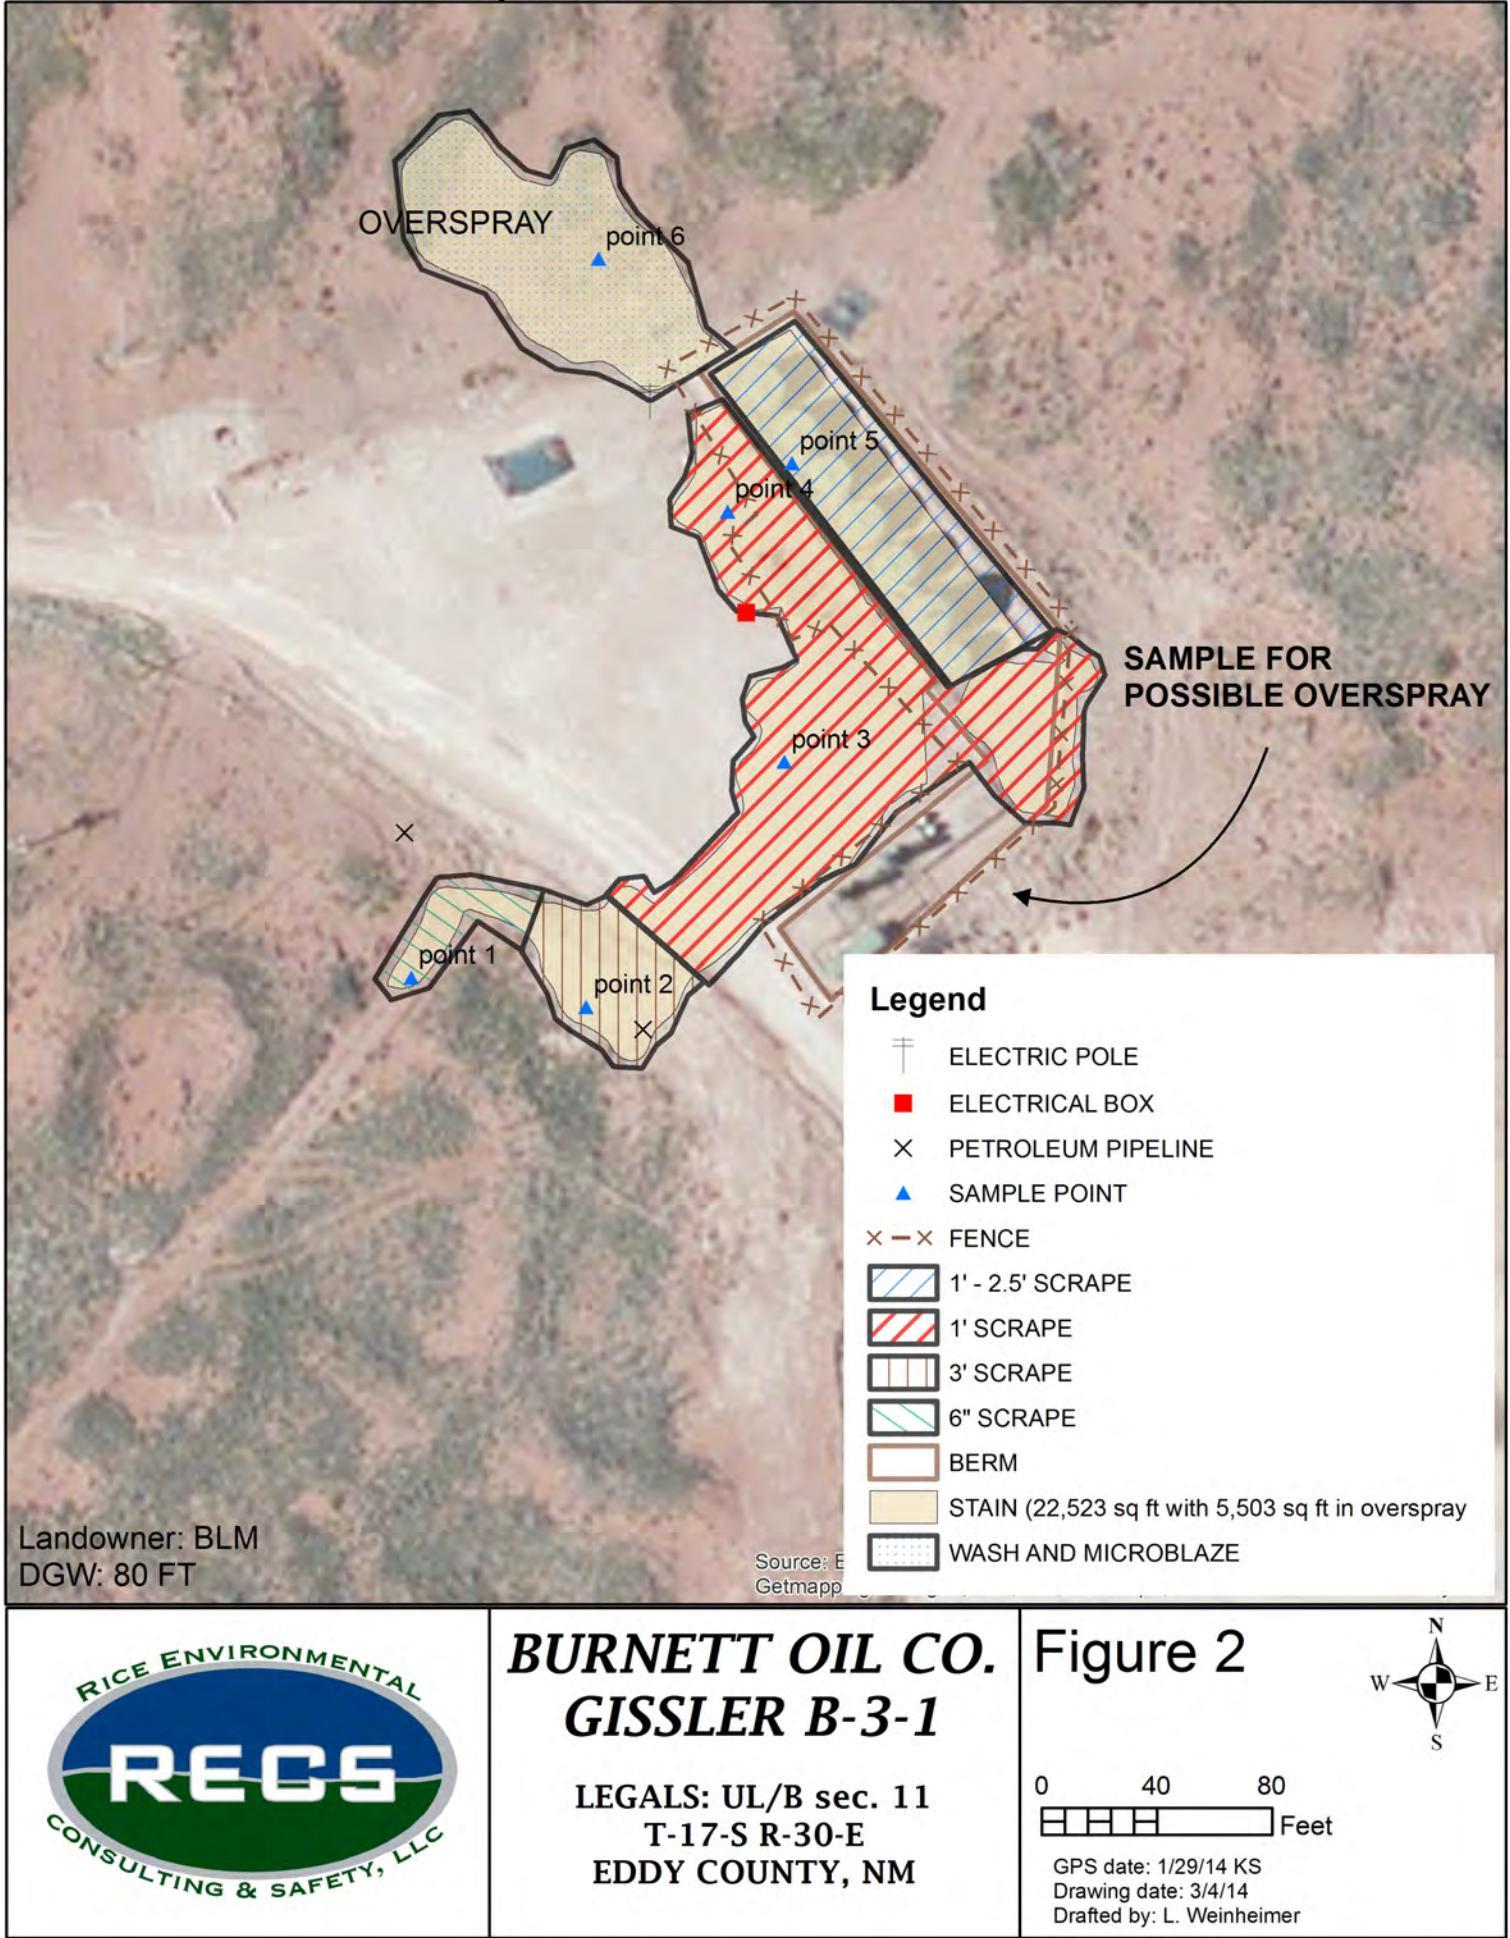
Proposed Corrective Actions

Based on the field and laboratory analyses, the area around Point 1 will be scraped down to 6 inches bgs. The area around Point 2 will be scraped down to 3 ft bgs. Composite samples from the base of the scrape and from each wall will be taken to a commercial laboratory to confirm all constituents are below regulatory standards. The area around Point 3 and Point 4 will be scraped down to 1 ft bgs. A composite sample from the base of the scrape will be taken to a commercial laboratory to confirm all constituents are below regulatory standards. Inside the bermed battery, the area will be scraped down 1 - 12.5 ft as safety concerns allow. A composite sample from the base of the scrape will be taken to a commercial laboratory to confirm if all constituents are below regulatory standards. If any constituents remain after the scrape, they will be remediated during site abandonment. The overspray area will be washed with clean water and sprayed with Micro-Blaze. The berm in the overspray area will be scraped to remove the asphaltine and then rebuilt. Southeast of the battery is a possible overspray area. This area will be sampled to determine if any contamination occurred. Once sampled, NMOCD and BLM will be notified by email of the remediation actions that will be taken in this area as needed.

All excavated soils will be evaluated for use as backfill and any soils that do not meet regulations will be disposed of at a NMOCD approved facility. Clean soil will be imported to the site as necessary to replace any disposed soil. The remainder of the excavated soil will be blended on site to use as backfill. A sample of the blended soils will be taken to a commercial laboratory to confirm the constituents are below regulatory standards. The areas in the pasture will be backfilled with the blended soils taken from the pasture areas, and the areas on the lease pad will be backfilled with the blended caliche. All areas will be contoured to the surrounding location, and the pasture areas will be seeded with a blend of native vegetation.
