SUBJECT: Remediation Closure Report for the Julie #1 Pipeline Release (2RP-5569), Eddy County, New Mexico

Julie #1 Remediation Closure Report (2RP-5569) August 20, 2019

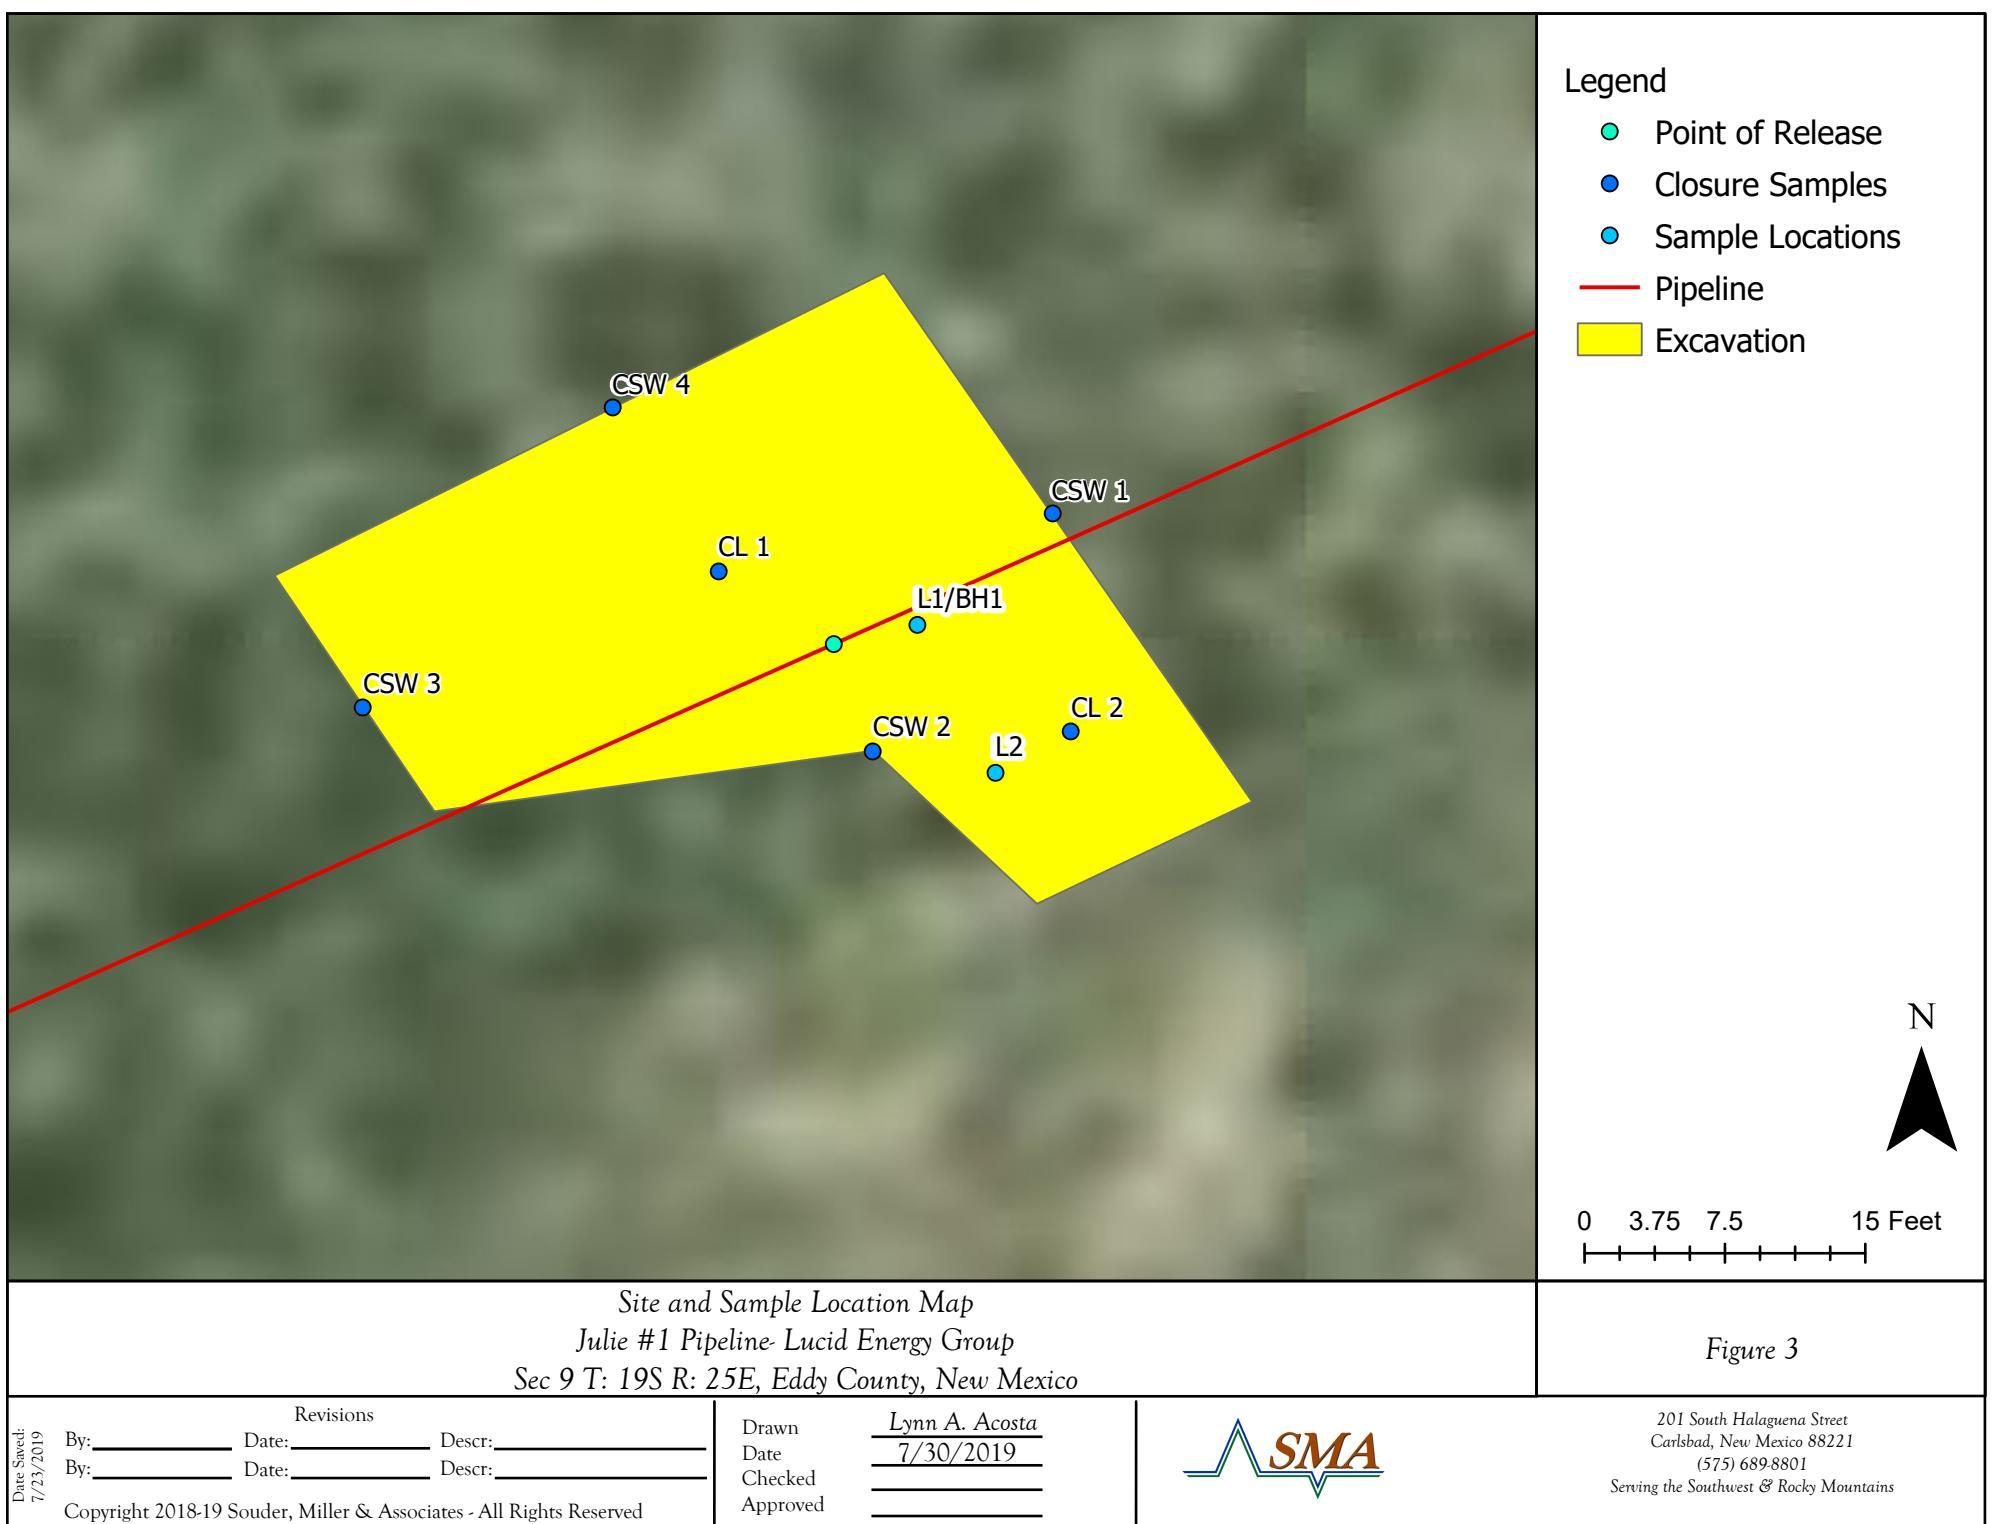
On July 19, 2019, SMA conducted confirmation sampling of the walls and base of the excavation, which measured approximately 31 x 16 x 15 feet.

Confirmation samples were comprised of five-point composites of the base (CL1 and CL2) and walls (CSW1, 2, 3, and 4).

Figure 3 shows the extent of the excavation and sample locations. Laboratory results are summarized in Table 3. Laboratory reports are included in Appendix D.
