### Burlington Resources Oil Gas Company, LP San Juan Basin Closure Report

### Lease Name: SAN JUAN 28-5 UNIT 67P API No.: 30-039-31081

In accordance with Rule 19.15.17.13 NMAC the following information describes the closure of the temporary pit referenced above. All proper documentation regarding closure activities is being included with the C-144. The temporary pit for this location was constructed and location drilled before June 16, 2008 (effective date for Rule 19.15.17). While closure of the temporary pit did fall within the rule some dates for submittals are after the rig release date.

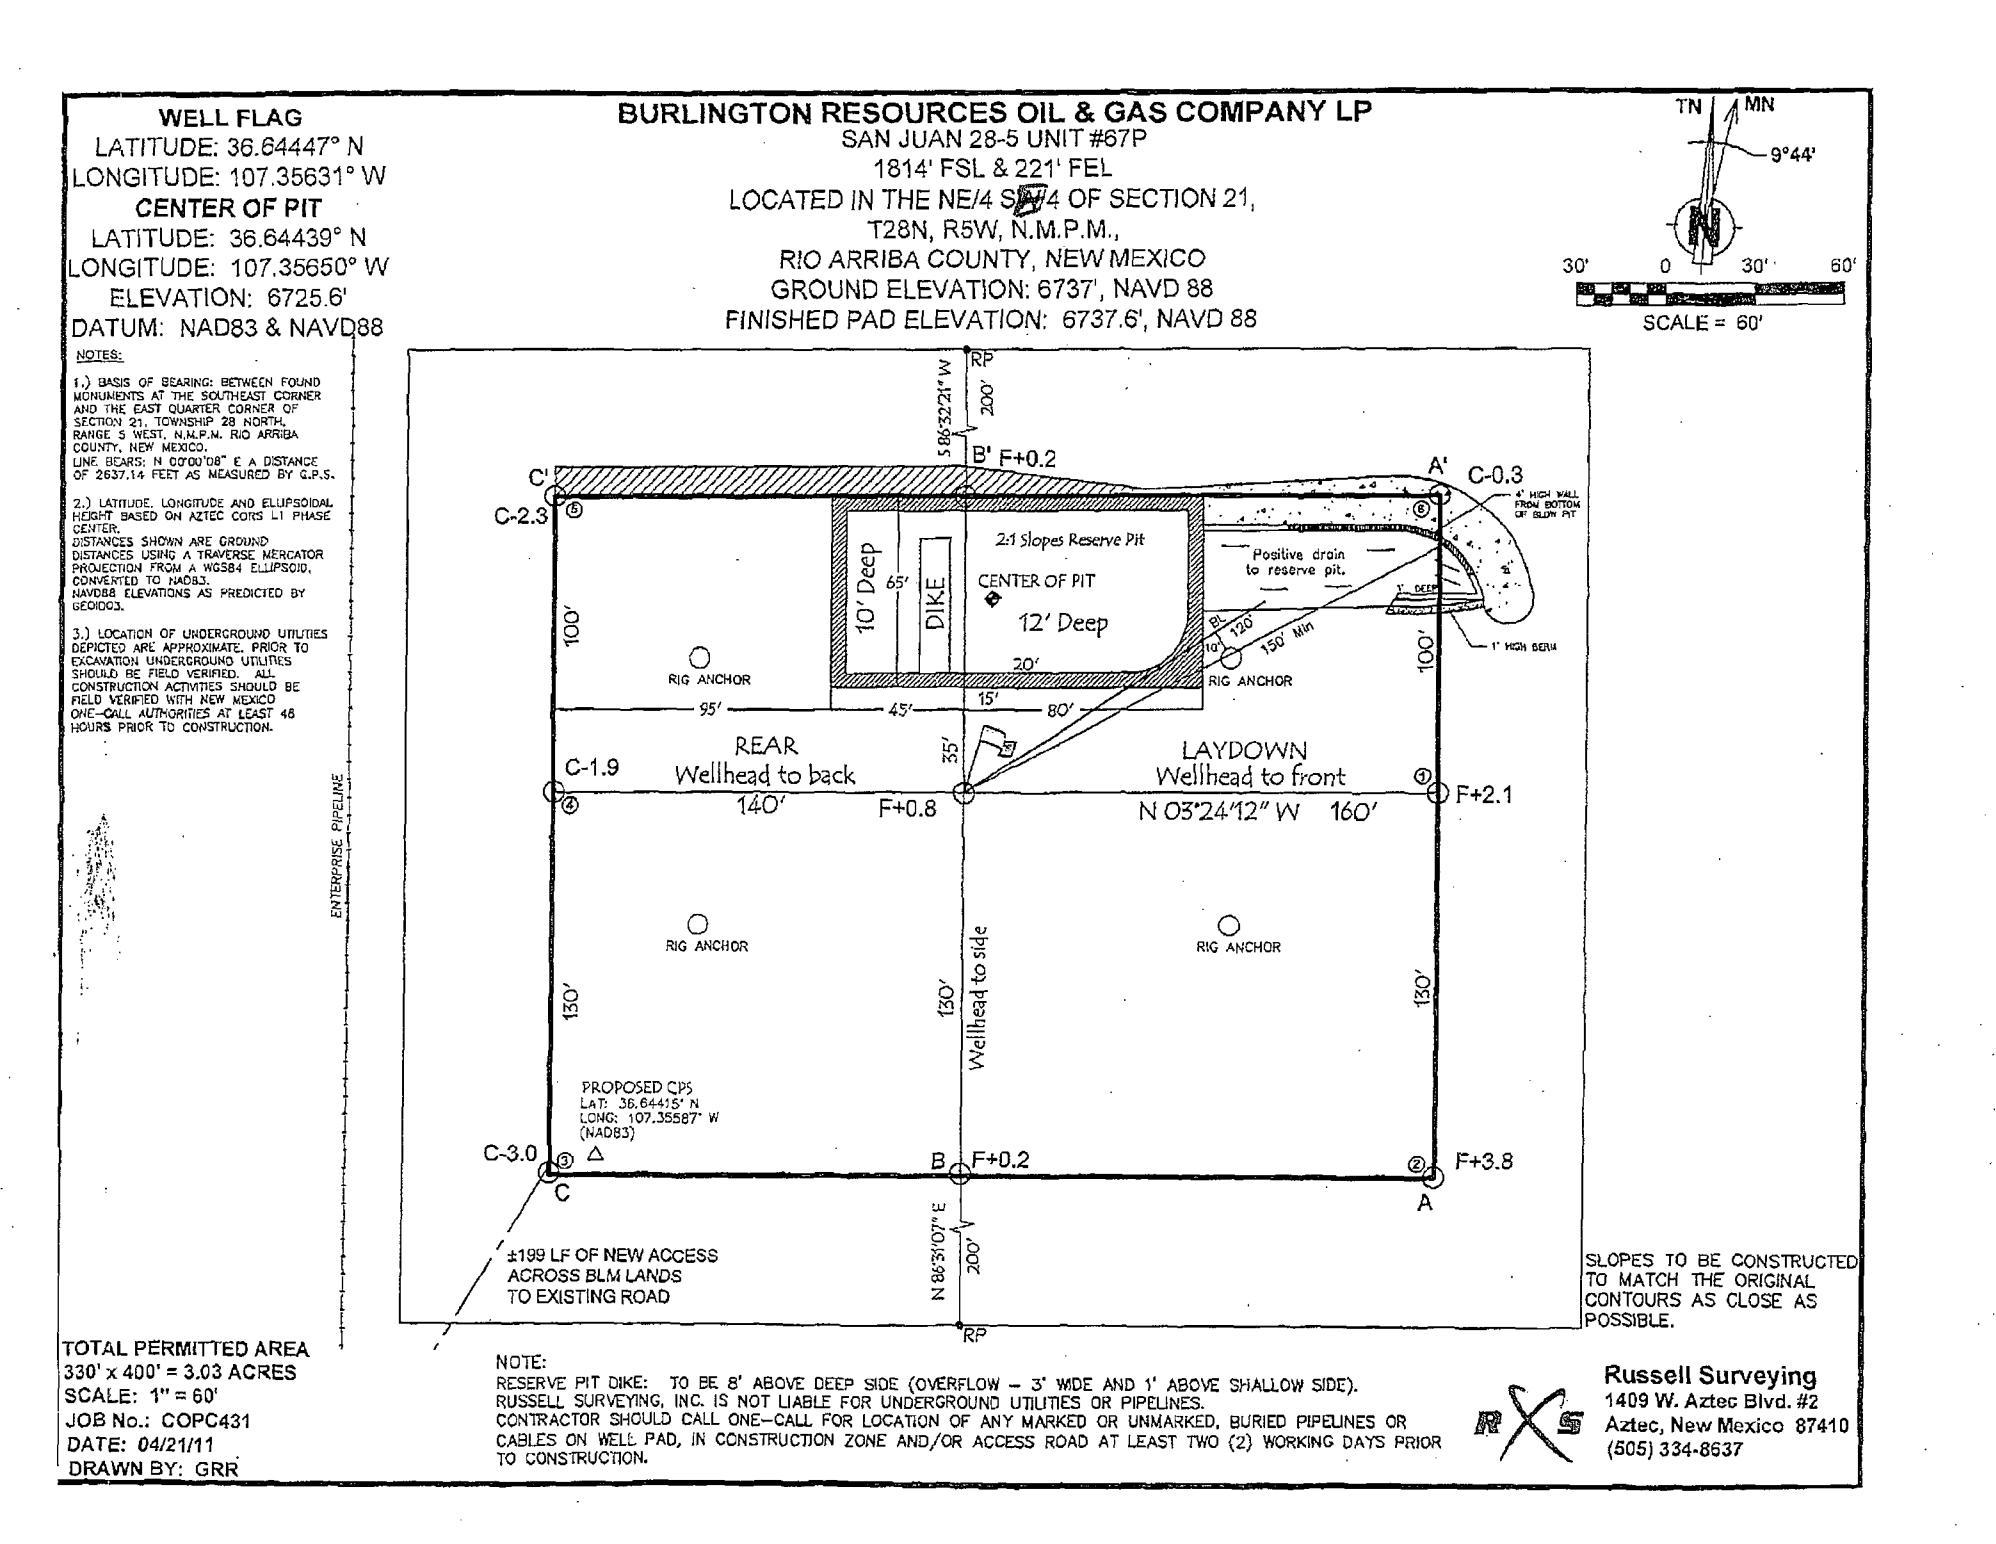
### WELL LOCATION AND ACREAGE DEDICATION PLAT

Number			Pool Code					<sup>3</sup> Pool Nam	3		
30-039	<u>-310</u>	81	72	319/71	599		BLANG	O MES	AVERDE/E	BASIN DAKUTA		
Property Co	ode				Pro	perty l	Name				~ <del>*</del> *	E70
/400					SAN JU	AN 28	3-5 UNII					
7 OGRID No	, ]			LUCTON	50pe ⊐⊐⊃¢u⊃¢	erator 1	Name	10.1111			-	Elevation
14538			BUR		RESOURC	ES O	IL & GAS CON	/PANY	LP 			6/3/°
					<sup>10</sup> Surf	lace	Location					
UL or lot no.	Section	Township	Range	Lot Idn	Feet from	the	North/South lin	e Feet	from the	East/We	est line	County
i	21	28N	5₩		1814	<u>.</u>	SOUTH	<u>.                                    </u>	221'	EAS	ST	RIO ARRIBA

ł				1			Arl	een l	R. Ke	llywood
		1		1		i			Printe	1 Name		
		}		1		]						
1		1		I		I	END 2.5"	60	E-mai	1 Address		
		<u> </u>		1 —			GLO 1914		18 5	URVEY	YOR CE	RTIFICATION
		†	2	<u>_</u>		-+			I hereby c	ertify that	the well loca	tion shown on this
