XTO Energy Inc. San Juan Basin Below Grade Tank Closure Report

Lease Name:Gallegos Federal 26-13-24 #2API No.:30-045-28833Description:Unit M, Section 24, Township 26N, Range 13W, San Juan County

XTO Energy, Inc. Gallegos Federal 26-13-24 #2 Section 124, Township 26N, Range 13W Closure Date 11/29/2010

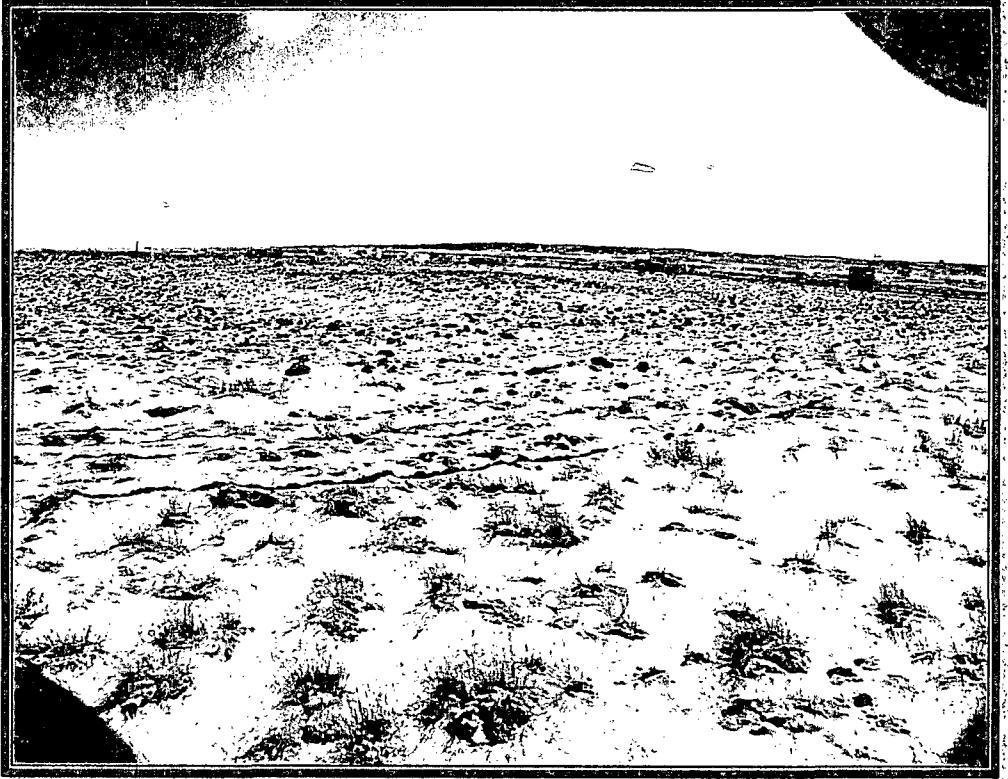
Photo 1: Gallegos Federal 26-13-24 #2 after Reclaimation (view 1)

11. Re-contouring of location will match fit, shape, line, form and texture of the surrounding area. Re-shaping will include drainage control, prevent ponding, and prevent erosion. Natural drainages will be unimpeded and water bars and/or silt traps will be placed in areas where needed to prevent erosion on a large scale. Final re-contour shall have a uniform appearance with smooth surface, fitting the natural landscape.

The site has been recontoured to match the above mentioned specifications.

The site has been backfilled to match these specifications.

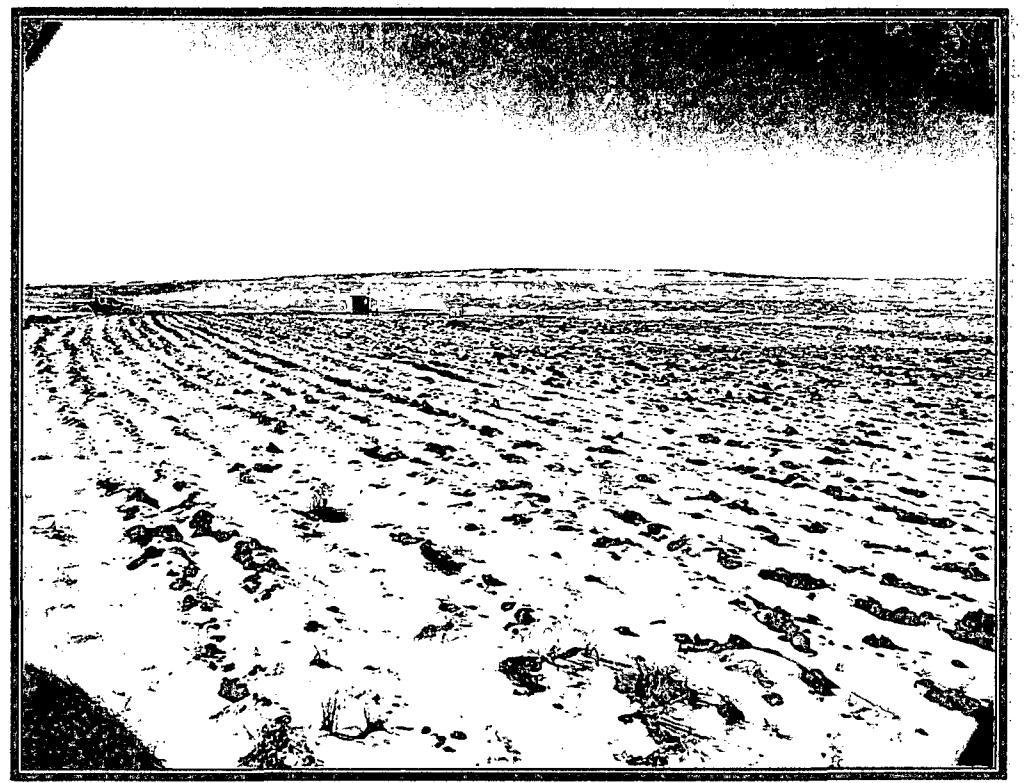
Photo 2: Gallegos Federal 26-13-24 #2 after Reclaimation (view 2)
