WPX Energy Production Co., LLC San Juan Basin: New Mexico Assets Below-Grade Tank Removal Closure Report Rosa Unit #077A (API #30-039-25515) Unit Letter I, Section 33, T31N, R05W Rio Arriba County, NM

Below-Grade Tank Removal Plan/Closure Report WPX Energy Production, LLC

WPX Energy Production, LLC Rosa Unit #077A BGT Closure Report Photograph Log

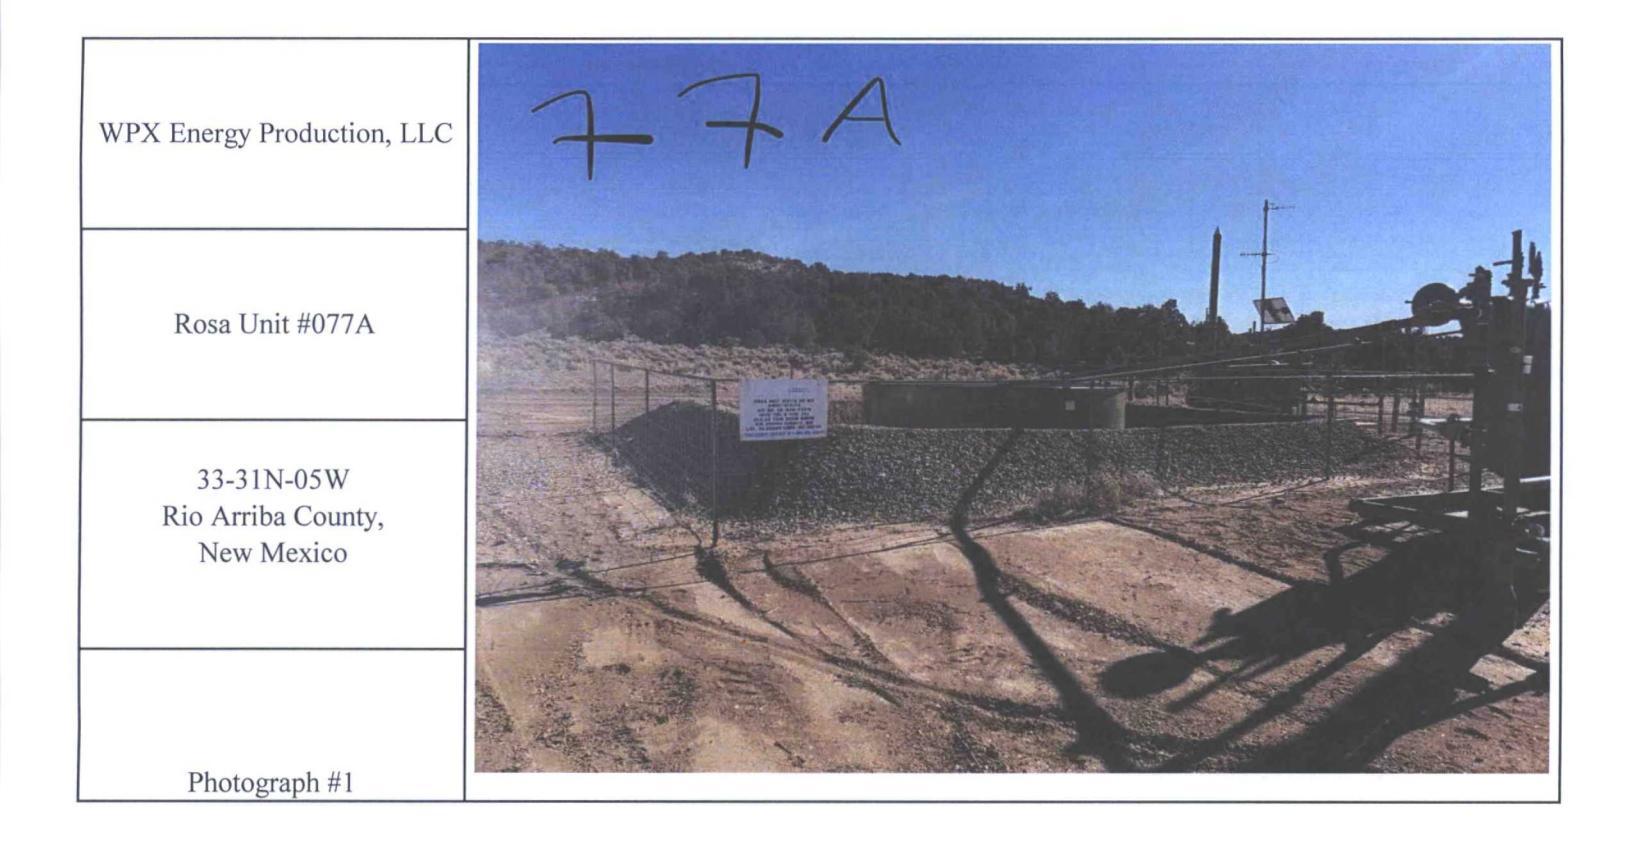
The BGT location was backfilled with clean soil and compacted during following BGT removal. The BGT location will be reclaimed when it is no longer needed for production operations.
