Re: Red Byrd #2 Release Site NW/4, SW/4 Section 31, T19S, R37E NMOCD Ref. 1-R-0086 EMS No. 2000-10477 Closure Request

Re: Plains All American Site Investigation, Remediation Summary and Closure Request Red Byrd #2 Release Site EMS No.: 2000-10477 NW/4, SW/4 Section 31, T19S, R37E Lea County, New Mexico

### SITE INVESTIGATION, REMEDIATION SUMMARY AND CLOSURE REQUEST

### RED BYRD #2 NW ¼ of the SW ¼ of SECTION 31, TOWNSHIP 19 SOUTH, RANGE 37 EAST LEA COUNTY, NEW MEXICO PLAINS EMS NUMBER 2000-10477

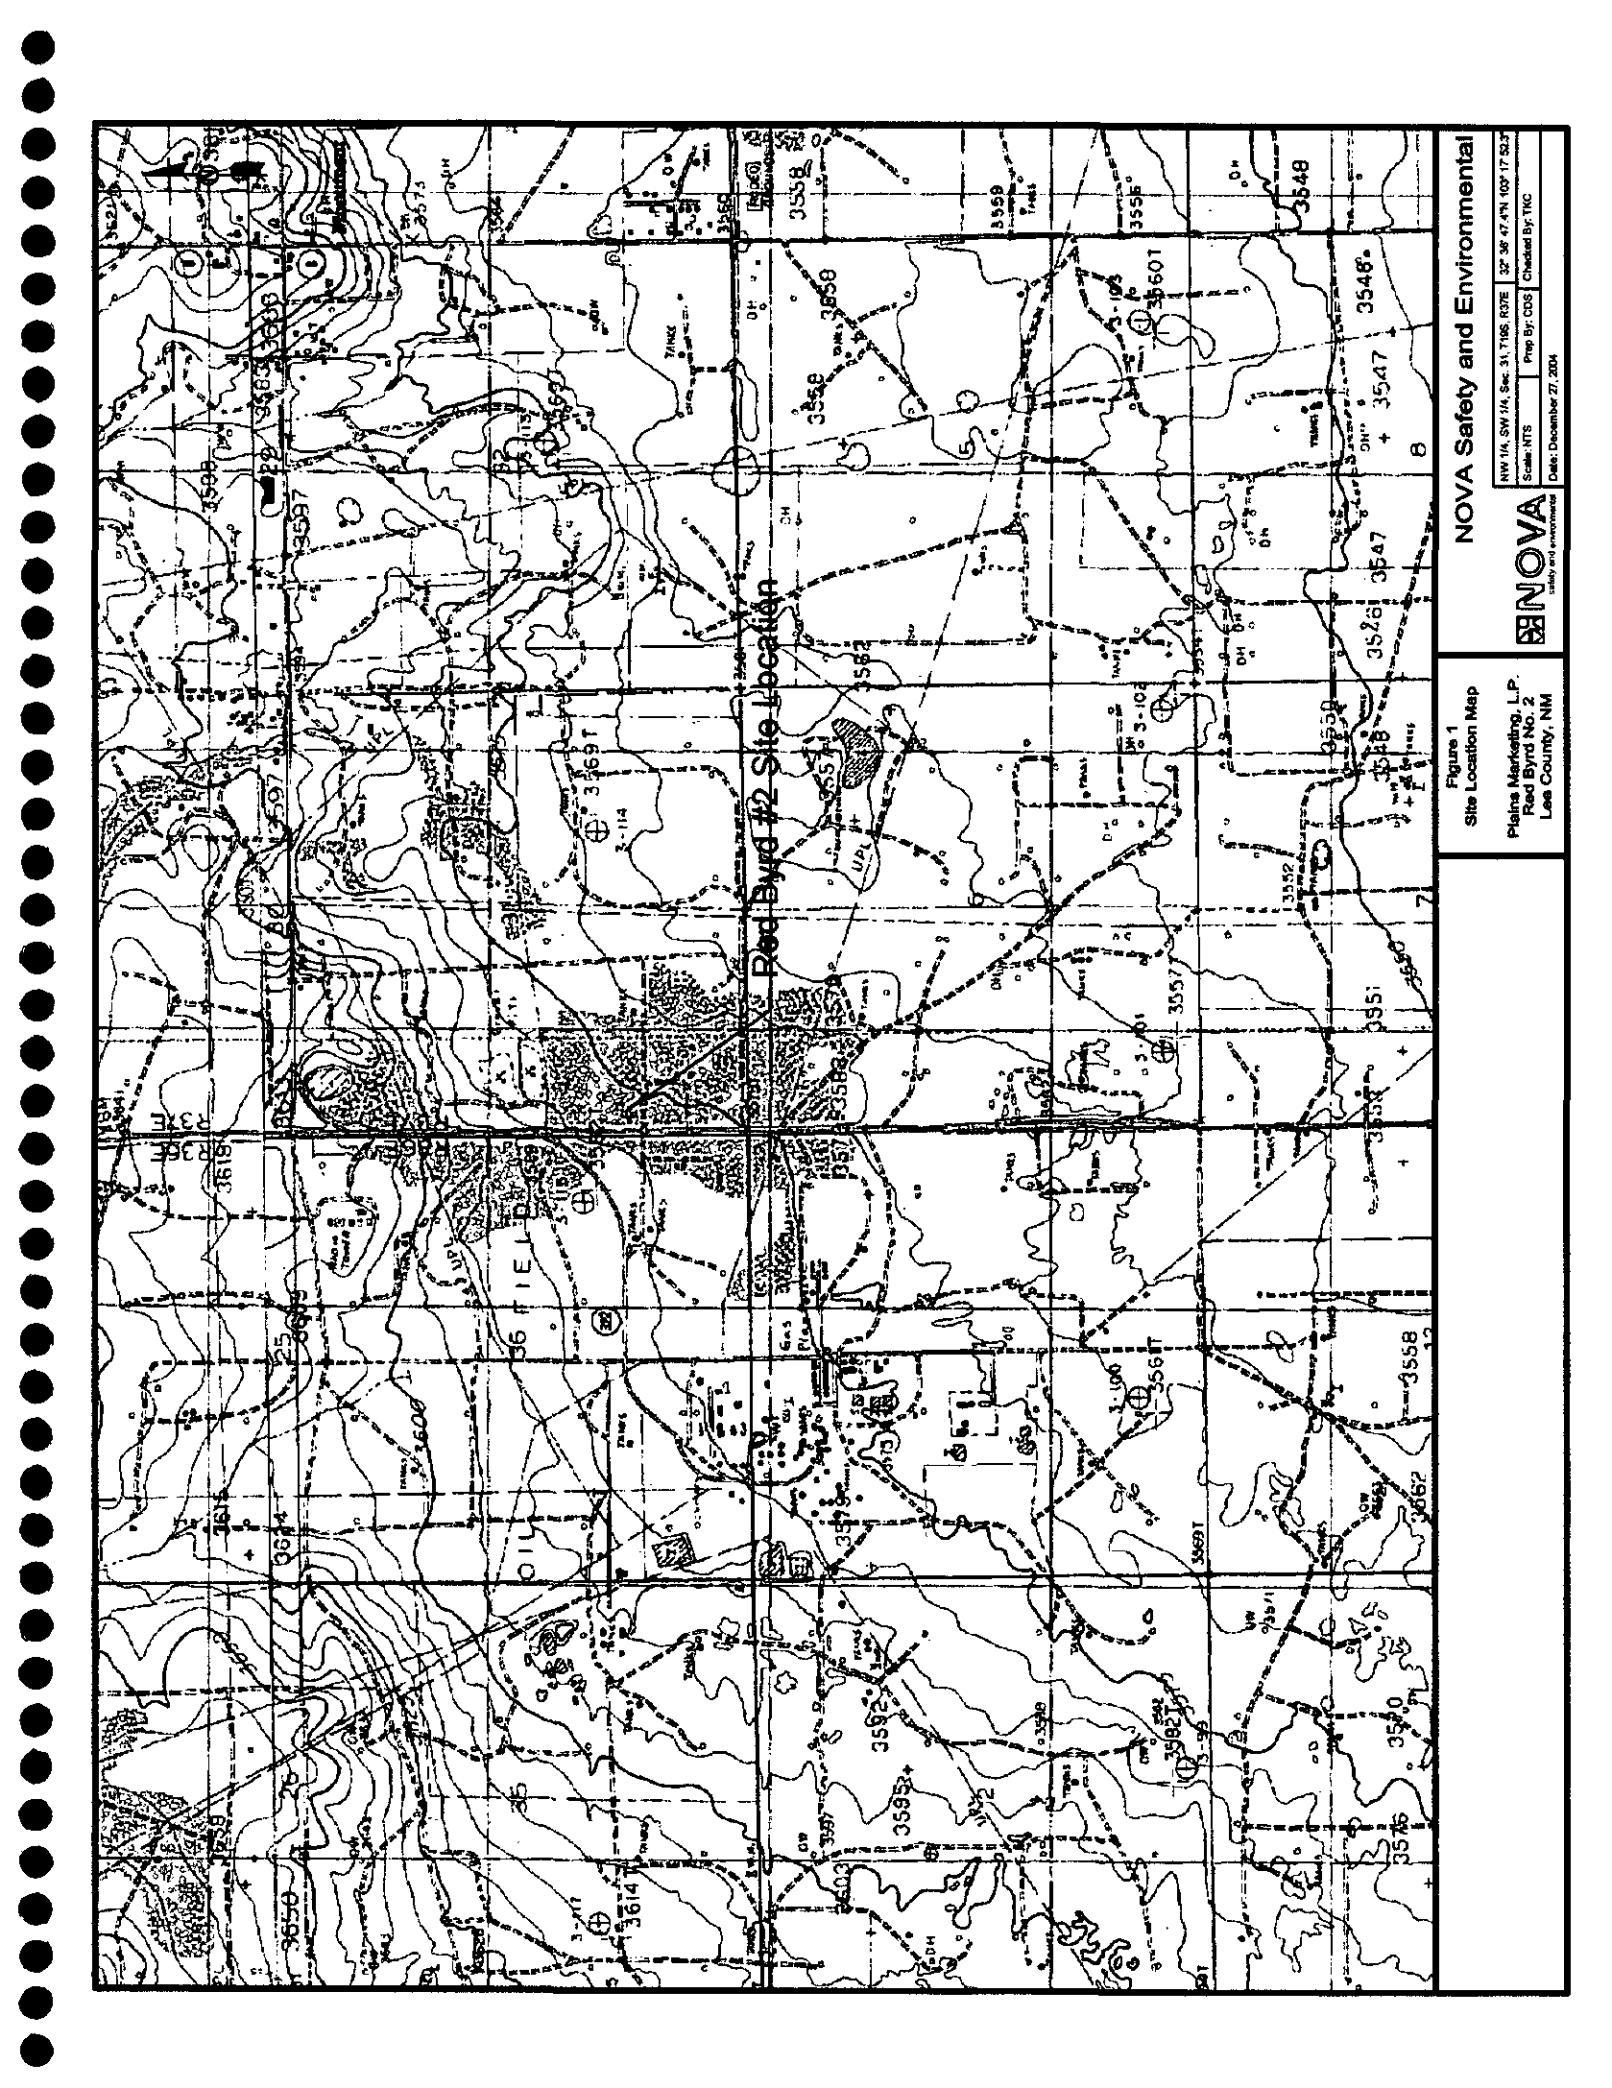
The crude oil released from the EOTT pipeline was initially discovered on the Red Byrd Ranch in November of 1999. The release site was designated Red Byrd #2 Site by EOTT, and is shown in Figure 1. The release resulted in a relatively small surface stain measuring approximately 20 feet in length by 5 feet in width. Upon discovery of the release, the leak was repaired by clamping the leak point on the pipeline and subsequent permanent repair by installing a new section of pipeline. In early 2000, the surface stained area was excavated with a back hoe. Additionally, a trench was dug along the pipeline approximately 40-feet long by 10-feet in depth and a second trench, approximately 20-feet long by 10-feet in depth was placed perpendicular to the release. Following this work, it was determined that contamination extended beyond the depth of these excavations and that a subsurface soil assessment would be needed. The trenches were backfilled with the excavated soil.

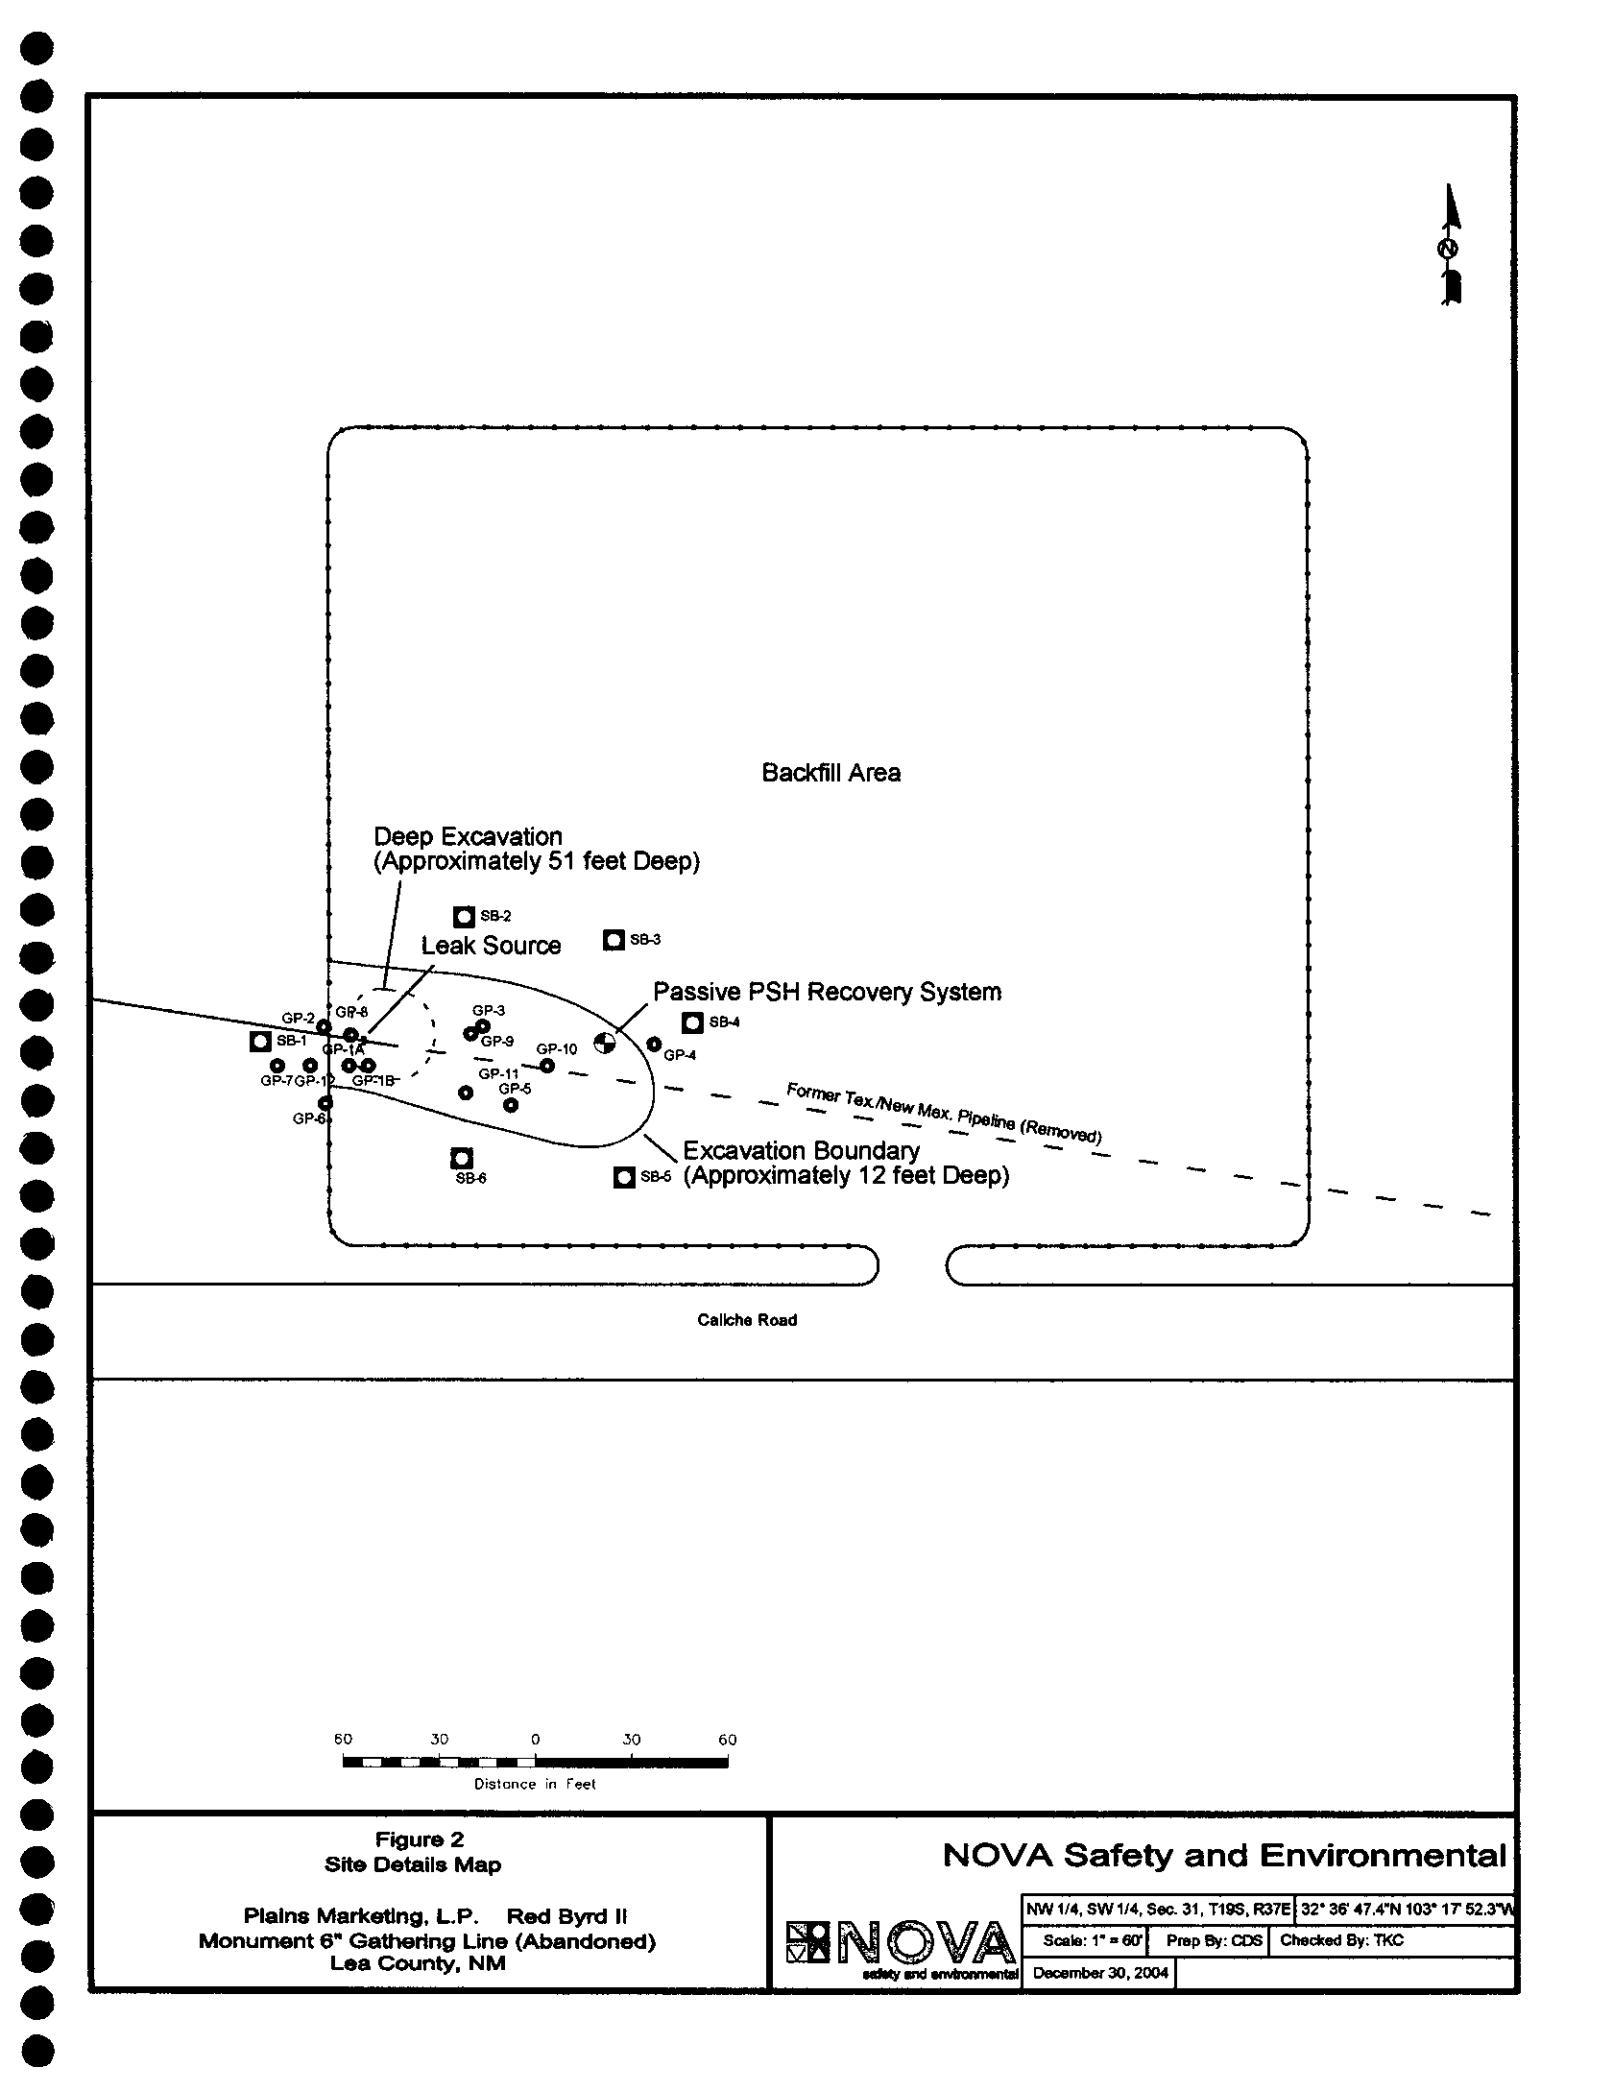
A Geoprobe ® unit was mobilized to the site in April 2000 and 14 soil borings were advanced in the area adjacent to and surrounding the release site. Soil boring locations were identified as GP-1A and GP1-B through GP-14. Soil borings were advanced to a point of refusal, occurring at a

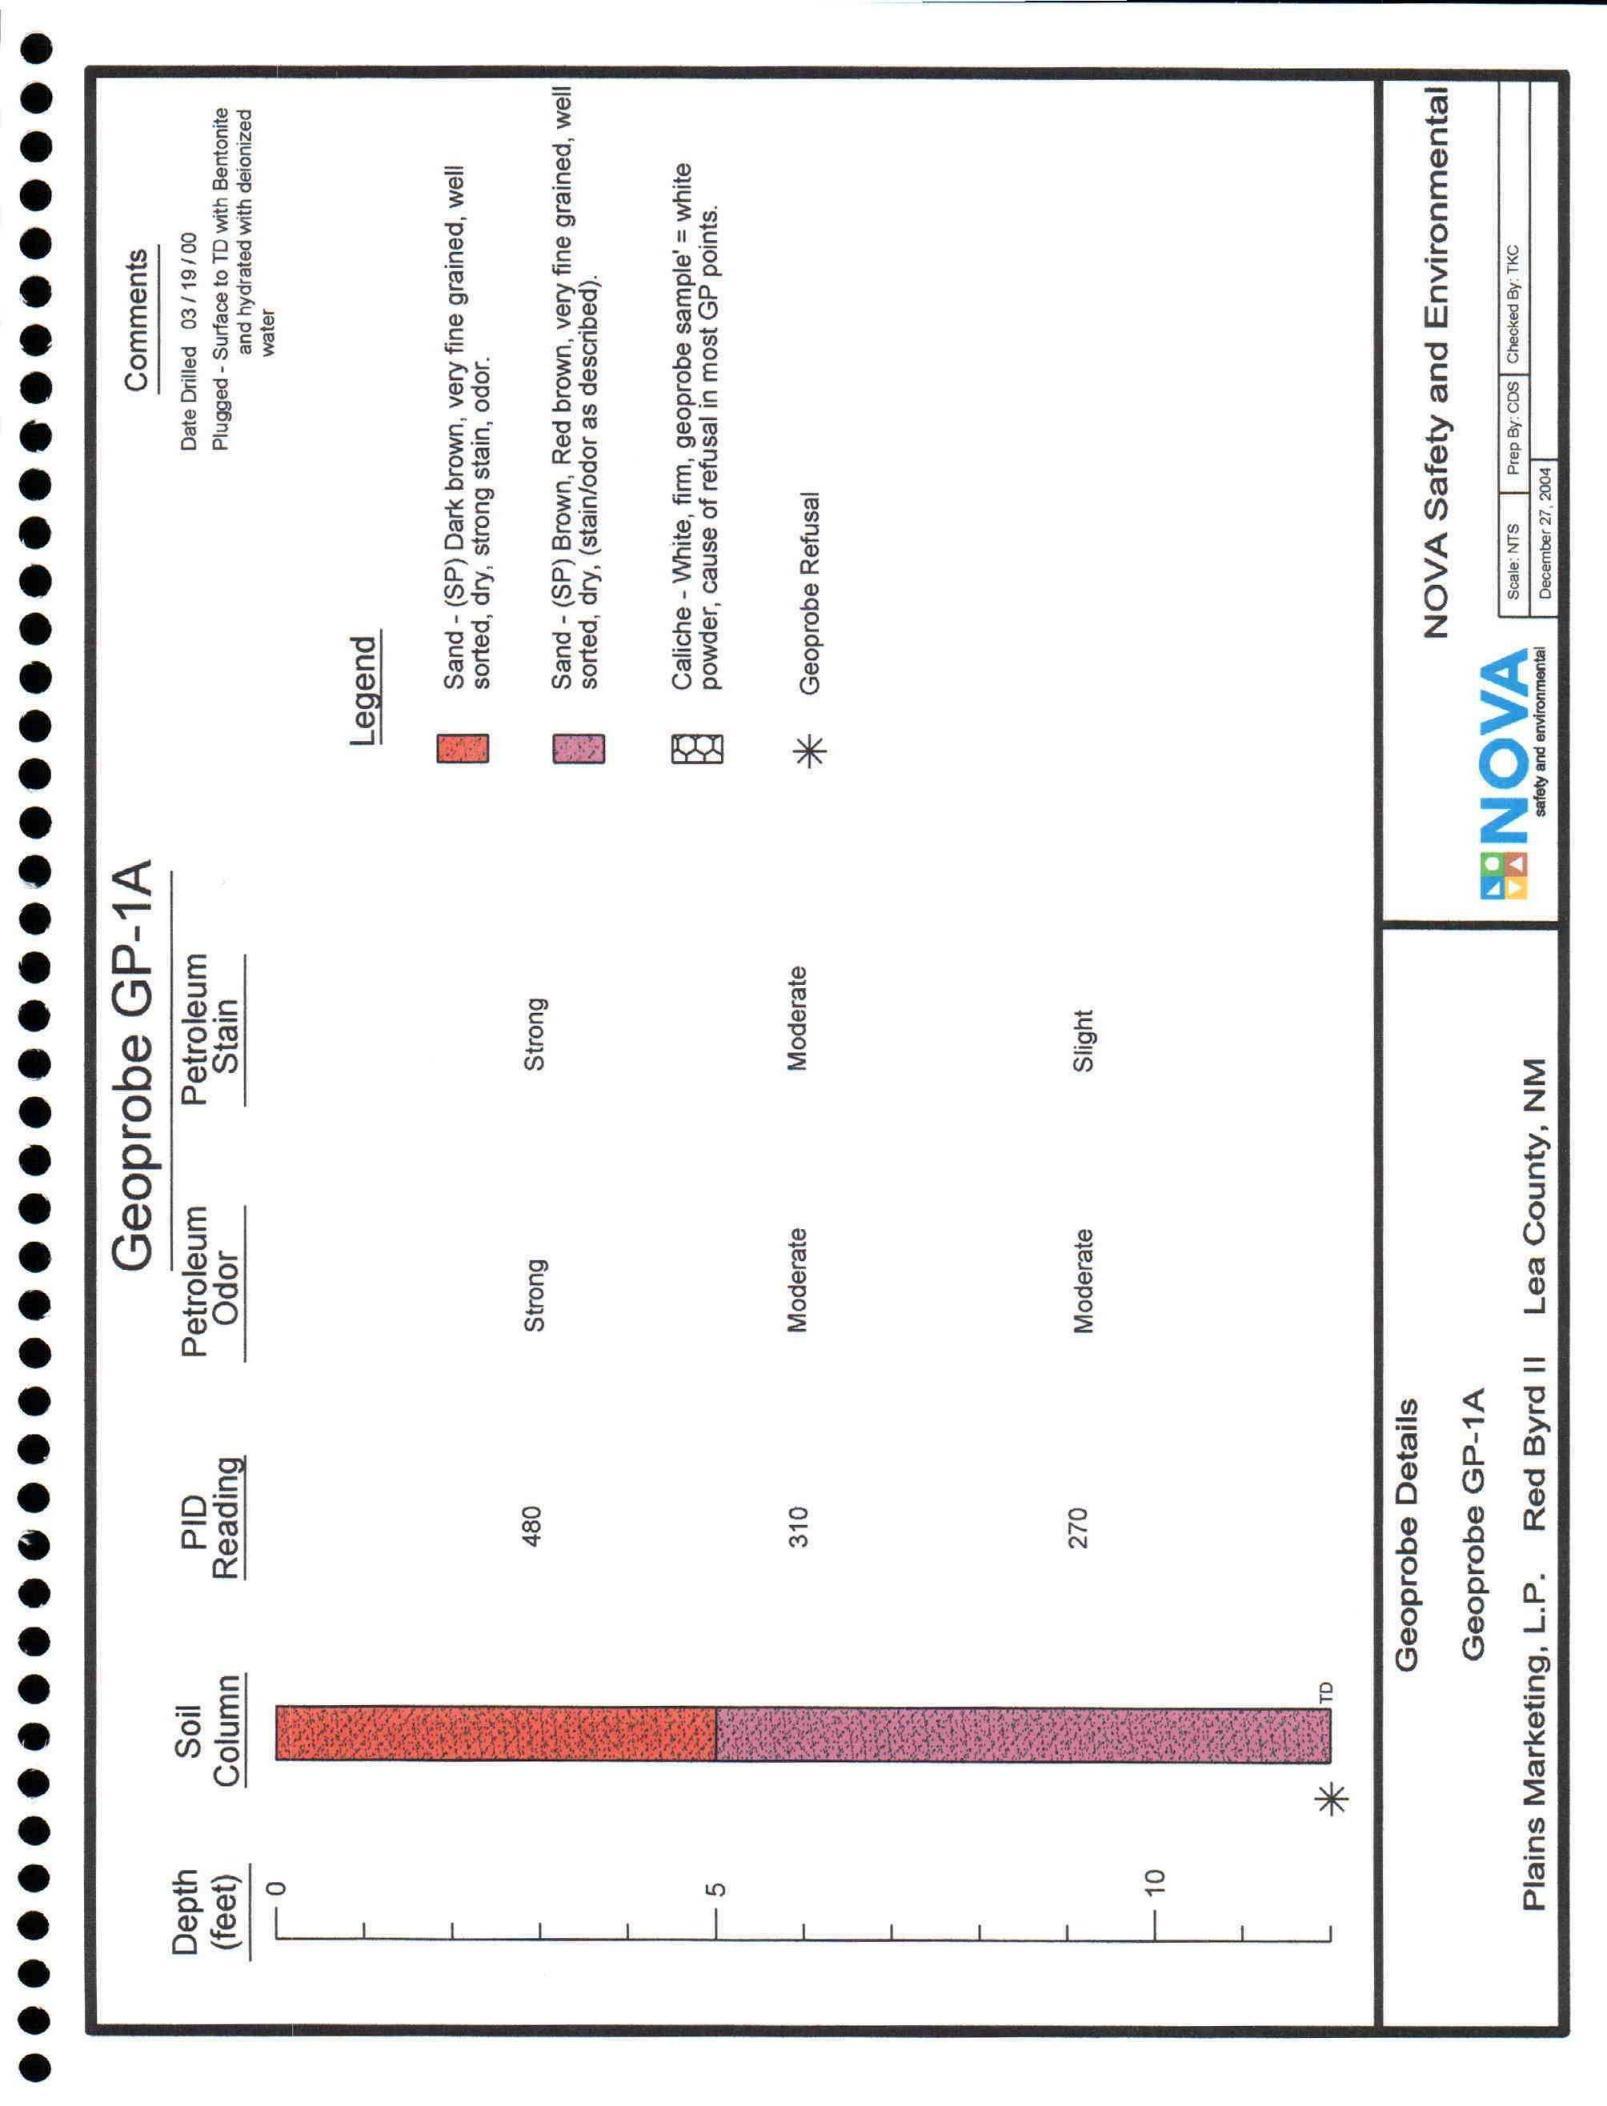
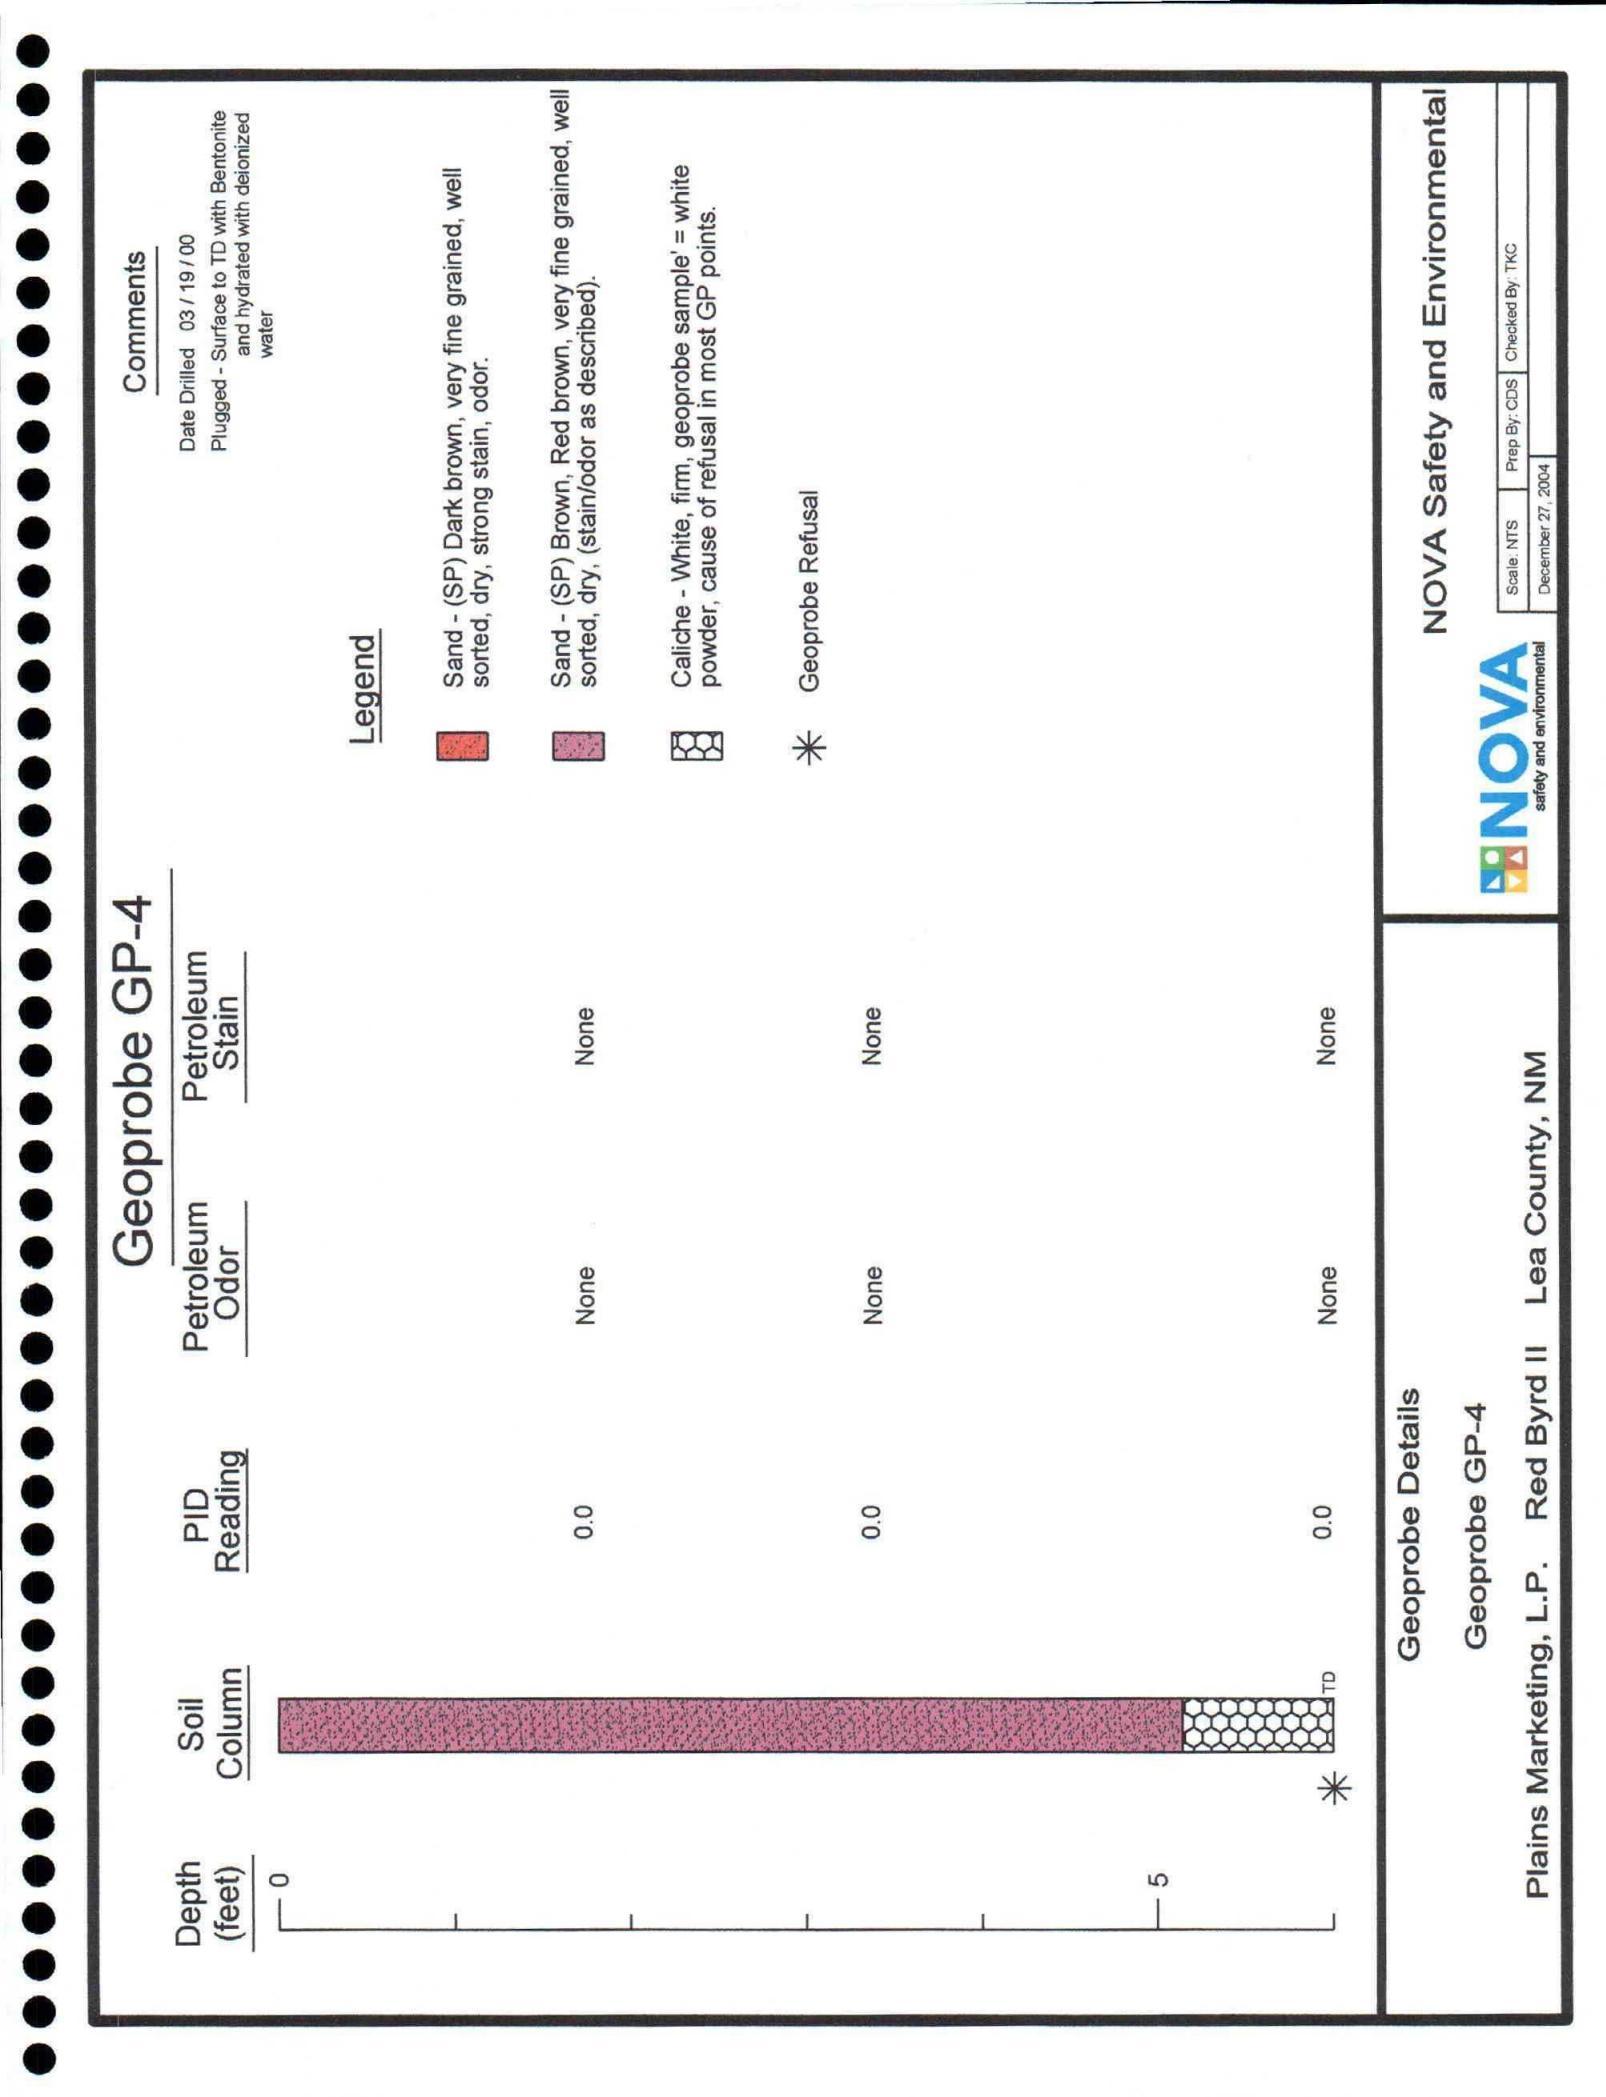
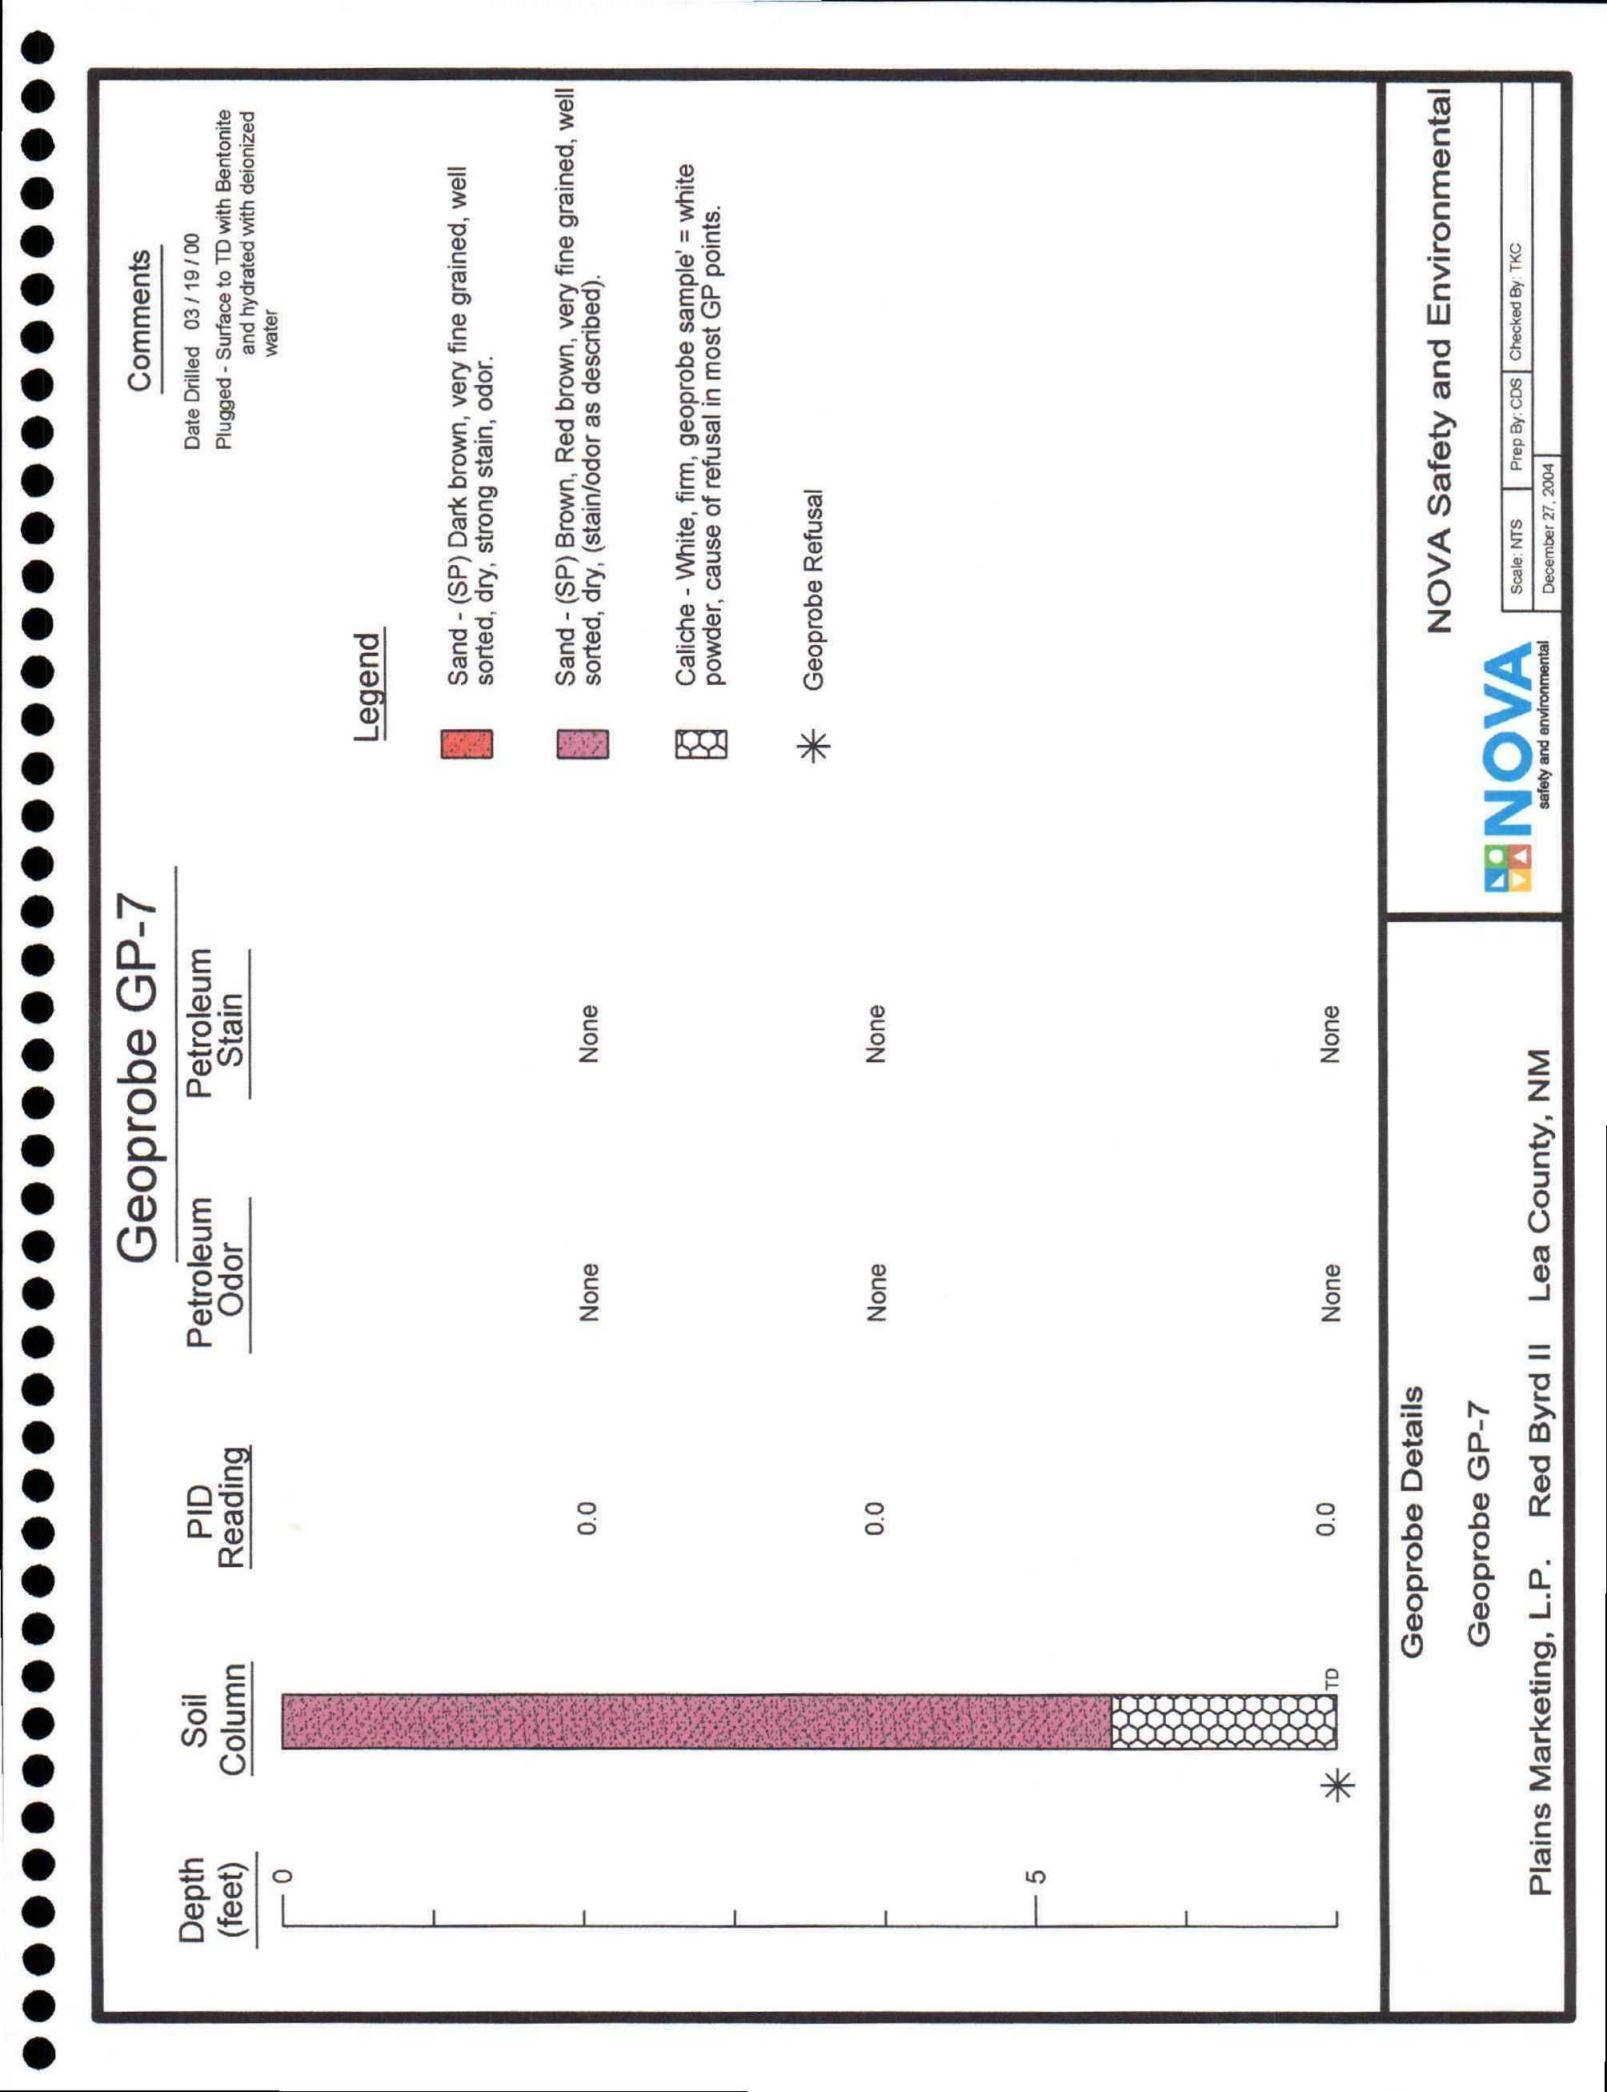
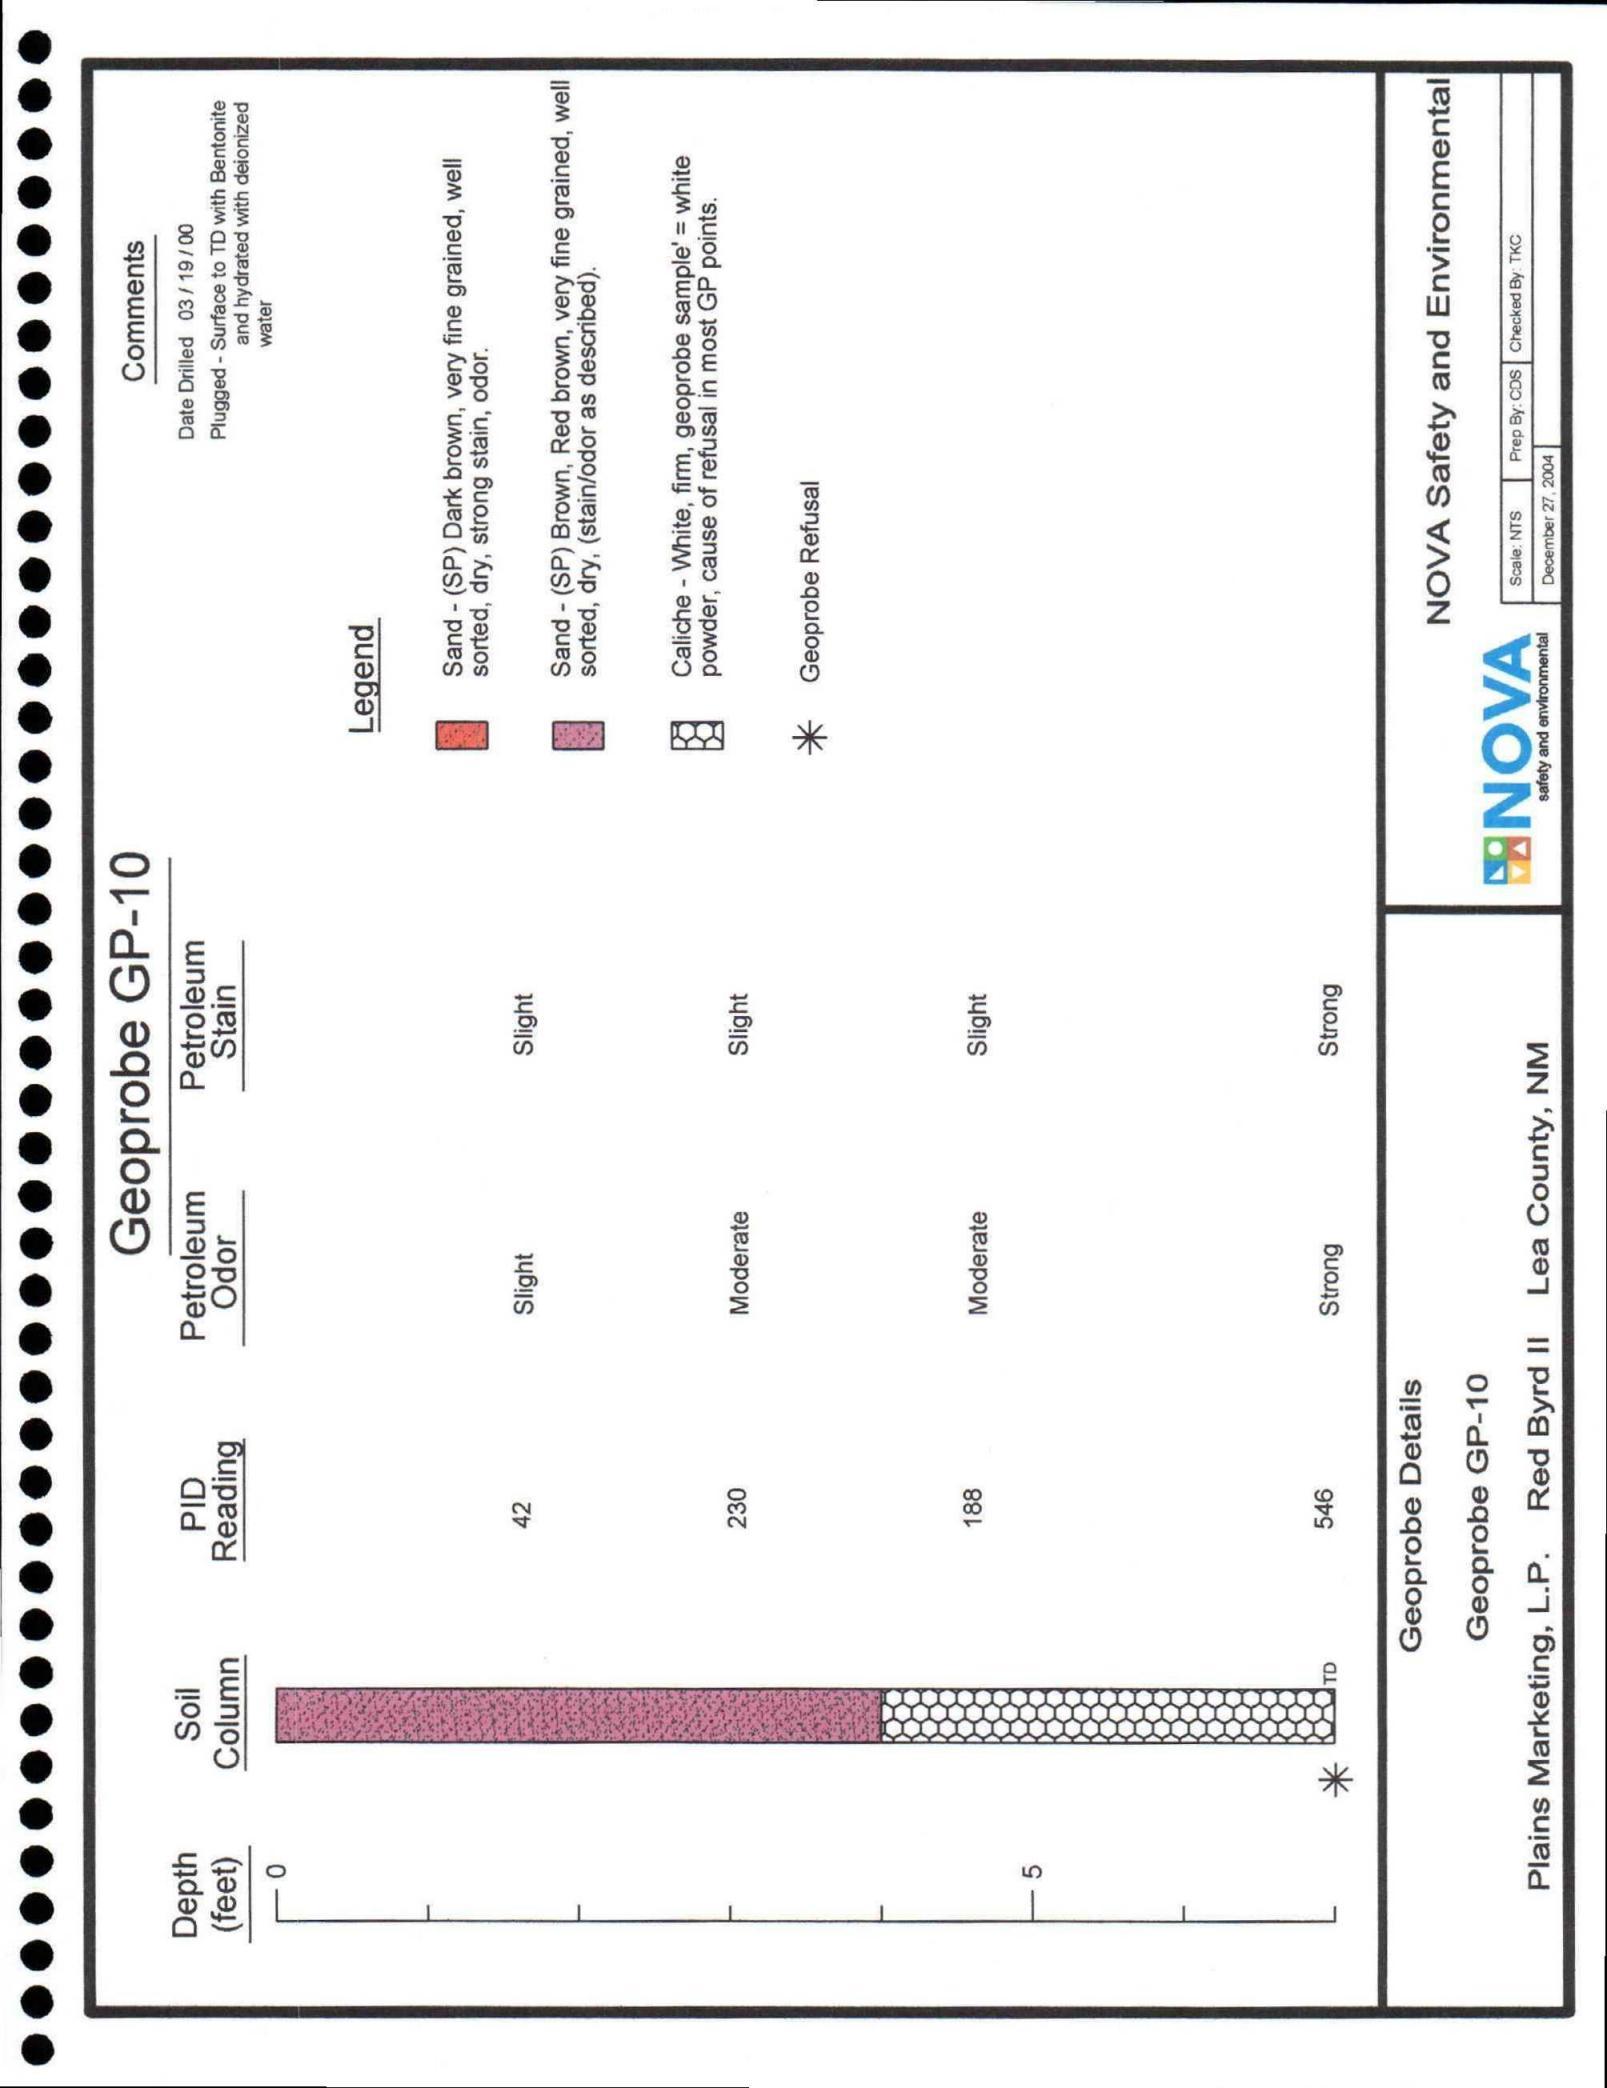
### Appendix A: Geoprobe and Soil Boring Logs

Sand - (SP) Brown, Red brown, very fine grained, well sorted, dry, (stain/odor as described). NOVA Safety and Environmental Plugged - Surface to TD with Bentonite and hydrated with deionized Caliche - White, firm, geoprobe sample' = white powder, cause of refusal in most GP points. Sand - (SP) Dark brown, very fine grained, well sorted, dry, strong stain, odor. Date Drilled 03 / 19 / 00 Scale: NTS Prep By: CDS Checked By: TKC Comments water December 27, 2004 Geoprobe Refusal Legend safety and environmental \* Z Geoprobe GP-2 Petroleum Stain None None None Red Byrd II Lea County, NM Petroleum Odor None None None **Geoprobe Details** Geoprobe GP-2 PID Reading 0.0 2.0 0.0 Plains Marketing, L.P. Column PLA PLA Soil \* Depth (feet) 0 S

Sand - (SP) Brown, Red brown, very fine grained, well sorted, dry, (stain/odor as described). NOVA Safety and Environmental Plugged - Surface to TD with Bentonite and hydrated with deionized water Caliche - White, firm, geoprobe sample' = white powder, cause of refusal in most GP points. Sand - (SP) Dark brown, very fine grained, well sorted, dry, strong stain, odor. Date Drilled 03 / 19 / 00 Scale: NTS Prep By: CDS Checked By: TKC Comments December 27, 2004 Geoprobe Refusal Legend safety and environmental \* 1.1.1 Geoprobe GP-3 Petroleum Stain None None None Red Byrd II Lea County, NM Petroleum Odor None None None Geoprobe Details Geoprobe GP-3 PID Reading 0.0 0.0 0.0 Plains Marketing, L.P. A m Column Soil \* Depth (feet) 0 5

Sand - (SP) Brown, Red brown, very fine grained, well sorted, dry, (stain/odor as described). NOVA Safety and Environmental Plugged - Surface to TD with Bentonite and hydrated with deionized Caliche - White, firm, geoprobe sample' = white powder, cause of refusal in most GP points. Sand - (SP) Dark brown, very fine grained, well sorted, dry, strong stain, odor. Date Drilled 03 / 19 / 00 Prep By: CDS Checked By: TKC Comments water December 27, 2004 Geoprobe Refusal Scale: NTS Legend safety and environmenta A A A \* W E.S. 2 Geoprobe GP-5 Petroleum Stain None None None Lea County, NM Petroleum Odor None None None Red Byrd II Geoprobe Details Geoprobe GP-5 Reading PID 0.0 0.0 0.0 Plains Marketing, L.P. Column Soil \* Depth (feet) 0 5

Sand - (SP) Brown, Red brown, very fine grained, well sorted, dry, (stain/odor as described). NOVA Safety and Environmental Plugged - Surface to TD with Bentonite and hydrated with deionized Caliche - White, firm, geoprobe sample' = white powder, cause of refusal in most GP points. Sand - (SP) Dark brown, very fine grained, well sorted, dry, strong stain, odor. Date Drilled 03 / 19 / 00 Scale: NTS Prep By: CDS Checked By: TKC Comments water December 27, 2004 Geoprobe Refusal Legend safety and environmental \* 2.87 Z Geoprobe GP-6 Petroleum Stain Slight None None Red Byrd II Lea County, NM Petroleum Odor moderate Slight Slight **Geoprobe Details** Geoprobe GP-6 Reading DID 39.0 26.8 89 Plains Marketing, L.P. Column Soil \* Depth (feet) 0 5

Sand - (SP) Brown, Red brown, very fine grained, well sorted, dry, (stain/odor as described). NOVA Safety and Environmental Plugged - Surface to TD with Bentonite and hydrated with deionized Caliche - White, firm, geoprobe sample' = white powder, cause of refusal in most GP points. Sand - (SP) Dark brown, very fine grained, well sorted, dry, strong stain, odor. Date Drilled 03 / 19 / 00 Scale: NTS Prep By: CDS Checked By: TKC Comments water December 27, 2004 Geoprobe Refusal Legend safety and environmental \* 2.87 Geoprobe GP-8 Petroleum Stain Moderate Slight Slight None Red Byrd II Lea County, NM Petroleum Odor Moderate Moderate Moderate Slight **Geoprobe Details** Geoprobe GP-8 Reading PID 17.8 329 110 380 Plains Marketing, L.P. Column Soil \* Depth (feet) 0 5

Sand - (SP) Brown, Red brown, very fine grained, well sorted, dry, (stain/odor as described). NOVA Safety and Environmental Plugged - Surface to TD with Bentonite and hydrated with deionized Caliche - White, firm, geoprobe sample' = white powder, cause of refusal in most GP points. Sand - (SP) Dark brown, very fine grained, well sorted, dry, strong stain, odor. Date Drilled 03 / 19 / 00 Scale: NTS Prep By: CDS Checked By: TKC Comments water December 27, 2004 Geoprobe Refusal Legend safety and environmental \* 3.35 Geoprobe GP-9 Petroleum Stain None None None Red Byrd II Lea County, NM Petroleum Odor None None None **Geoprobe Details** Geoprobe GP-9 PID Reading 0.0 0.0 0.0 Plains Marketing, L.P. Column Soil \* Depth (feet) 0 5

maximum depth of approximately 22 feet bgs. Continuous soil samples from each boring were field screened for the presence of volatile organic compounds (VOCs), utilizing a photo ionization detector (PID). Selected soil samples from each boring were submitted for laboratory analysis of benzene, toluene, ethylbenzene and xylene (BTEX) as well as total petroleum hydrocarbons (TPH) gasoline range organics and diesel range organics (TPH-GRO/DRO) by EPA SW 846 Methods 8021B and 8015B, respectively. Figure 2 illustrates the locations of the Geoprobe ® borings. Soil boring logs displaying lithology, visual and olfactory observations and PID results of each Geoprobe ® and Soil Borings are presented in Appendix A. Table 1 presents concentrations of BTEX and TPH in soil. The laboratory reports are included in Appendix B.
