Release Notification

| Latitude | 32.277111 | Longitude | -103.935915 |
|---|---|---|--|
| Site Nam | REMUDA SOUTH 25 STATE 126H | Site Type | Well Location |

Cause of Release: During drilling operations a returns flow line was parted at a slip joint. Approximately 8.8 bbls of produced water was released to pad surface, a vacuum truck recovered 8 bbls. Additional third party resources have been retained to assist in the remediation.

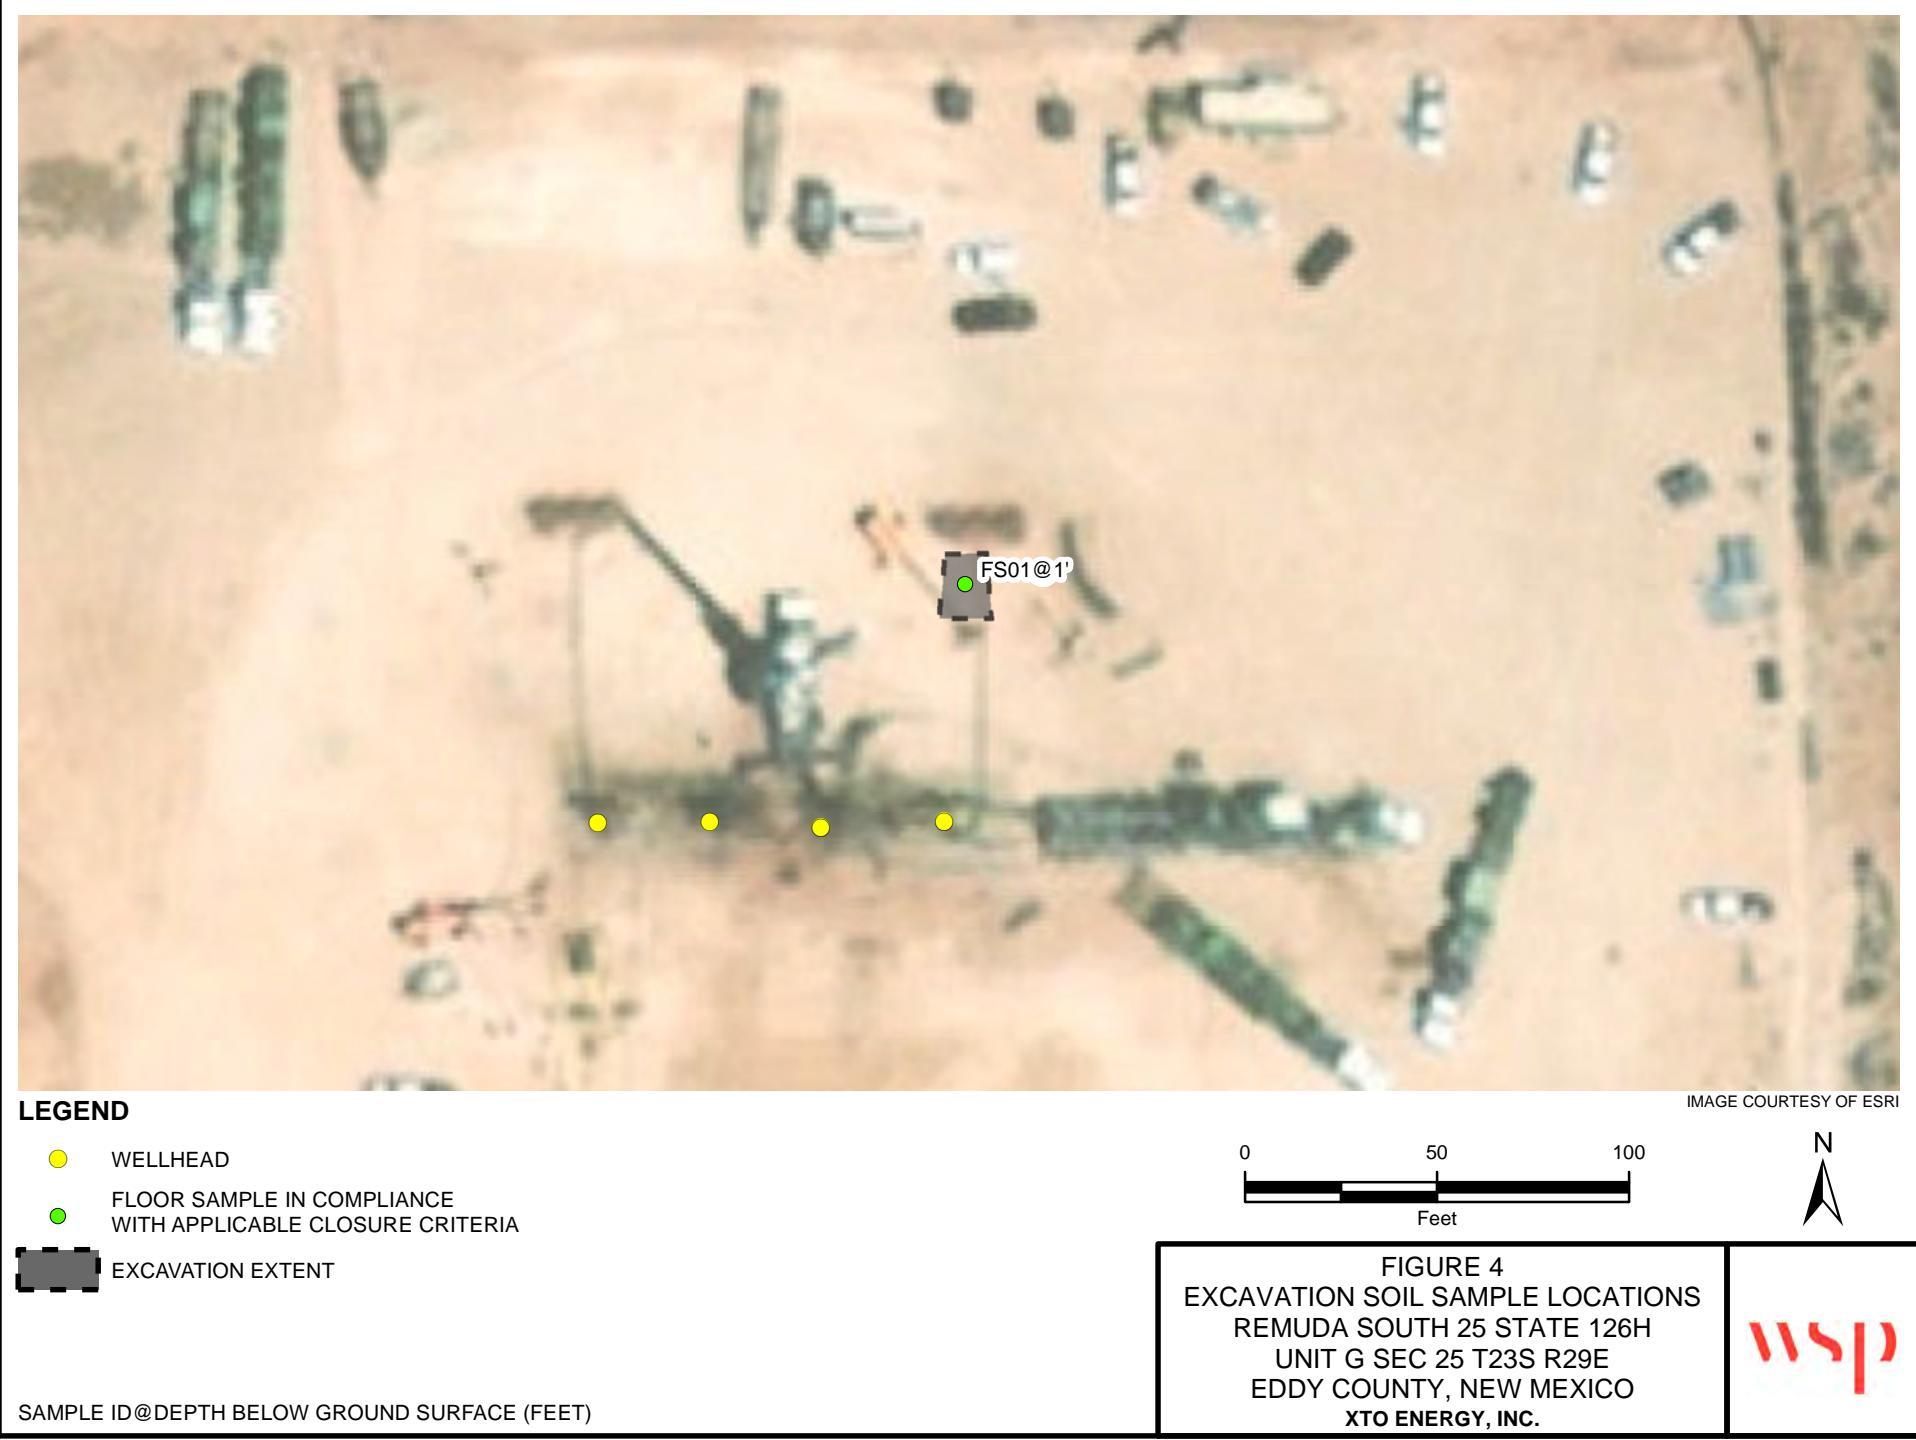
P:\XTO Energy\GIS\MXD\012919260_REMUDA SOUTH 25 STATE 126H\012919260_FIG04_EXCAVATION_2020.mxd

Based on observed staining and field screening results, WSP directed excavation activities to remove discolored soil in the area around preliminary soil sample SS01. To direct excavation activities, WSP screened soil for volatile aromatic hydrocarbons and chloride utilizing a PID and Hach[®] chloride QuanTab[®] test strips, respectively. The final excavation measured approximately 200 square feet and was completed to a depth of 1-foot bgs. Following removal of impacted soil, LTE collected a 5-point composite soil sample from the floor of the excavation. The 5-point composite sample was collected by placing five equivalent aliquots of soil into a 1-gallon, resealable plastic bag and homogenizing the sample by thoroughly mixing. One composite floor soil sample (FS01) was collected from the excavation at a depth of approximately 1-foot bgs. The excavation soil sample was collected, handled, and analyzed as described above. The excavation extent and excavation soil sample location are presented on Figure 4.
