Site Name Pierce Canyon 17 TB	Site Type Tank Battery		
Date Release Discovered 5-17-2020	API# (if applicable)

RE: Closure Request Addendum XTO Energy, Inc. Pierce Canyon 17 TB Incident Number NRM2015454866 Eddy County, New Mexico

On May 17, 2020, the water tanks overflowed through the top of the thief hatches, resulting in 35 barrels (bbls) of produced water being released into the lined secondary containment. A vacuum truck was immediately dispatched to the Site to recover freestanding fluids, of which approximately 35 bbls of produced were recovered. A liner integrity inspection was immediately conducted by XTO personnel following the recovery. A 48-hour advance notice of liner inspection was provided via email to the NMOCD District II office and upon inspection, the liner was determined to be compromised. XTO reported the release to the NMOCD via email on May 18, 2020 and submitted a Release Notification and Corrective Action Form C-141 (Form C-141) on May 29, 2020 that was subsequently assigned Incident Number NRM2015454866.

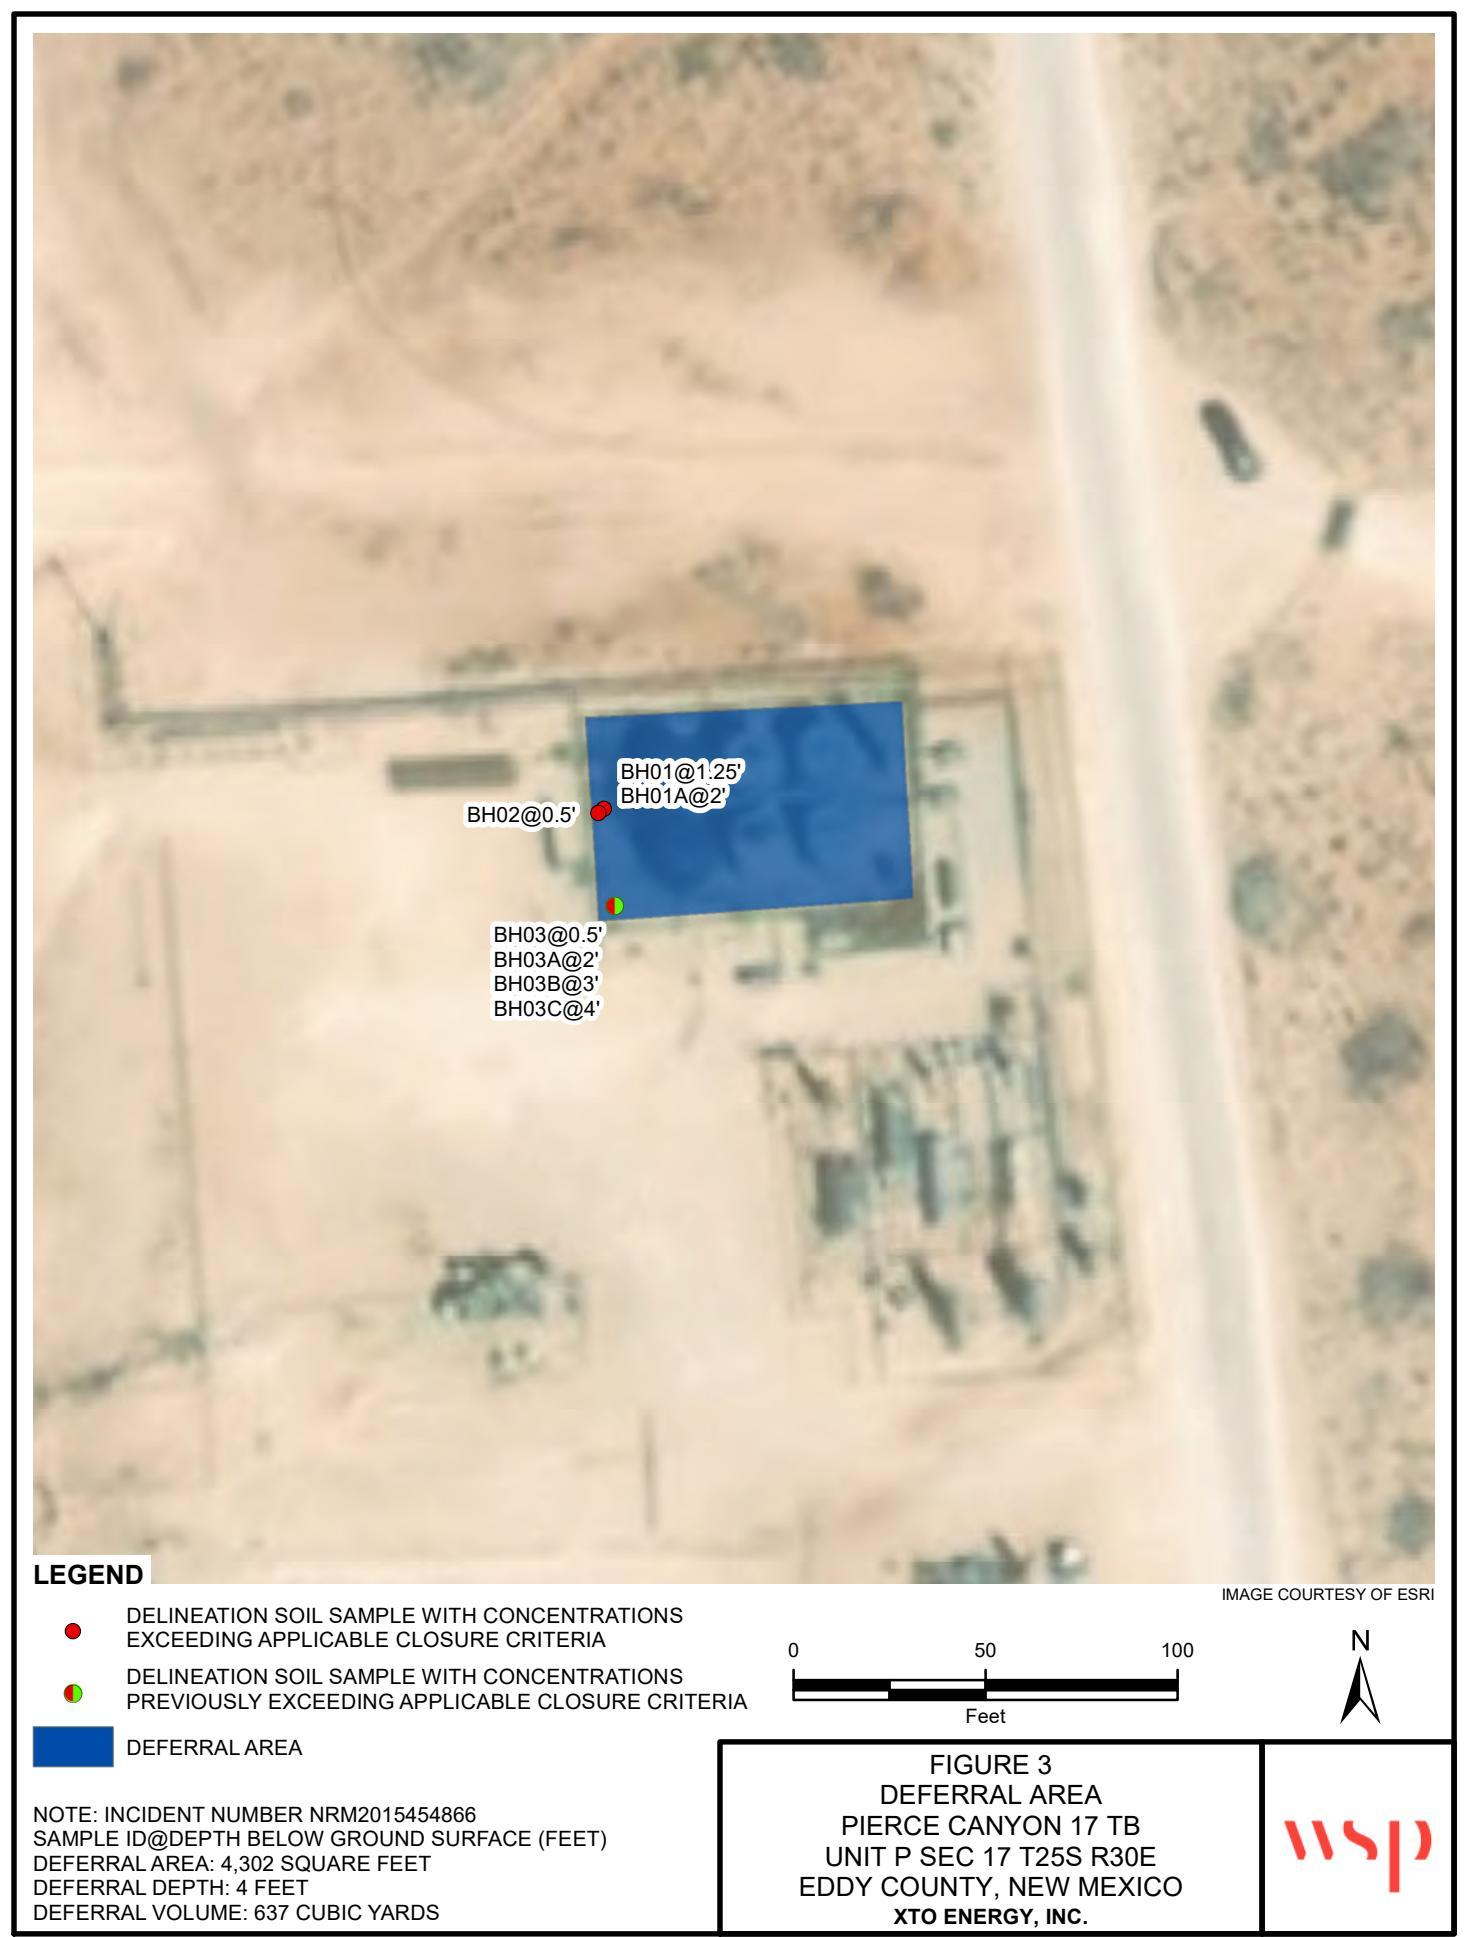
The borehole soil sample was field screened for volatile aromatic hydrocarbons and chloride utilizing a photo-ionization detector (PID) and Hach<sup>®</sup> chloride QuanTab<sup>®</sup> test strips, respectively. Field screening results and observations for the continuation of BH03 were logged on a lithologic/soil sampling log, which is included in Attachment 1. The delineation soil sample location is depicted on Figure 2. Photographic evidence is included in Attachment 2.
