RE: Revised Sampling Workplan Incident ID: nRM2003454039 Location: Wool Head 20 State Com 703H AEP #: 08282019-1430-unknown

In response to the closure denial, we present this revised confirmation soil sampling plan for additional laboratory analysis of closure criteria constituents listed in Table 1 of 19.15.29 NMAC.

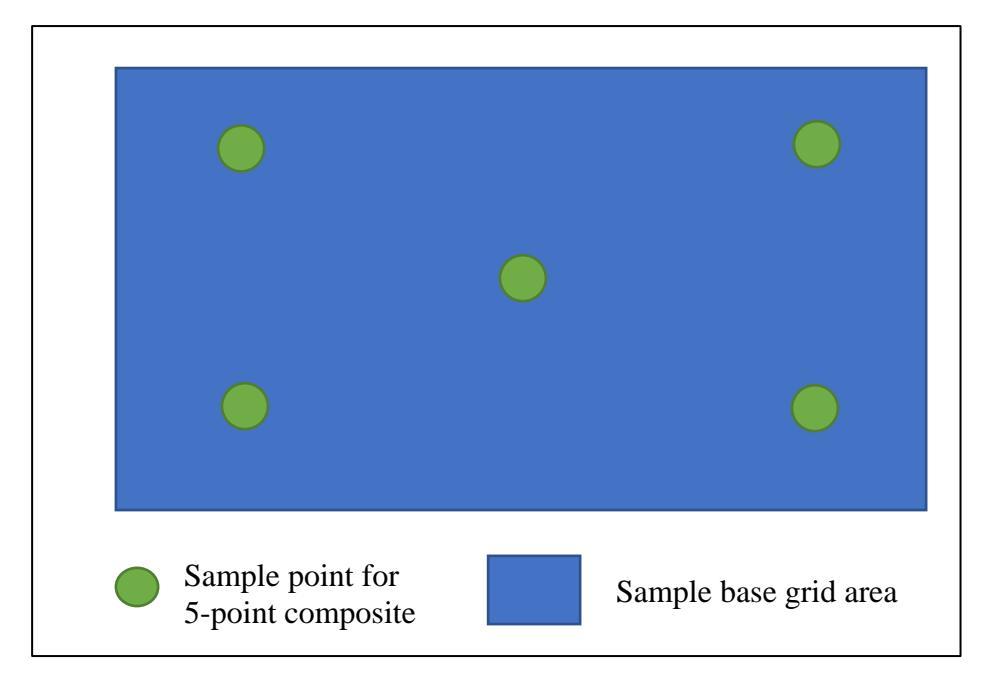
Plate R1-1 shows the sampling diagram for base samples performed to date. A 5-point composite base sample was collected from each grid for confirmation sampling. Five-point composite sample points were evenly spaced within each sample grid to obtain a representative sample of the area (Figure 1, below example).

Figure 1: Example of 5-point sample grid for composite sampling.
