## **Release Notification**

Site Name: NORTHEAST BLANCO UNIT 605 001H	Site Type: Natural Gas Production Water System
Date Release Discovered: 7/6/2021	API# (if applicable): <b>30-045-35851</b>

## SIMCOE LLC Northeast Blanco Unit 605 001-H Release

Producd Water Gathering Line Release - Lab Results

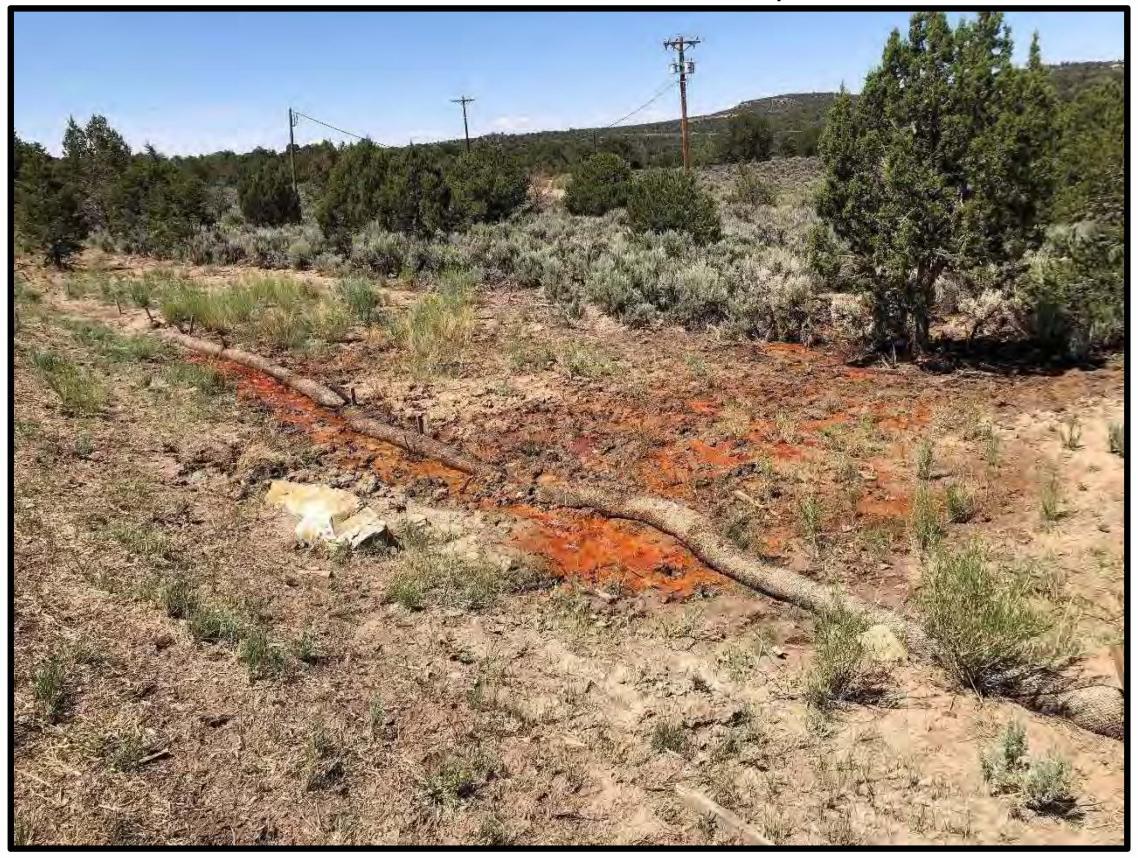
Unknown failure of produced water transfer line. Soil samples indicate <u>hydrocarbon impacts below the remedial action level</u>. The area will be turned and raked to break up any surface staining. Additional visual monitoring will be performed to ensure there are no long-term aesthetic impacts from the release. No further action is requested. Page 2

Photo 1 – Release area on 7/6/2021.

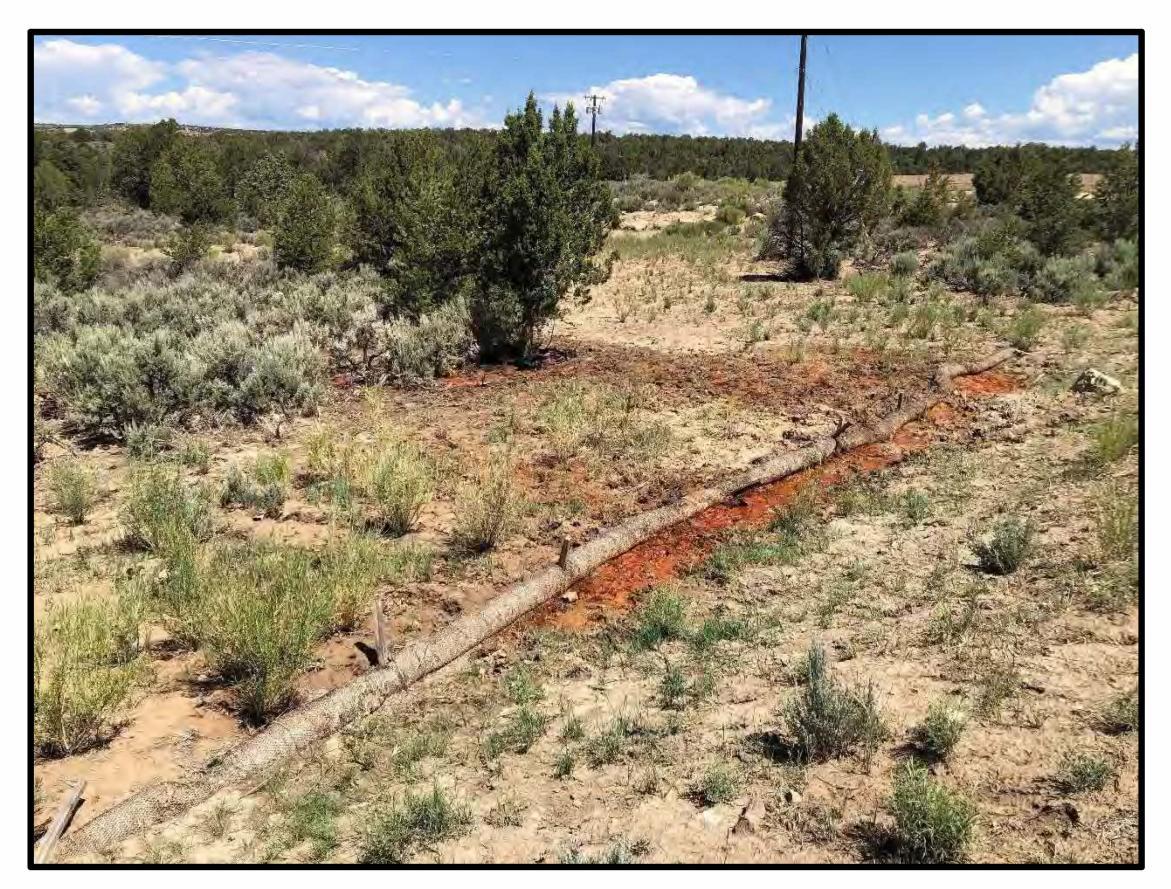
Photo 2 – Release area on 7/6/2021.

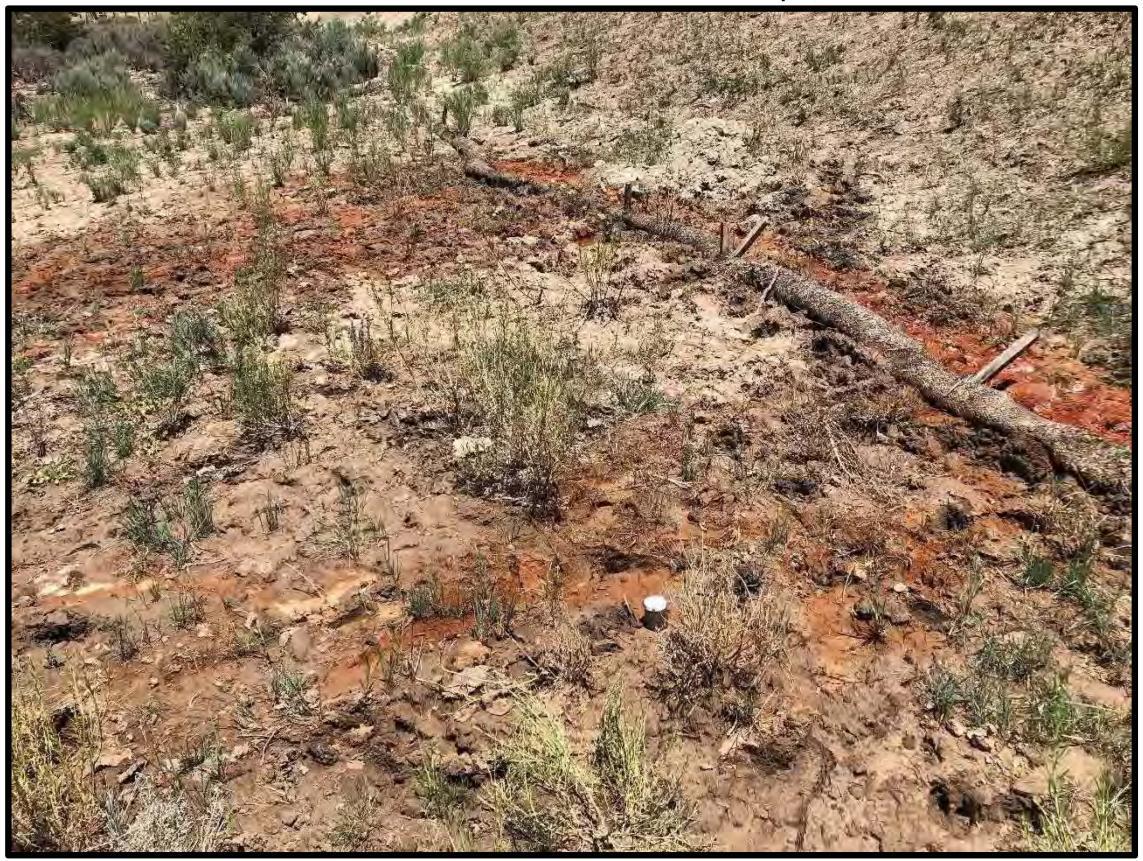
Photo 3 – SSO1 grab sample location.

CLIENT:	SIMCOE		Clien	t Sample ID:	SS01		
Project:	Northeast Blanco Unit 605 001H	Collection Date: 7/6/2021 1:20:00 PM					
Lab ID:	2107172-001	Matrix: SOIL         Received Date: 7/7/2021 8:30:00 AM					
Analyses		Result	RL (	Qual Units	DF	Date Analyzed	
EPA MET	HOD 8015M/D: DIESEL RANGE	ORGANICS				Analyst: <b>SB</b>	
Diesel R	ange Organics (DRO)	ND	9.9	mg/Kg	1	7/10/2021 1:50:12 PM	
Motor Oi	I Range Organics (MRO)	ND	49	mg/Kg	1	7/10/2021 1:50:12 PM	
Surr: [	DNOP	91.5	70-130	%Rec	1	7/10/2021 1:50:12 PM	
EPA MET	HOD 8015D: GASOLINE RANGE					Analyst: <b>mb</b>	
Gasoline	Range Organics (GRO)	ND	4.9	mg/Kg	1	7/8/2021 2:52:00 PM	
Surr: E	3FB	97.3	70-130	%Rec	1	7/8/2021 2:52:00 PM	
EPA MET	HOD 8021B: VOLATILES					Analyst: <b>mb</b>	
Benzene		ND	0.024	mg/Kg	1	7/8/2021 2:52:00 PM	
Toluene		ND	0.049	mg/Kg	1	7/8/2021 2:52:00 PM	
Ethylben	zene	ND	0.049	mg/Kg	1	7/8/2021 2:52:00 PM	
Xylenes,	Total	ND	0.098	mg/Kg	1	7/8/2021 2:52:00 PM

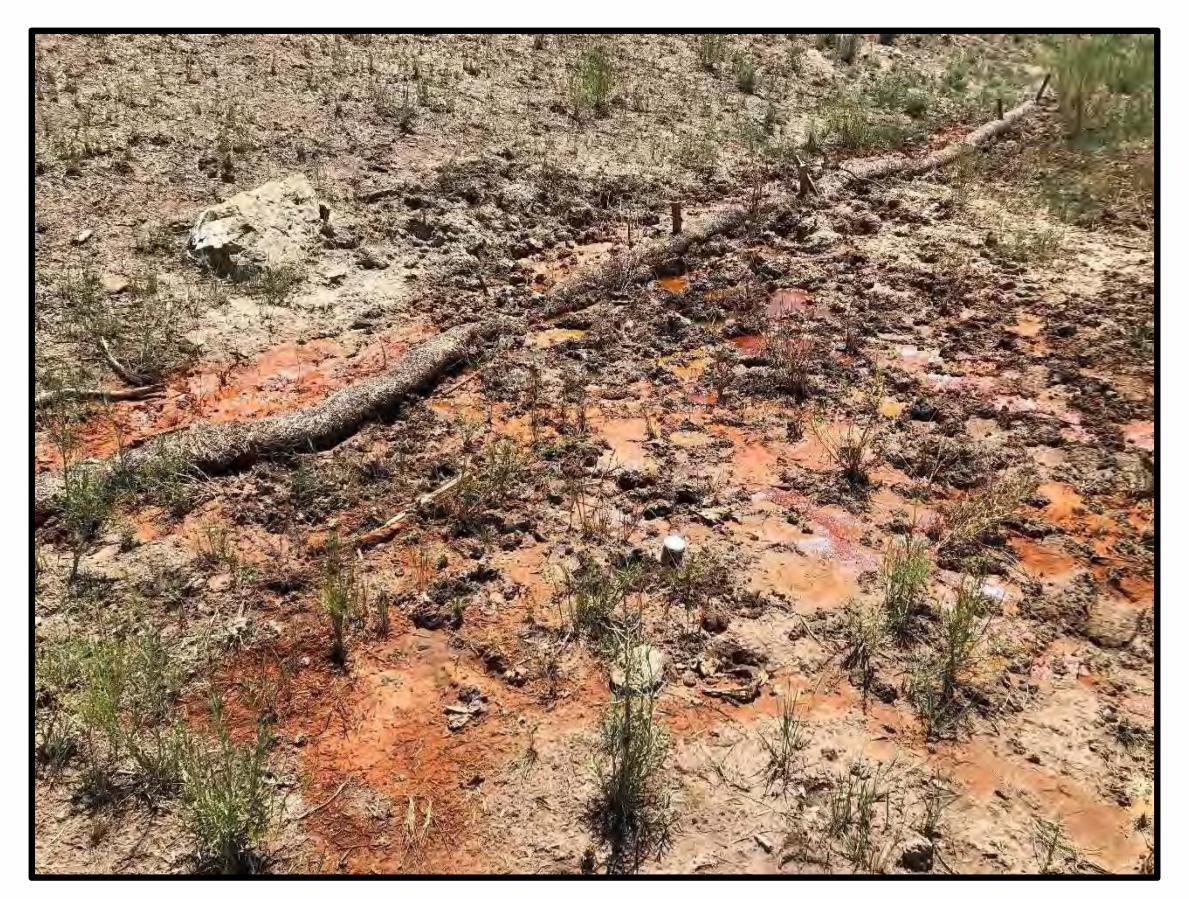
Photo 4 - SS02 grab sample location

CLIENT:	SIMCOE		Client S	Sample ID:	SS02	
Project:	Northeast Blanco Unit 605 00	1H	Collec	ction Date:	7/6/20	21 1:25:00 PM
Lab ID:	2107172-002	Matrix: SOIL	Rece	vived Date:	7/7/20	21 8:30:00 AM
Analyses		Result	RL Qu	al Units	DF	Date Analyzed
EPA MET	THOD 8015M/D: DIESEL RANG	E ORGANICS				Analyst: SB
Diesel R	ange Organics (DRO)	350	9.9	mg/Kg	1	7/10/2021 2:02:52 PM
Motor Oi	l Range Organics (MRO)	ND	49	mg/Kg	1	7/10/2021 2:02:52 PM
Surr: I	DNOP	87.9	70-130	%Rec	1	7/10/2021 2:02:52 PM
EPA MET	THOD 8015D: GASOLINE RAN	GE				Analyst: <b>mb</b>
Gasoline	Range Organics (GRO)	ND	24	mg/Kg	5	7/8/2021 3:52:00 PM
Surr: I	BFB	106	70-130	%Rec	5	7/8/2021 3:52:00 PM
EPA MET	THOD 8021B: VOLATILES					Analyst: <b>mb</b>
Benzene		ND	0.12	mg/Kg	5	7/8/2021 3:52:00 PM
Toluene		ND	0.24	mg/Kg	5	7/8/2021 3:52:00 PM
Ethylben	zene	ND	0.24	mg/Kg	5	7/8/2021 3:52:00 PM
Xylenes,	Total	ND	0.47	mg/Kg	5	7/8/2021 3:52:00 PM
Surr: 4	4-Bromofluorobenzene	99.5	70-130	%Rec	5	7/8/2021 3:52:00 PM

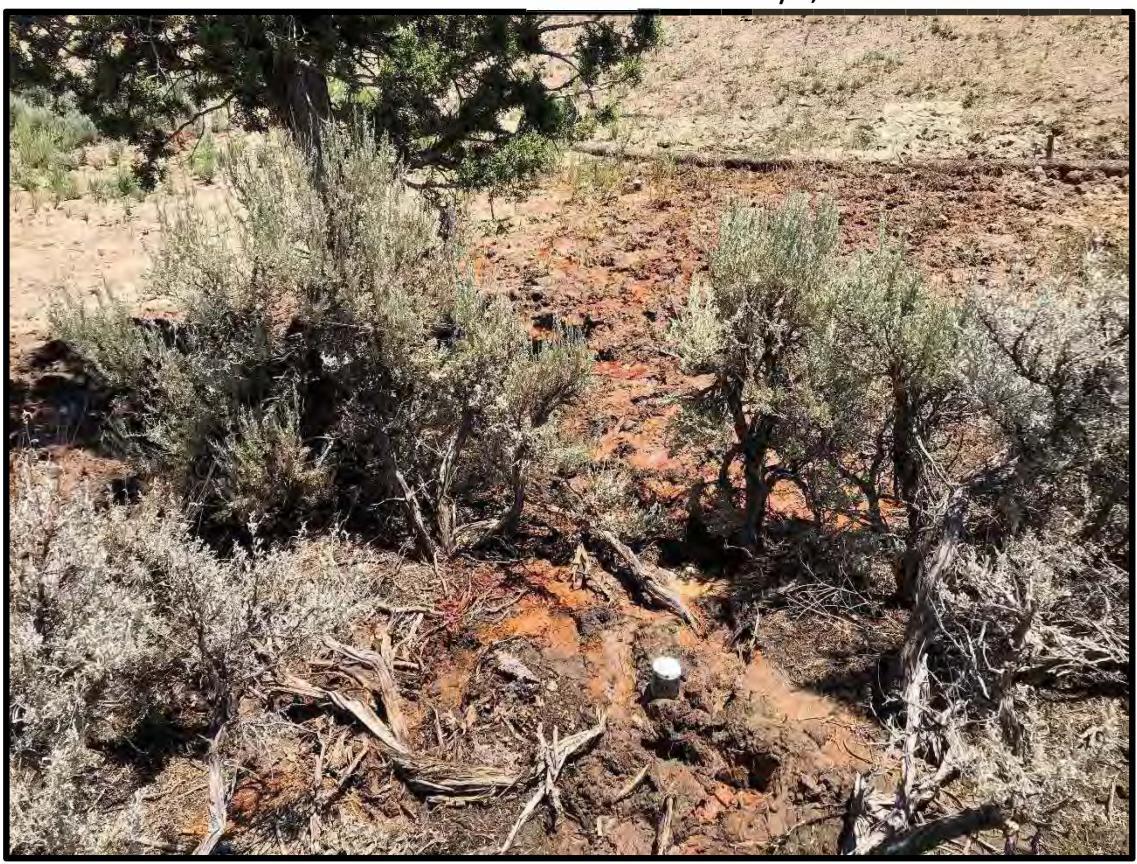
Photo 5 – SSO3 grab sample location.

CLIENT:	SIMCOE		Client	Sample ID:	SS03	
Project:	Northeast Blanco Unit 605 001	Н	Colle	ction Date:	7/6/20	21 1:30:00 PM
Lab ID:	2107172-003	Matrix: SOIL	Rec	eived Date:	7/7/20	21 8:30:00 AM
Analyses		Result	RL Qu	al Units	DF	Date Analyzed
EPA MET	HOD 8015M/D: DIESEL RANG	E ORGANICS				Analyst: <b>SB</b>
Diesel R	ange Organics (DRO)	270	9.5	mg/Kg	1	7/10/2021 2:15:25 PM
Motor Oi	l Range Organics (MRO)	ND	47	mg/Kg	1	7/10/2021 2:15:25 PM
Surr: I	DNOP	93.2	70-130	%Rec	1	7/10/2021 2:15:25 PM
EPA MET	HOD 8015D: GASOLINE RANG	GE				Analyst: <b>mb</b>
Gasoline	e Range Organics (GRO)	ND	24	mg/Kg	5	7/8/2021 4:52:00 PM
Surr: I	BFB	107	70-130	%Rec	5	7/8/2021 4:52:00 PM
EPA MET	THOD 8021B: VOLATILES					Analyst: <b>mb</b>
Benzene		ND	0.12	mg/Kg	5	7/8/2021 4:52:00 PM
Toluene		ND	0.24	mg/Kg	5	7/8/2021 4:52:00 PM
Ethylben	zene	ND	0.24	mg/Kg	5	7/8/2021 4:52:00 PM
Xylenes,	Total	ND	0.48	mg/Kg	5	7/8/2021 4:52:00 PM
Surr: 4	4-Bromofluorobenzene	100	70-130	%Rec	5	7/8/2021 4:52:00 PM

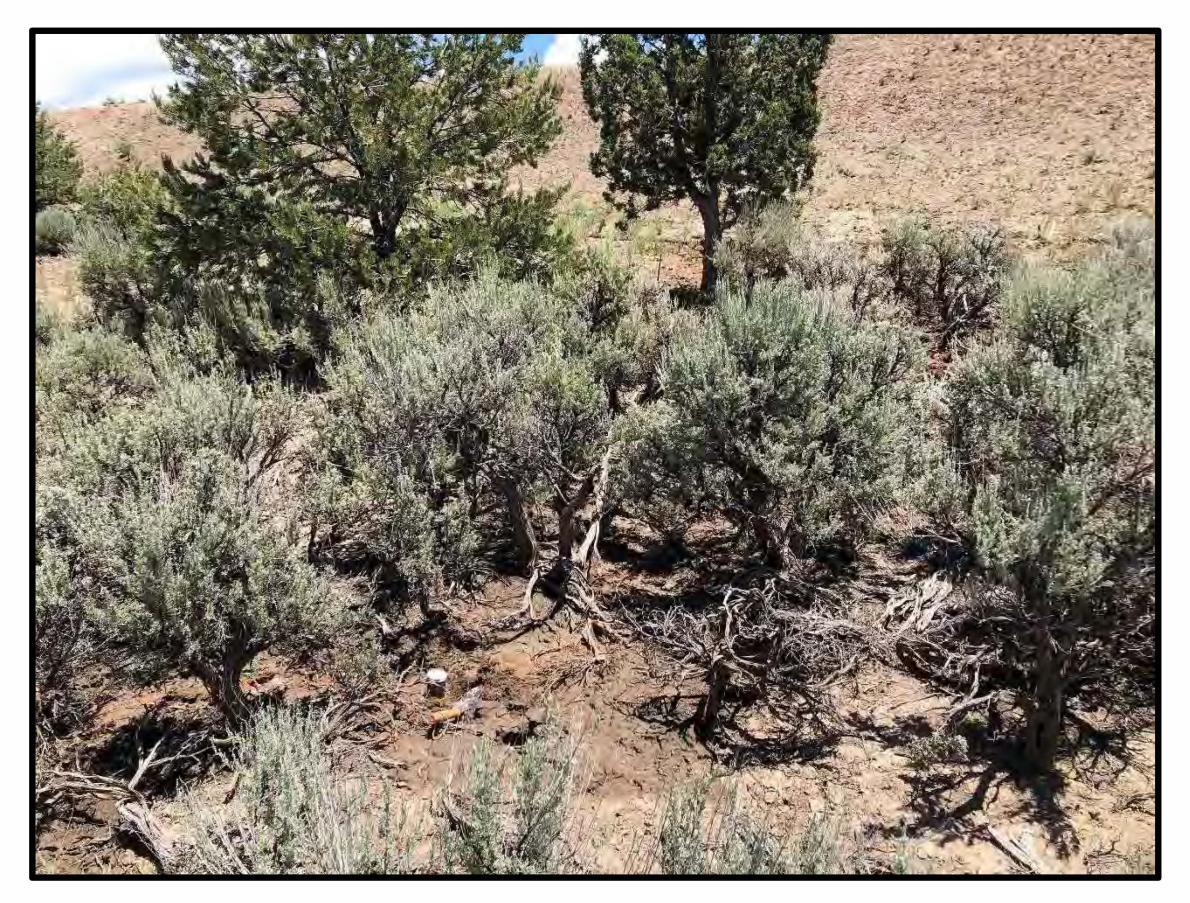
Photo 6 – SS04 grab sample location at the terminus of the release flow.

CLIENT:	SIMCOE		Client	Sample ID:	SS04			
Project:	Northeast Blanco Unit 605 00	)1H	<b>Collection Date:</b> 7/6/2021 1:35:00 PM					
Lab ID:	2107172-004	Matrix: SOIL	Reco	eived Date:	7/7/20	21 8:30:00 AM		
Analyses		Result	RL Qu	al Units	DF	Date Analyzed		
EPA MET	HOD 8015M/D: DIESEL RAN	GE ORGANICS				Analyst: <b>SB</b>		
Diesel R	ange Organics (DRO)	14	9.7	mg/Kg	1	7/10/2021 2:28:05 PM		
Motor Oi	I Range Organics (MRO)	ND	49	mg/Kg	1	7/10/2021 2:28:05 PM		
Surr: [	DNOP	93.9	70-130	%Rec	1	7/10/2021 2:28:05 PM		
EPA MET	HOD 8015D: GASOLINE RAM	IGE				Analyst: <b>mb</b>		
Gasoline	Range Organics (GRO)	ND	4.8	mg/Kg	1	7/8/2021 5:13:00 PM		
Surr: E	3FB	105	70-130	%Rec	1	7/8/2021 5:13:00 PM		
EPA MET	HOD 8021B: VOLATILES					Analyst: <b>mb</b>		
Benzene		ND	0.024	mg/Kg	1	7/8/2021 5:13:00 PM		
Toluene		ND	0.048	mg/Kg	1	7/8/2021 5:13:00 PM		
Ethylben	zene	ND	0.048	mg/Kg	1	7/8/2021 5:13:00 PM		
Xylenes,	Total	ND	0.095	mg/Kg	1	7/8/2021 5:13:00 PM

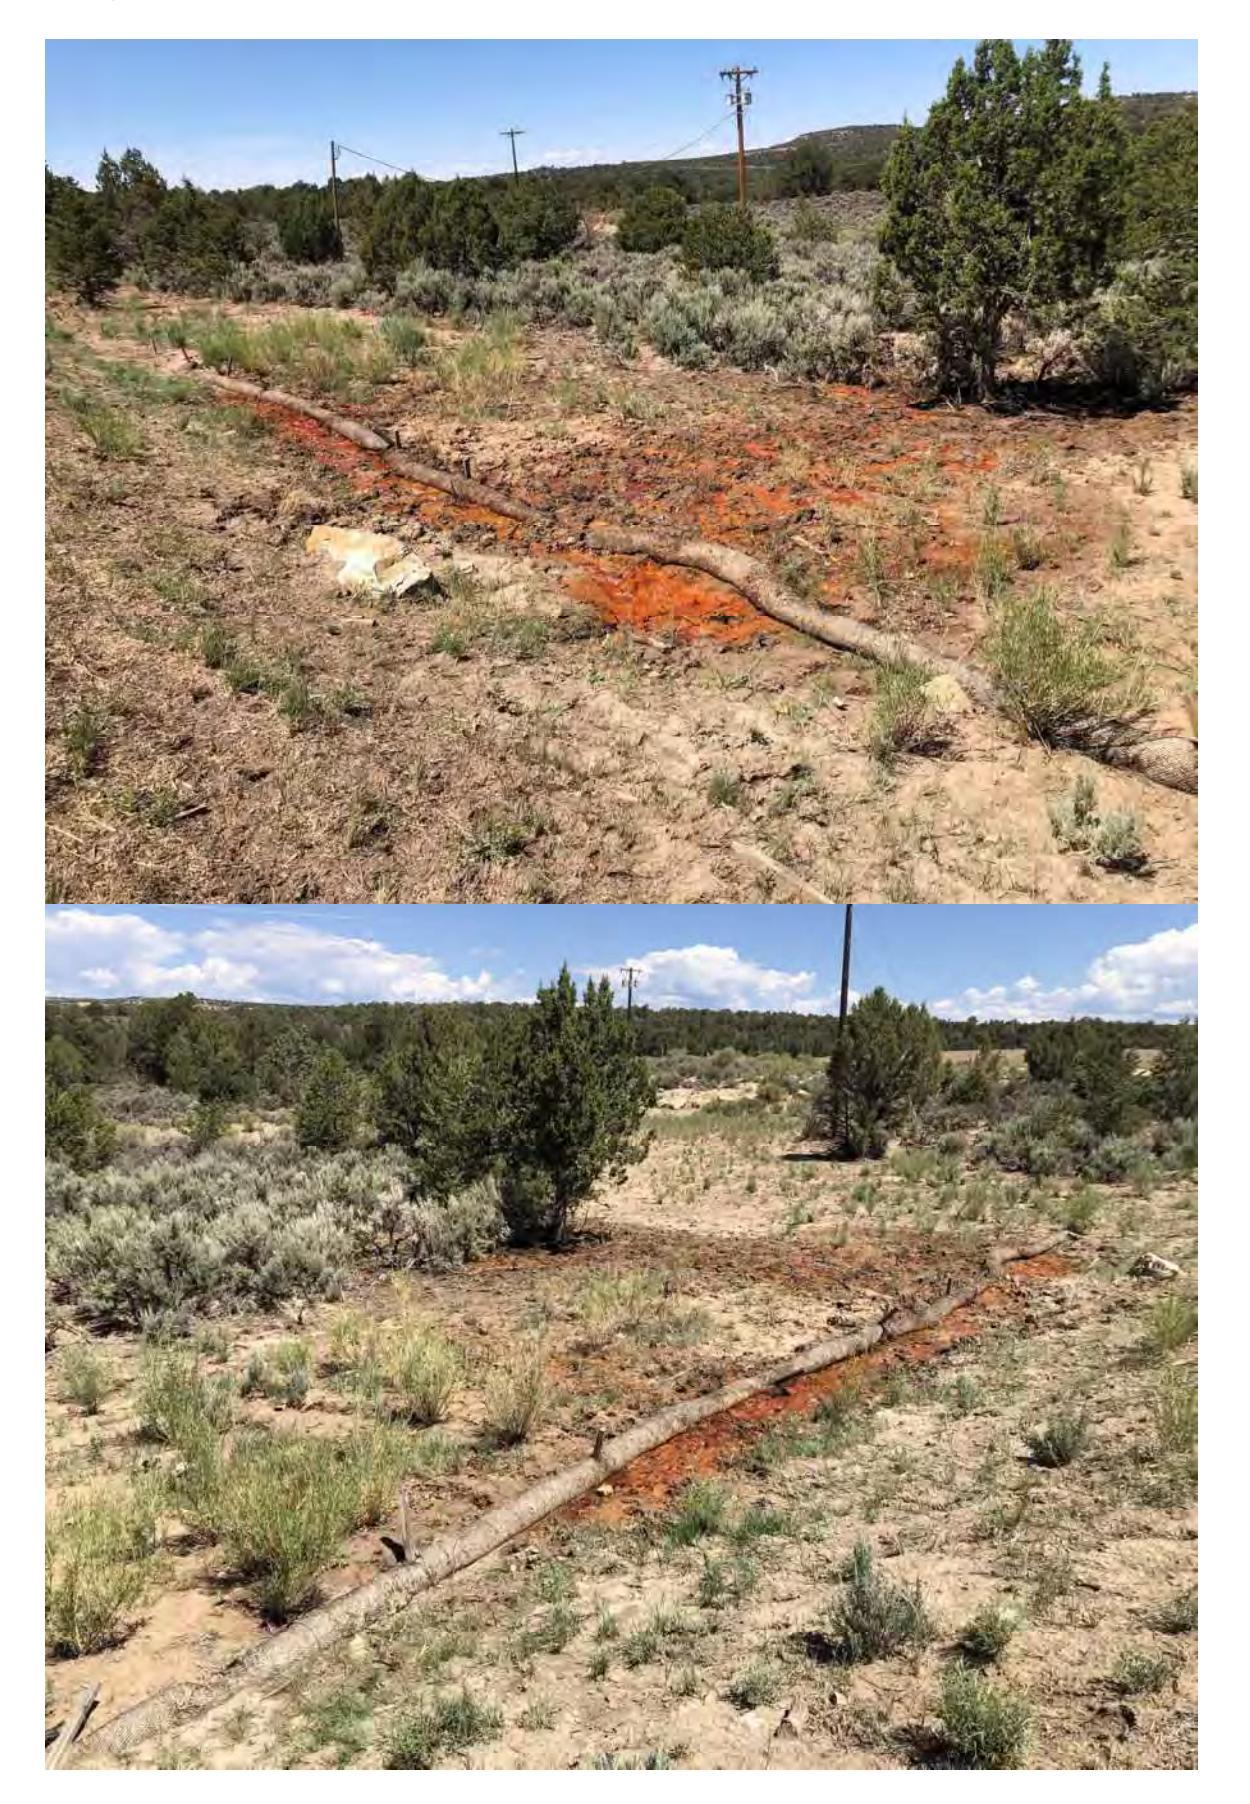
The release measures approximately 925 sq ft. I propose to collect 4 grab samples from the release area, bisecting (2 sample) the lateral NW/SE sections at the release point and 2 samples from the downgradient flow to the west. The attached map depicts the proposed sampling points in <u>GREEN DOTS</u>.

Due to the 605 well pad being a recent development location, the Google Earth imagery does not have a current depiction. I have added the approximate footprint of the well pad.
