Re: Release Characterization and Remediation Work Plan ConocoPhillips SEMU Permian Upper Battery Release Unit Letter K, Section 19, Township 20 South, Range 38 East Lea County, New Mexico Incident ID# nAPP2207049431

Release Characterization and Remediation Work Plan May 29, 2022

- Figure 1 Overview Map
- Figure 2 Topographic Map
- Figure 3 Approximate Release Extent
- Figure 4 Initial Response and Site Assessment
- Figure 5 Proposed Remediation Extent
- Figure 6 Alternative Confirmation Sampling Plan

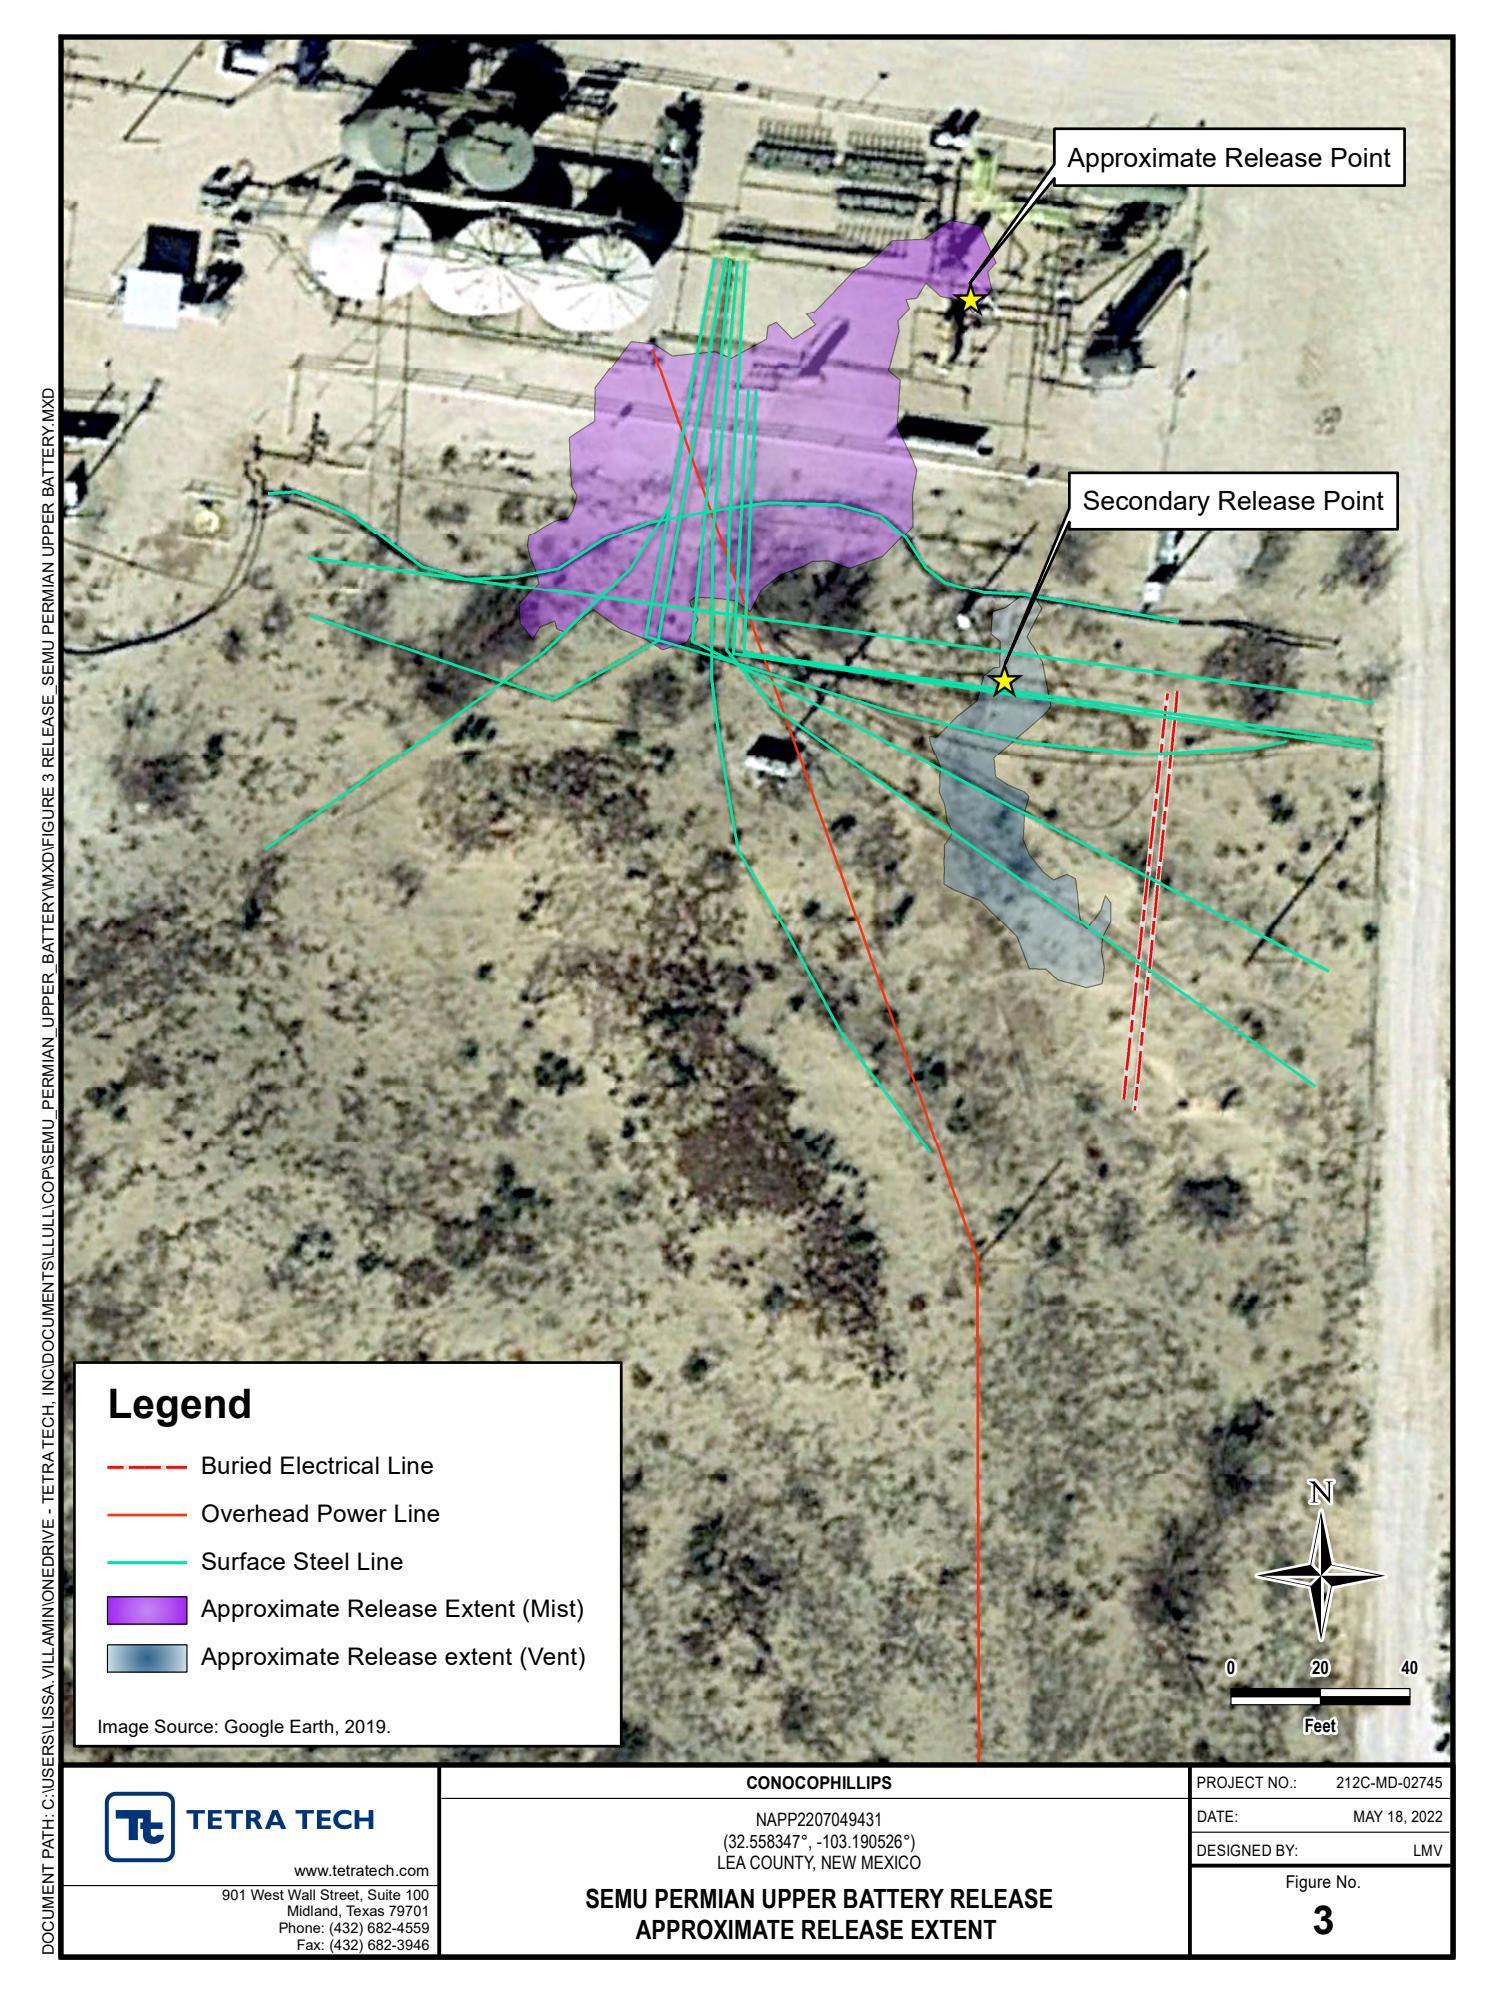
Initial response remedial actions were performed at the release site between April 7 and 11, 2022. Visually stained areas of the pastureland were scraped to remove impacted materials to approximately 1 foot bgs, resulting in approximately 46 cubic yards of contaminated soil being removed. and sent to R360 Halfway Facility in Hobbs, New Mexico. Waste manifests can be found in Appendix C. The initial response area is indicated in Figure 3.

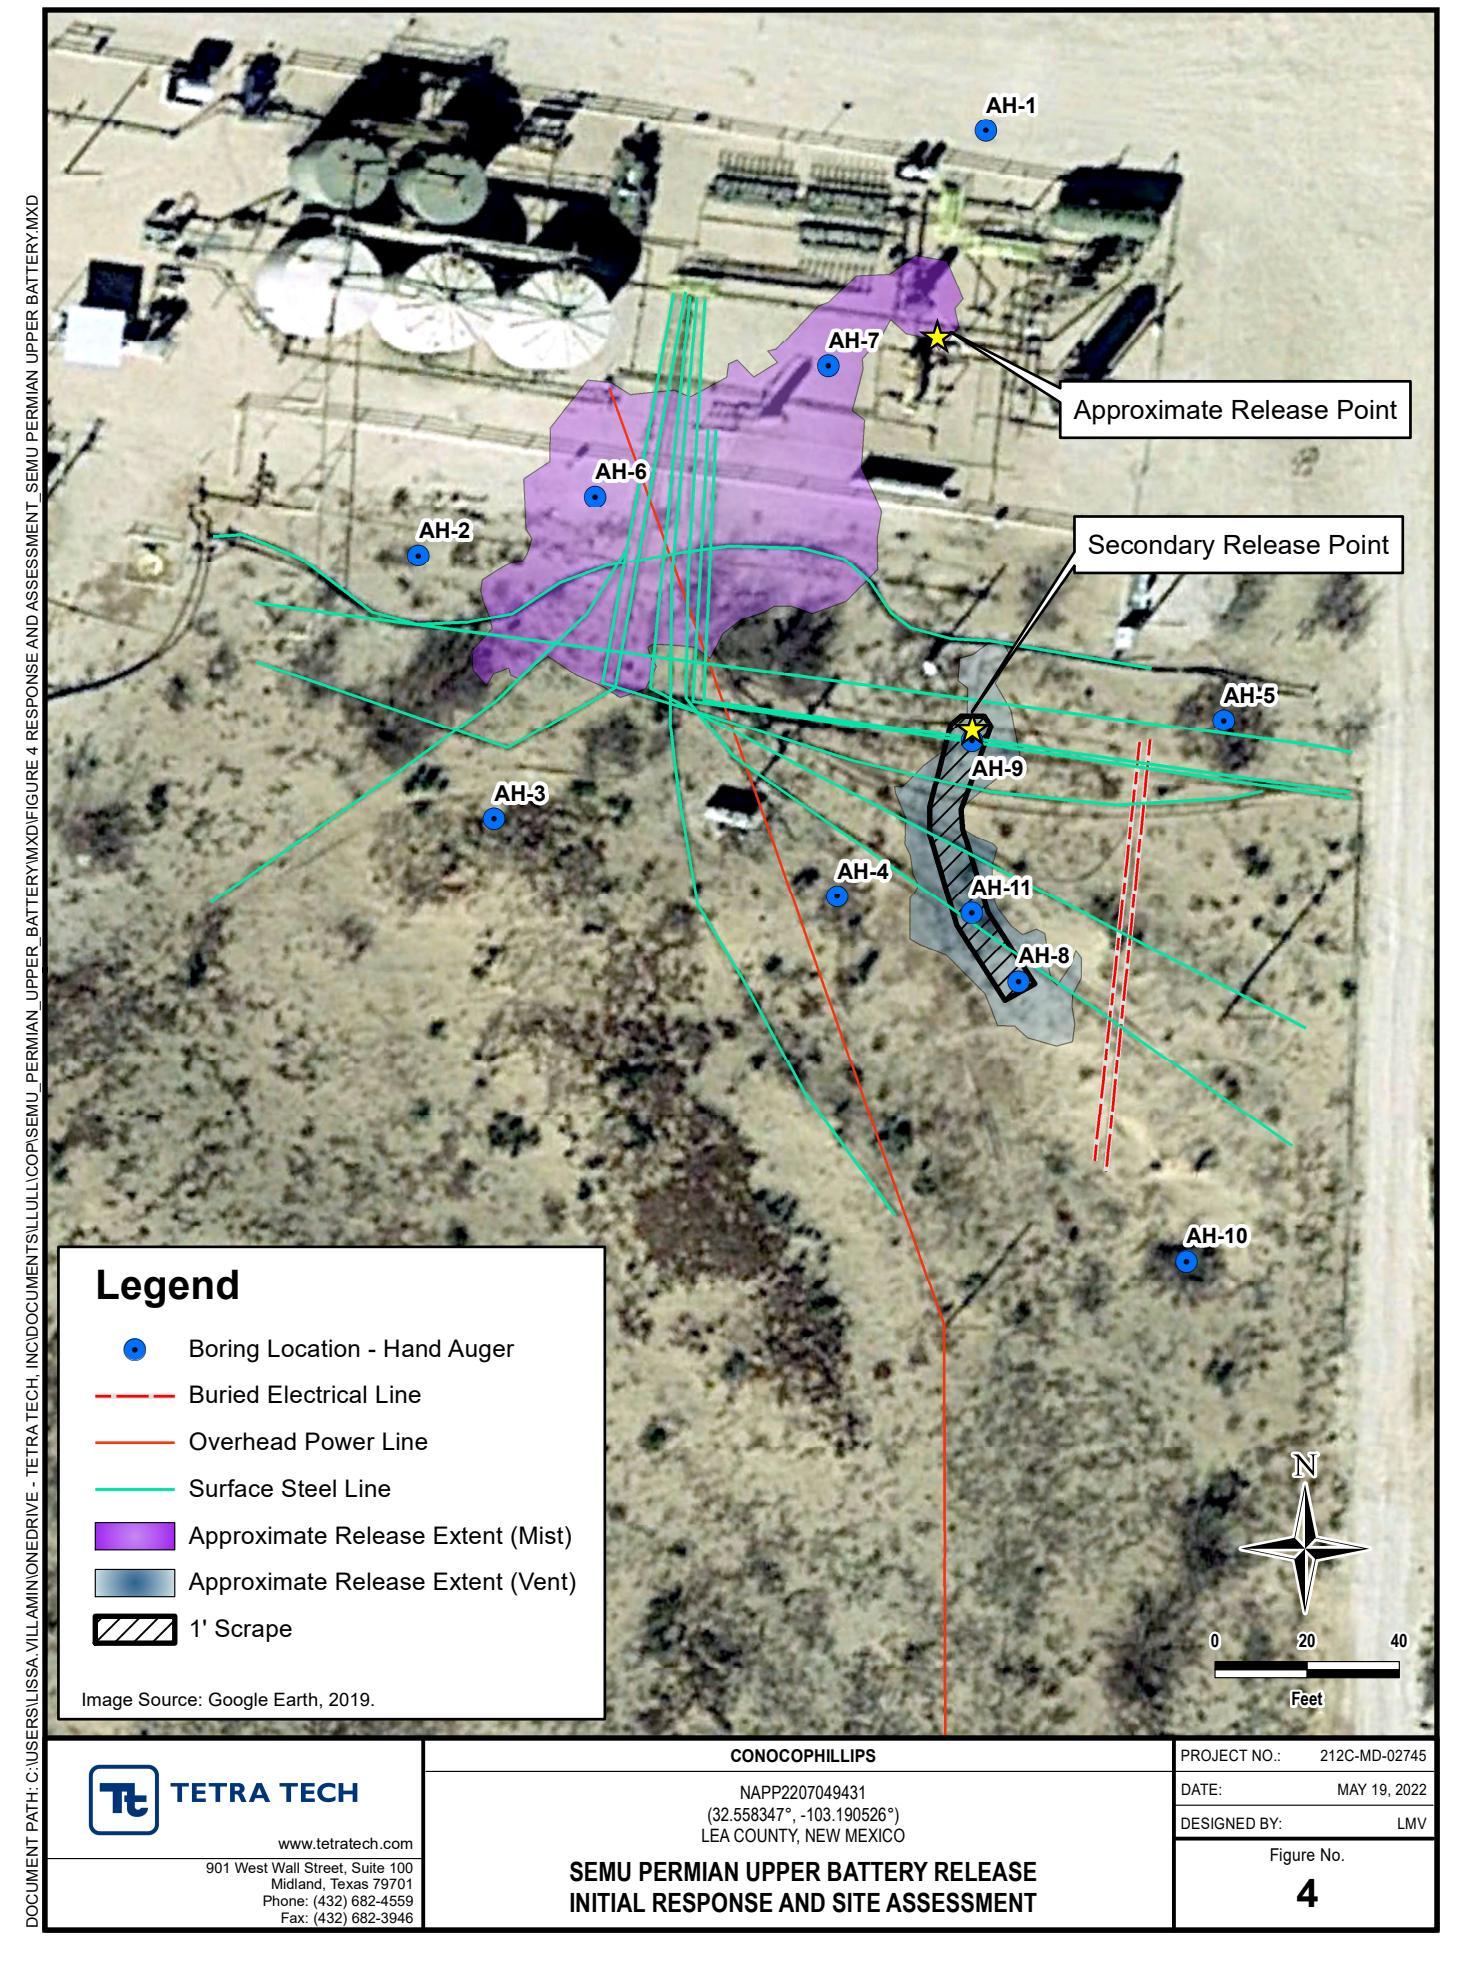
of the release area. Six (6) borings (AH-1 through AH-6) were installed around the perimeters of the release extents to a depth of 1-foot bgs to determine the lateral extent of impacted soil. The remaining three (3) borings (AH-7 through AH-9) were installed within the release footprints to depths ranging from 1 to 3 feet bgs to determine the extent of vertical impact of the releases. Photographic documentation of the Site conditions at the time of the assessment is presented in Appendix D. Boring locations are presented in Figure 4.

Tetra Tech personnel returned to the Site on May 20, 2022 to complete vertical and horizontal delineation of the "Vent" release extent. A total of two (2) borings (AH-10 and AH-11) were advanced in the vicinity of the release area. One (1) boring (AH-10) was installed southeast of the perimeter of the release extent to a depth of 1 foot bgs to determine the lateral extent of the impacted soil. One (1) boring (AH-11) was installed within the release extent to a depth of 6 feet bgs to determine the vertical impact of the release. These additional boring locations are presented in Figure 4.

Results from the May 4, 2022 soil sampling event are summarized in Table 1. The analytical results associated with boring locations AH-8 and AH-9 exceeded the reclamation requirement and Site RRALs for TPH to the total boring depth of 3 feet. The results associated with the remainder of analyzed samples were below the Site proposed RRALs and/or reclamation requirements for chloride, TPH, and BTEX. Neither vertical nor horizontal delineation of the "Vent" release was achieved during the May 4 assessment activities. Analytical results associated with the "Mist" release were below Site RRALs and reclamation requirements.

Results from the May 20, 2022 soil sampling event are summarized in Table 1. The analytical results associated with boring location AH-11 exceeded the reclamation requirement and Site RRALs for TPH in the 3'-4' interval. The results associated with the remainder of analyzed samples were below the Site RRALs and/or reclamation requirements for chloride, TPH, and BTEX. After review of analytical results from the sampling events, both horizontal and vertical delineation of the "Vent" release were achieved during the May assessment activities.

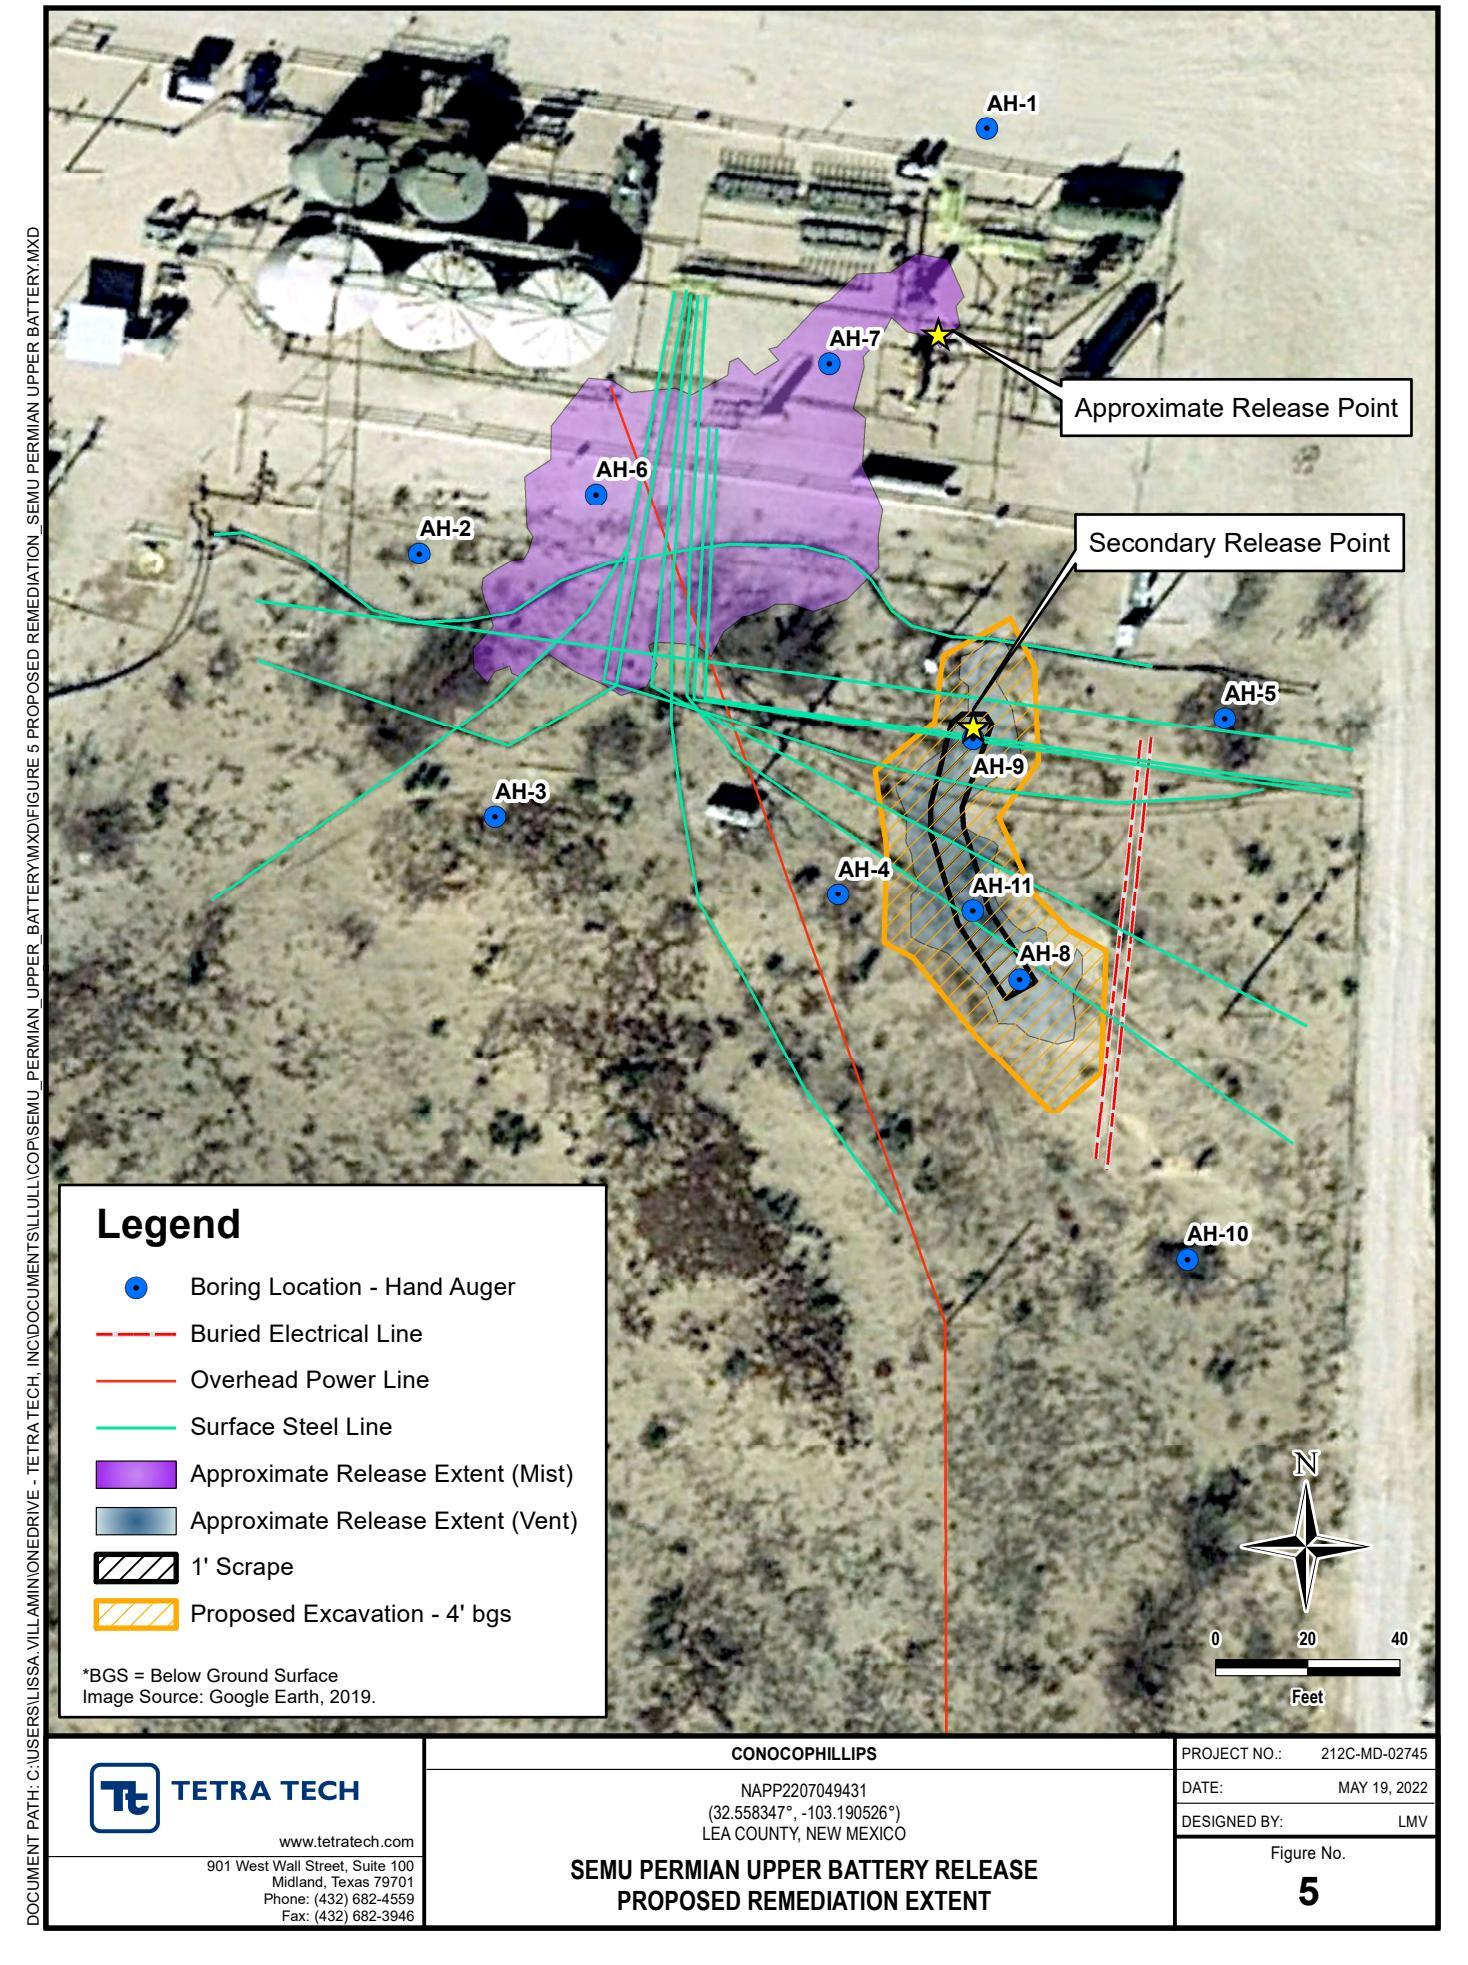
Based on the analytical results from the site assessment, ConocoPhillips proposes to remove the impacted material within the "Vent" release extent as shown in Figure 5. Due to acceptable analytical results within the "Mist" release footprint, no further remediation is proposed in this area. Impacted soils will be excavated using methods applicable for the Site. There are numerous subsurface, surface, and overhead lines in the release footprint. Where applicable, heavy equipment (backhoes and excavators) will be used to excavate to a maximum depth of 4 feet below the surrounding surface or until a representative sample from the walls and bottom of the excavation is below the Site RRALs and reclamation requirements for soils above 4 feet. Heavy equipment will come no more than 4 feet from any pressurized lines. Impacted soils within the vicinity of the surface and subsurface lines which intersect the release footprint will be dug by hand to the maximum extent practicable.

Excavated soils will be transported offsite and disposed of at an NMOCD-approved or permitted facility. Confirmation bottom and sidewall samples will be collected for verification of remedial activities, and analyzed for TPH, BTEX, and chlorides. Once analytical results are received, NMOCD will be notified, and the excavation will then be backfilled with clean material to surface grade. The estimated volume of material to be remediated is approximately 425 cubic yards.

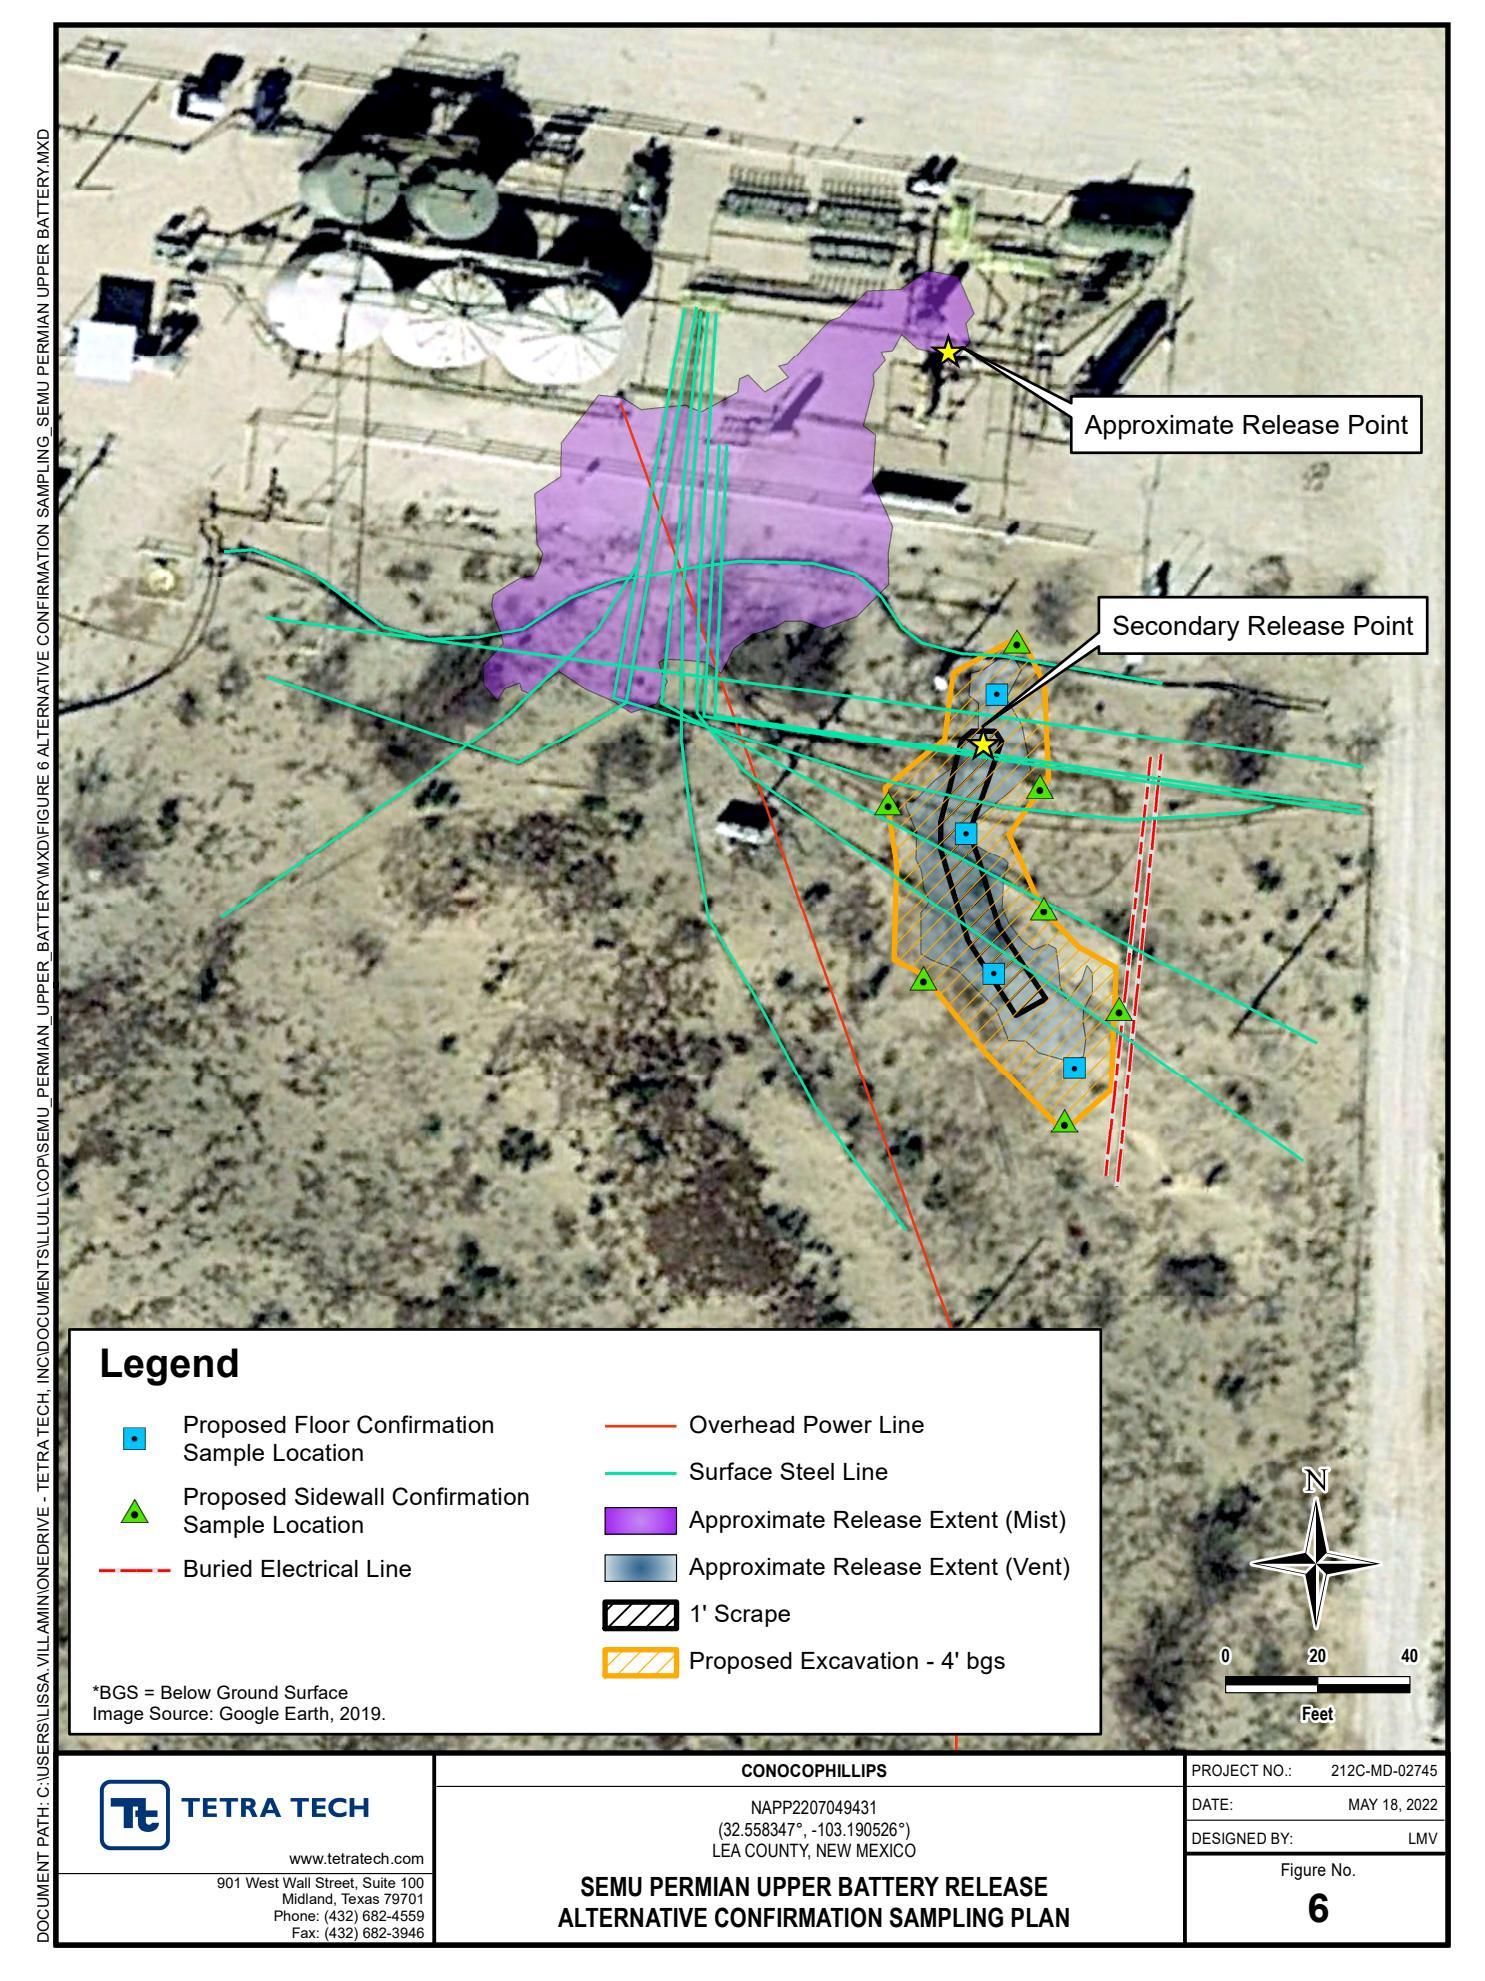
In accordance with 19.15.29.12(D)(1)(b) NMAC, ConocoPhillips proposes the following alternative confirmation sampling plan to adhere with NMOCD requirements. The proposed confirmation sample locations are depicted in Figure 6. Four (4) confirmation floor samples and seven (7) confirmation sidewall samples are proposed for verification of remedial activities. The proposed excavation encompasses a surface area of approximately 2,850 square feet.

These confirmation sidewall and floor samples will be representative of no more than approximately 500 square feet of excavated area. Confirmation samples will be sent to an accredited laboratory for analysis of TPH (Method 8015 modified), BTEX (Method 8260B), and chloride (USEPA Method 4500.0/300.0). Once results are received, NMOCD will be notified, and the excavation will then be backfilled with clean material to surface grade.
