RE: Liner Inspection and Closure Report Gaucho Unit 6H CTB API No. N/A GPS: Latitude 32.386298 Longitude -103.485981 UL- P, Section 17, Township 22S, Range 34E, Lea County, NM NMOCD Reference No. NAPP2230630561

GAUCHO UNIT 6H CTB

Liner Inspection

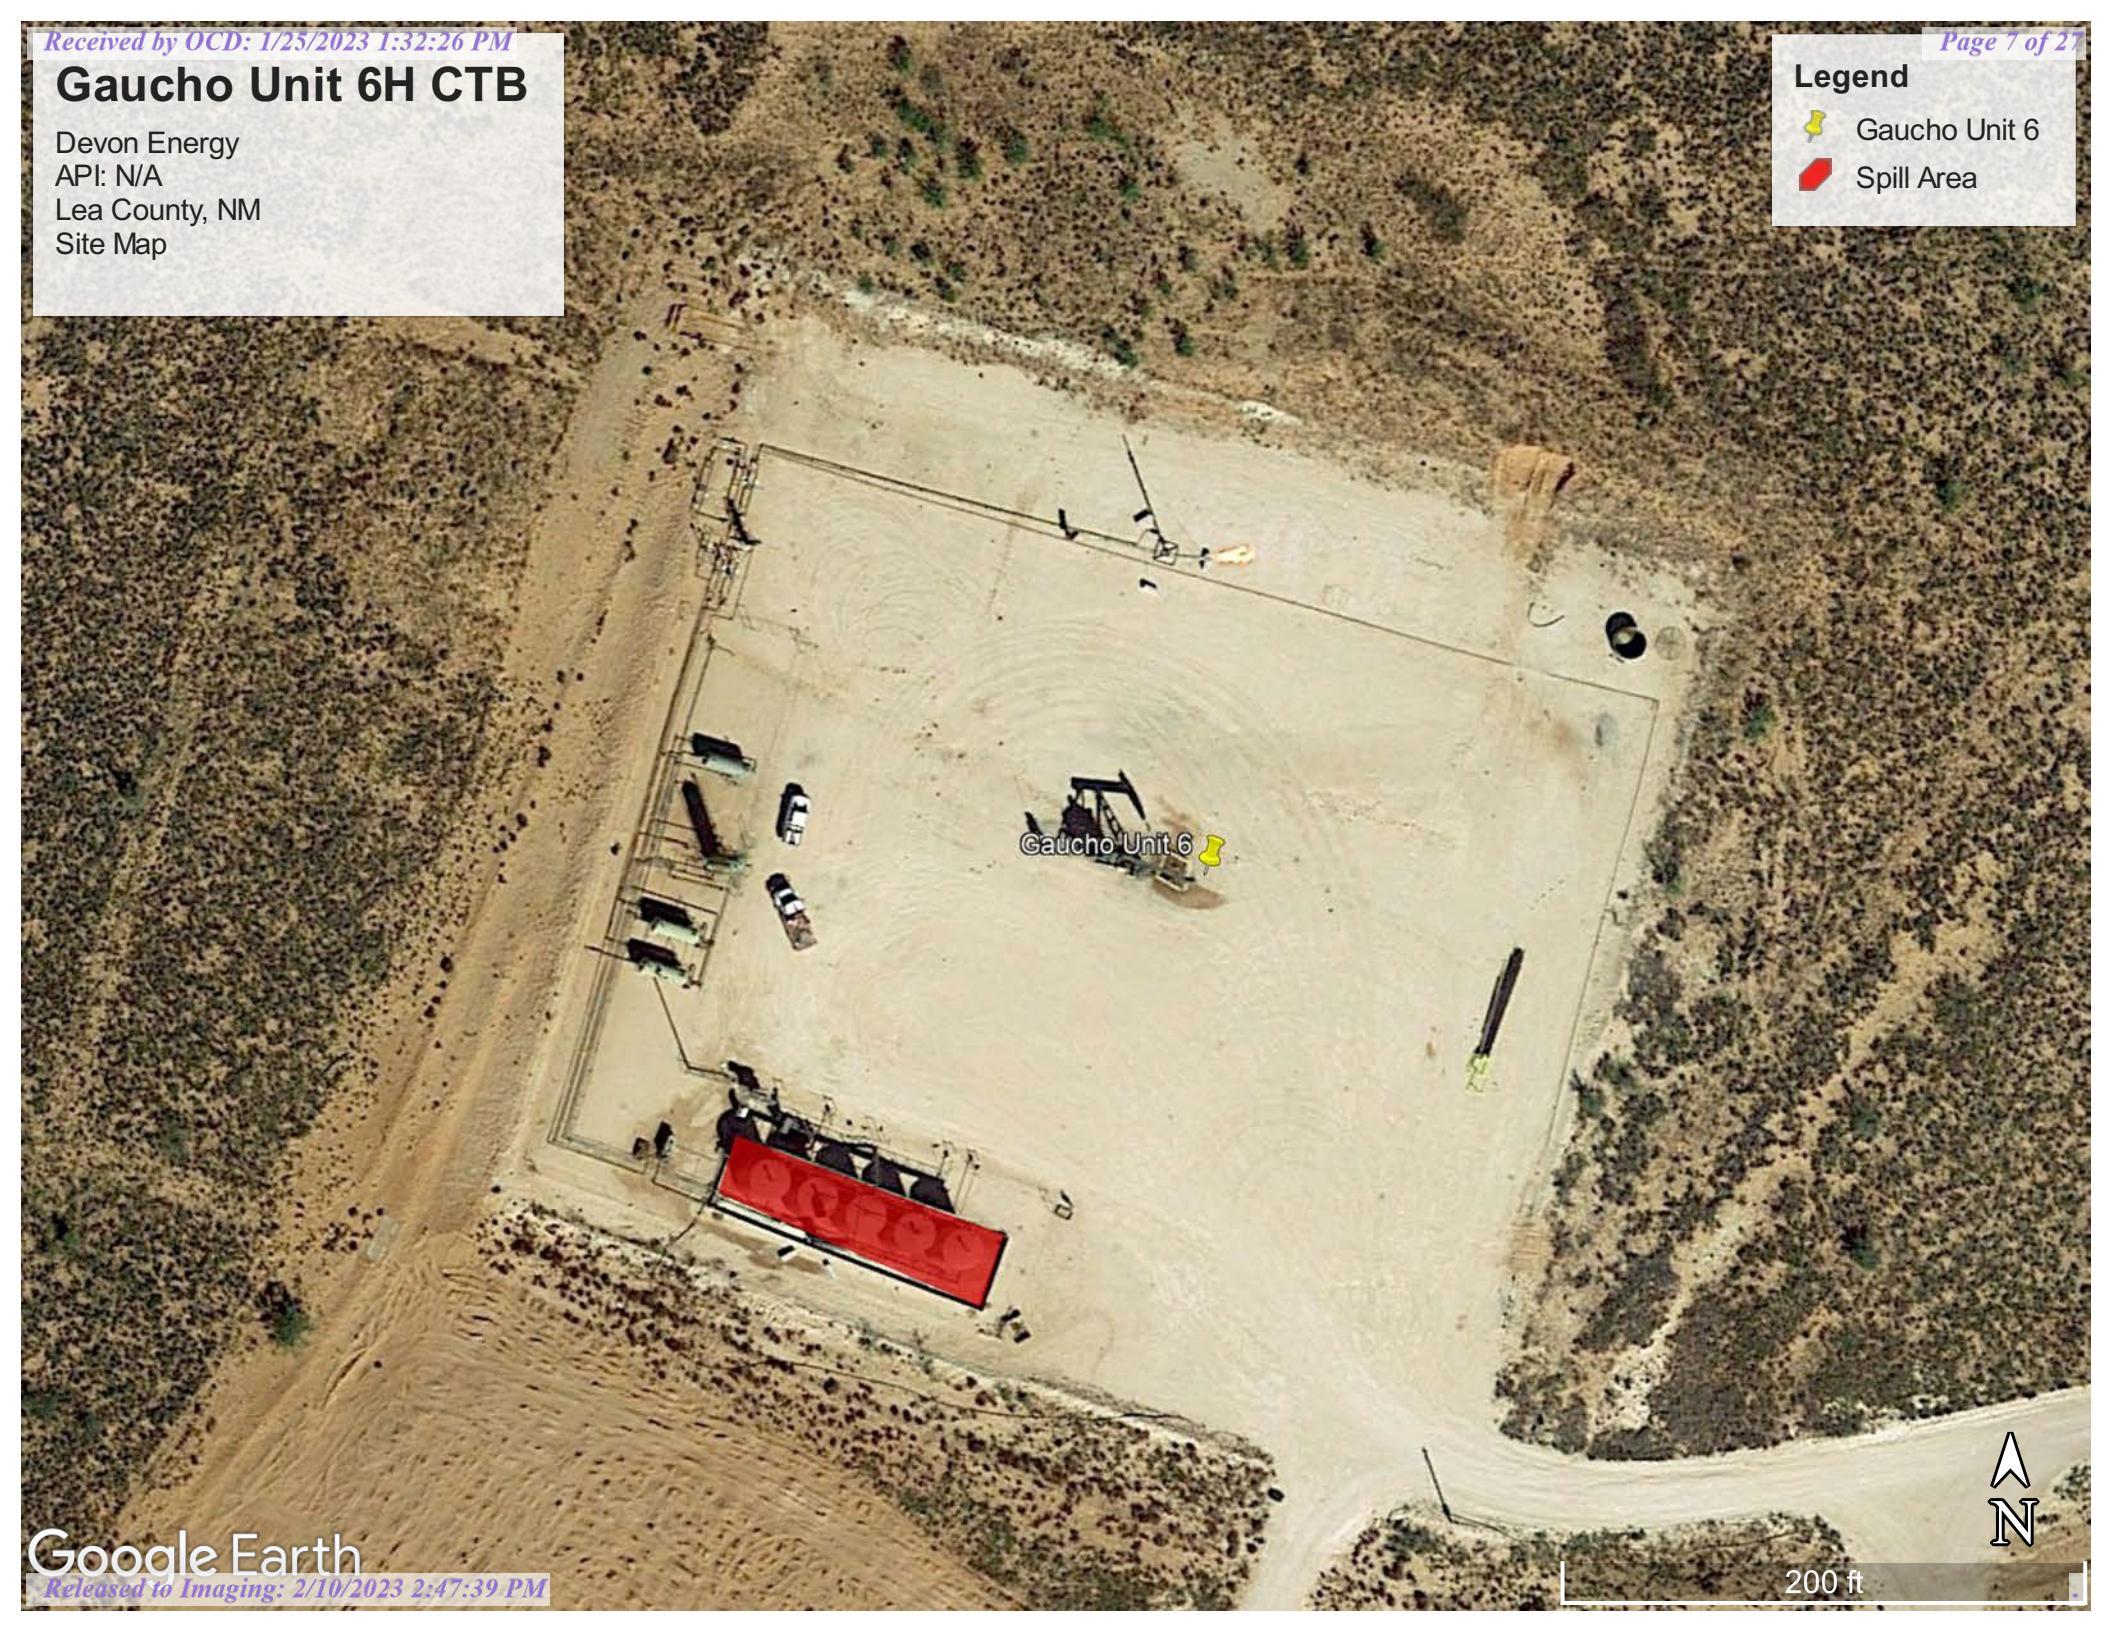
4-Site Map

NAPP2230630561: On November 11, 2022. A connection to a tank developed a leak. Approximately 52 barrels (bbls) of produced water was released from tank connection. A vacuum truck was dispatched and recovered all 52 bbls of fluid from the lined SPCC containment ring. Once fluids were removed, the liner was visually inspected by Devon field staff for any pinholes or punctures, and none were found. Based on this inspection there is no evidence that the spilled fluids left containment.

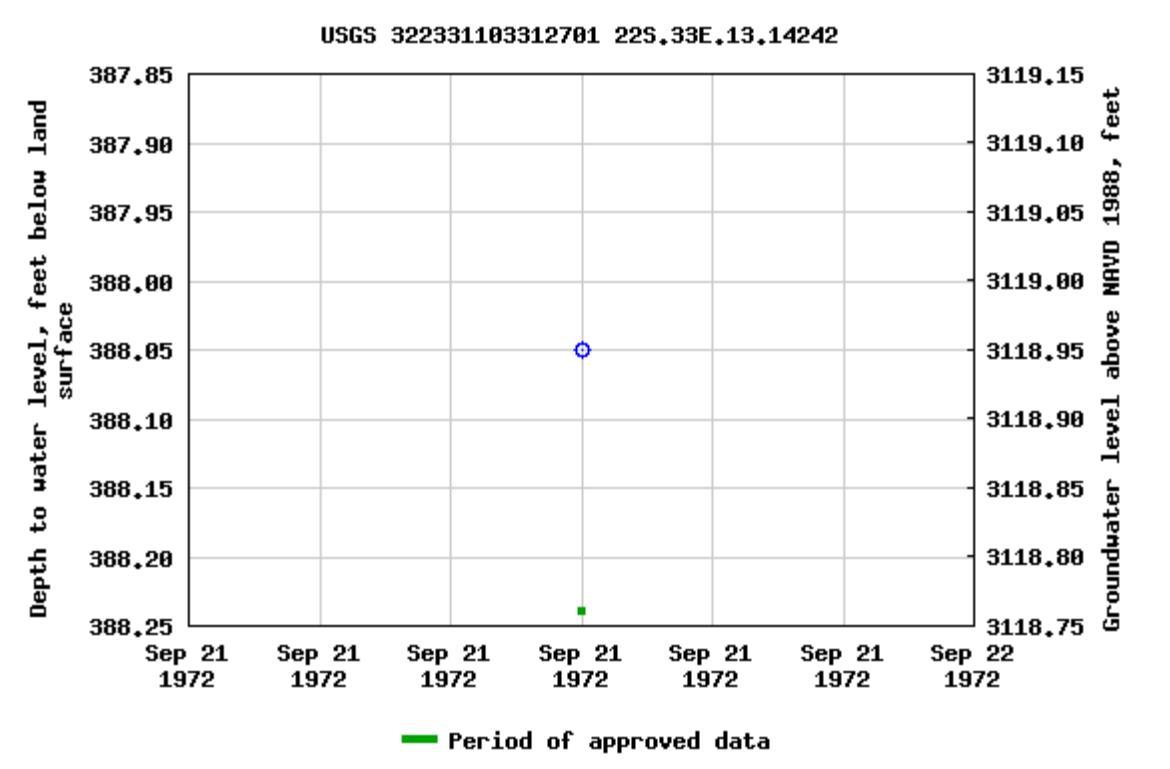
USGS 322331103312701 22S.33E.13.14242

Lea County, New Mexico Hydrologic Unit Code 13070007 Latitude 32°23'31", Longitude 103°31'27" NAD27 Land-surface elevation 3,507 feet above NAVD88 The depth of the well is 490 feet below land surface. This well is completed in the Other aquifers (N99990THER) national aquifer. This well is completed in the Chinle Formation (231CHNL) local aquifer.

Breaks in the plot represent a gap of at least one year between field measurements. <u>Download a presentation-quality graph</u>

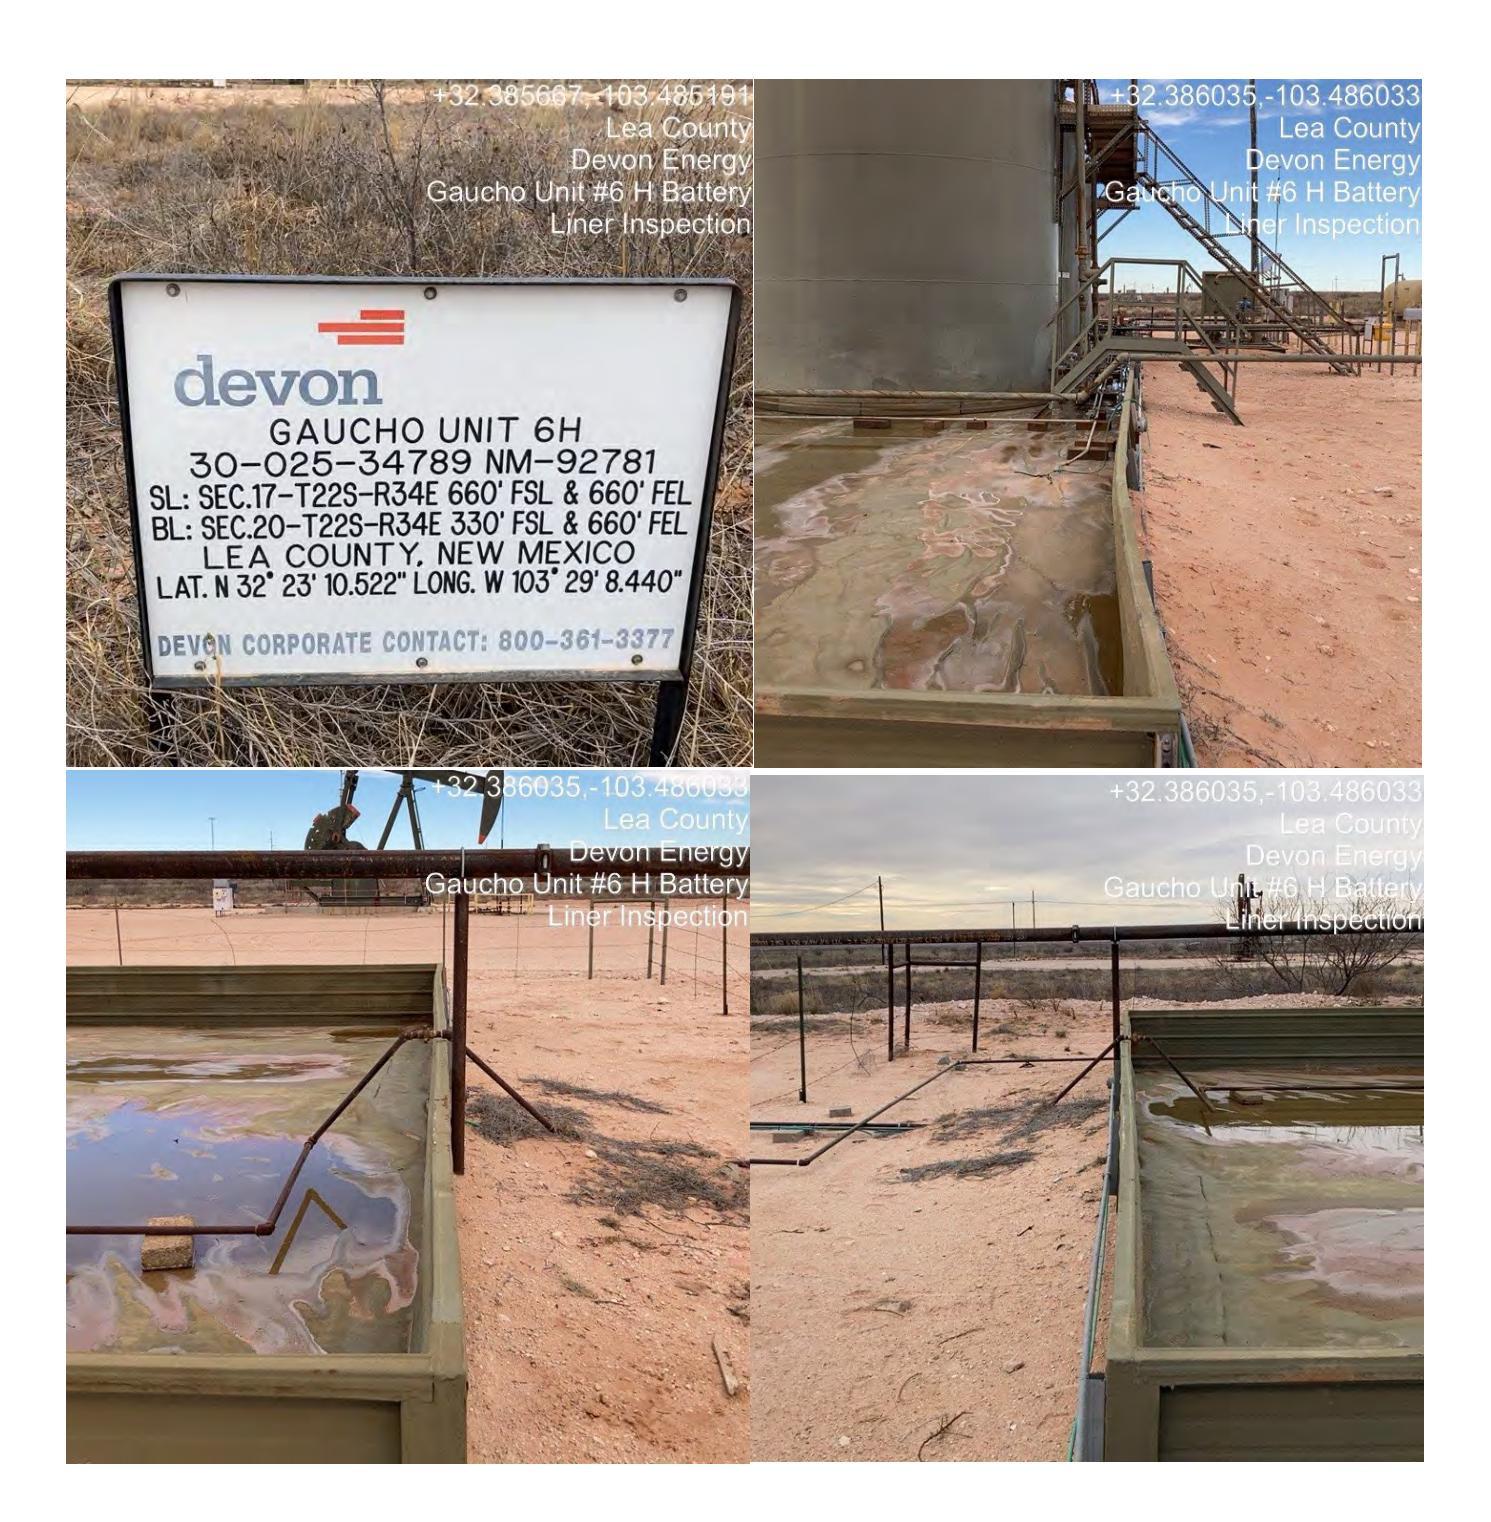
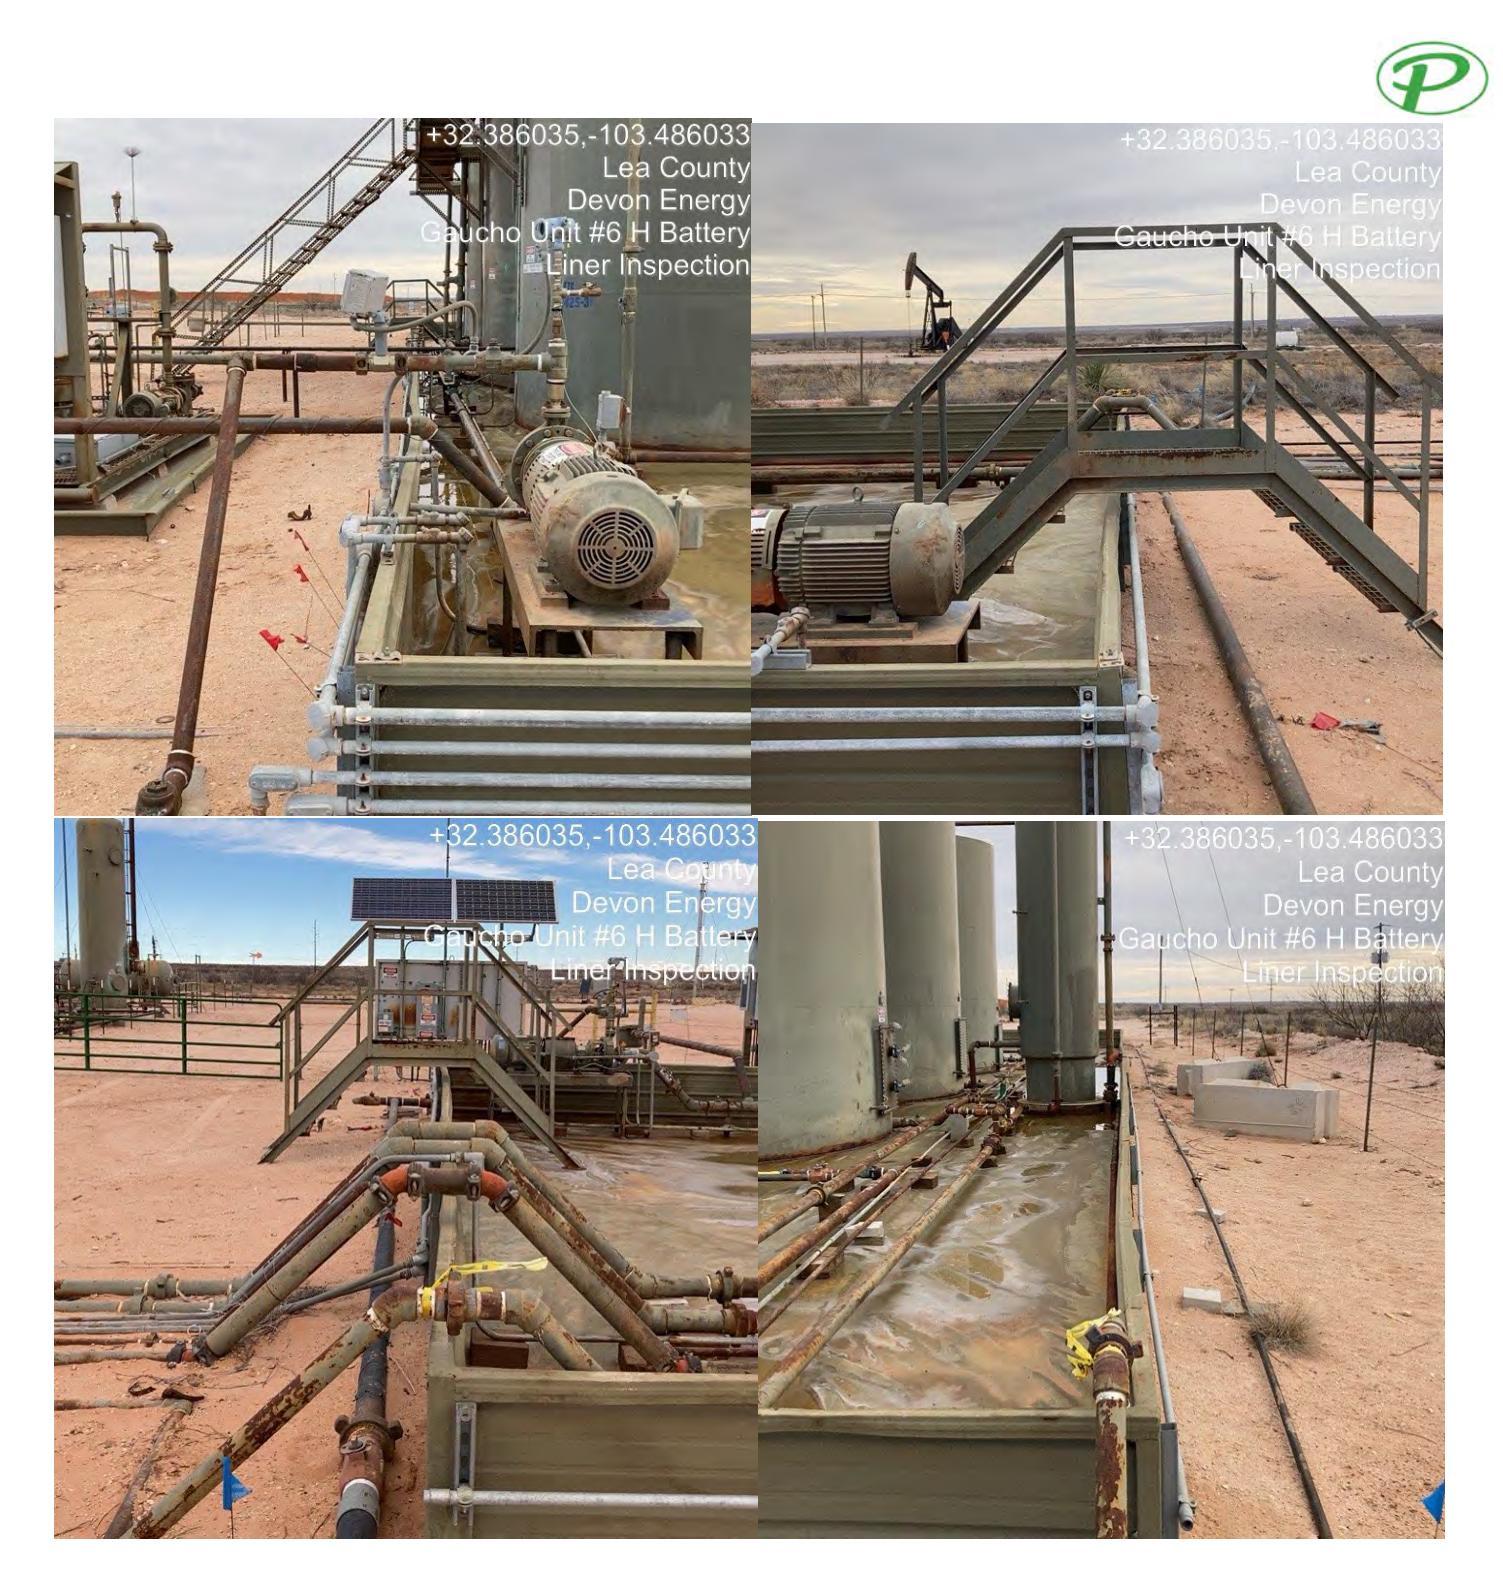
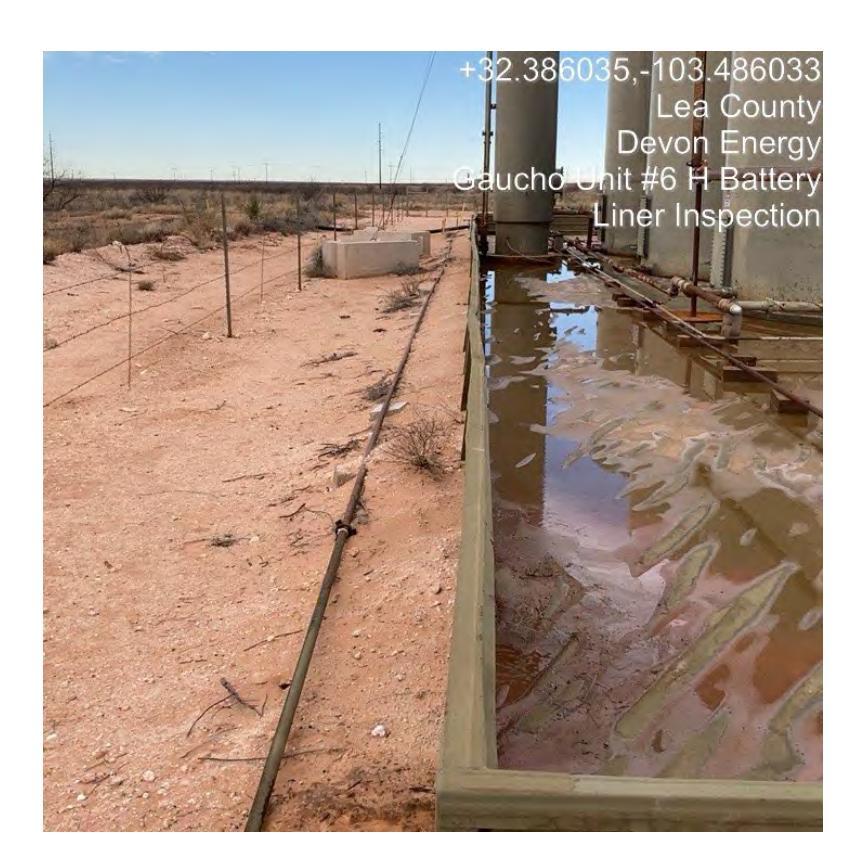
On December 31, 2022, after sending the 48-hour notification via email, Pima Environmental conducted a liner inspection at this location. We concluded that this liner and containment maintained its integrity and was able to retain the fluids. The Liner Inspection Form and Photographic Documentation can be found in Appendix C.

Visualization	Yes	No	Comments
Is there a tear in the liner?		Х	
Are there holes in the liner?		Х	
Is the liner retaining any fluids?	Х		Rainwater
Does the liner have integrity to contain a leak?	Х
