Re: Remediation Work Plan Revised Deferral Request ConocoPhillips Heritage Concho Graham Cracker 16 State #002H Tinhorn Release Unit Letters N and O, Section 9, Township 26 South, Range 28 East Eddy County, New Mexico Incident ID# nAB1806438251

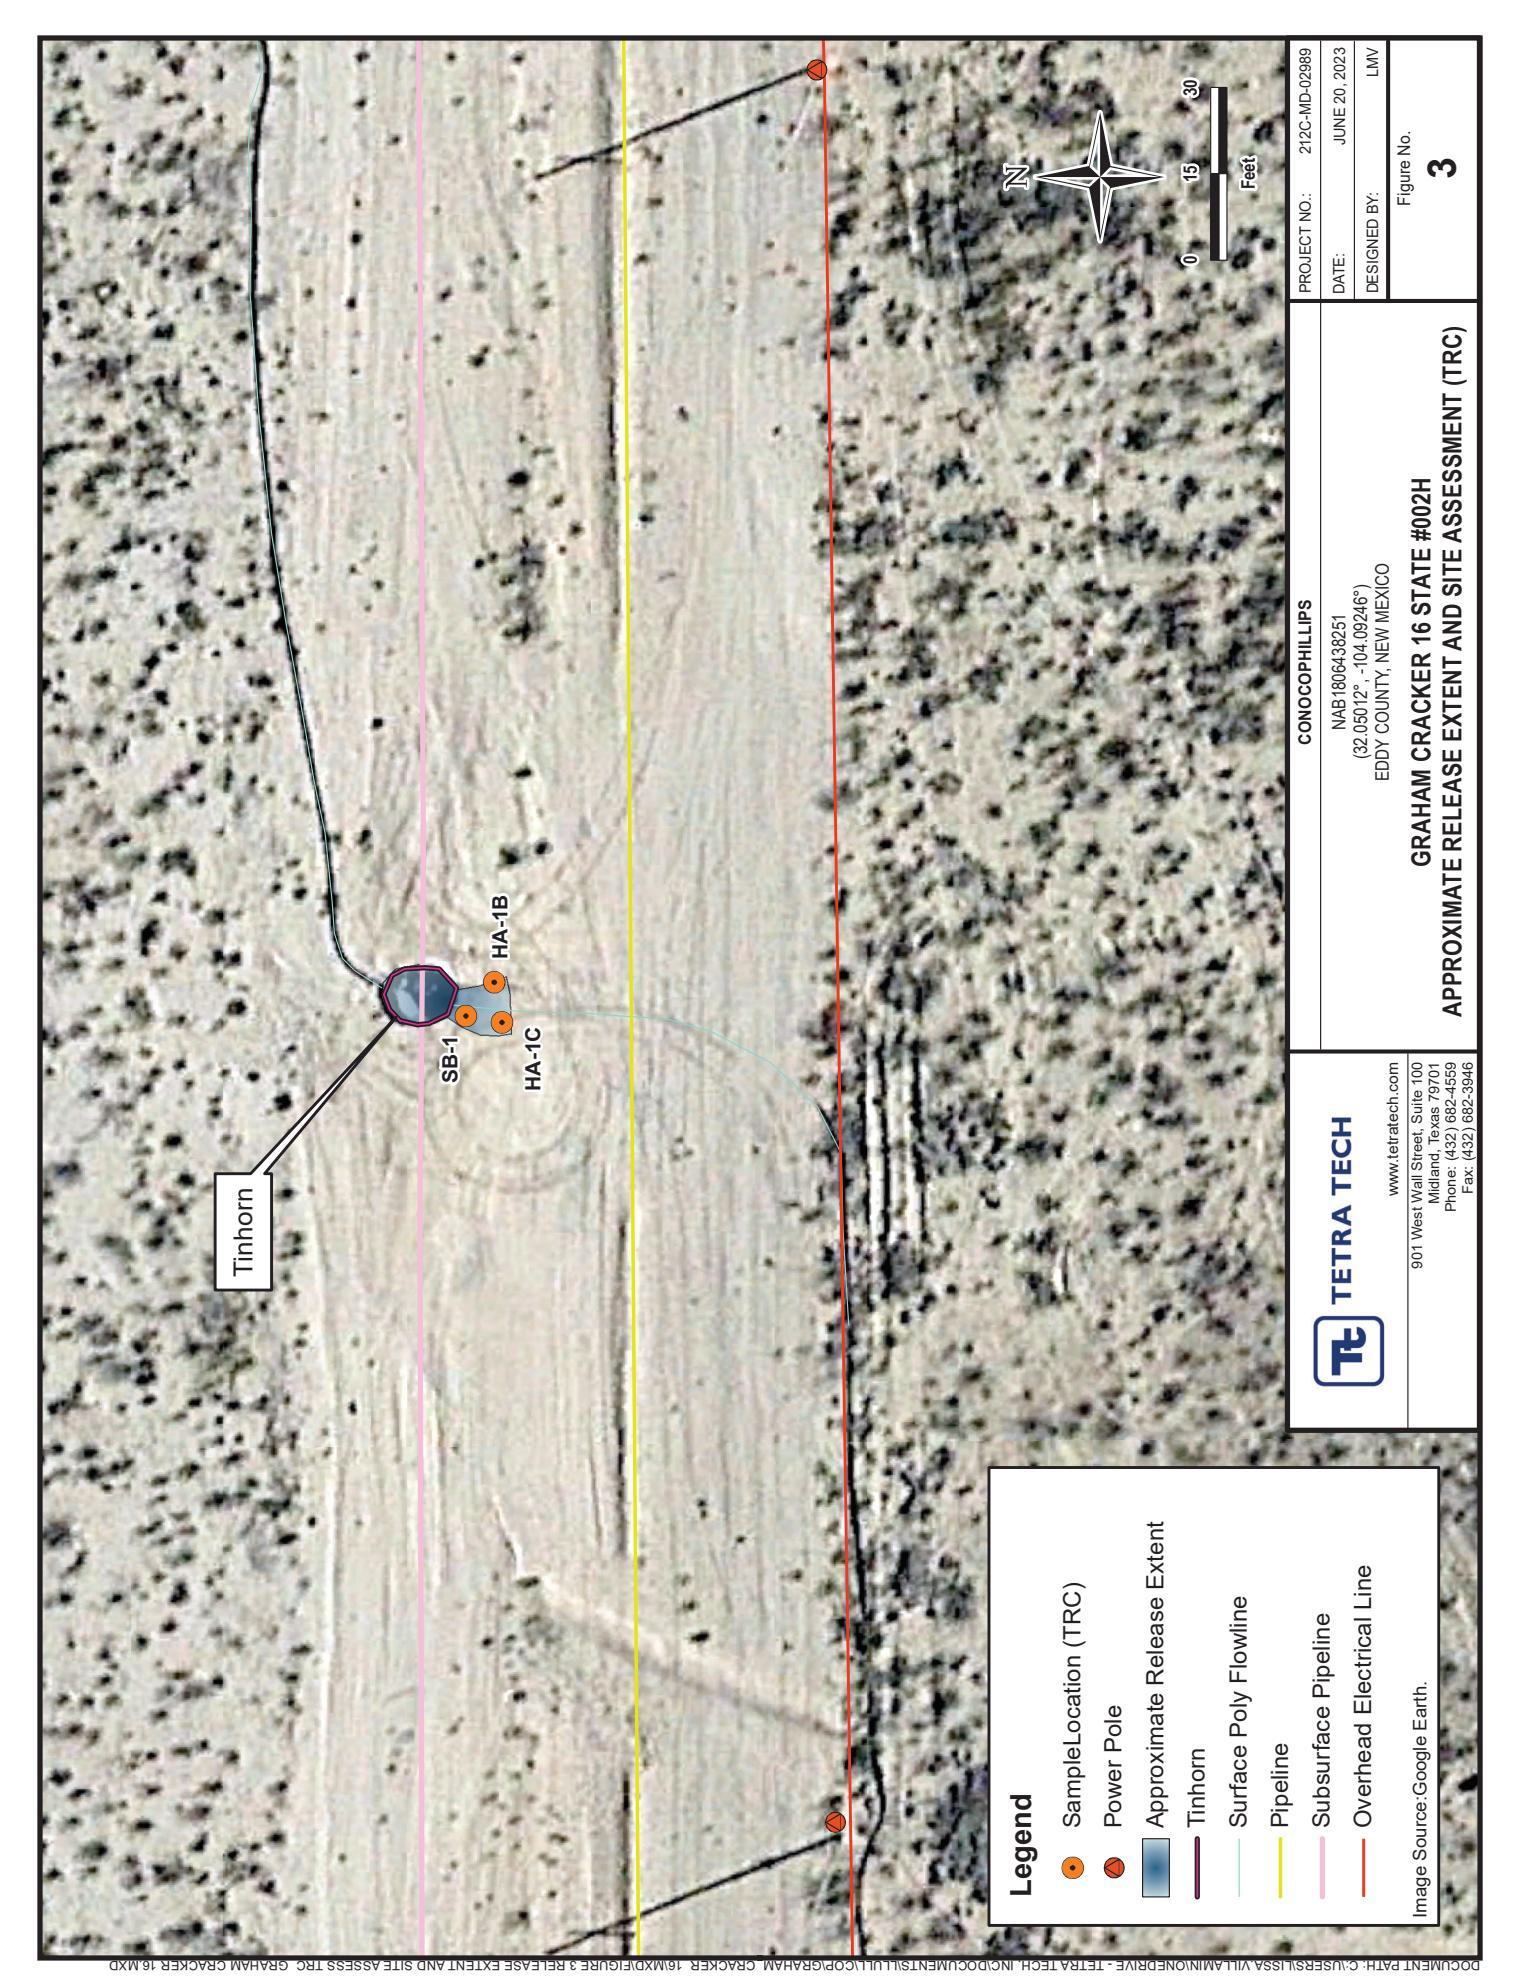
On June 25, 2018, TRC Environmental Corporation (TRC) conducted an initial soil assessment at the Site on behalf of Concho. The release extent provided by TRC includes an overspill area adjacent to the tinhorn that was not described in the initial C-141, as shown on Figure 3.

Although field screening results from HA-1 were not reported by TRC, all three soil screening results indicated chloride concentrations that exceeded the proposed NMOCD Closure Criteria of 10,000 mg/kg. On August 17, 2018 a Geoprobe was utilized to install a soil boring (SB-1) in the overspill area adjacent to the tinhorn in an effort to determine the vertical extent of soil impact. Three (3) soil samples (SB-1 @ 6', SB-1 @12', and SB-1 @14') were collected and submitted to Cardinal Laboratories in Hobbs, New Mexico to be analyzed for chlorides via EPA Method 300.0. Additional hand auger samples were collected from the overspill area on October 25 (HA-1B @ Surface and HA-1C @ Surface) and submitted to Cardinal Laboratories to be analyzed for BTEX via EPA Method 8021B, TPH via EPA Method 8015M, and chloride via EPA Method 300.0. TRC returned to the Site on November 14, 2018 to collect additional soil samples (HA-1B @ 1' and HA-1C @ 1') to complete vertical delineation of TPH impact. The initial assessment sampling locations are indicated on Figure 3. The initial assessment results are summarized in Table 1.

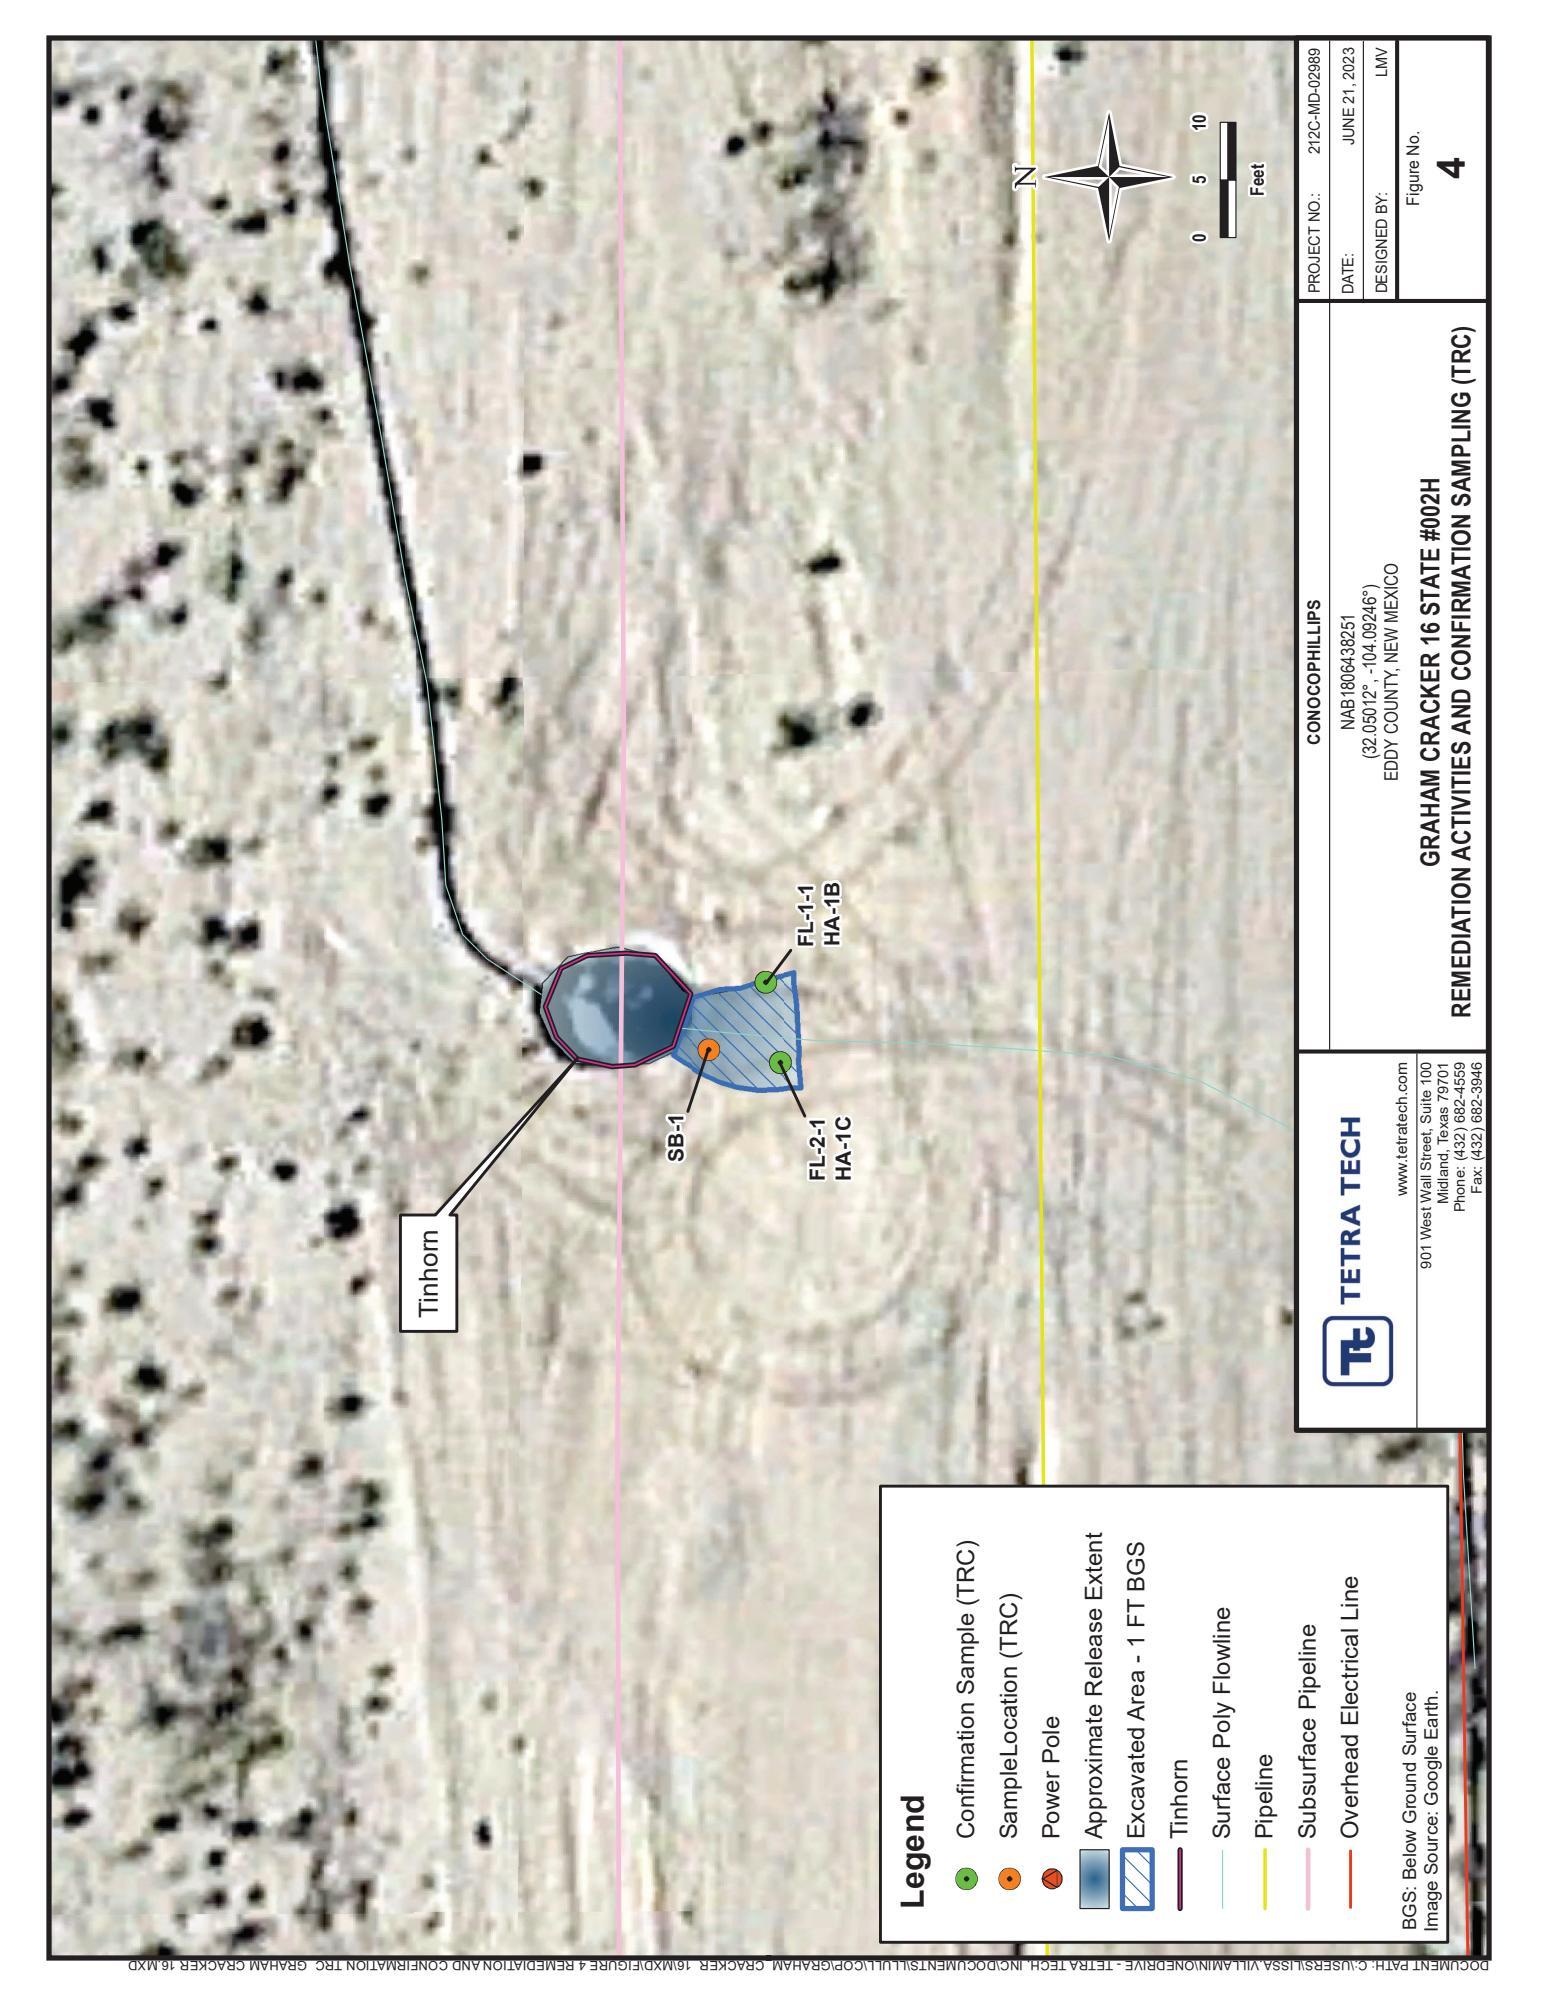
Based on the directive provided by NMOCD, Tetra Tech was onsite on March 1, 2023 to conduct assessment activities on behalf of ConocoPhillips. One additional assessment boring (BH-23-1) was installed using an air rotary drill rig within the release footprint in the pasture to 25 feet bgs to complete vertical delineation of the release extent. Sampling inside of the tinhorn was not feasible at the time of the additional assessment sampling activities, due to safety concerns for personnel working in the immediate vicinity of an active pipeline. Four additional hand auger borings (AH-23-1 through AH-23-4) were installed to 3 feet bgs to the north, east, south, and west of the release footprint to achieve horizontal delineation of the release extent. The sample locations are shown on Figure 4.

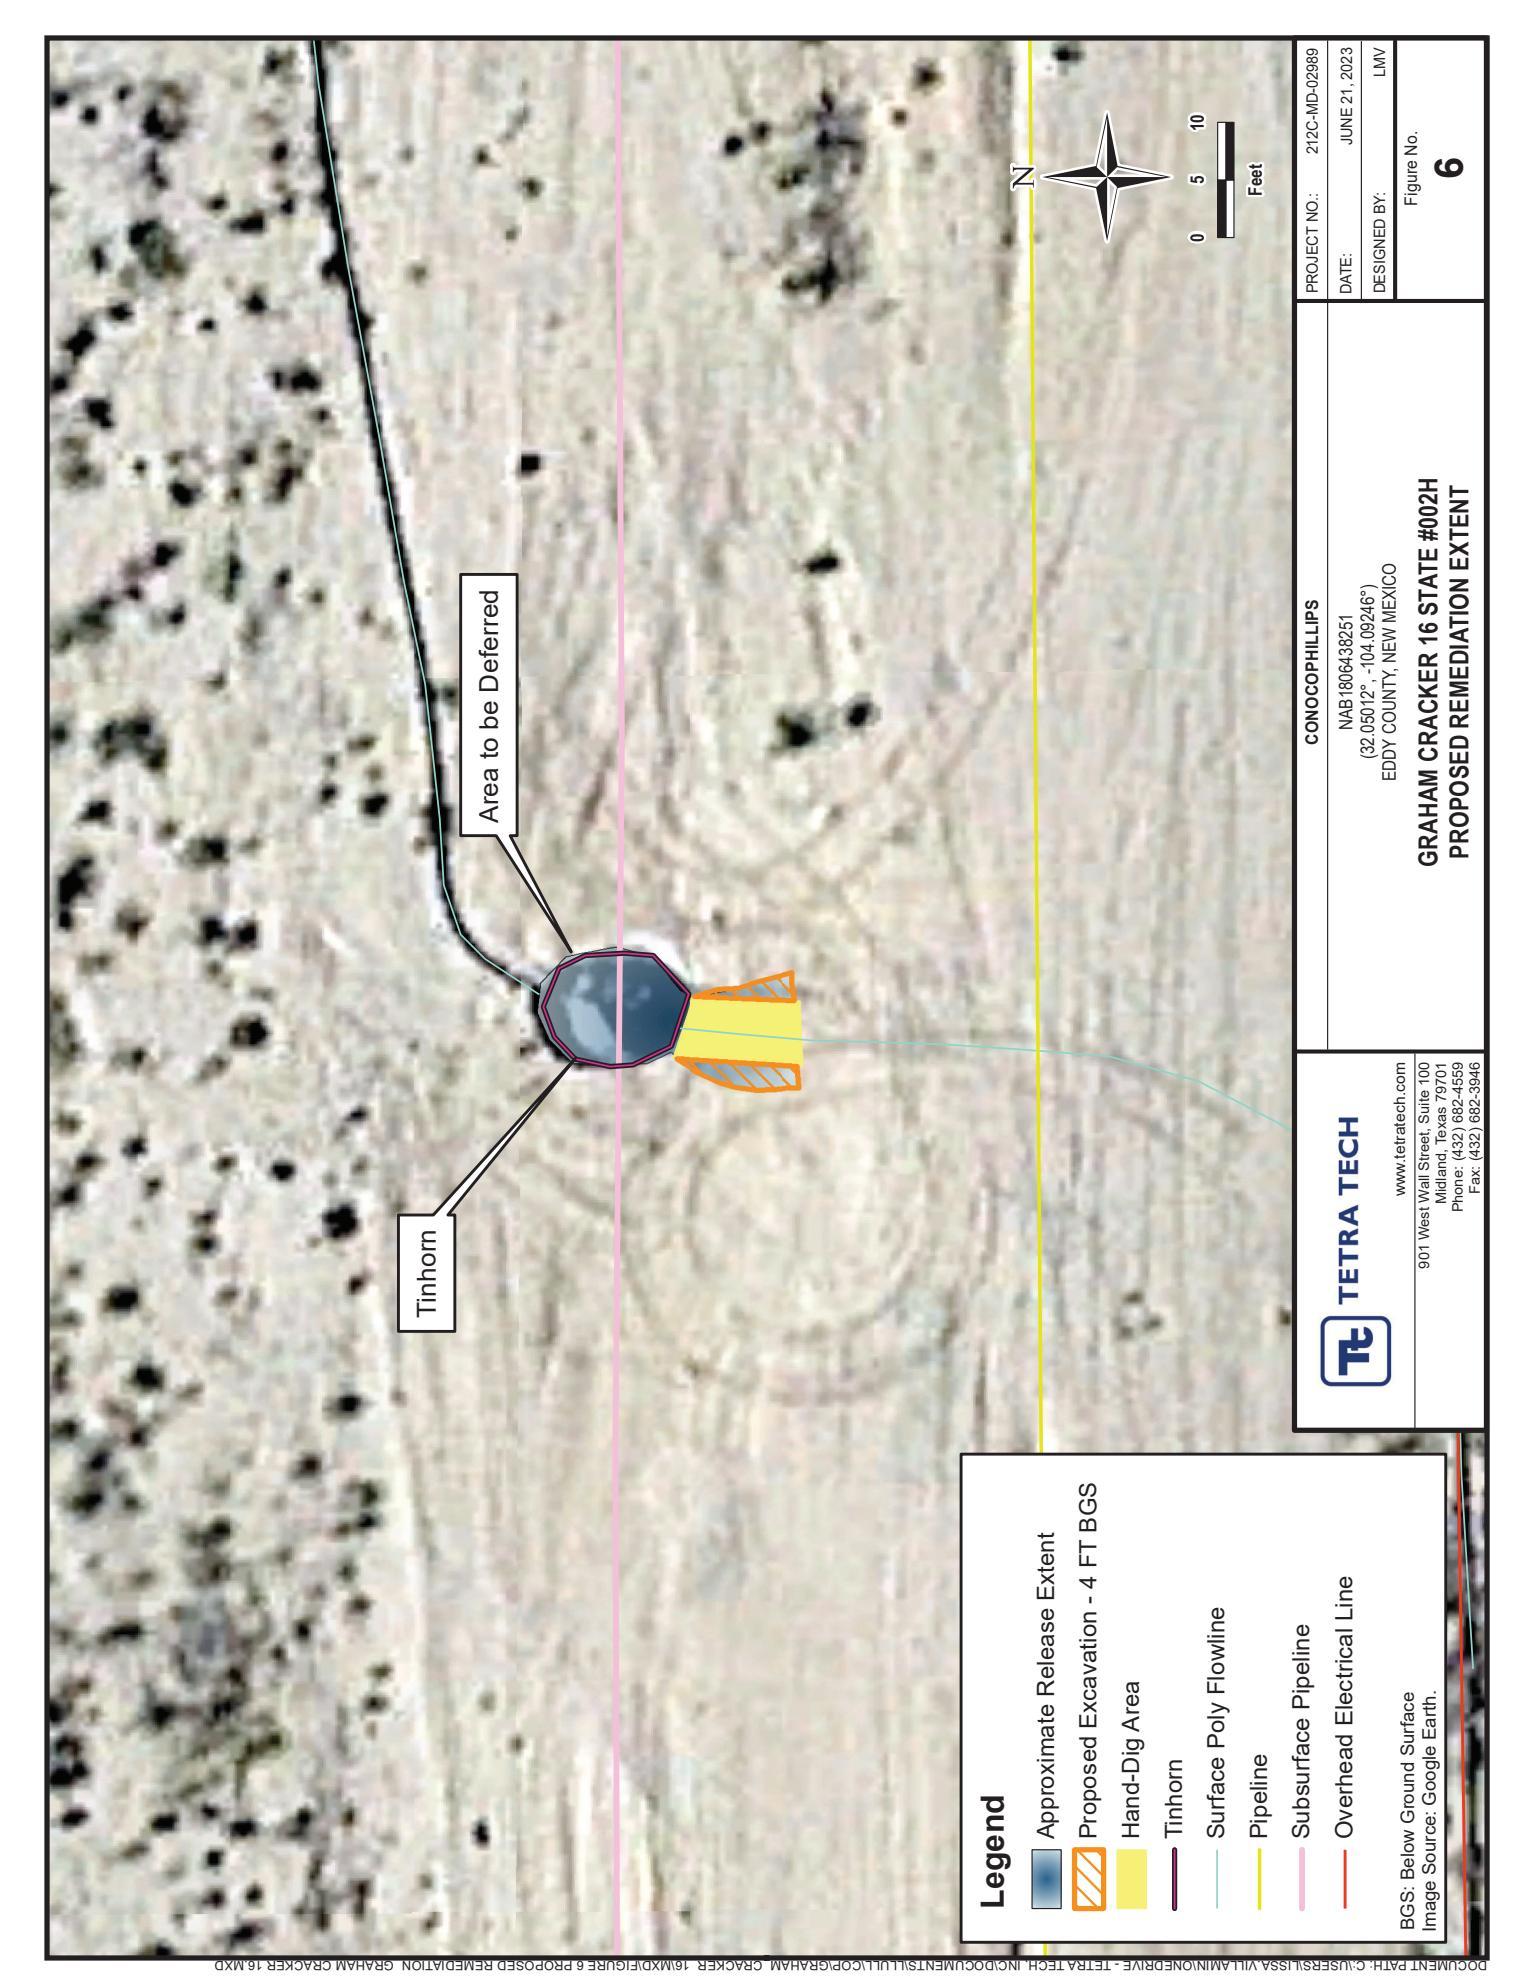
Based on the analytical results and the NMOCD rejection of the 2023 deferral request, ConocoPhillips proposes to remove the remaining impacted material as shown in Figure 6. Release footprint soils in the area of BH-1-23 impacted with chloride above the reclamation limit of 600 mg/kg will be excavated using heavy equipment (backhoes, hoe rams, and track hoes) to a maximum depth of 4 feet below the surrounding surface or until a representative sample from the walls and bottom of the excavation is below the RRALs. Select areas containing pressurized lines will be hand-dug to a depth of 4 feet or the maximum extent practicable and heavy equipment will come no more than 3 ft from any pressurized lines.

Excavated soils will be transported offsite and disposed of at an NMOCD-approved or permitted facility. In accordance with subsection D of 19.15.29.12 NMAC, the responsible party will notify the appropriate division district office prior to conducting confirmation sampling. Confirmation bottom and sidewall samples representative of no more than 200 square feet will be collected for verification of remedial activities, and analyzed for TPH, BTEX, and chlorides. Once results are received, the excavation will then be backfilled with clean material to surface grade. The estimated volume of material to be remediated is approximately 30 cubic yards.

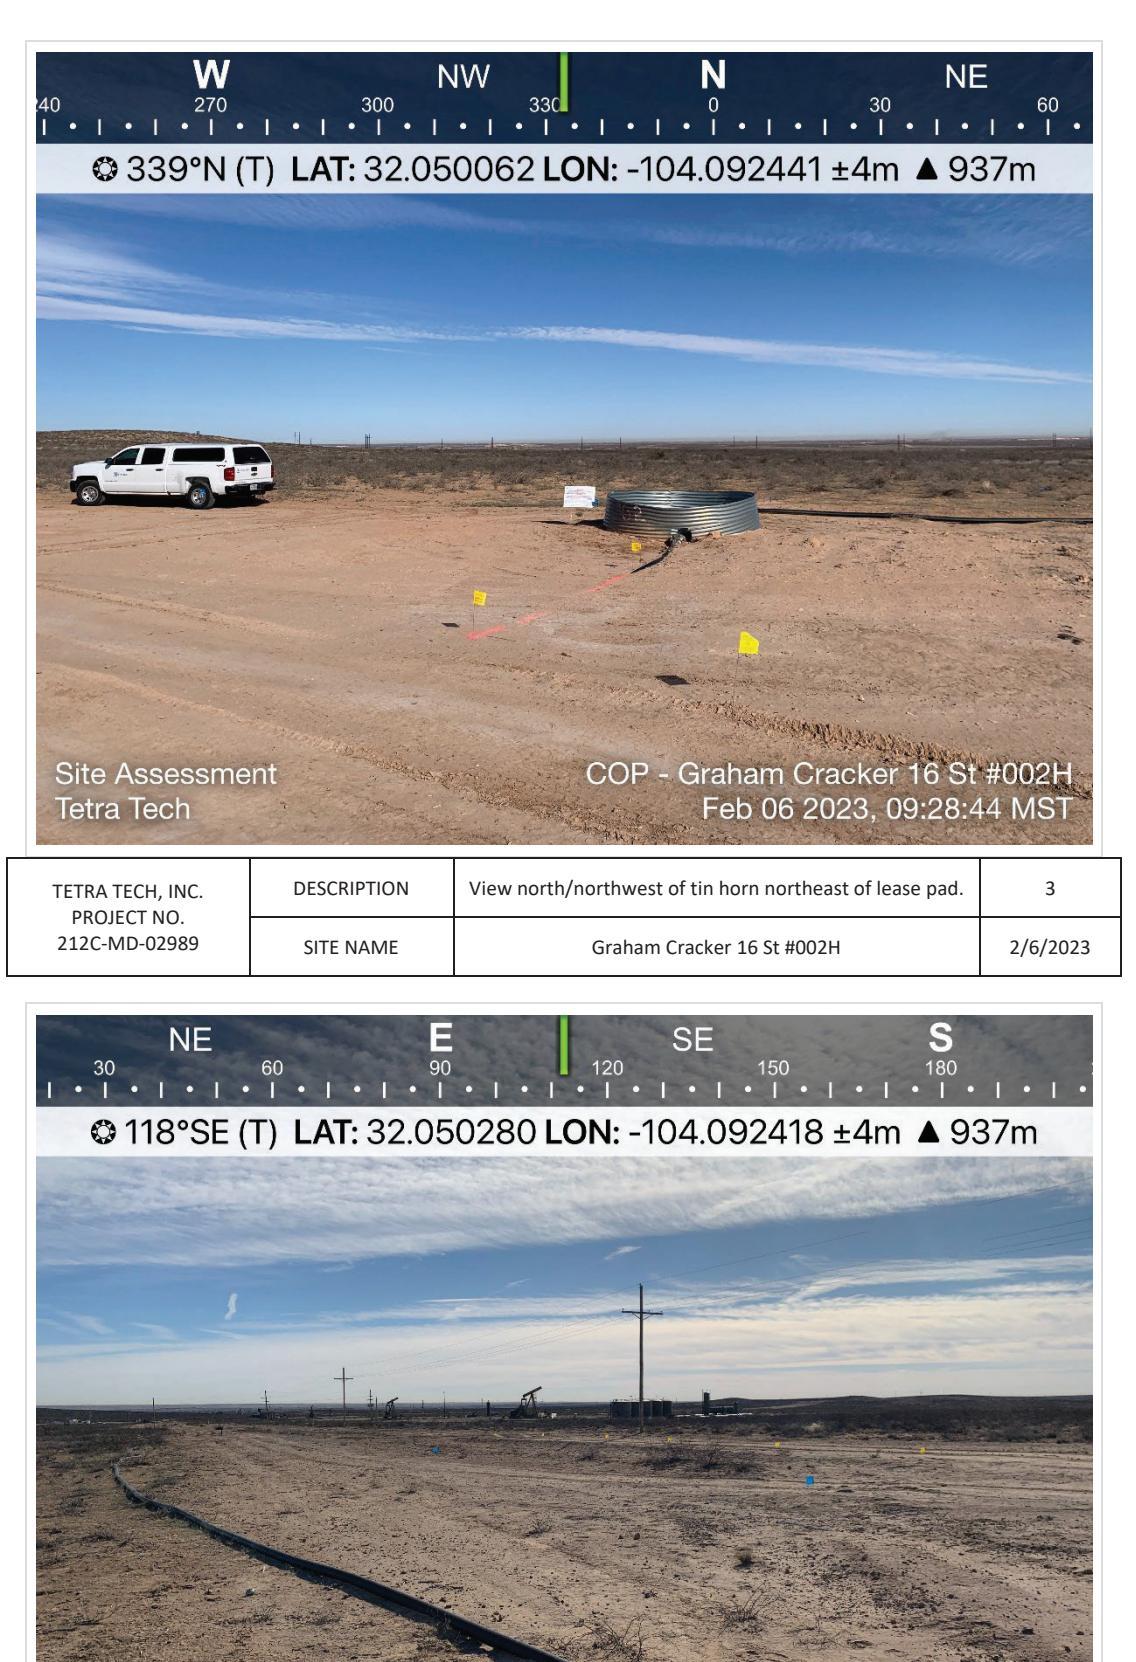
TETRA TECH, INC.	DESCRIPTION	View east/southeast of surface polylines and overhead power lines.	4
212C-MD-02989	SITE NAME	Graham Cracker 16 St #002H	2/6/2023
