Re: Fourth Quarter 2023 – SVE System Update Lambe 2C San Juan County, New Mexico Hilcorp Energy Company NMOCD Incident Number: NVF1836050592

Ensolum, LLC (Ensolum), on behalf of Hilcorp Energy Company (Hilcorp), presents this *Fourth Quarter* 2023 – *SVE System Update* report summarizing the soil vapor extraction (SVE) system performance at the Lambe 2C natural gas production well (Site), located in Unit H, Section 20, Township 31 North, and Range 10 West in San Juan County (Figure 1). Specifically, this report summarizes Site activities performed in October, November, and December of 2023 to the New Mexico Oil Conservation Division (NMOCD).

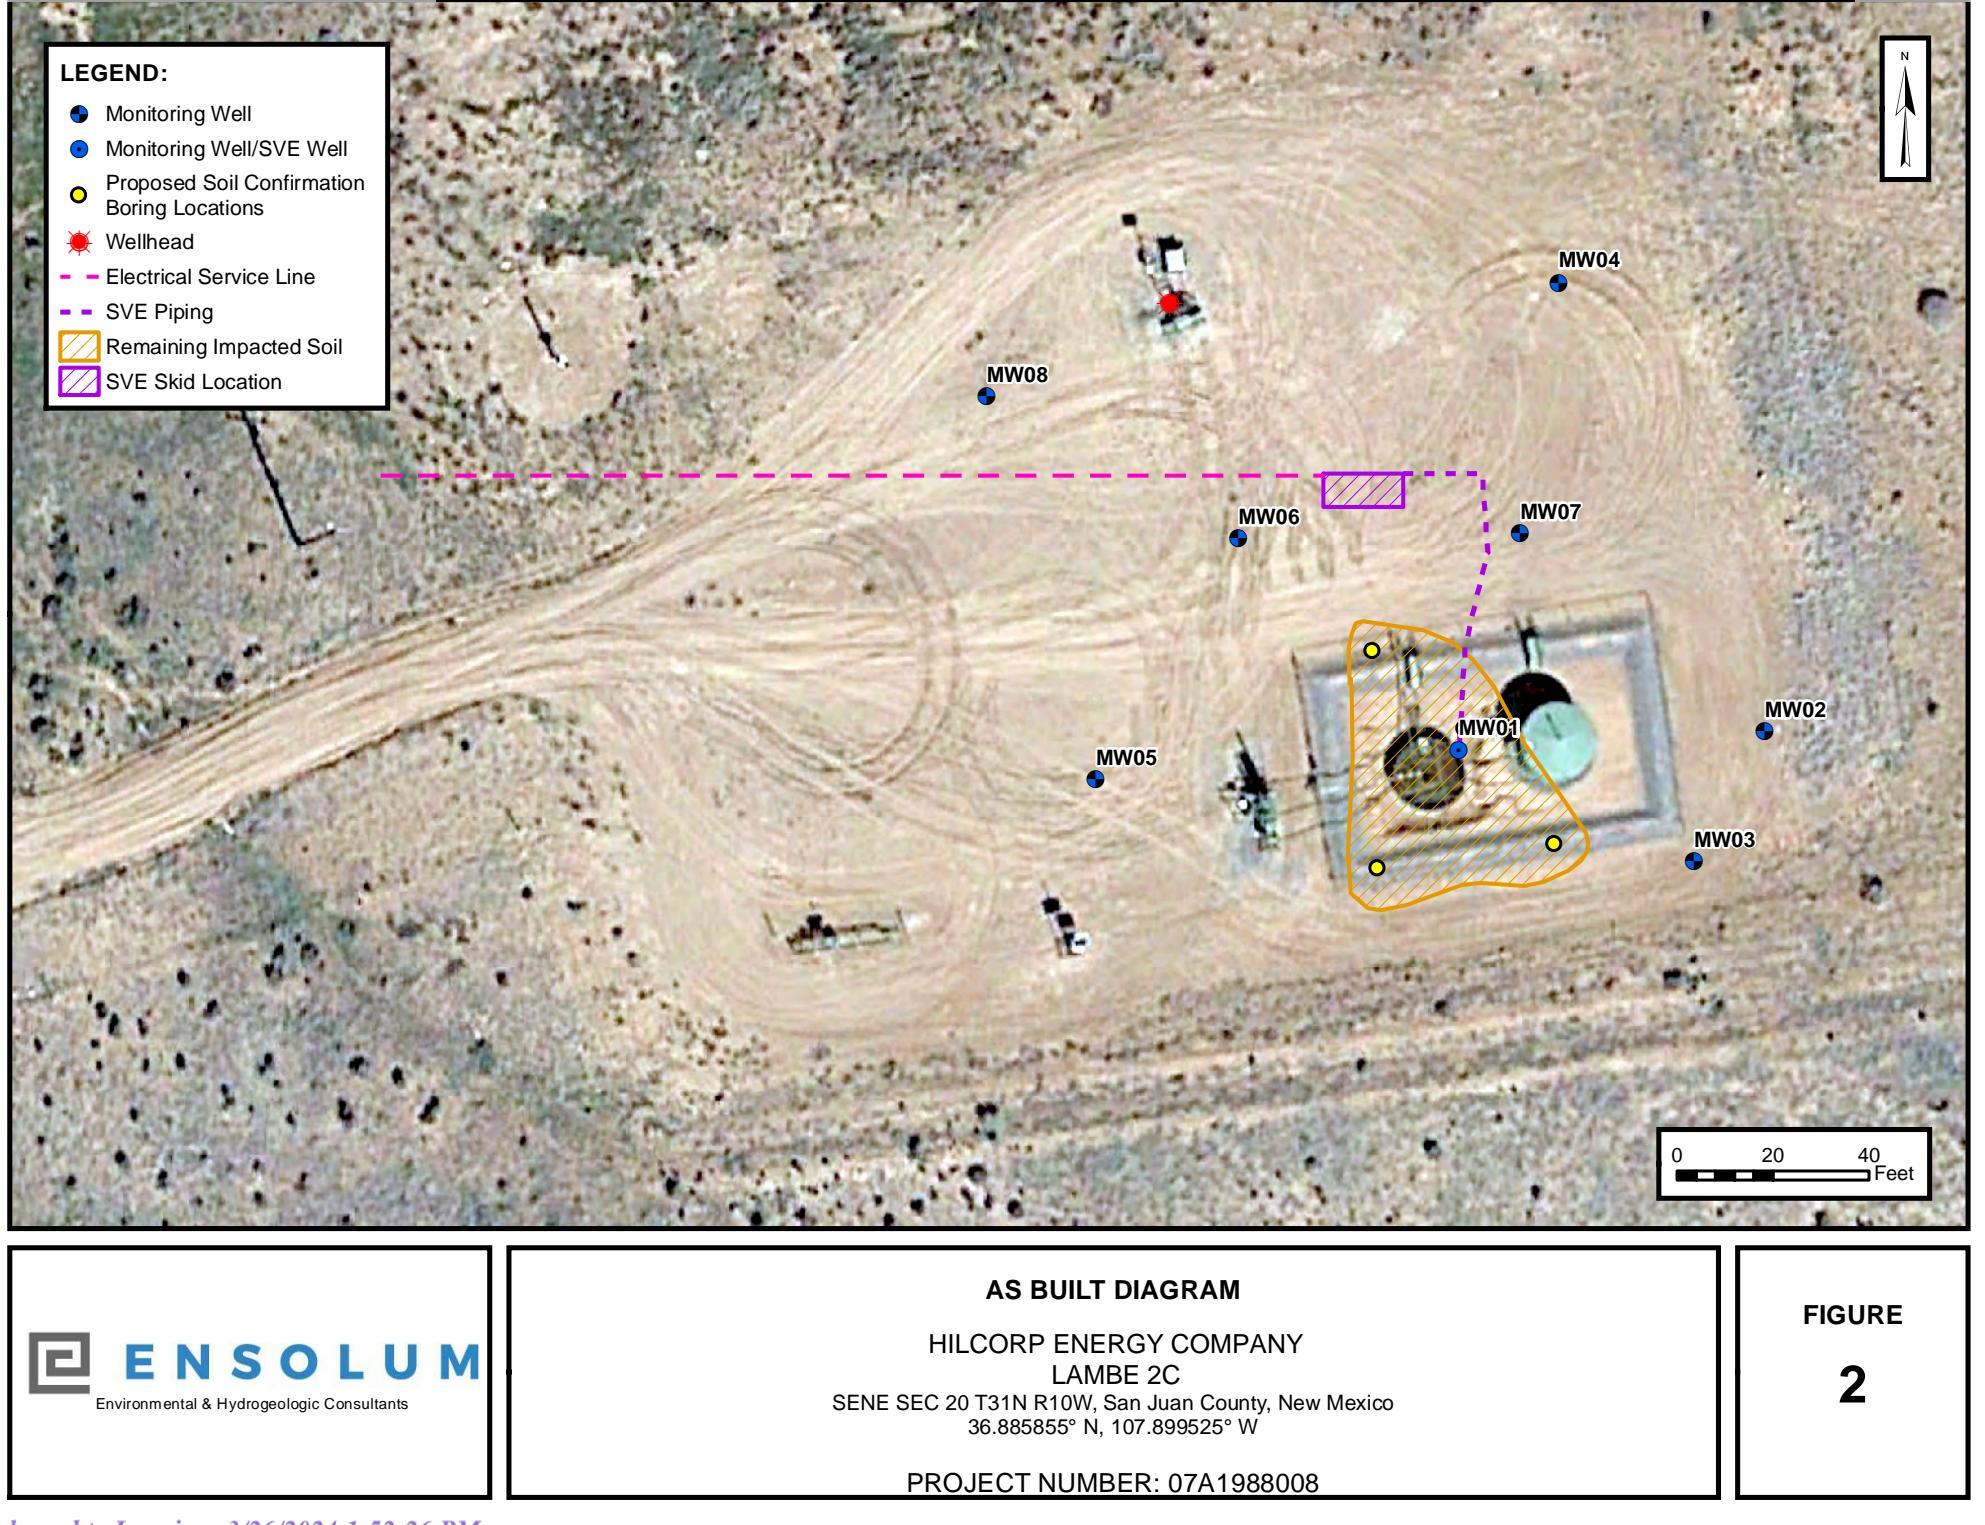
The current SVE system was installed at the Site in September 2021, with operation beginning on September 24, 2021. The SVE system is configured so vacuum is being applied to well MW01 (shown on Figure 2). SVE well MW01 is screened across the impacted soil interval from approximately 20 feet to 35 feet below ground surface (bgs). The SVE system consists of a 1 horsepower Atlantic Blower model AB-202/1 regenerative blower capable of producing 50 standard cubic feet per minute (scfm) flow and 30 inches of water column (IWC) vacuum. The layout of the SVE system and piping is shown on Figure 2.
