Incident Number: nAPP2319260257

Release Assessment and Closure

Red Bull 29 Federal #1H Section 29, Township 23 South, Range 35 East County: Lea Vertex File Number: 23E-04311

Prepared for: Devon Energy Production Company, LP

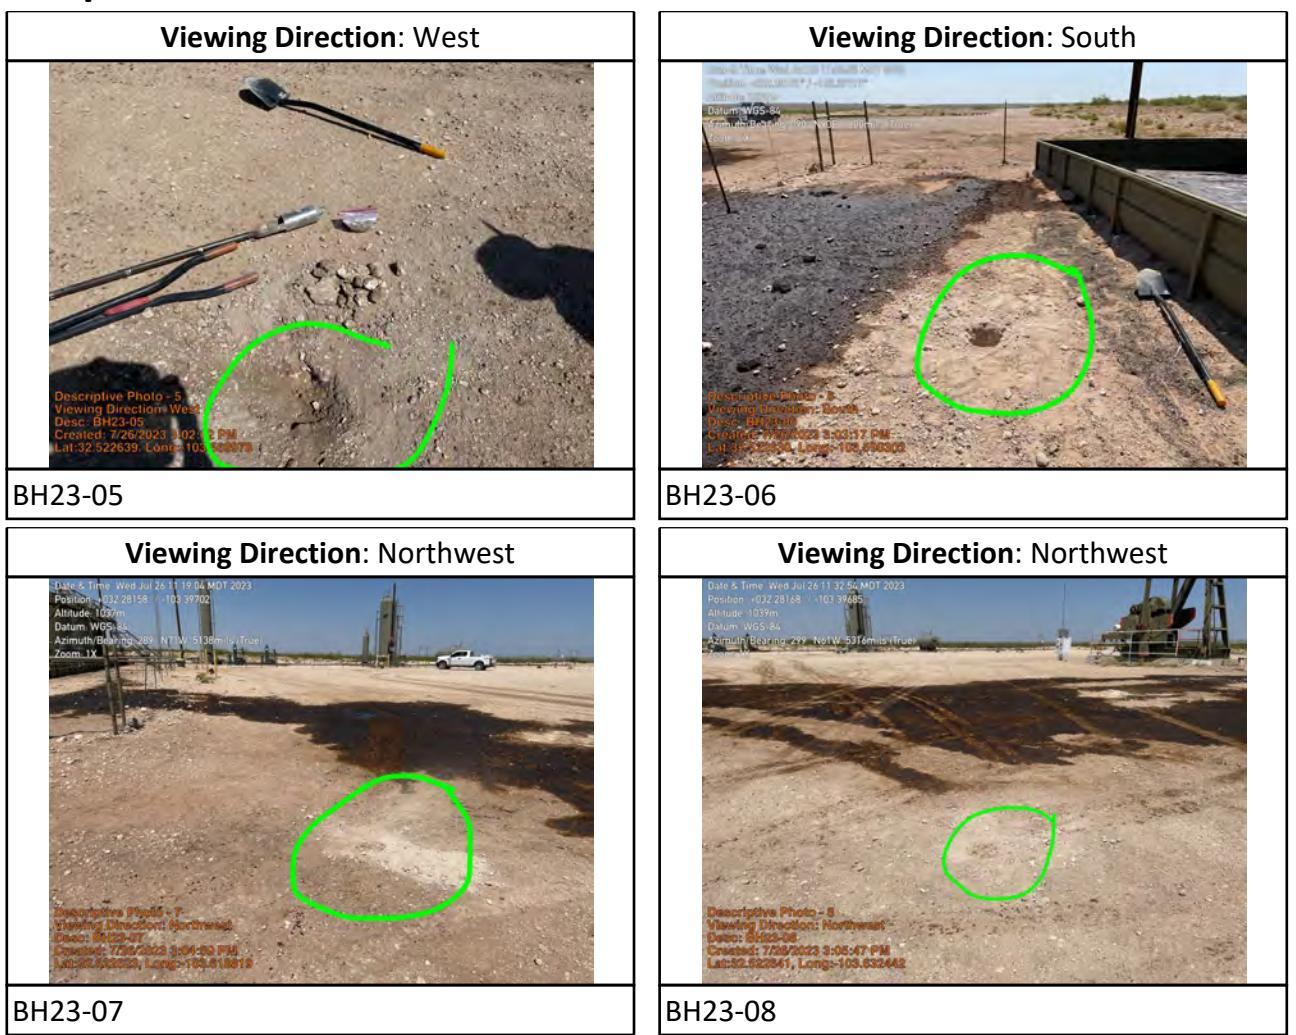
Site Photos Viewing Direction: West Viewing Direction: West BH23-01 BH23-02 Viewing Direction: West Viewing Direction: Northwest BH23-03 BH23-04

Discussed the remediation plan of 6 inch excavation of staining and 1 foot excavation around BH23-02 in addition to showing location of BH23-02 and vicinity of 1 foot excavation.

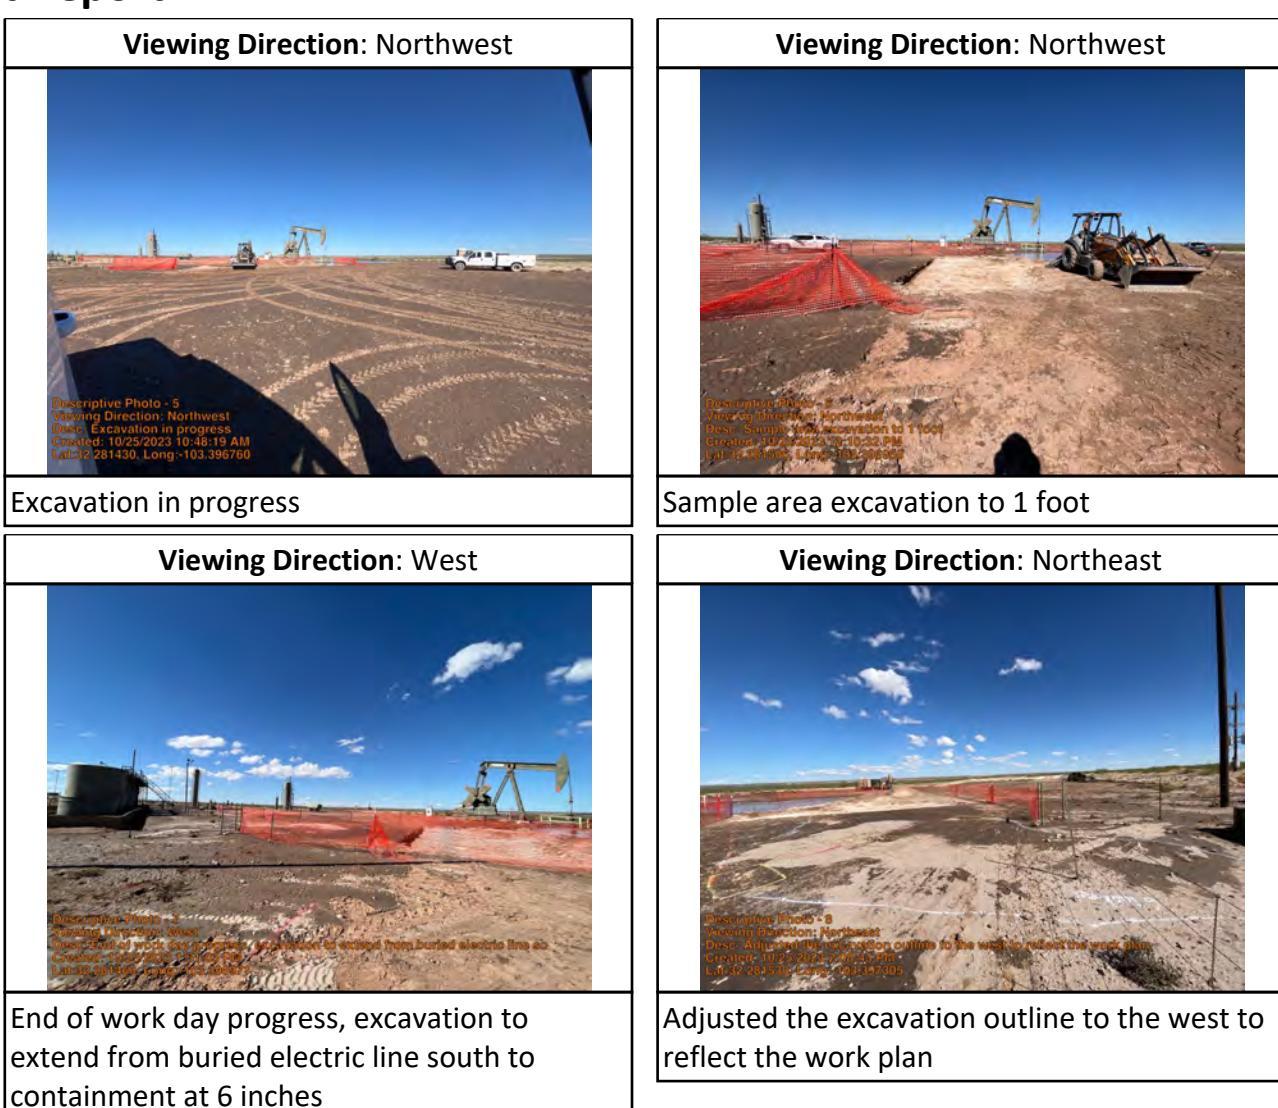
Site Photos Viewing Direction: South Viewing Direction: Southeast von Site information placard 1-2 inches of rainwater in containment Viewing Direction: Northeast Viewing Direction: Southeast North half of excavation full of rainwater, Muddy, uphill (of inundated excavation) area excavated to 1 foot and extended to around of unexcavated half with pot holes for utility wellhead. lines and orange construction paint marking the staining marked on Oct. 23, 2023.

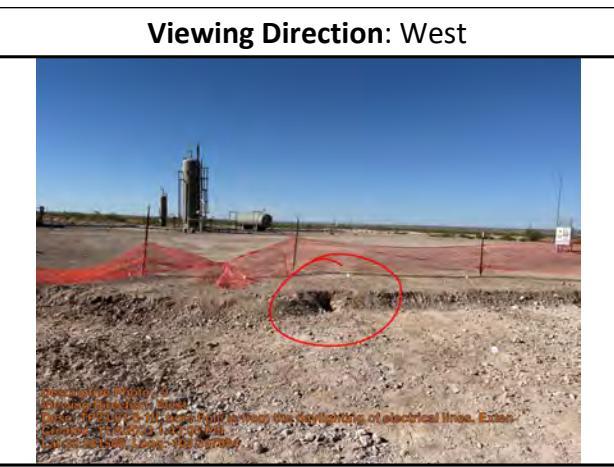
TP23-01 0-1ft, bore hole is from the daylighting of electrical lines. Extends approximately 1-1.5 ft back from current wall.

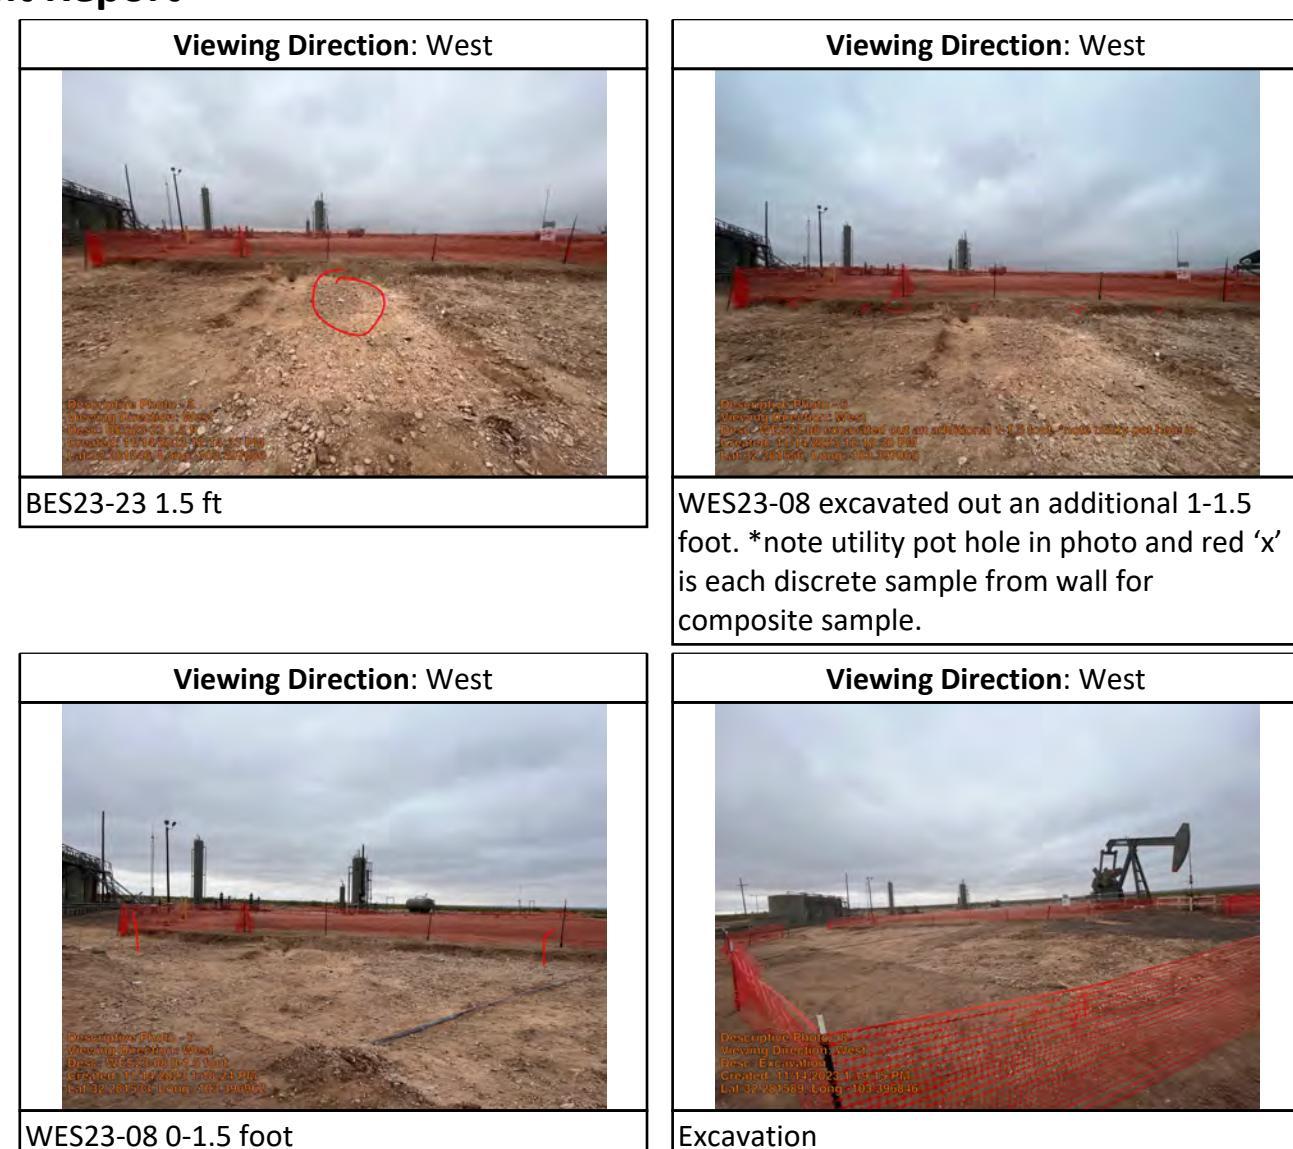
14:15 Arrived on site, examined site for hazards and completed safety assessment for job and documents. Collected composite samples BES23-12 1.5 foot, BES23-23 1.5 foot and WES23-09 0-1.5 foot.

Site Photos Viewing Direction: South Viewing Direction: Northwest devon FEDERAL #1 C.29-T235-R35E 375' FSL & 375' FM A COUNTY, NEW MEXICO Site information placard BES23-12 excavated to 1.5 foot depth Viewing Direction: West Viewing Direction: West BES23-12 1.5 ft BES23-23 excavated to 1.5 foot depth. *note utility pot hole in photo

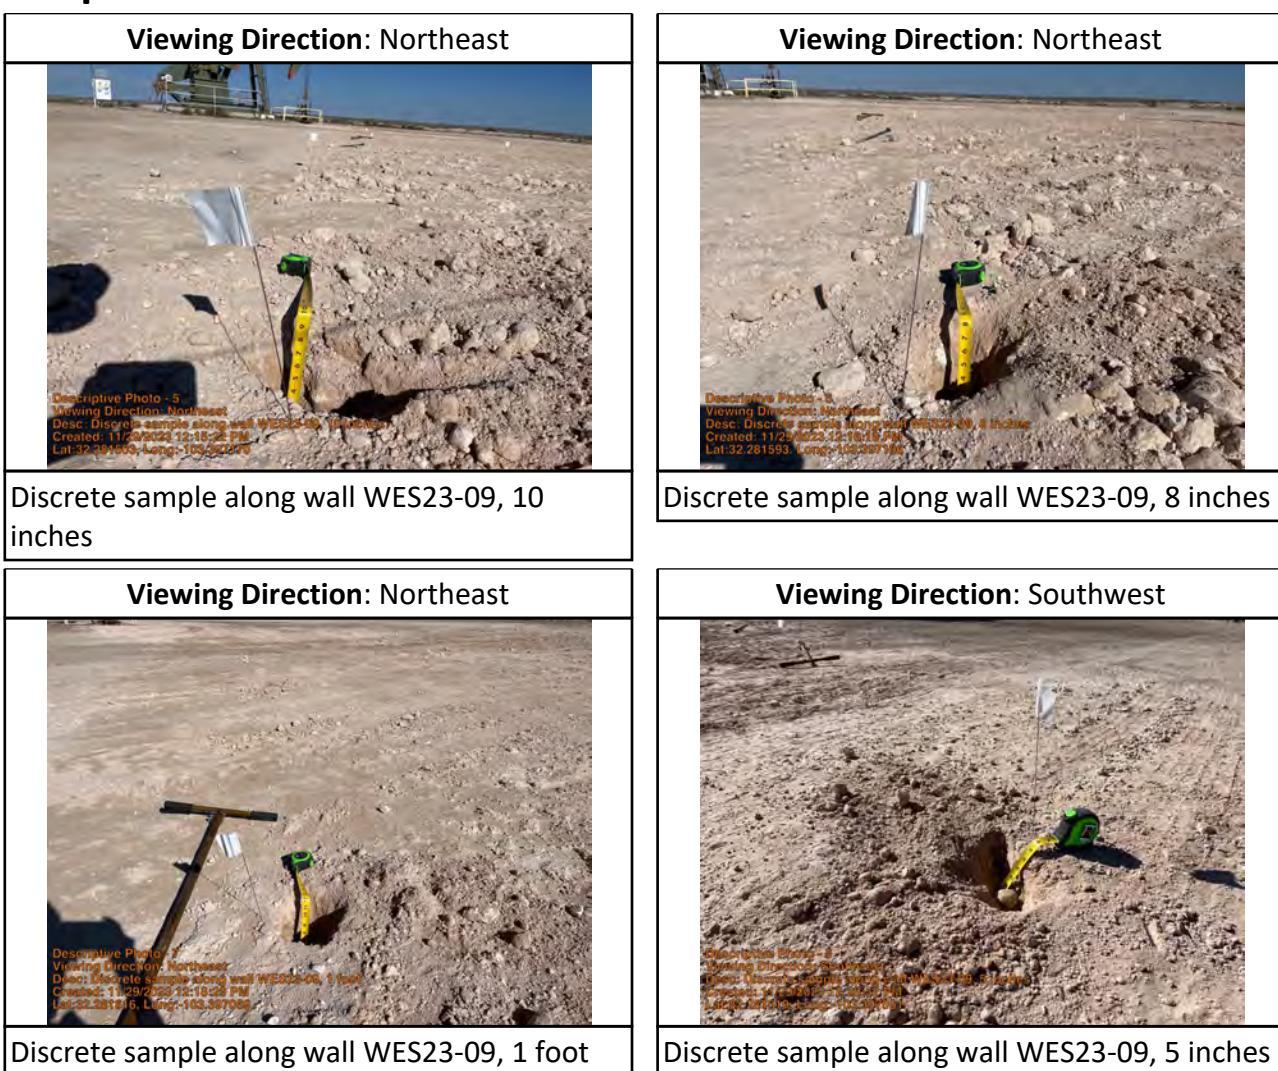
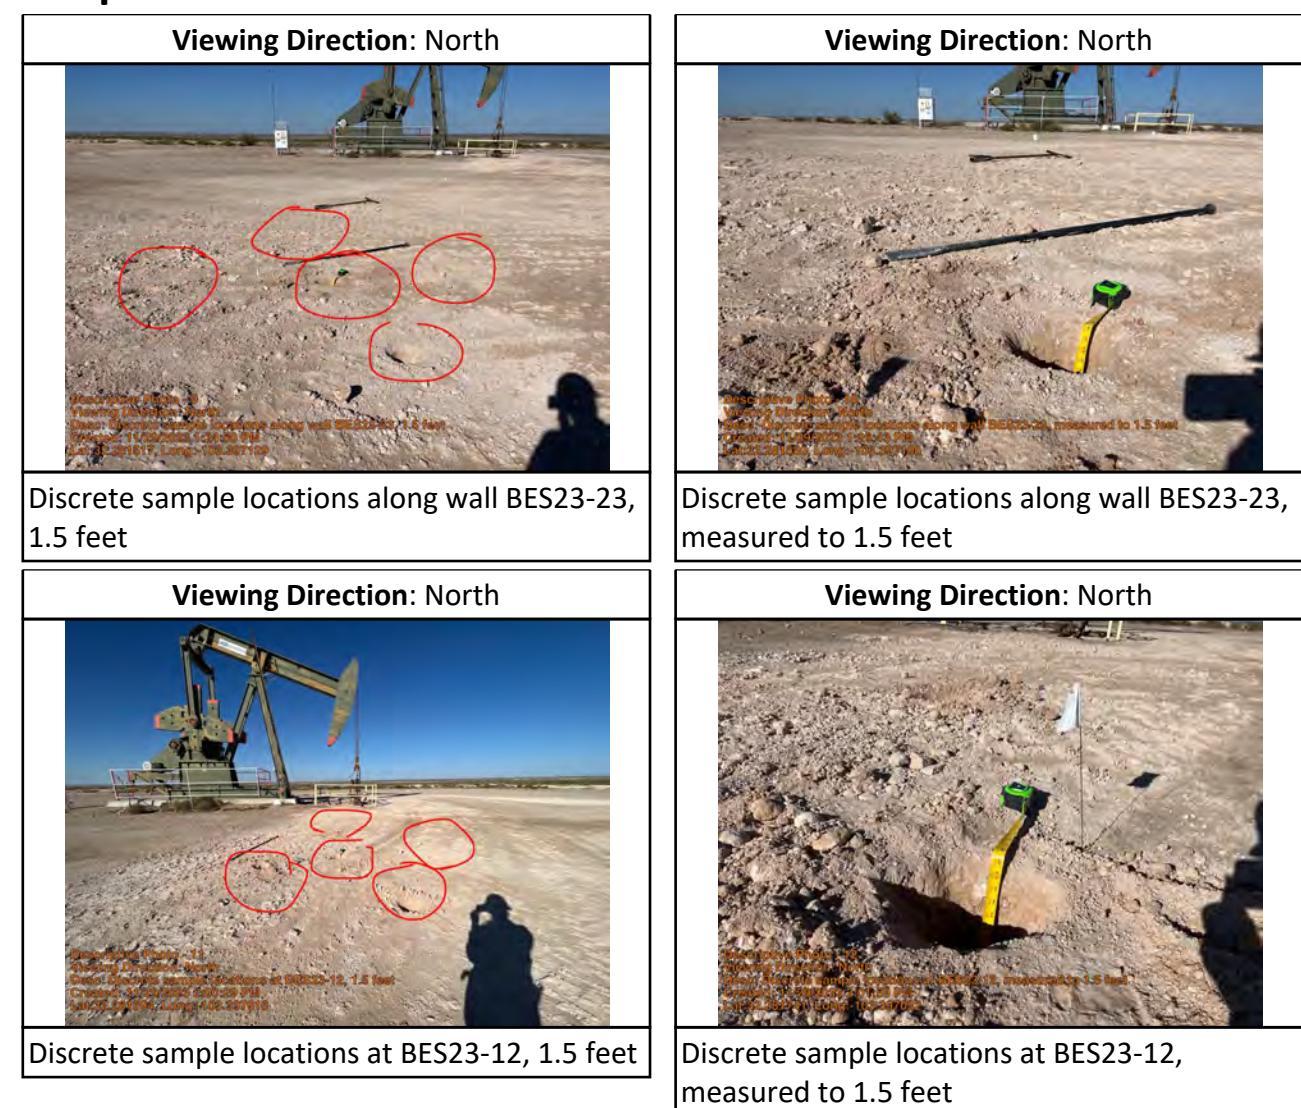
Site Photos Viewing Direction: East Viewing Direction: Southwest Site information placard Backfilled site Viewing Direction: Northeast Viewing Direction: Northeast Discrete sample locations along wall WES23-Discrete sample along wall WES23-09, 1.5 feet 09, 0-1.5 feet

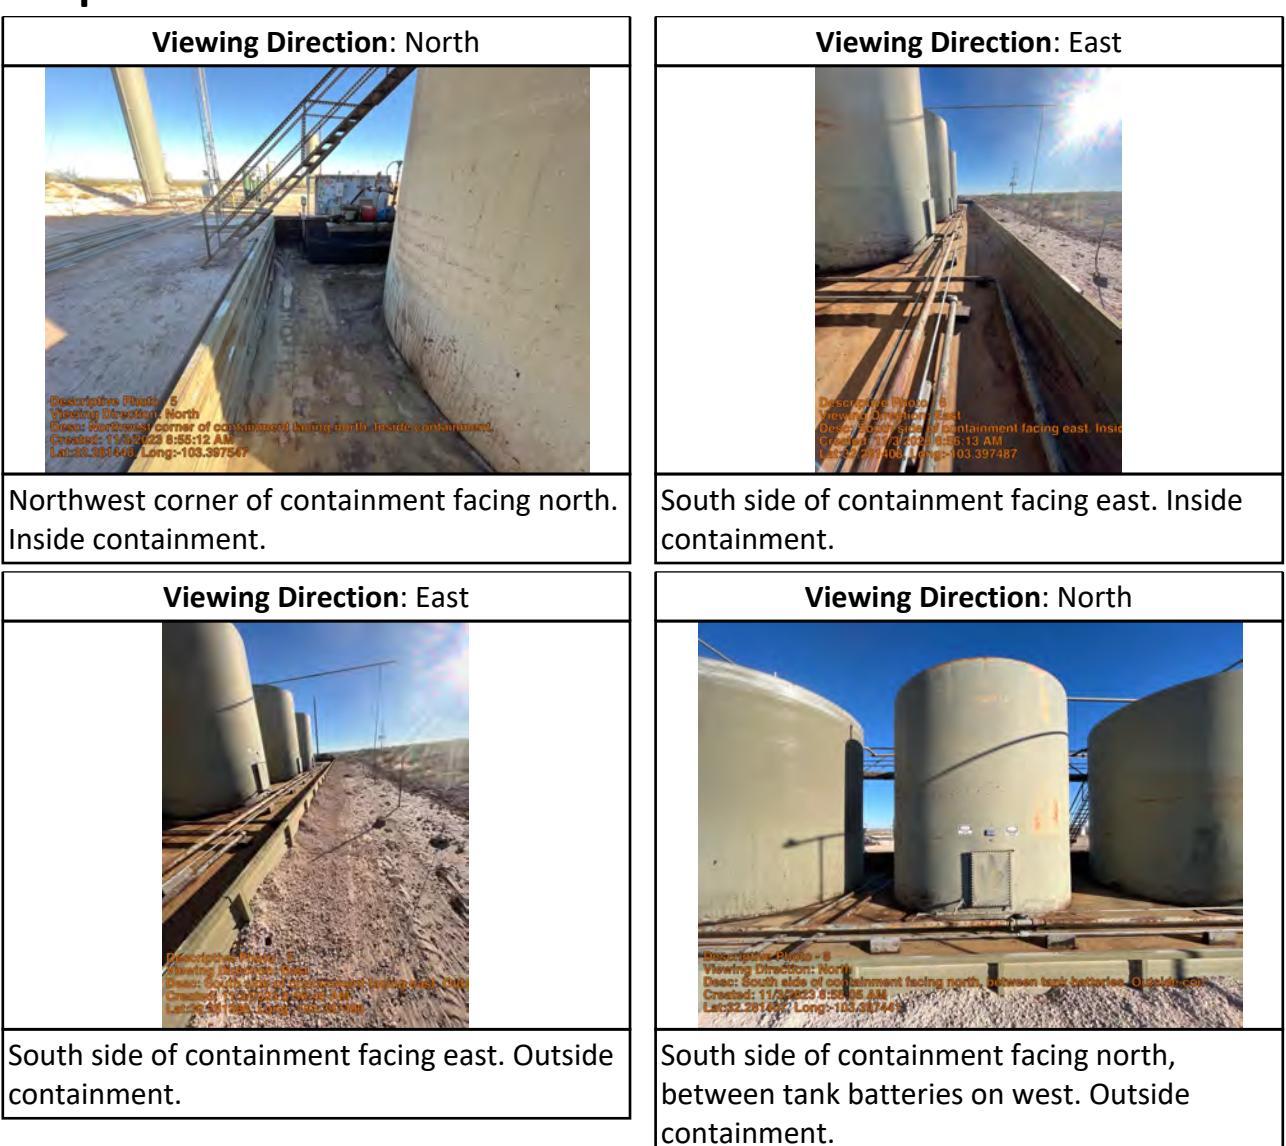
9:23 Inspected both inside and outside walls of containment/liner and did not find any compromising damage or unexpected breaches. No unexpected staining on soil outside the containment or from area of breach, which has been delineated.
Inspection of liner around and between equipment and tanks, inside containment did not yield any damage, breaches, or areas of concern with liner.
See photos of liner below.

Site Photos Viewing Direction: South Viewing Direction: Southeast devon RED BULL 29 FEDERAL #1H 30-025-40628 NMNM-117558 54.5664" LONG. W 103" 23" 49.07724 Northwest corner of containment facing Site information placard southeast. North end outside containment. Viewing Direction: East Viewing Direction: West Southwest corner of containment facing east. Southwest corner of containment facing west. Outside containment. Inside containment.

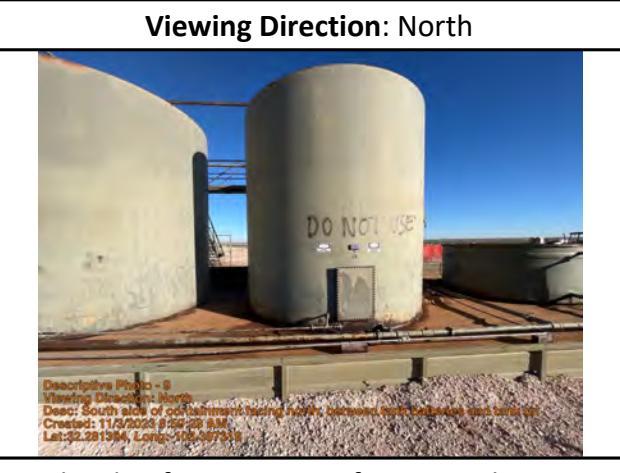
South side of containment facing north, between tank batteries and tank on east. Outside containment.

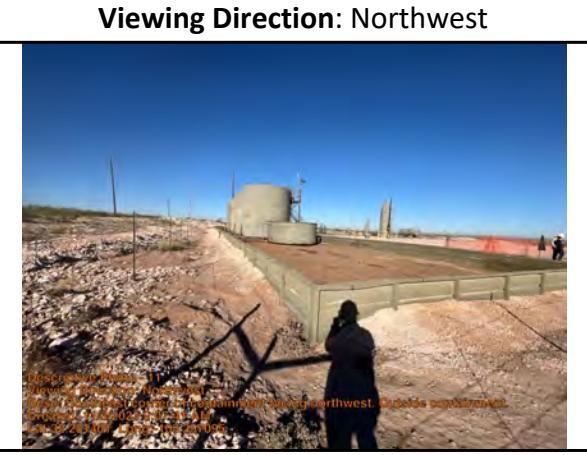
Southeast corner of containment facing northwest. Outside containment.

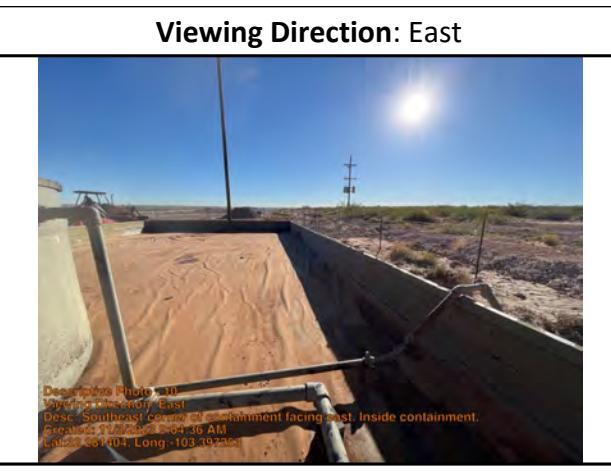
Southeast corner of containment facing east. Inside containment.

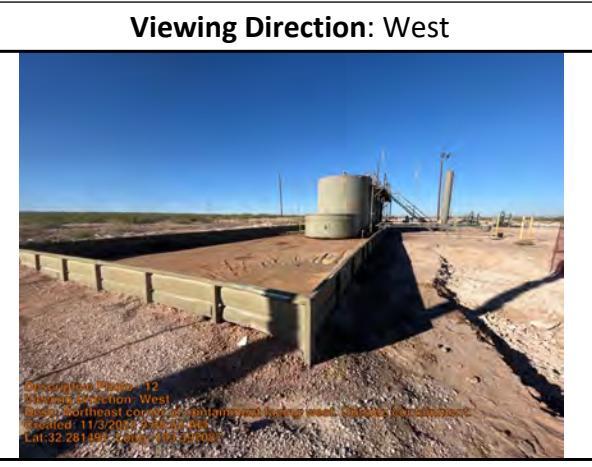
Northeast corner of containment facing west. Outside containment.

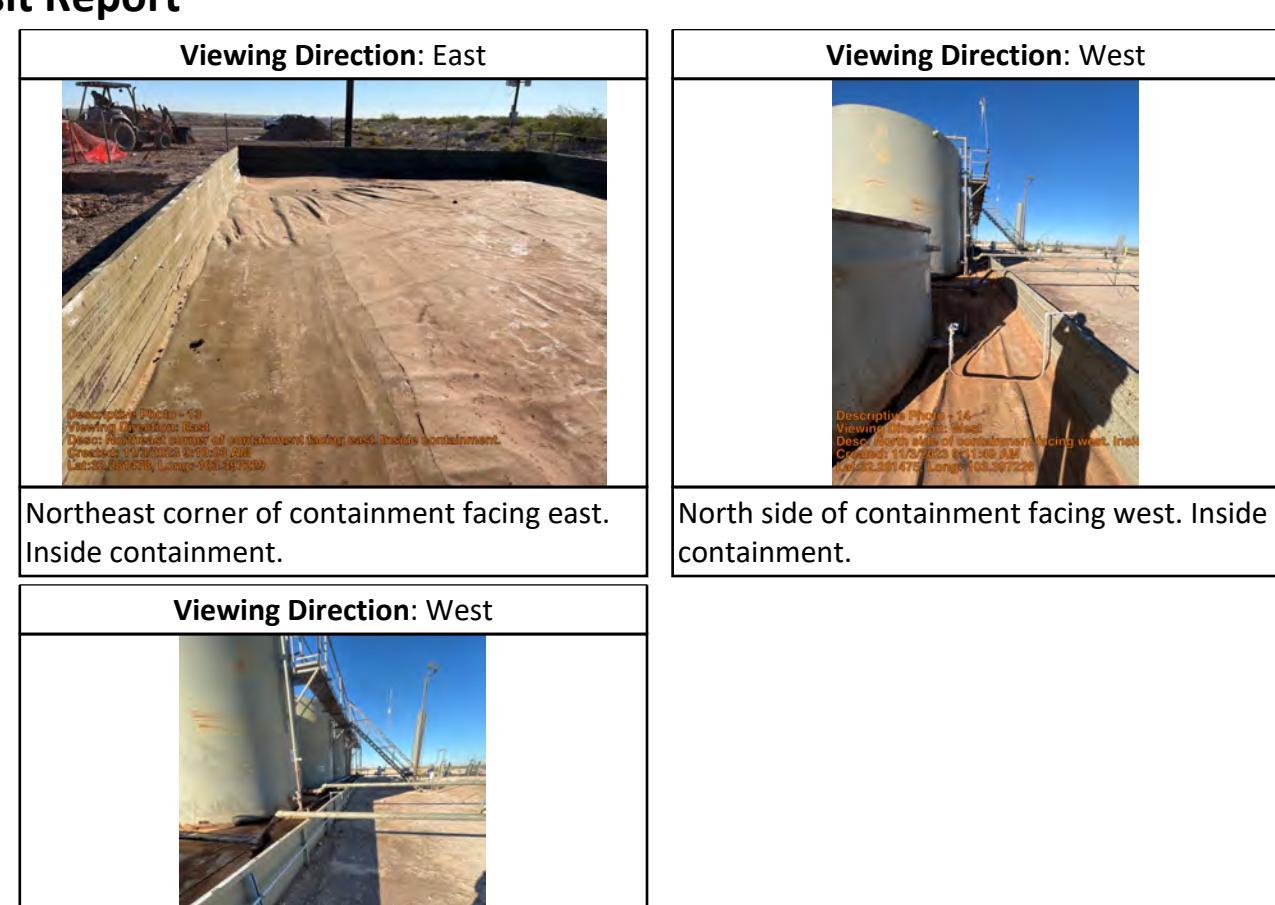
containment.

North side of containment facing west. Outside
