Release Assessment and Closure

Aldabra 25 Federal #006H & #007H Battery

Section 25, Township 23 South, Range 31 East API: 30-015-38602 County: Eddy Vertex File Number: 23E-04614

Date: March 2024 Devon Energy Production Company, LP Aldabra 25 Federal #006H & #007H Battery Release Assessment and Closure March 2024

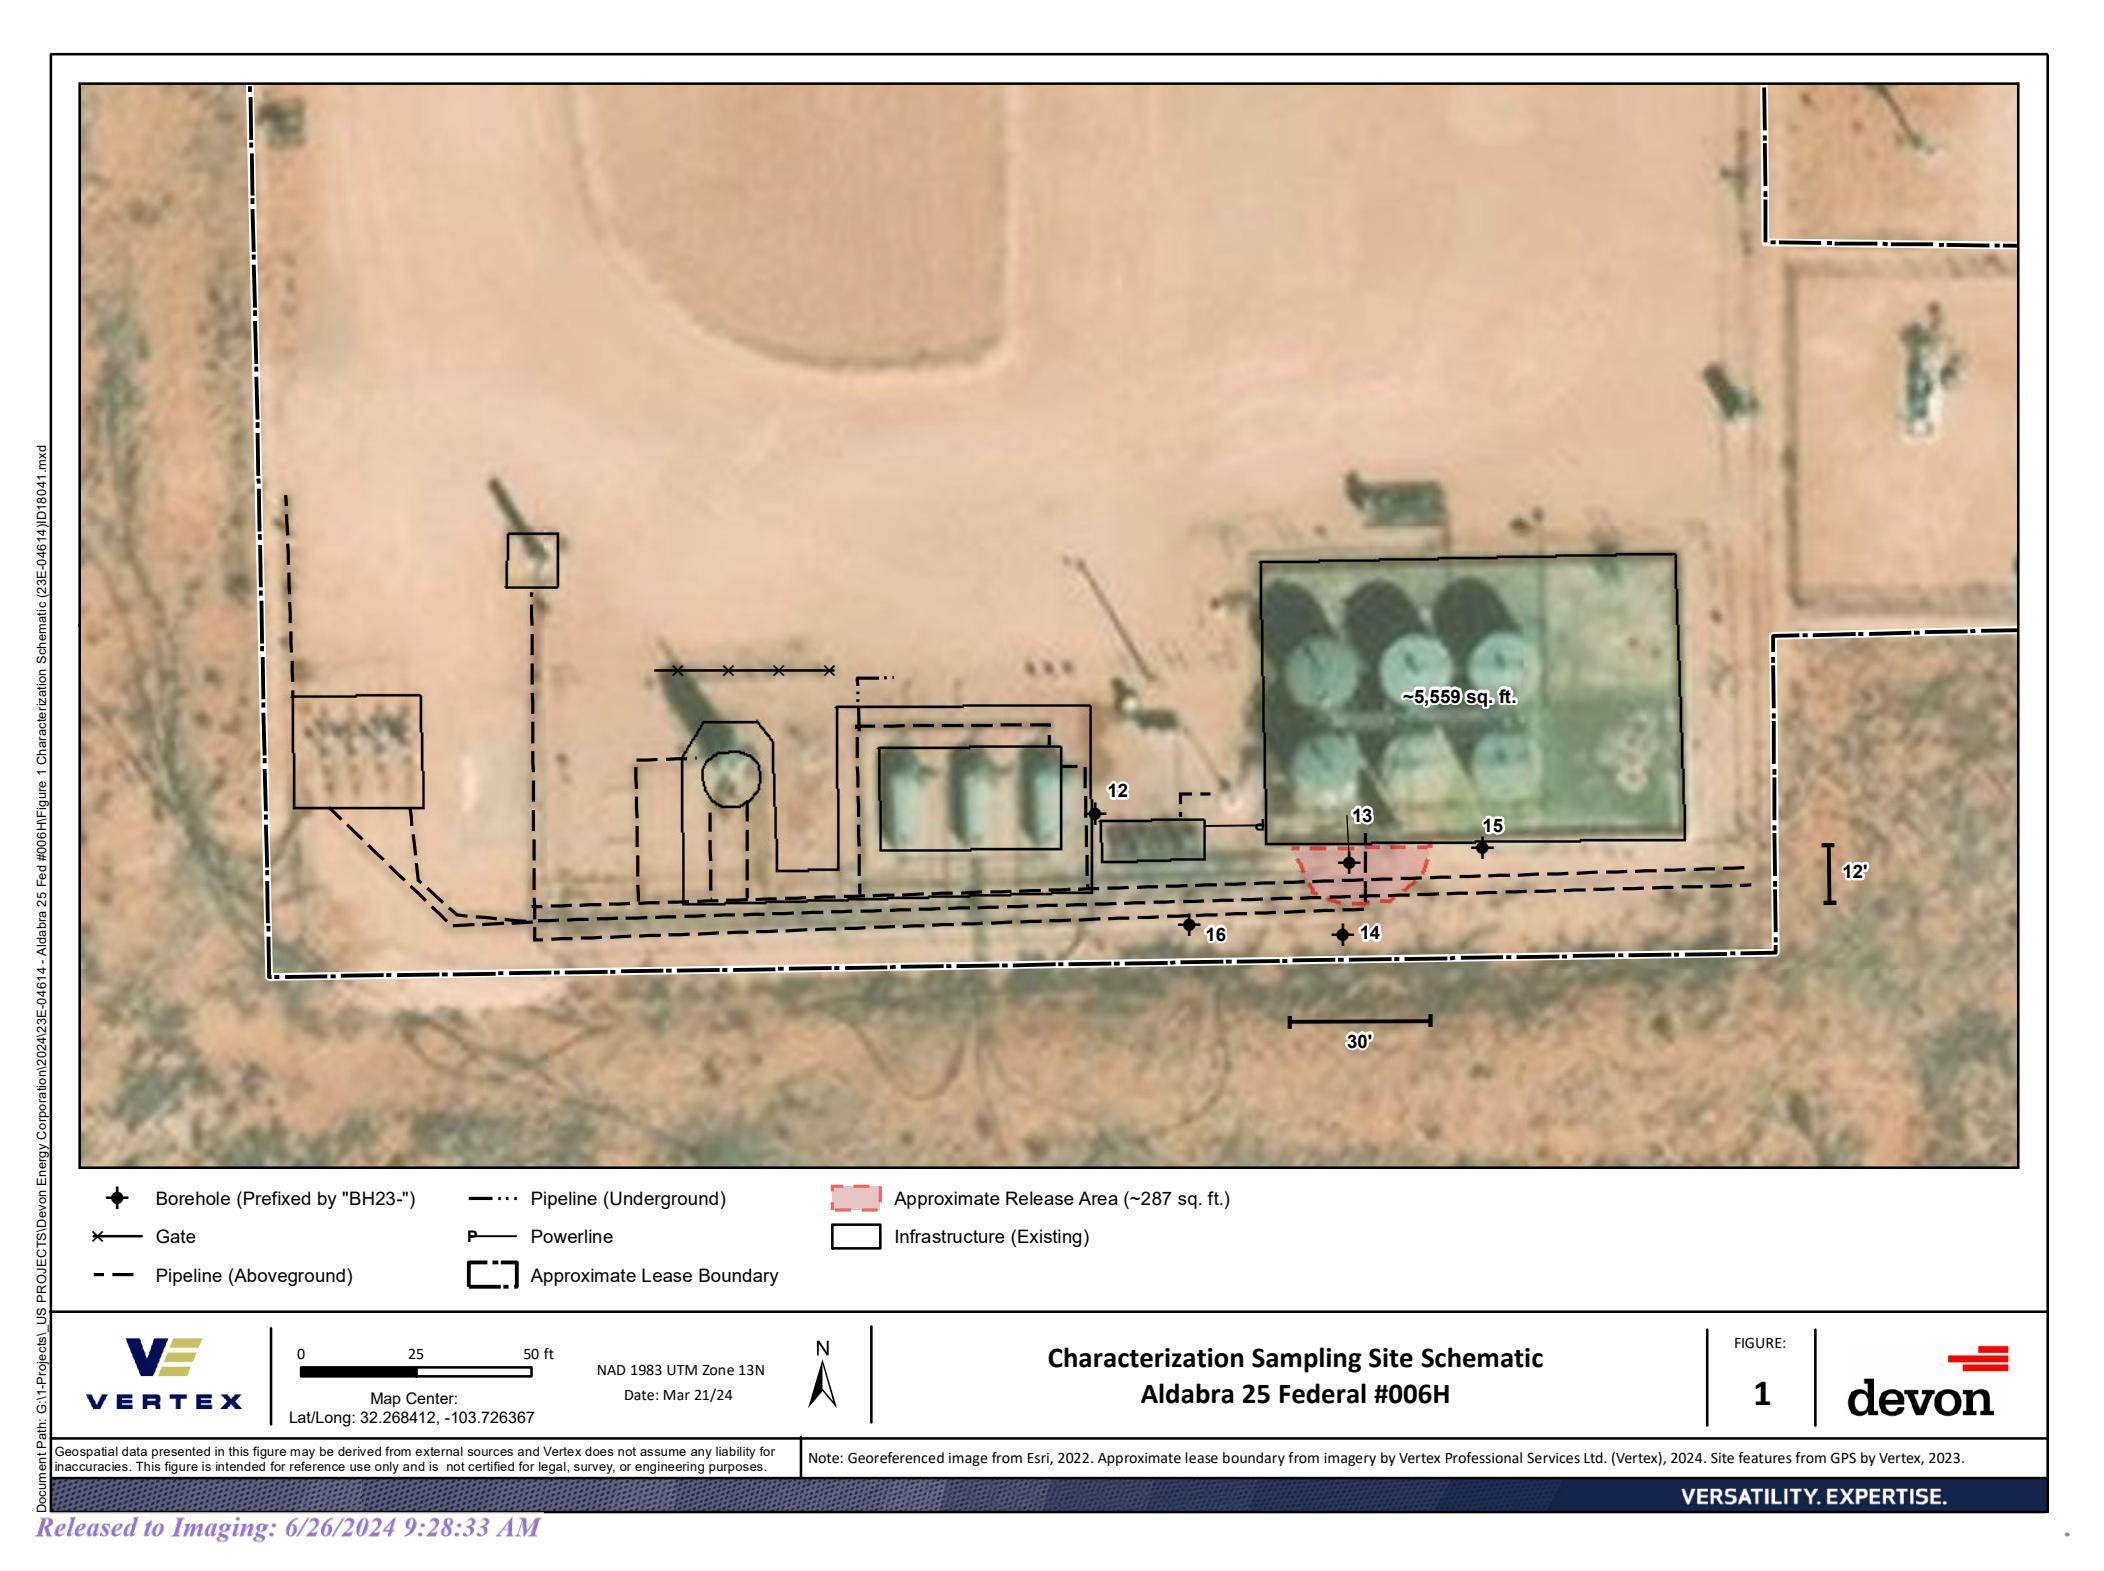
Figure 1. Characterization Sampling Site Schematic

The site is located approximately 22.3 miles southeast of Malaga, New Mexico, at 32.2686806, - 103.7263489 (Google Inc., 2024). The legal location for the site is Section 25, Township 23 South and Range 31 East in Eddy County, New Mexico. The release area is located on Bureau of Land Management property. An aerial photograph and site schematic are presented on Figure 1.

The location is typical of oil and gas exploration and production sites in the Permian Basin and is currently used for oil and gas production, and storage. The following sections specifically describe the release area at the site on or in proximity to the constructed pad (Figure 1).

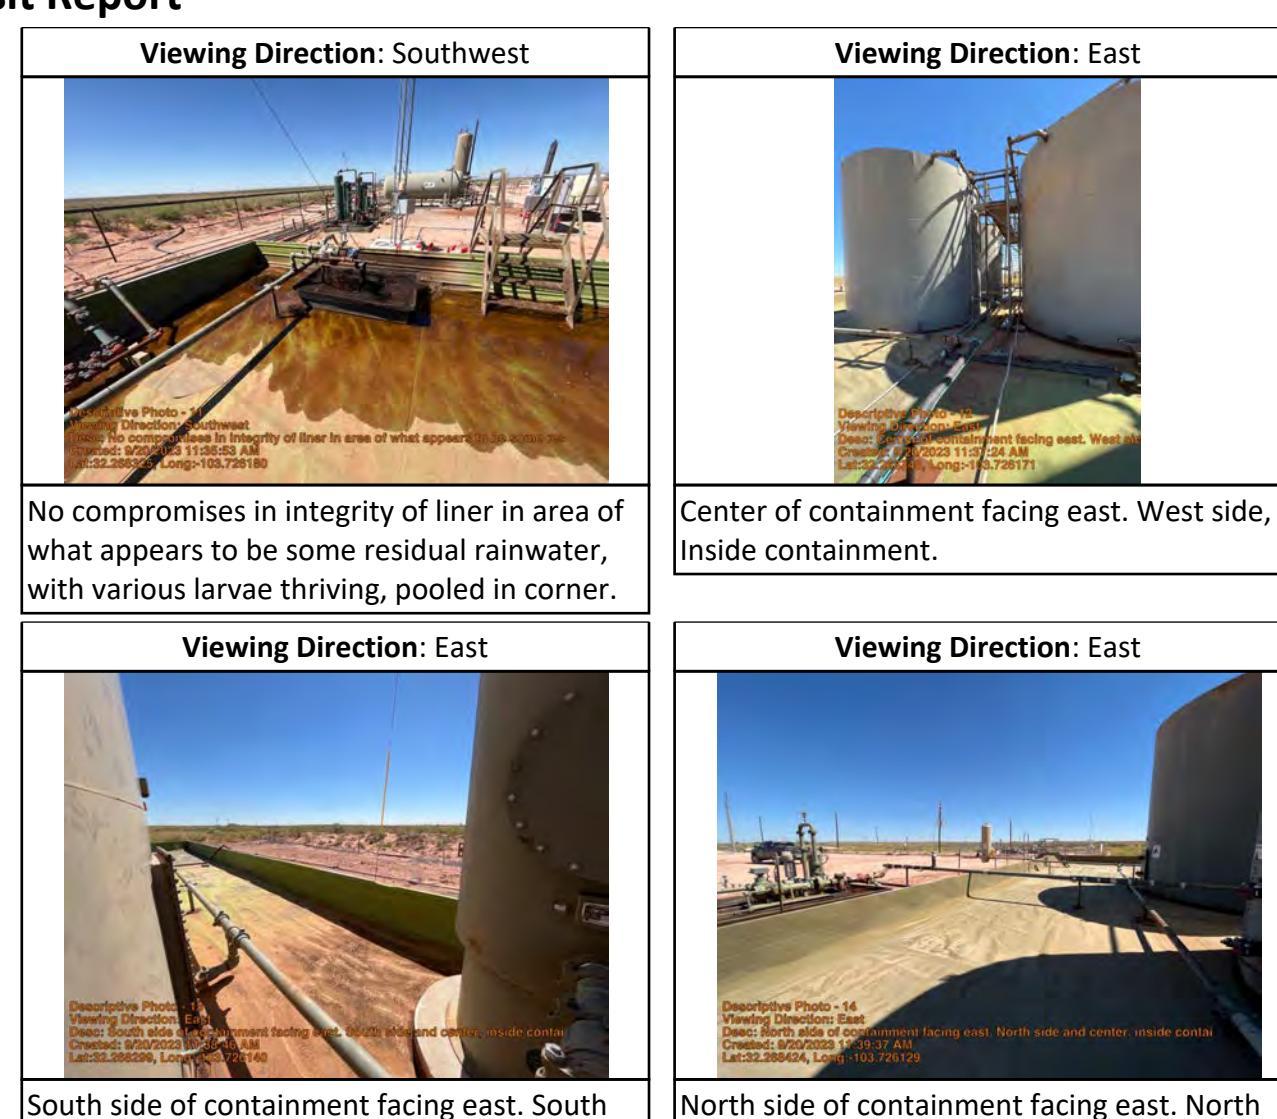
Appears to be some residual rainwater, with various larvae thriving, pooled in corner.

side and center, inside containment.

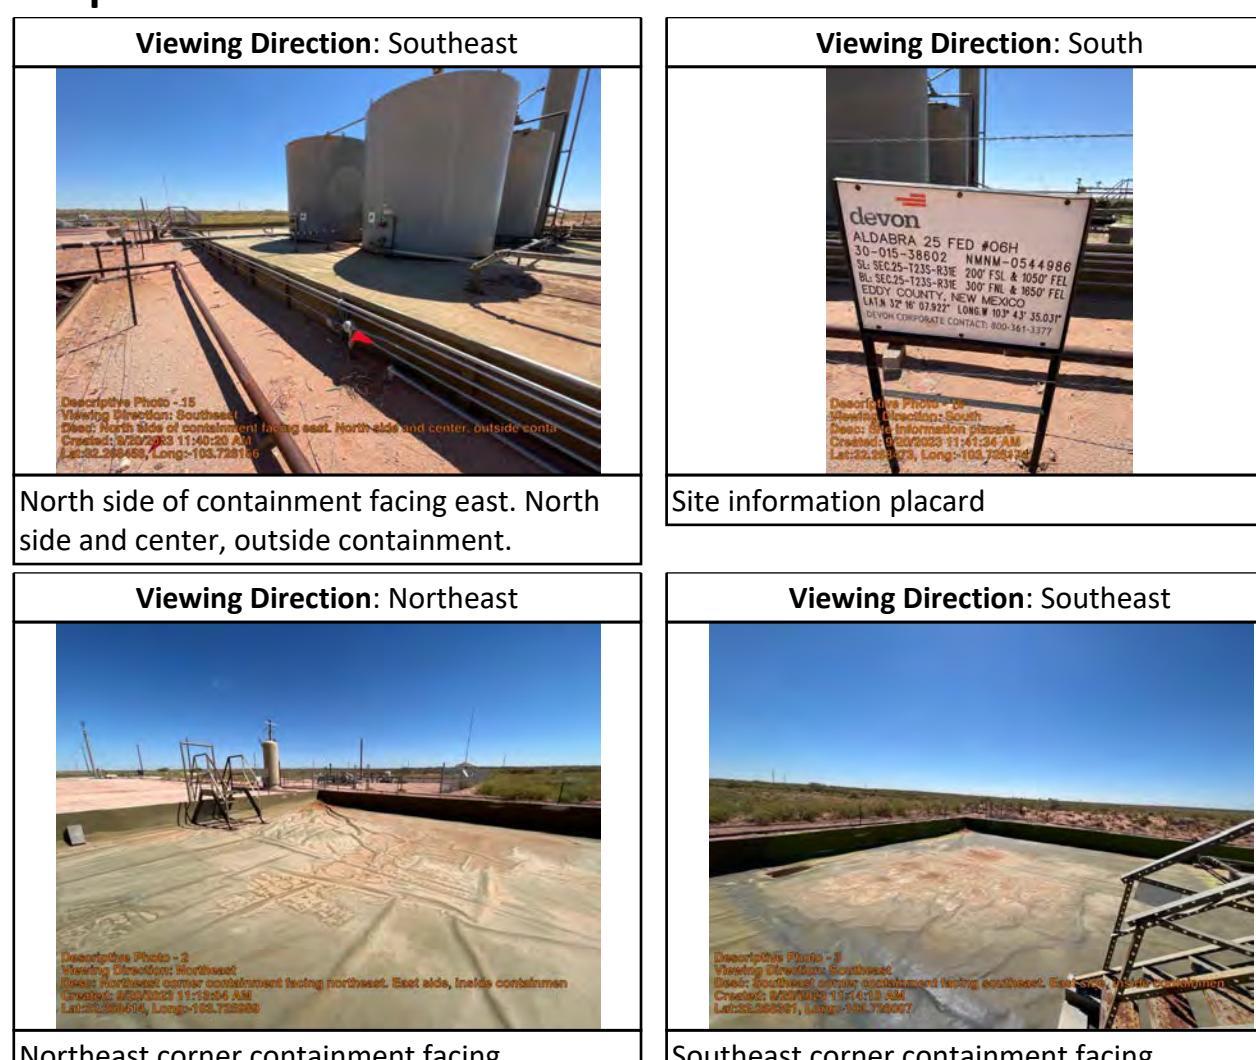
Northeast corner containment facing northeast. East side, inside containment.

Southeast corner containment facing southeast. East side, inside containment.
