RCRA FACILITY INVESTIGATION TASK 1: DESCRIPTION OF CURRENT CONDITIONS

BLOOMFIELD REFINING COMPANY 50 COUNTRY ROAD 4990 BLOOMFIELD, NEW MEXICO

MARCH 1993

RCRA FACILITY INVESTIGATION TASK I: DESCRIPTION OF CURRENT CONDITIONS BLOOMFIELD REFINING COMPANY 50 COUNTY ROAD 4990 (SULLIVAN ROAD) BLOOMFIELD, NEW MEXICO

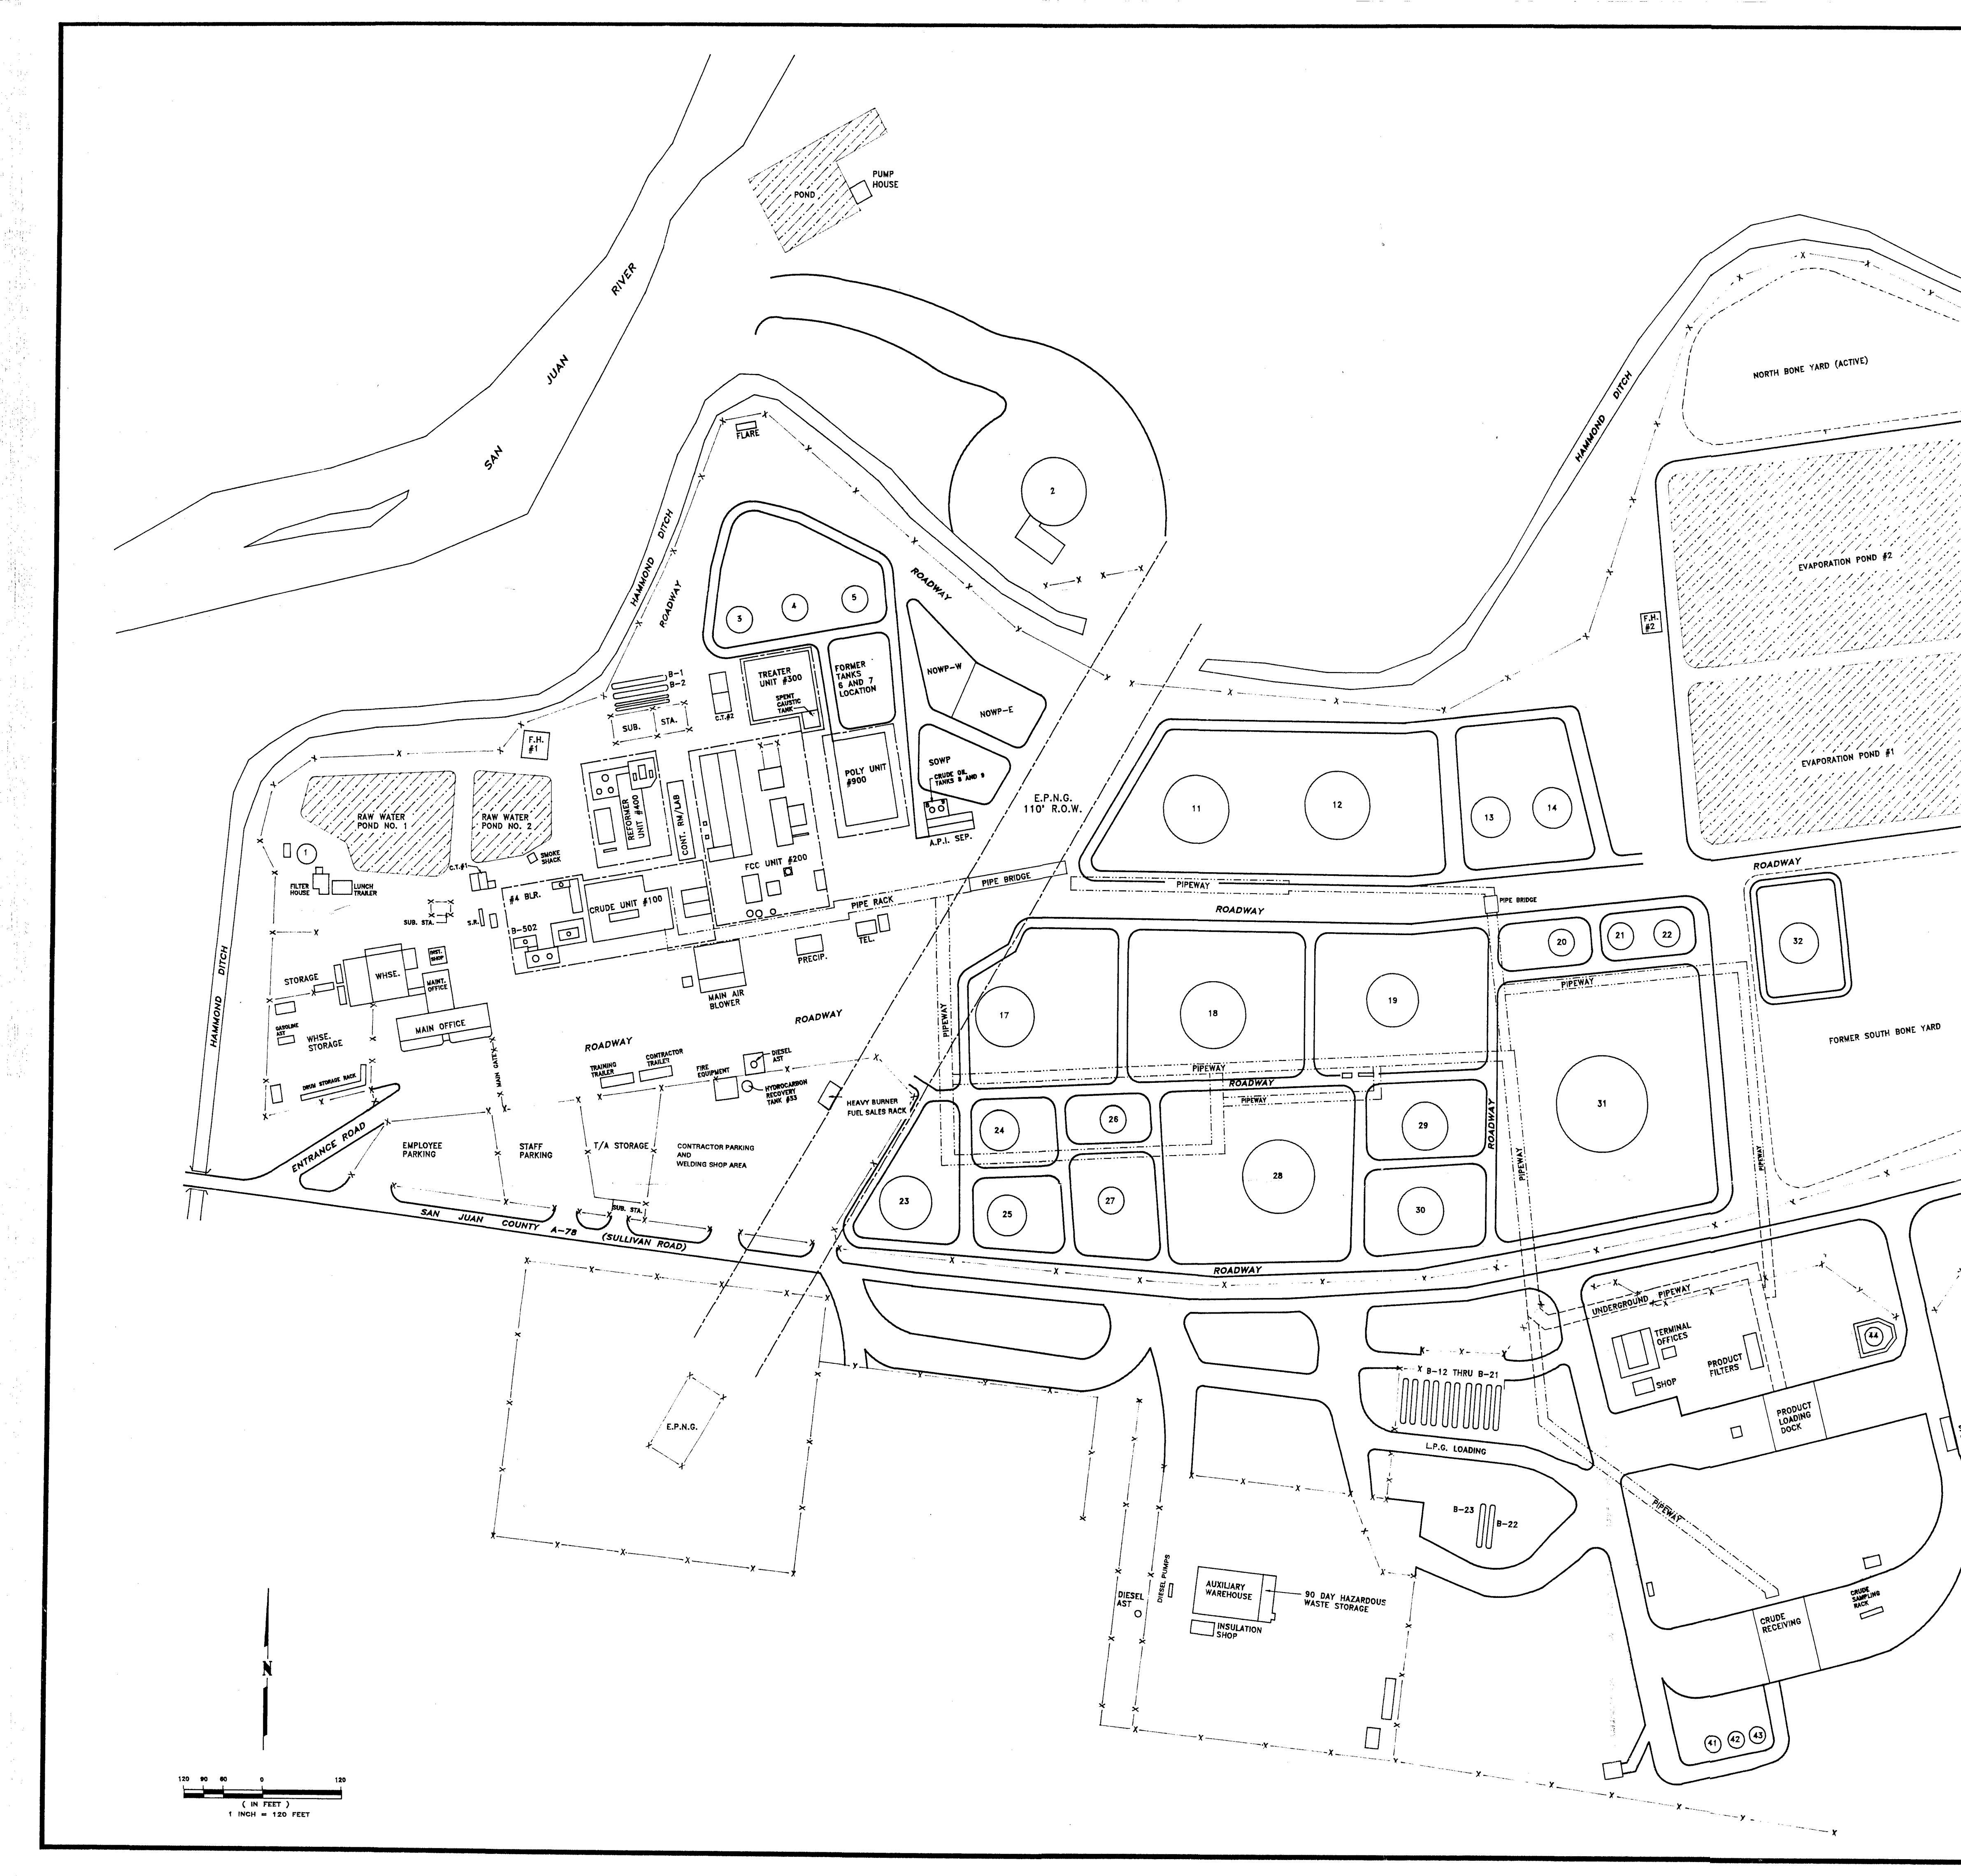
2. 25 2. 2.	FIGUI	?E 4		-

The current facility layout identifying all major aboveground structures is depicted in Figure 4. The refinery offices are located on the western end of Sullivan Road along with warehouse space, maintenance and shop areas, a drum storage area, raw water ponds (for temporary storage of water from the San Juan River), and one cooling tower (#1). Process units are located just east of the offices and include: the crude unit, the fluidized catalytic cracking unit, the gas con unit, the treater unit, one cooling tower, reformer/hydrotreater, catalytic polymerization unit, and API separator and oily water treatment ponds.

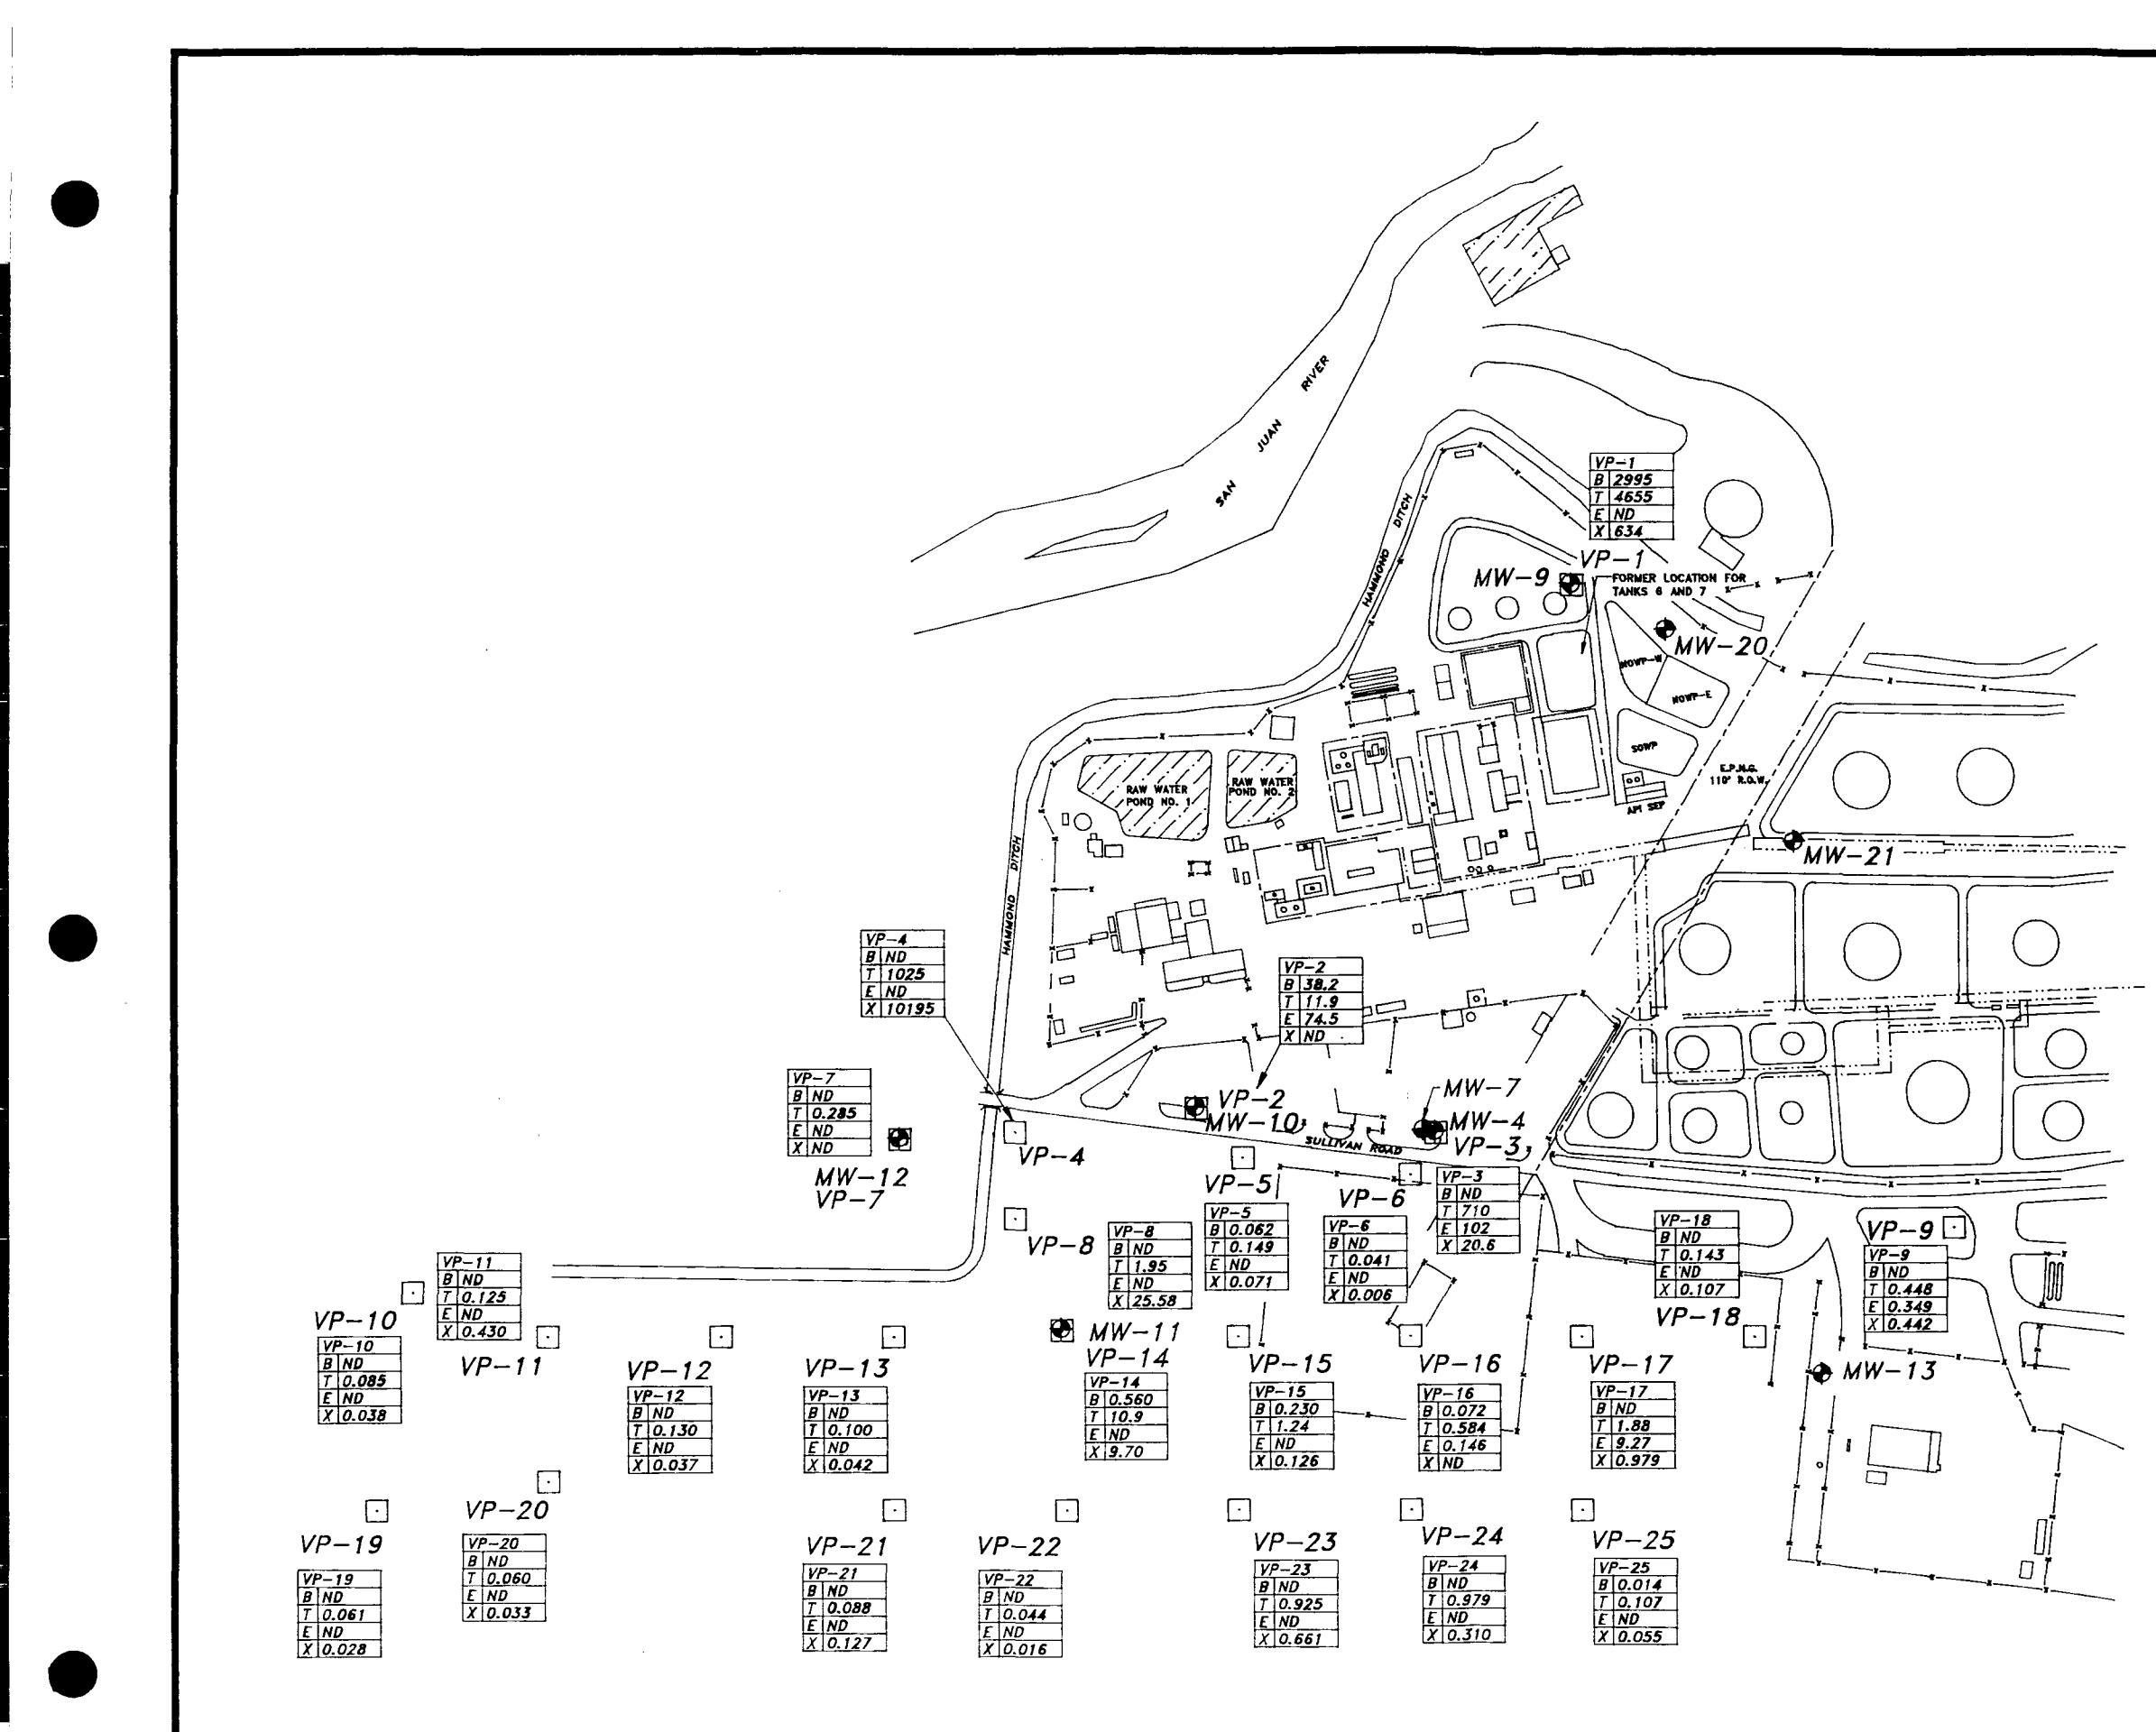
#50 COUNTY ROAD 4990 BLOOMFIELD. NEW MEXICO
	GROUNDWATER
1	1 ECHNOLOGY
	2501 YALE BLVD. SE, SUITE 204 ALBUQUEROUF, NEW MEXICO 87105
	(505) 242-3113
l N	BTEX CONCENTRATIONS (ppm)
	SOIL VAPOR SURVEY JULY 1988
	DESIGNED DRAFTED CHECKED BY: BY: BY: J. ML
I	DATE: FILE:
	MARCH 9, 1993 BTEX0788.DWG
300 150 0 300 (IN FEET)	PROJECT NO.: CONTRACT: 023353014
1 INCH = 300 FEET	DRAWING: REVISION:
	FIGURE 6

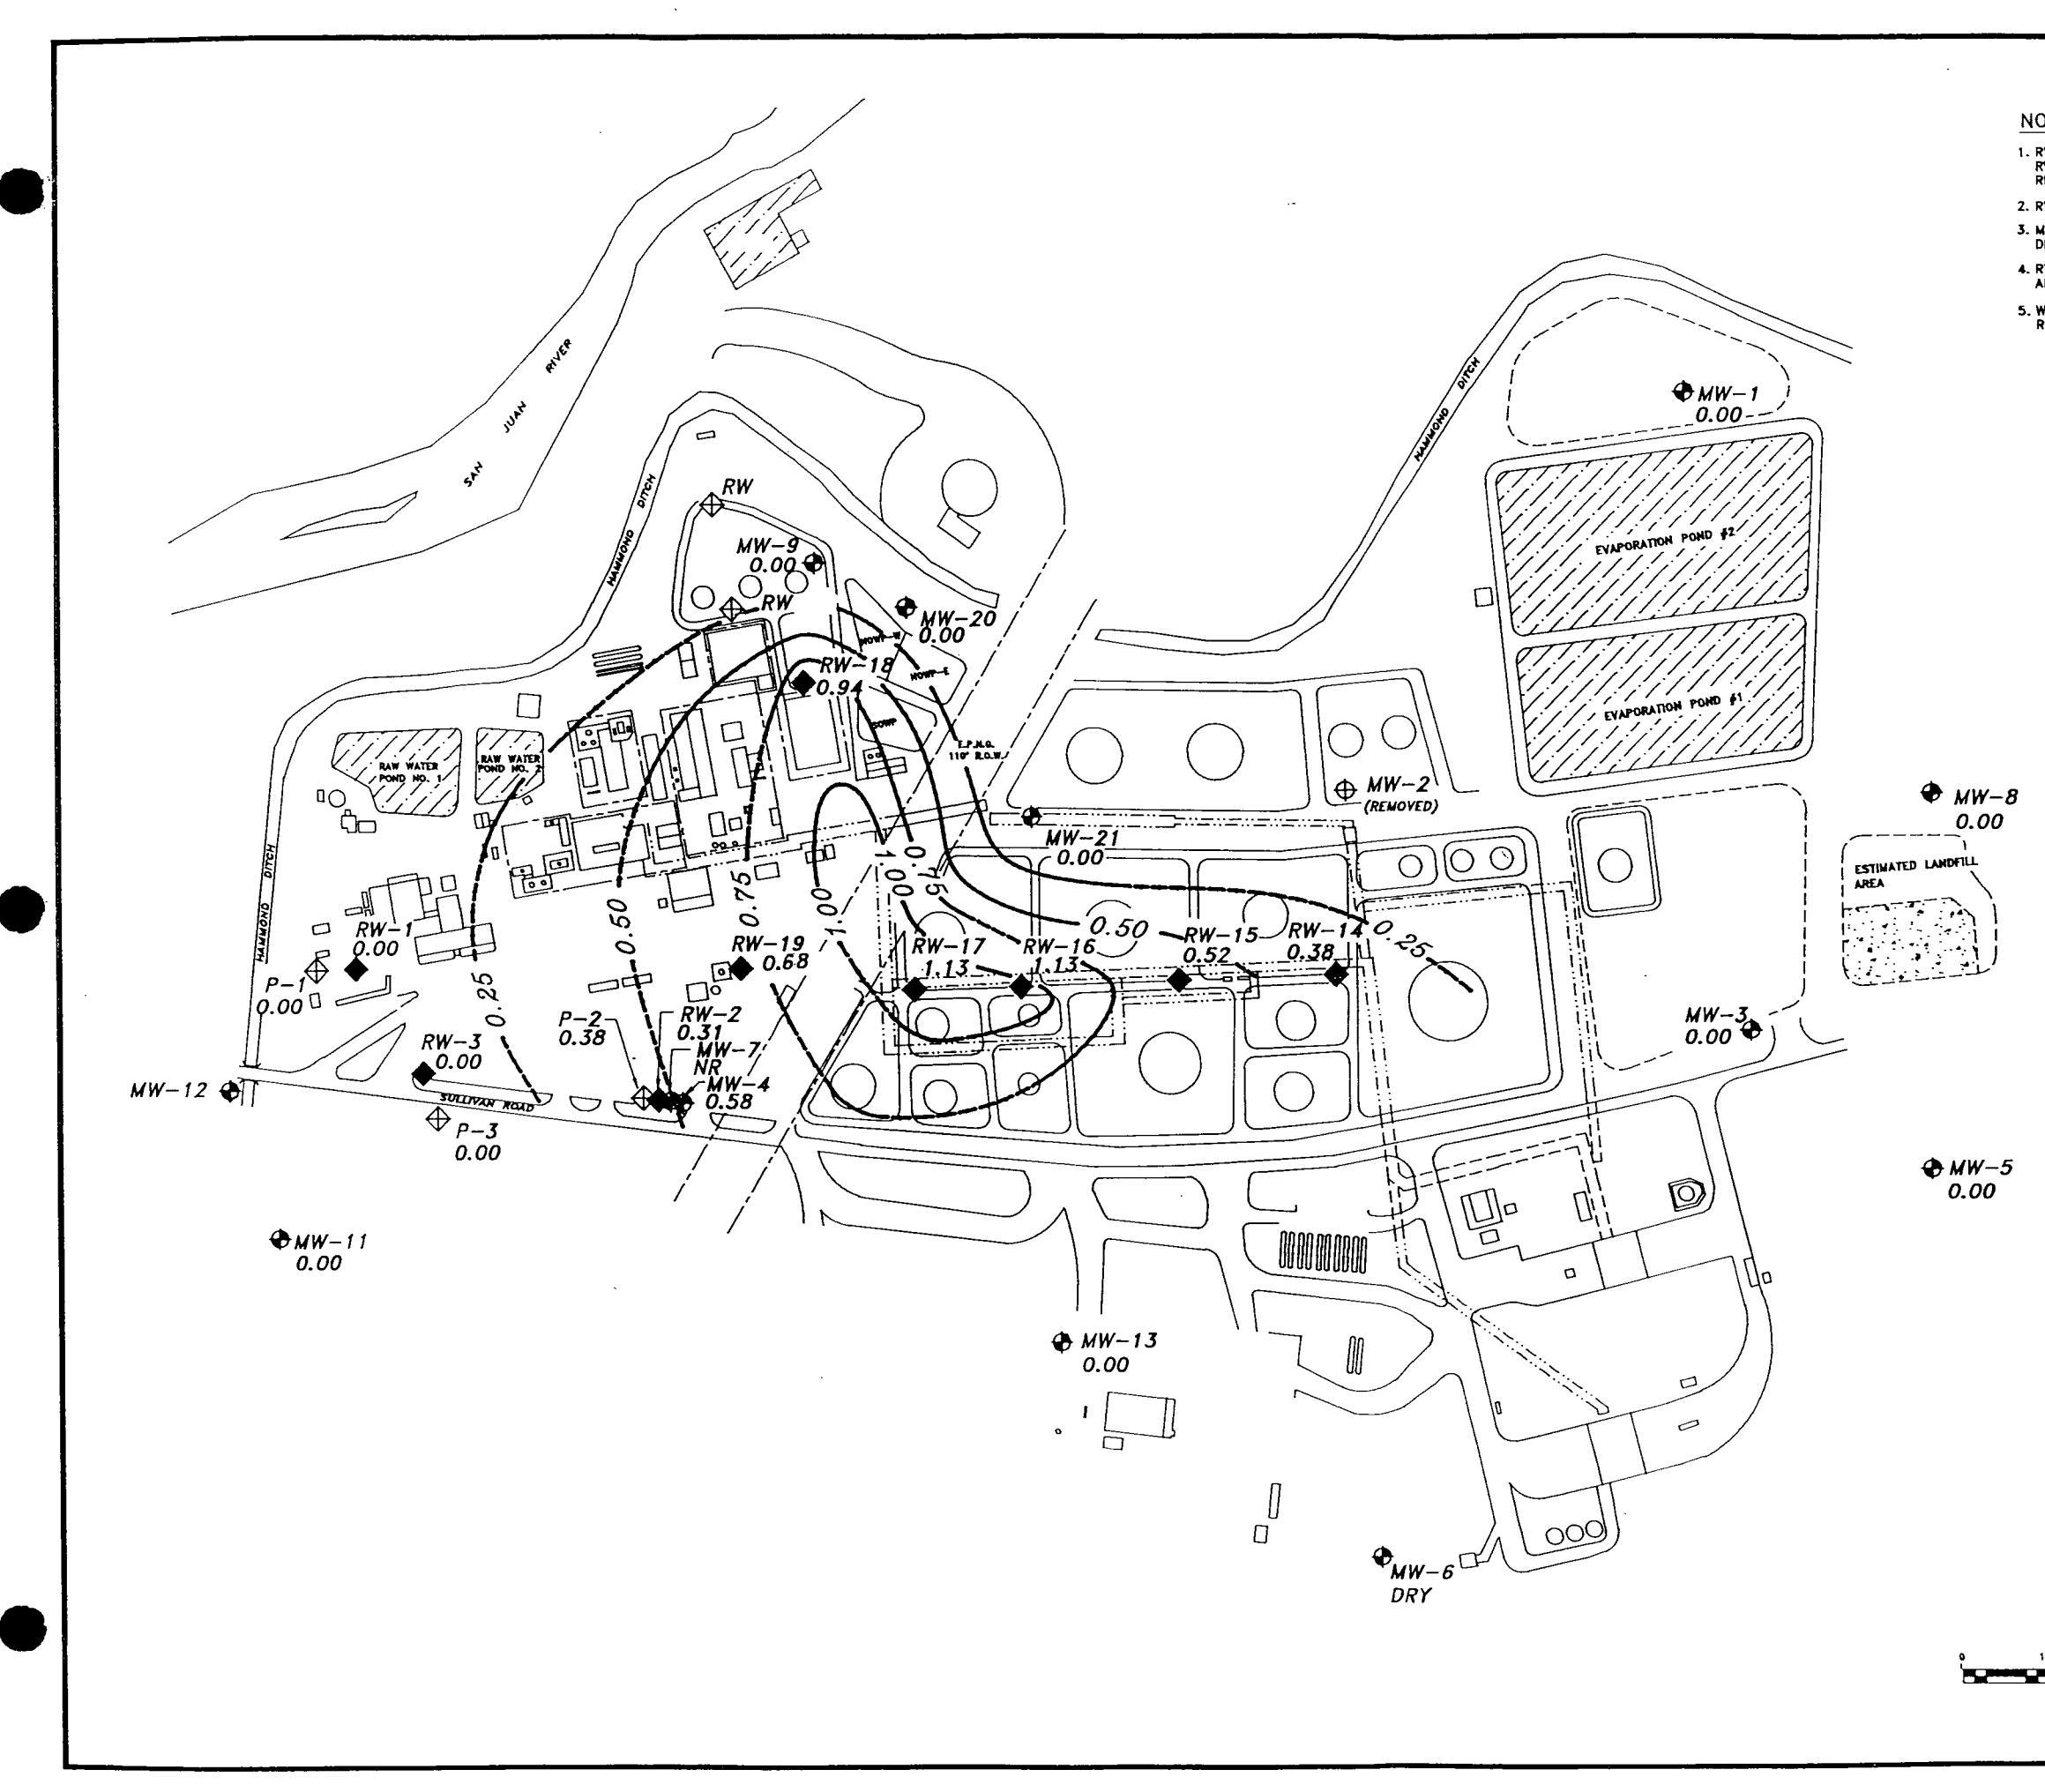
FEBRUARY-1993 SPHC-B5.DWG						
150 225 300 450 750	PROJECT NO.: CONTRACT: 023353014						
(IN FEET) 1 INCH = 300 FEET	DRAWING: REVISION:						
	FIGURE 12

0.00 HTUROCARBON THICKNESS (IN FEET)						
	CONTOUR (IN FEET) CONTOUR INTERVAL = .25 FEET						
	ATTENTION						
	THIS DRAWING AND ANY ATTACHMENTS (DRAWINGS) HAVE BEEN PRODUCED FOR THE SOLE						
	NOT BE USED, REUSED, REPRO DUCED, MODIFIED OR COPIED						
	OUT PRIOR WRITTEN APPROVAL OF GROUNDWATER TECHNOLOGY.						
	CONFIDENTIAL AND PROPRIETARY INFORMATION OF GROUNDWATER TECHNOLOGY, INC ANY UNAUTH- ORIZED USE OF THIS DRAWING IS STRICTLY PROHIBITED.						
	SIGNATURE DATE						
	PROJECT GEO:						
	PROJECT ENGR:						
	PROJECT MGR:						
	CLIENT:						
	Bloomfield Refining						
	Company A Gary Energy Corporation Subaddary \$50 COUNTY ROAD 4990 BLOOMFIELD, NEW MEXICO						
	GROUNDWATER TECHNOLOGY						
	2501 YALE BLVD. SE. SUITE 204 ALBUQUERQUE, NEW MEXICO 87106 (505) 242-3113						
	SEPARATE PHASE						
Ň	HYDROCARBON ISOPLETH						
	DESIGNED DRAFTED CHECKED BY: BY: BY:						
l l l l l l l l l l l l l l l l l l l	DATE: FILE:
