# SPILL REPORT & CLOSURE

Subject: Hobbs Service Yard-Waste Disposal

Hobbs Yard Spill Site Report Lea County, New Mexico

### SITE INSPECTION SHEET

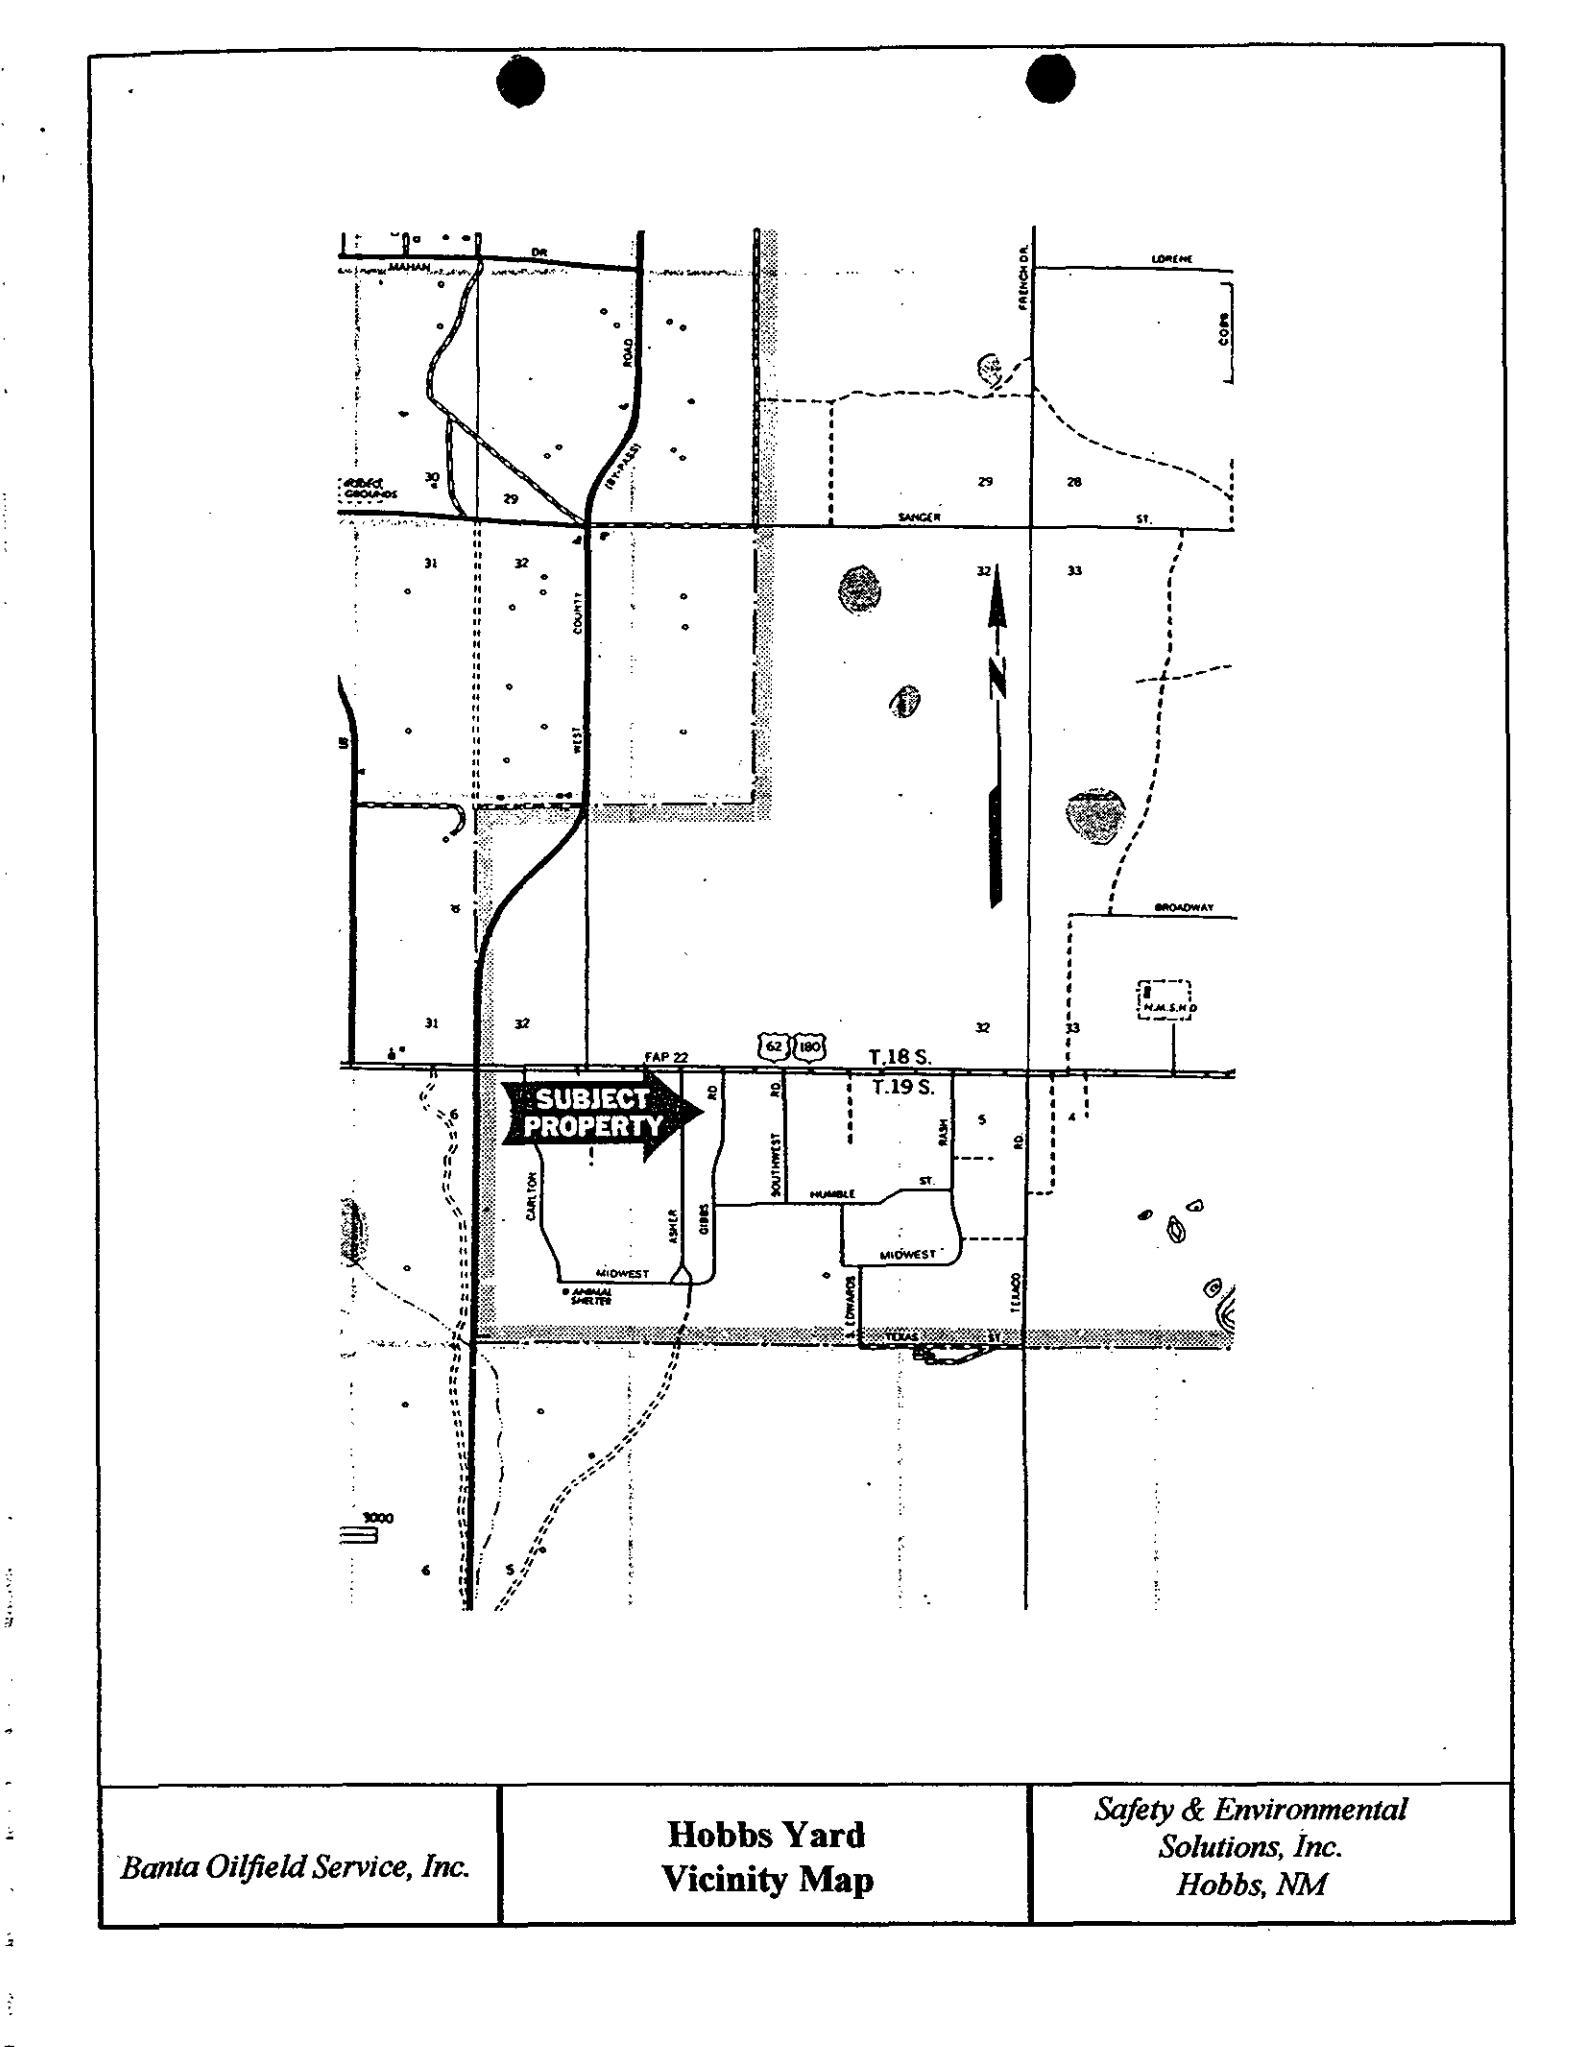
# Vicinity Map

The spill site is in the yard of Banta Oilfield Service at 2807 West Marland, in Lea County, New Mexico. The leak area is situated on a relatively level site. (Vicinity Map)

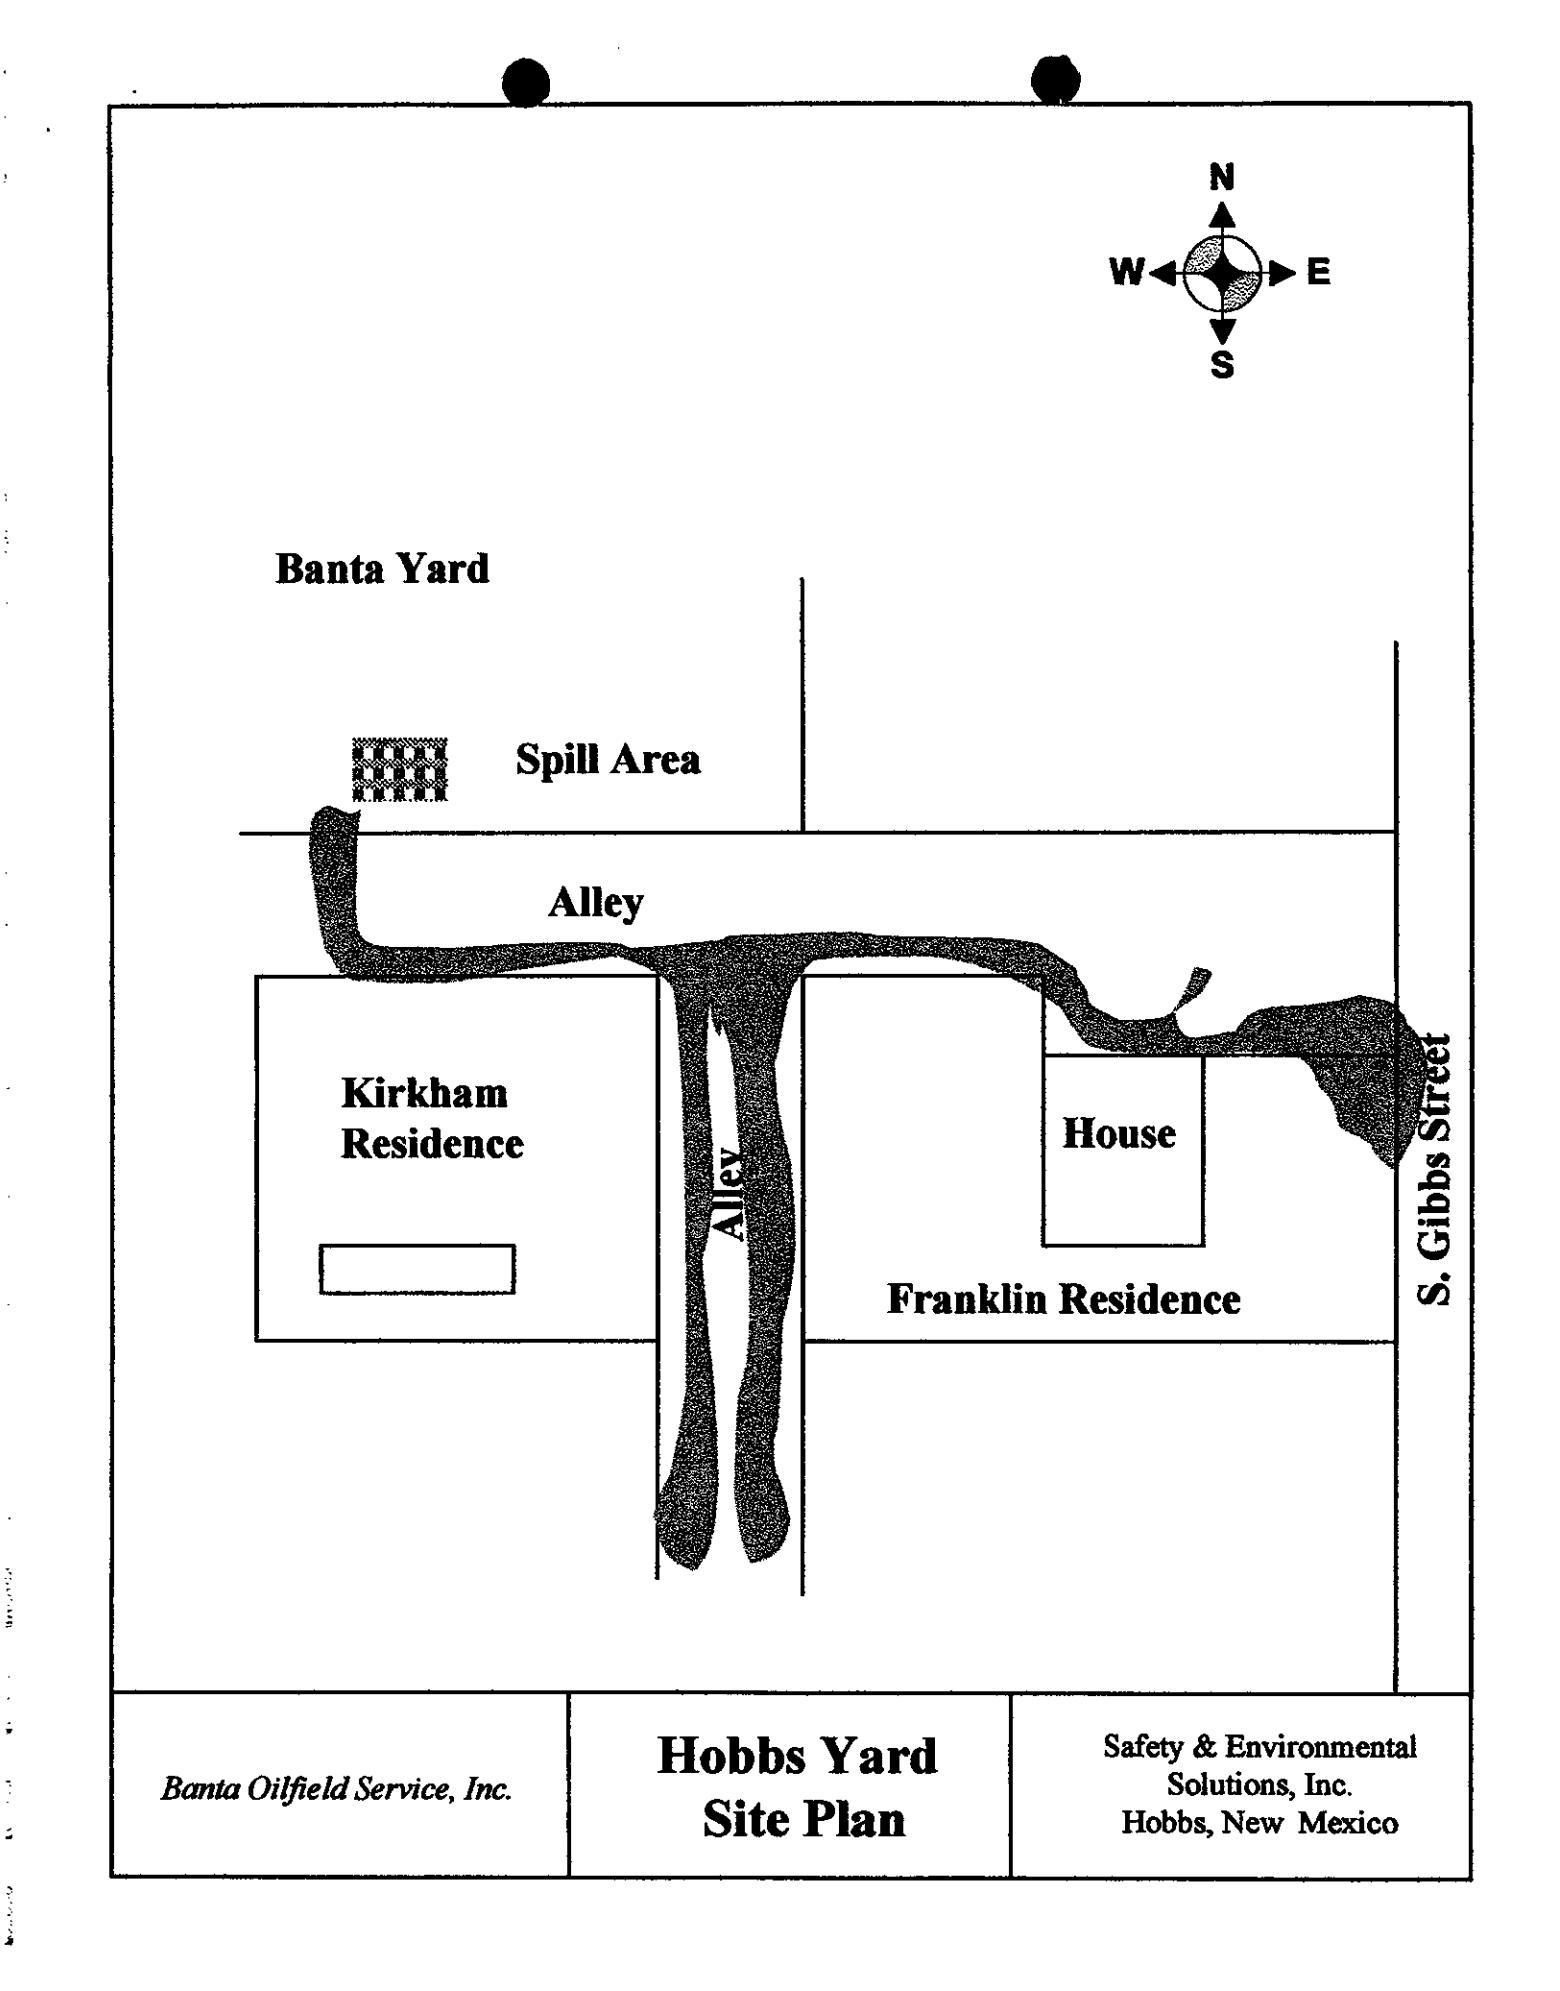
# Site Plan

A spill occurred at the south edge of the Banta yard when rainwater caused the overflow of an out of service used oil tank. This resulted in the discharge of a small amount of oil and water that ran along the ground through the fence and onto the adjacent alley and two private properties.

The overflow from the tank resulted in a used oil/water emulsion being discharged in a small stream adjacent to the fence-line and around the tank.

The tank overflow caused seepage around the tank and then fluid ran along the adjacent alley and into the grass at two private residences. The area underneath the tank was excavated and investigated for contamination.

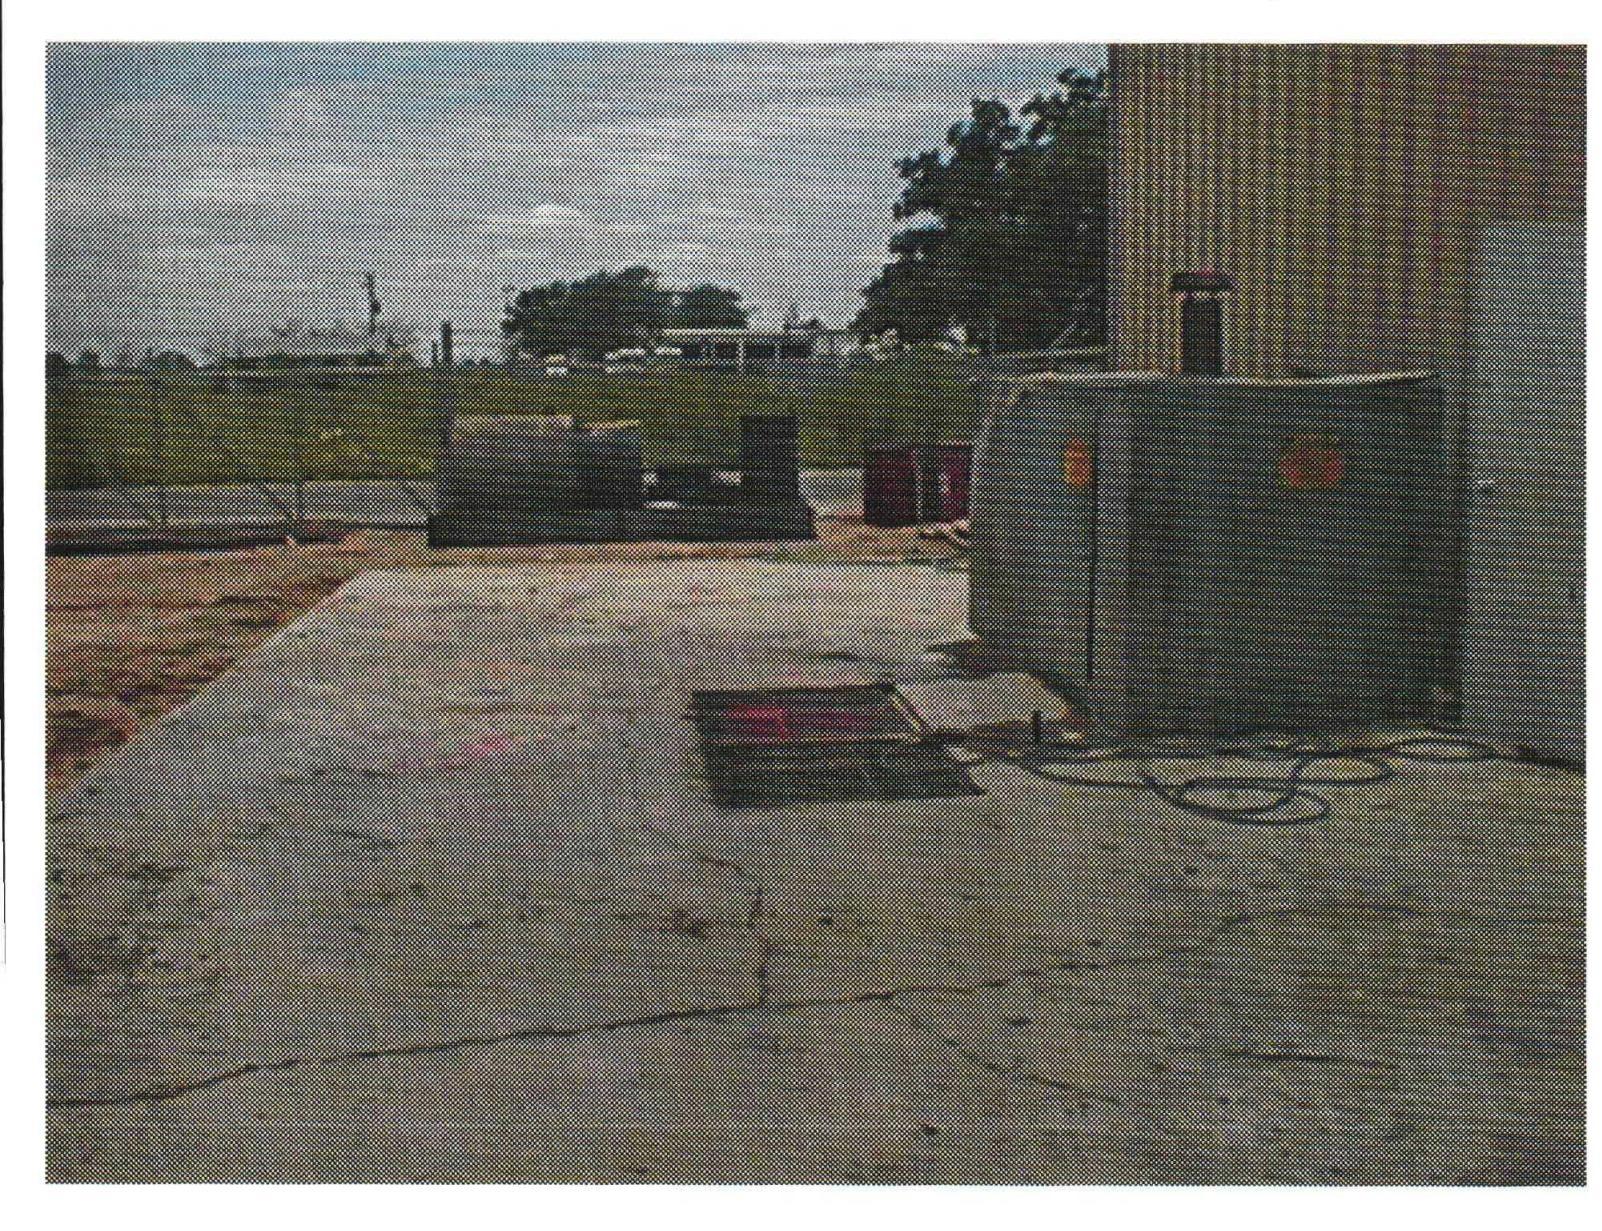
#1

Banta OilField Service Inc. 2807 W Marland-Hobbs NM Taken 6/17/99 By: W Price-OCD
