April 17, 2023

Re: Release Characterization and Closure Request ConocoPhillips Heritage Concho White Falcon 16 Federal CTB Release Unit Letter C, Section 16, Township 25 South, Range 35 East Lea County, New Mexico Incident ID# nCH1821232087

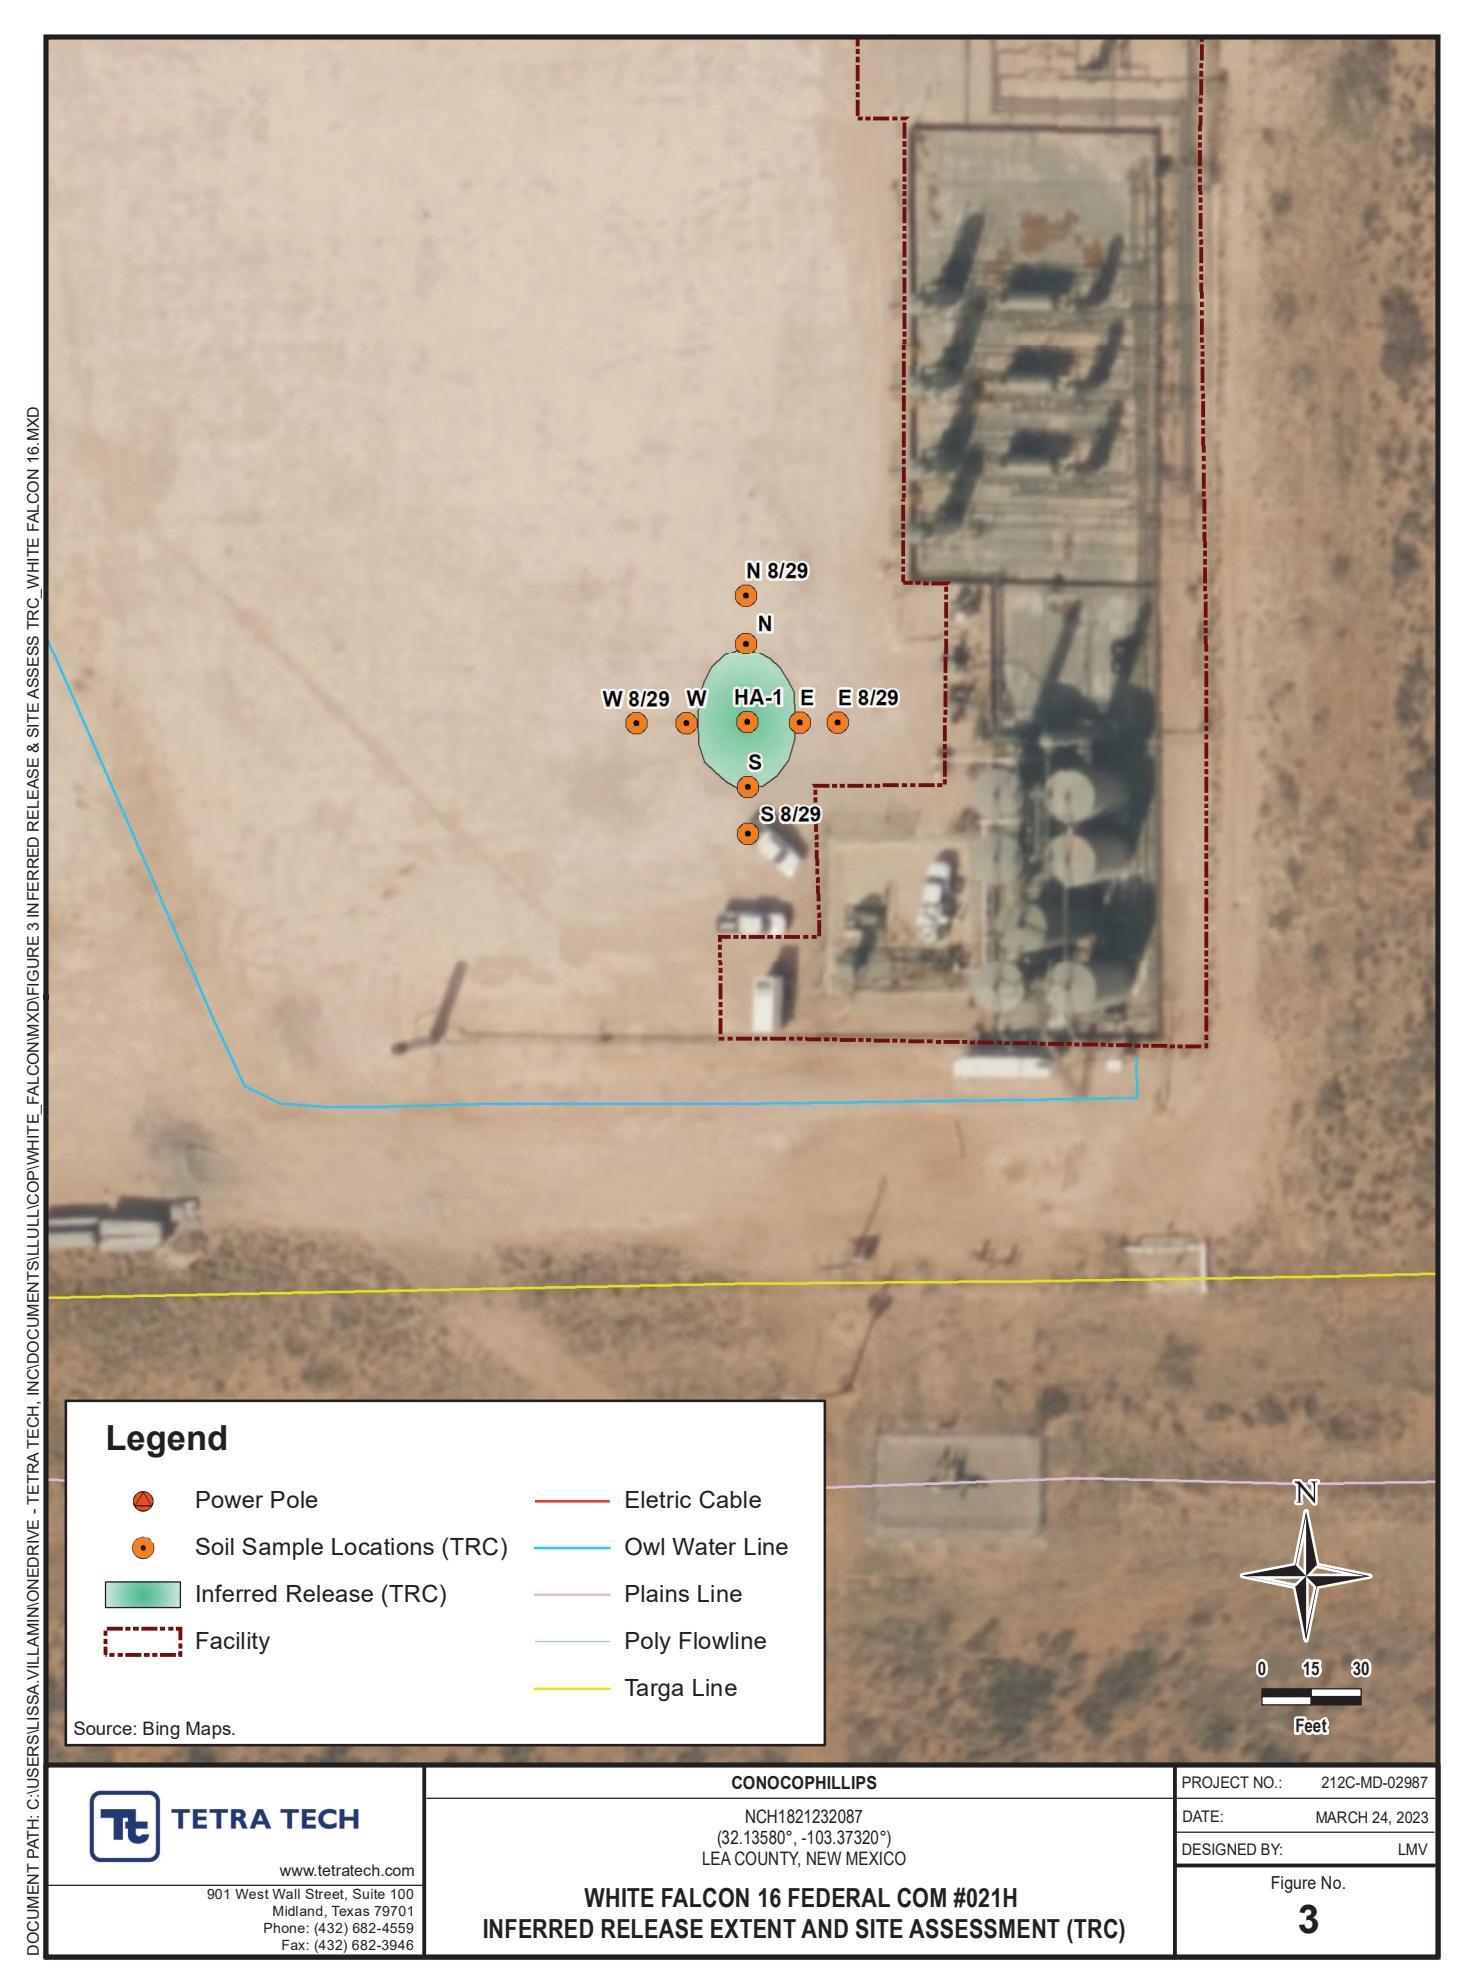
Figure 3 – Inferred Release Extent and Site Assessment (TRC)

On August 6, 2018, TRC Environmental Corporation (TRC) conducted an initial soil assessment at the Site on behalf of Concho. The approximate release extent provided by TRC is presented in Figure 3.

During the initial assessment, one (1) soil boring (HA-1) was installed using a hand auger to a depth of 1 foot bgs within the release extent. Two (2) samples (HA-1 @ 6" and HA-1 @ 1') were collected from the hand auger boring in an attempt to achieve vertical delineation of the release extent. Four (4) soil samples (N @ 6", E @ 6", S @ 6", and W @ 6") were collected from the inferred edges of the release margins in an effort to determine the horizontal extent of soil impact. The six (6) samples were submitted to Xenco Laboratories in Midland, TX to be analyzed for BTEX via EPA Method 8021B, TPH via EPA Method 8015M, and chloride via EPA Method 300.0.

TRC returned to the Site on August 29, 2018 to collect additional soil samples at step-out locations from the horizontal delineation sample locations (N, E, S, and W) to complete horizontal delineation of the release extent. The initial assessment sampling locations are indicated on Figure 4. The initial assessment results are summarized in Table 1.

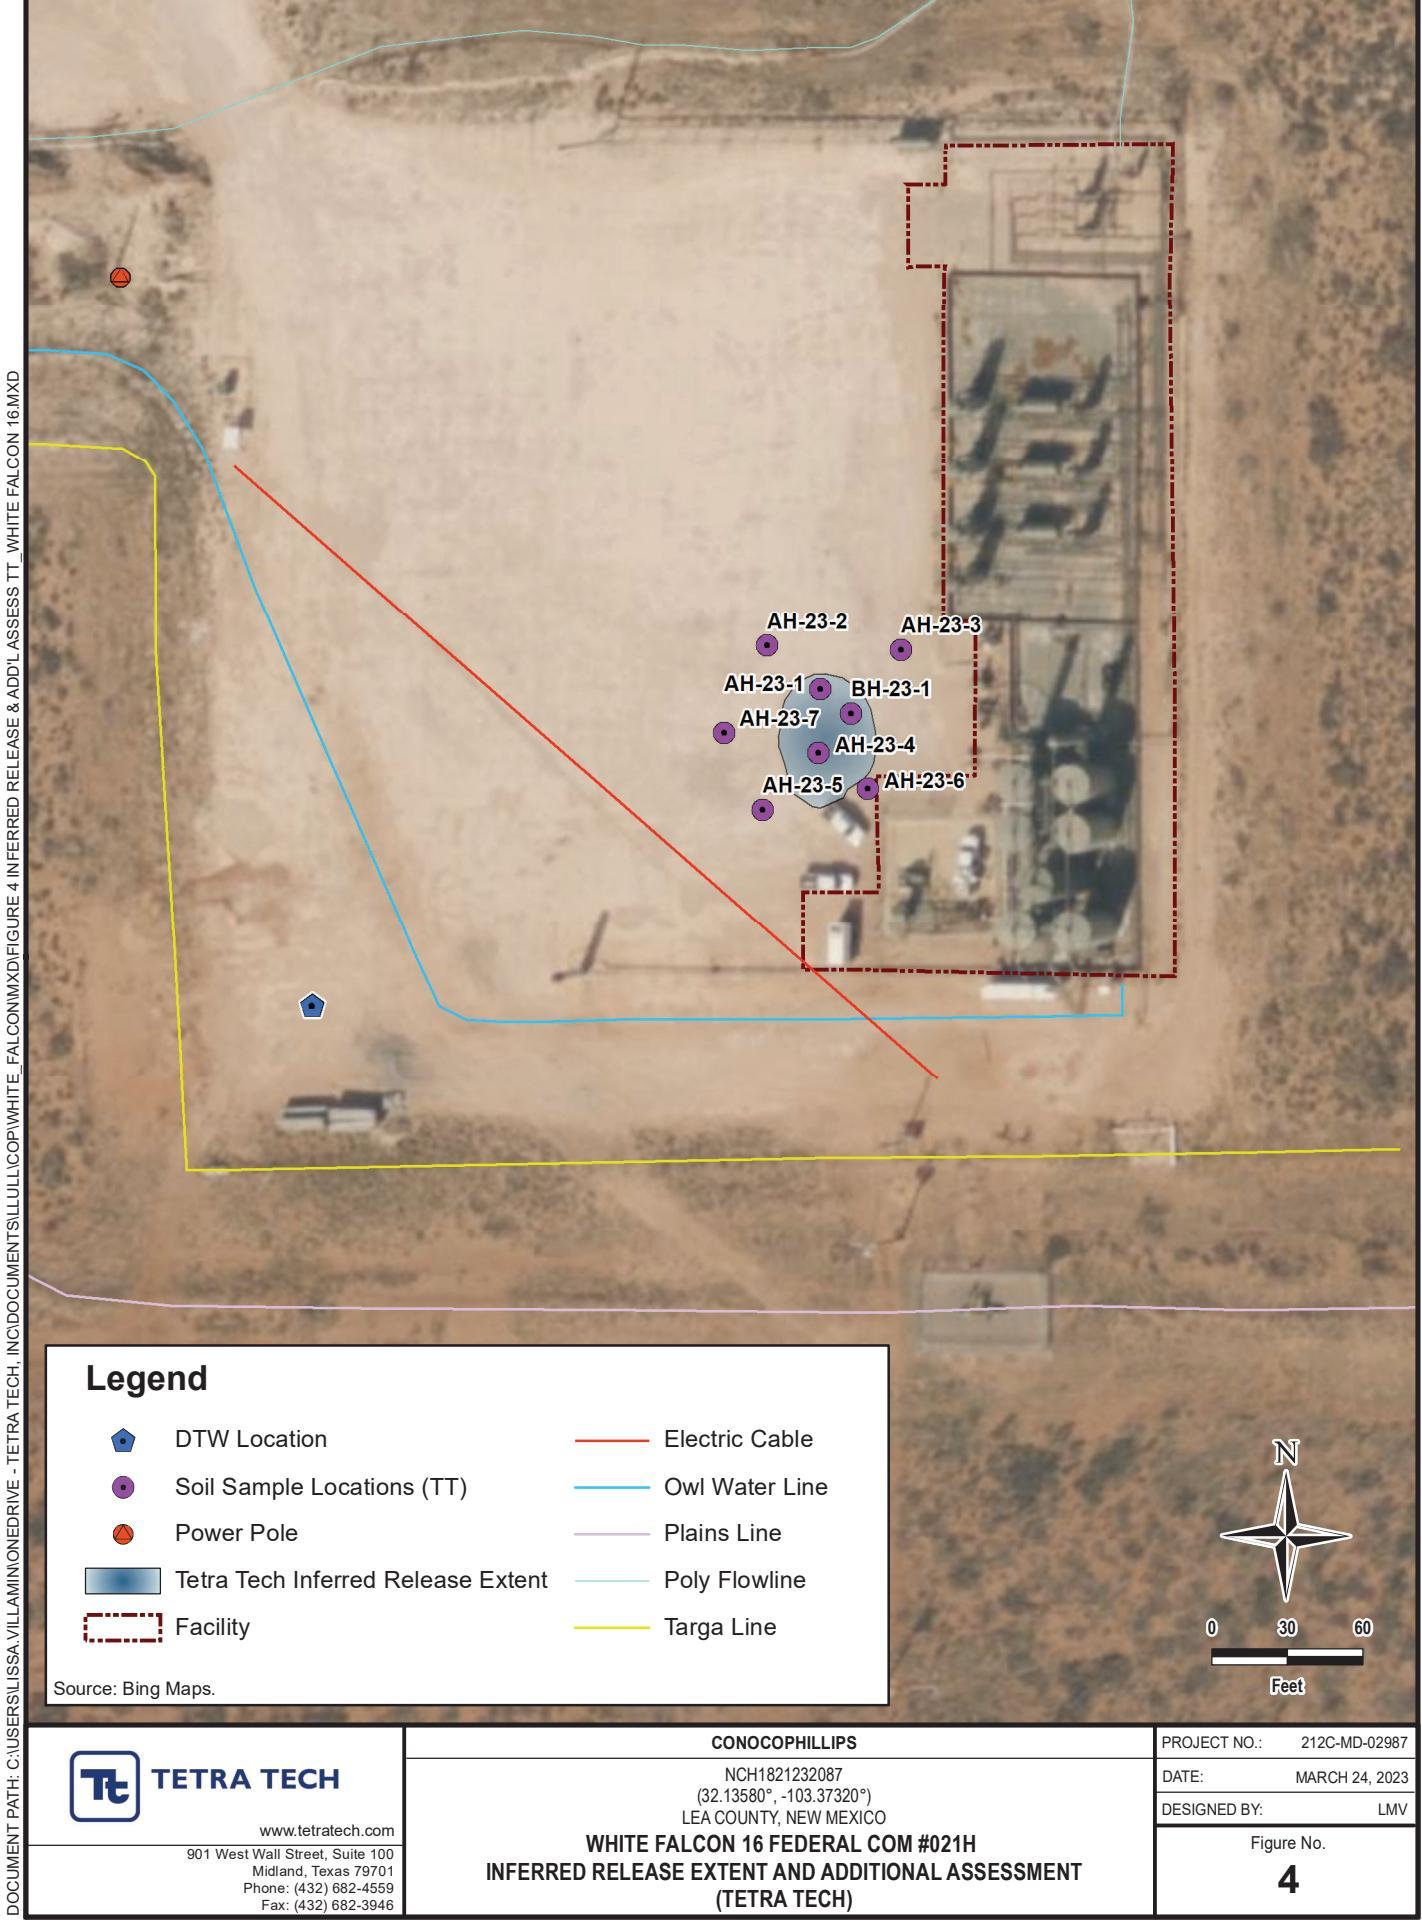
Figure 4 – Inferred Release Extent and Additional Assessment (Tetra Tech)

To comply with the NMOCD directive presented in the November 30, 2022, email rejection, a licensed well drilling subcontractor was onsite on March 3, 2023 to drill a groundwater determination borehole (DTW-1) to 55 feet bgs in the southwestern corner of the White Falcon 16 Federal CTB lease pad, located approximately 220 feet southwest of the release Site. The borehole location is indicated on Figure 3. The borehole was temporarily set and screened using 2-inch PVC well materials: 20 feet of blank casing and 35 feet of 0.010-inch slotted screen. The borehole was left for 72 hours and checked for the presence of groundwater. The borehole was dry upon drilling, and no water was present in the well after 72 hours. The well screen and casing were removed, and the borehole was plugged with 3/8-inch bentonite chips. The site characterization data and boring log are presented in Appendix C. The DTW location is indicated in Figure 4.

Based on the directive provided by NMOCD, Tetra Tech was onsite on March 1, 2023, to conduct assessment activities on behalf of ConocoPhillips. One additional assessment boring (BH-1) was installed using an air rotary drill rig within the release footprint to 10 feet bgs to complete vertical delineation of the release extent. Six additional hand auger borings (AH-23-1 through AH-23-6) were installed to 1 feet bgs within and around the release footprint.

On March 20, 2023, Tetra Tech personnel returned to the site to complete horizontal delineation of the release. One boring (AH-23-7) was installed using hand auger to 1-foot bgs. The sample locations are shown on Figure 4.

Analytical results from the 2023 assessment activities are summarized in Table 2. All analytical results were below the Site RRALs for all constituents for on-pad releases.

Based on the site characterization, the remaining soils on the production lease pad meet the closure criteria of Table I of 19.15.29.12 NMAC. All analytical results associated with the 2023 assessment results were below the Site RRALs; therefore, no remediation of the release footprint is necessary.
