Site Assessment/Characterization

Based on laboratory analytical results and field activities conducted to date, Etech recommends Goodnight provide copies of this *Remediation Summary & Soil Closure Request (Amended)* to the appropriate agencies and request closure be granted to the Tanks CRP Inlet release site.

#### Basic Data Report for Drillhole SNL-15 (C-3152) DOE/WIPP-05-3325

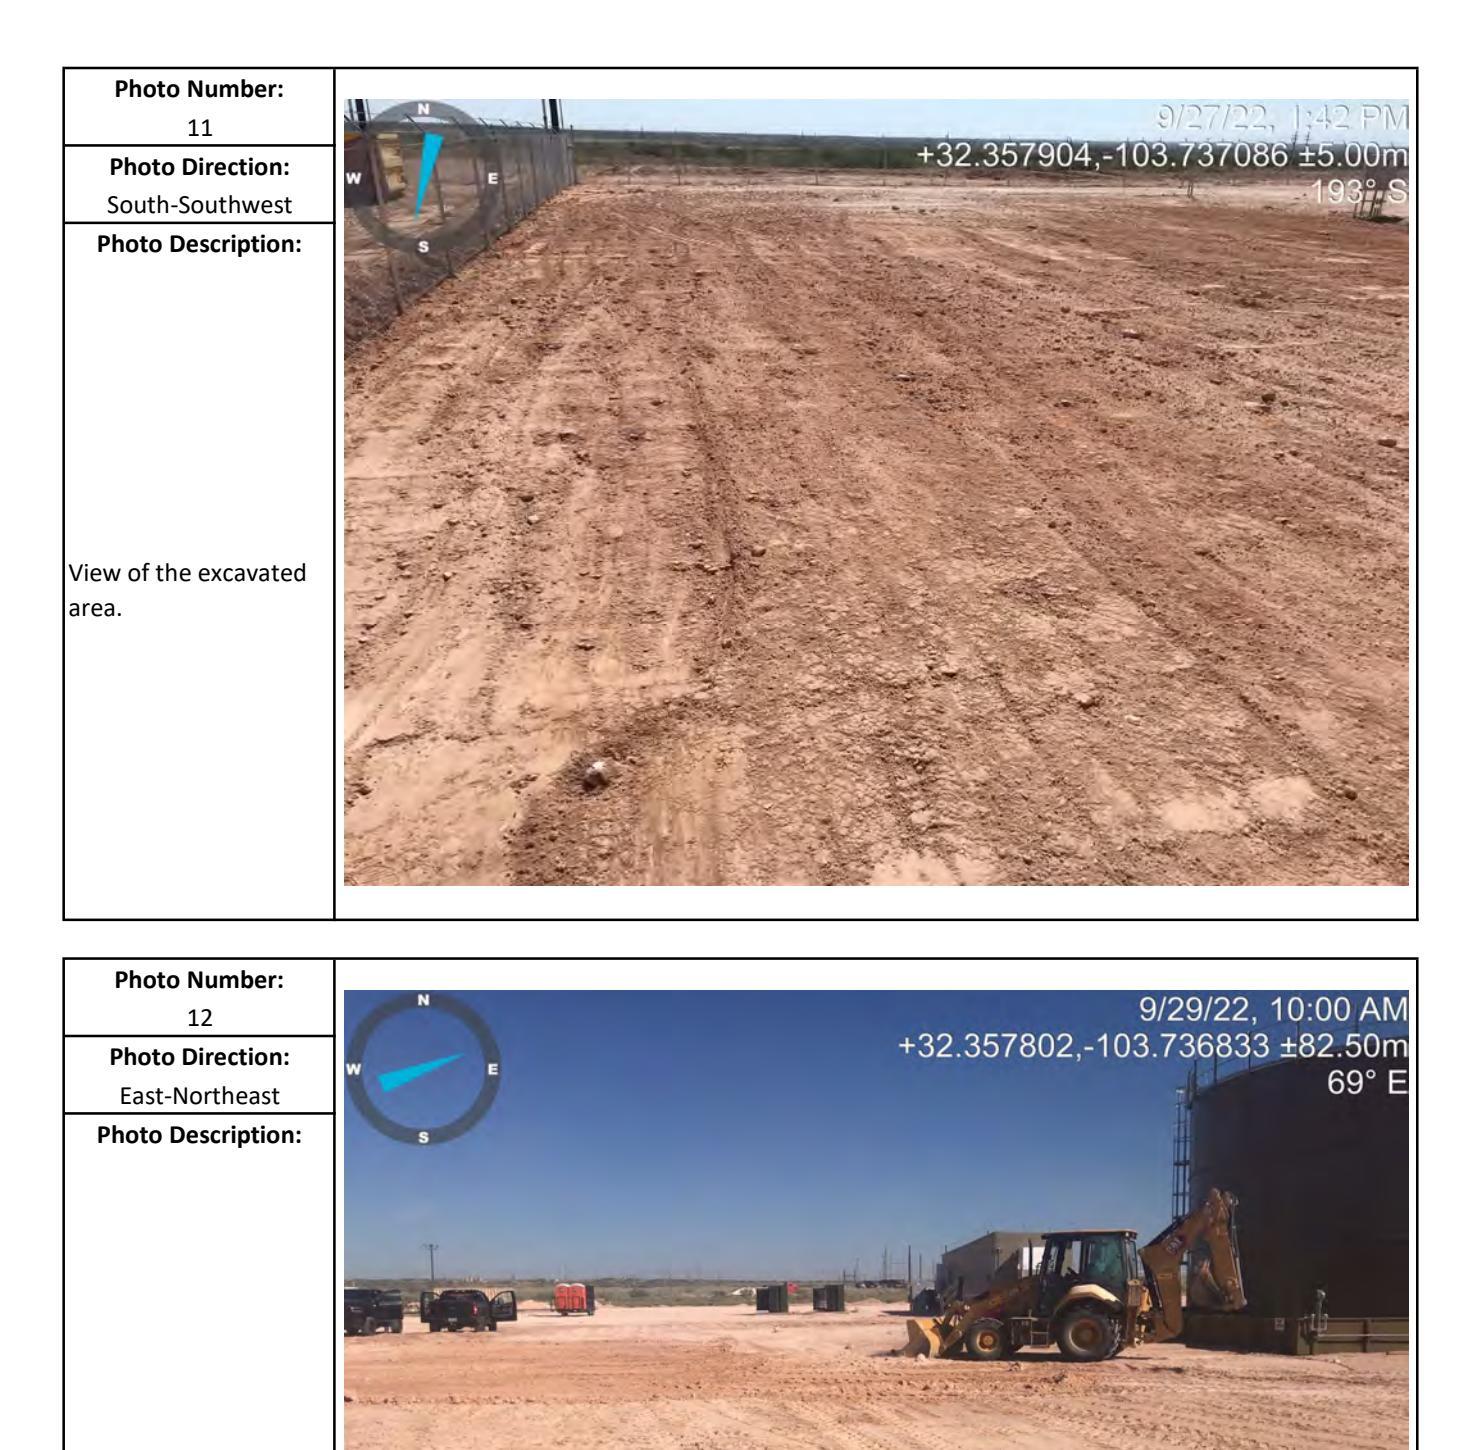
View of the excavated area.

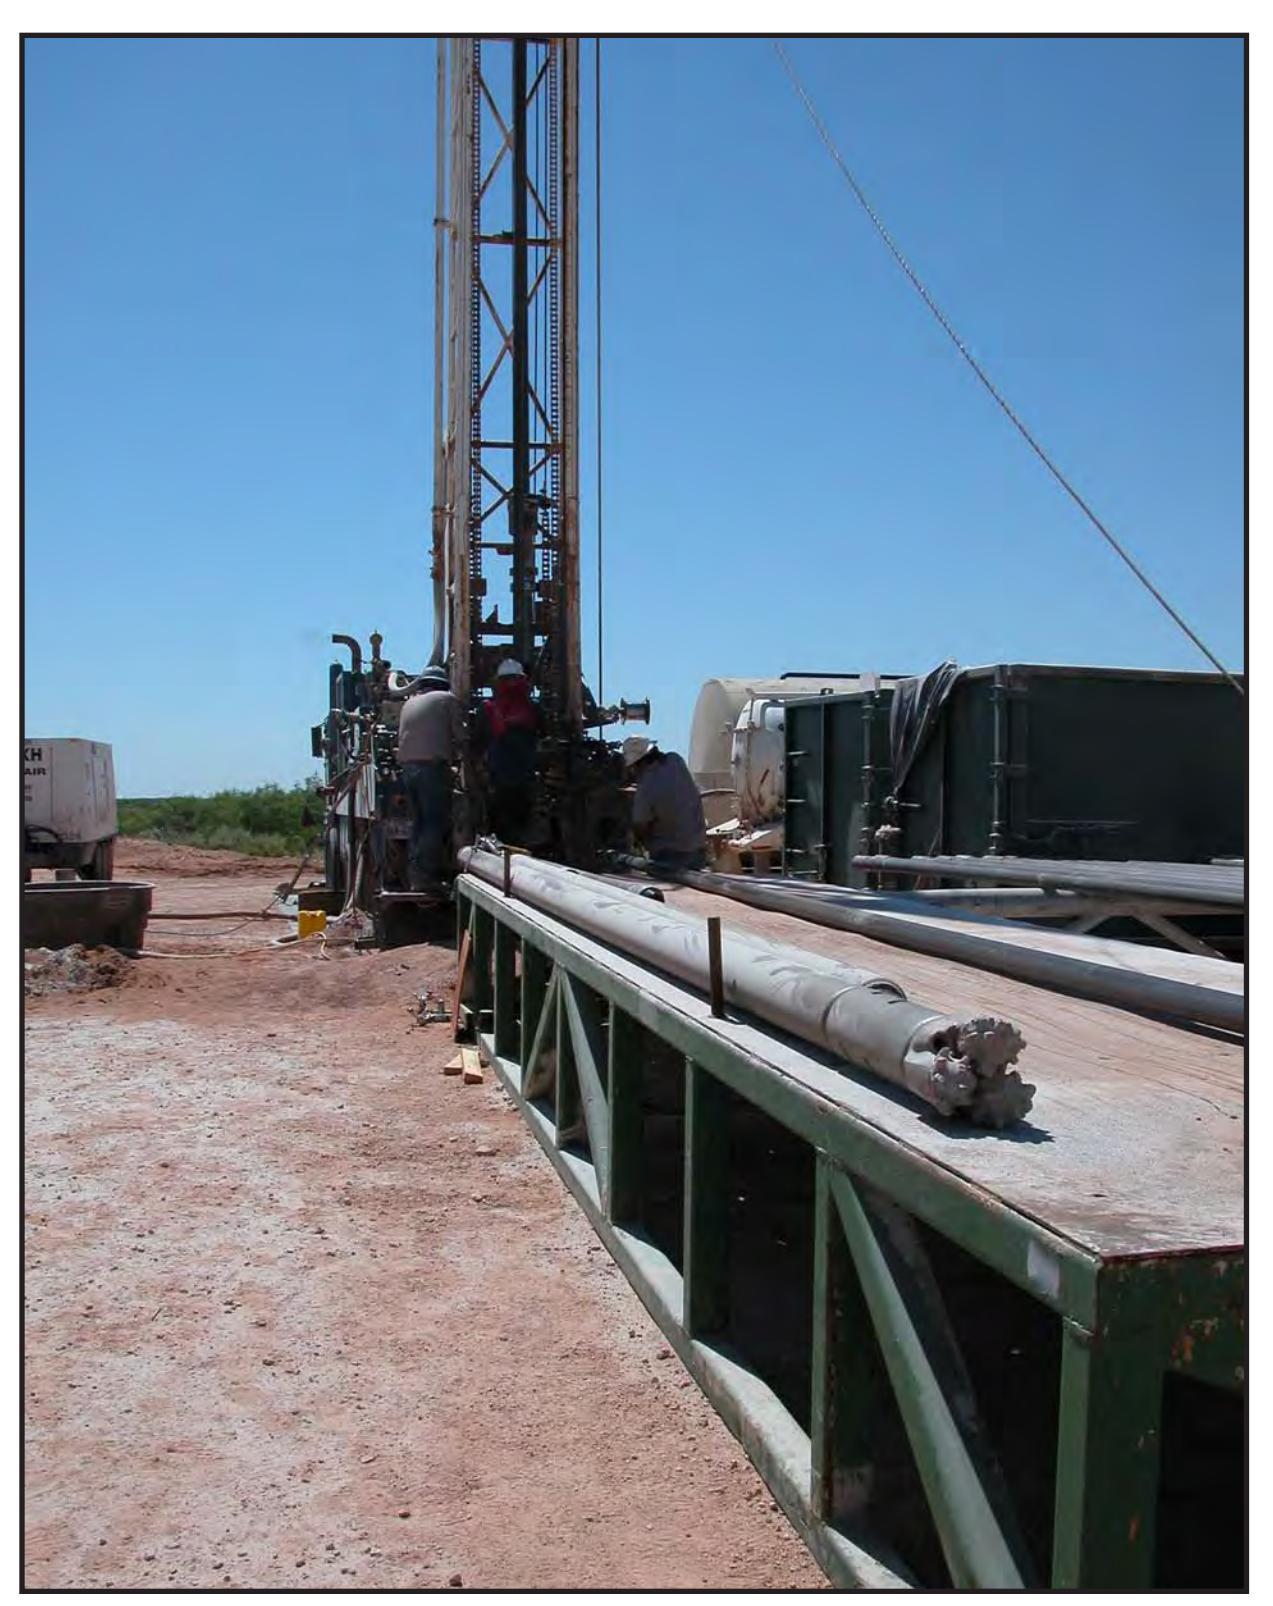
West Texas Water Well Service, Rig #15 at SNL-15, viewed toward the west. The 7.875-inch rotary bit has been laid down, and the crew is tripping in to begin coring using compressed air. Photo taken June 5, 2005, by Dennis W. Powers.

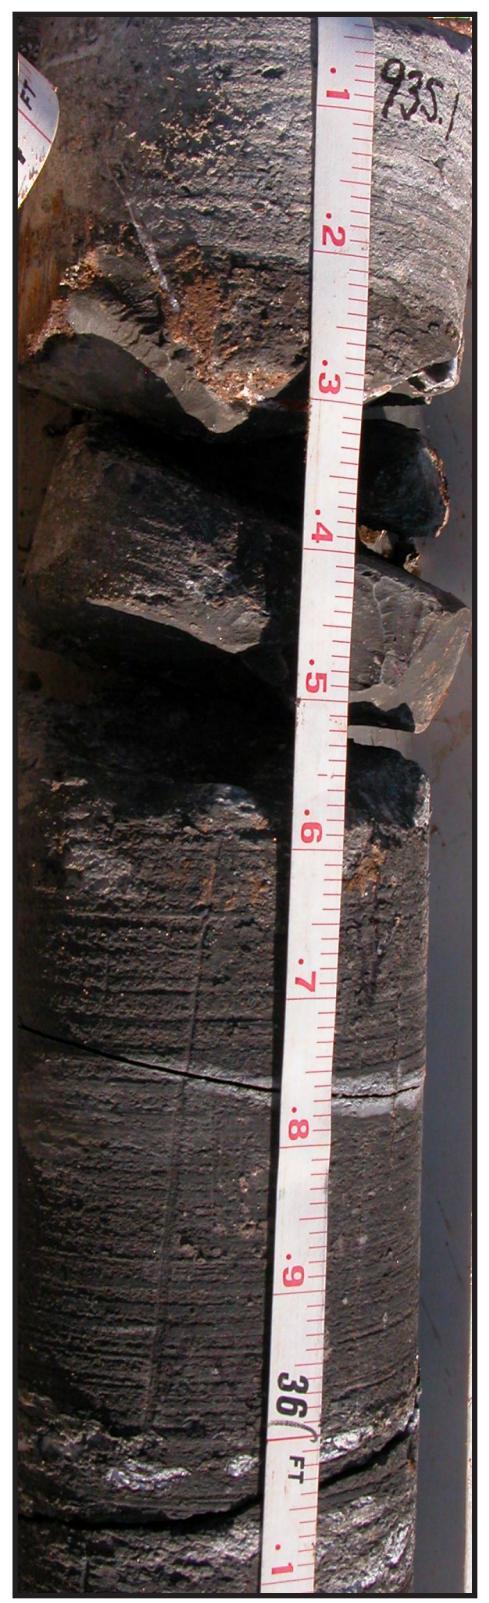
The upper 2.9 ft of M-2 consists of gray (5Y5/1) to dark gray claystone (5Y4/1) (Fig. 2-4) that shows evidence of thin bedding and laminae that are approximately horizontal. A narrow fracture from 936–937 ft is lled with gypsum and, possibly, halite. Slickensides in some of the claystone are ~50 degrees from horizontal. The contact at 935.4 ft with the Culebra is sharp and undeformed.

lled pores or spheres appear to be distributed through the lower Culebra, but they are to interpret or describe because they are visible Figure 2-4. Gray Claystone (M-2) and Overlying Culebra Dolomite

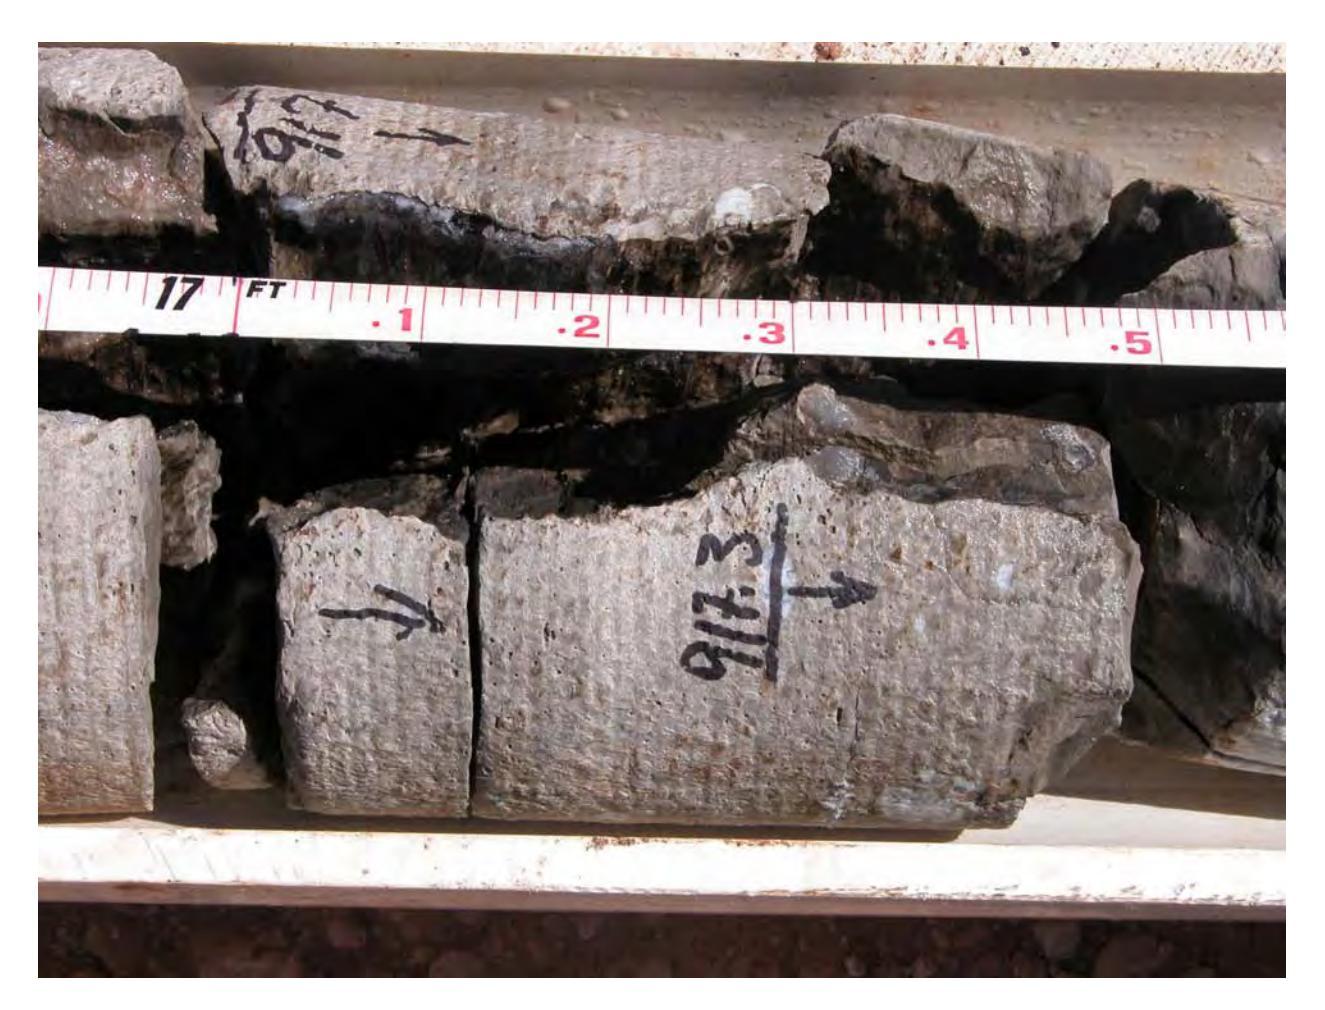
Figure 2-6. Halite on Fracture in Culebra Dolomite. The fracture shows black staining under the clear halite that coats much of the surface. Core has a 4-inch diameter.

The dolomite recovered in core from SNL-15 is generally light gray (5Y7/2) to pale yellow (5Y8/3). The Culebra at SNL-15 is thin bedded to laminar (Fig. 2-5). No open vugs were observed. Nodules are variable in size, ranging to ~2 inches, and are distributed through the unit. Nodules were composed of anhydrite with some probable gypsum. Some pore space associated with nodules also was lled with halite (Fig. 2-6). Very tiny

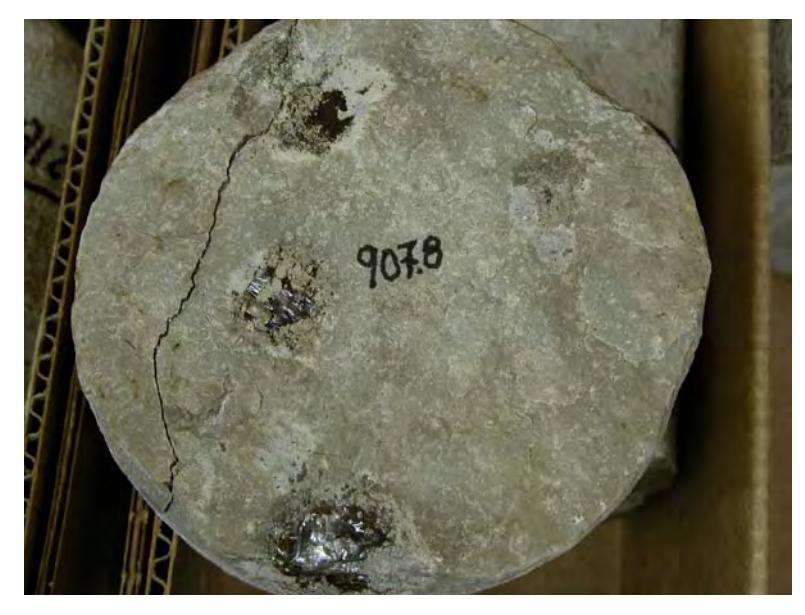
Figure 2-7. Halite in Culebra at 907.8 ft. Halite (dark, clear

Core is 4 inches across.

Subvertical fractures occur mainly between ~917 and 925 ft, and they are filled with halite (Fig. 2-7). The fractures generally have separations less than 0.25 inch.

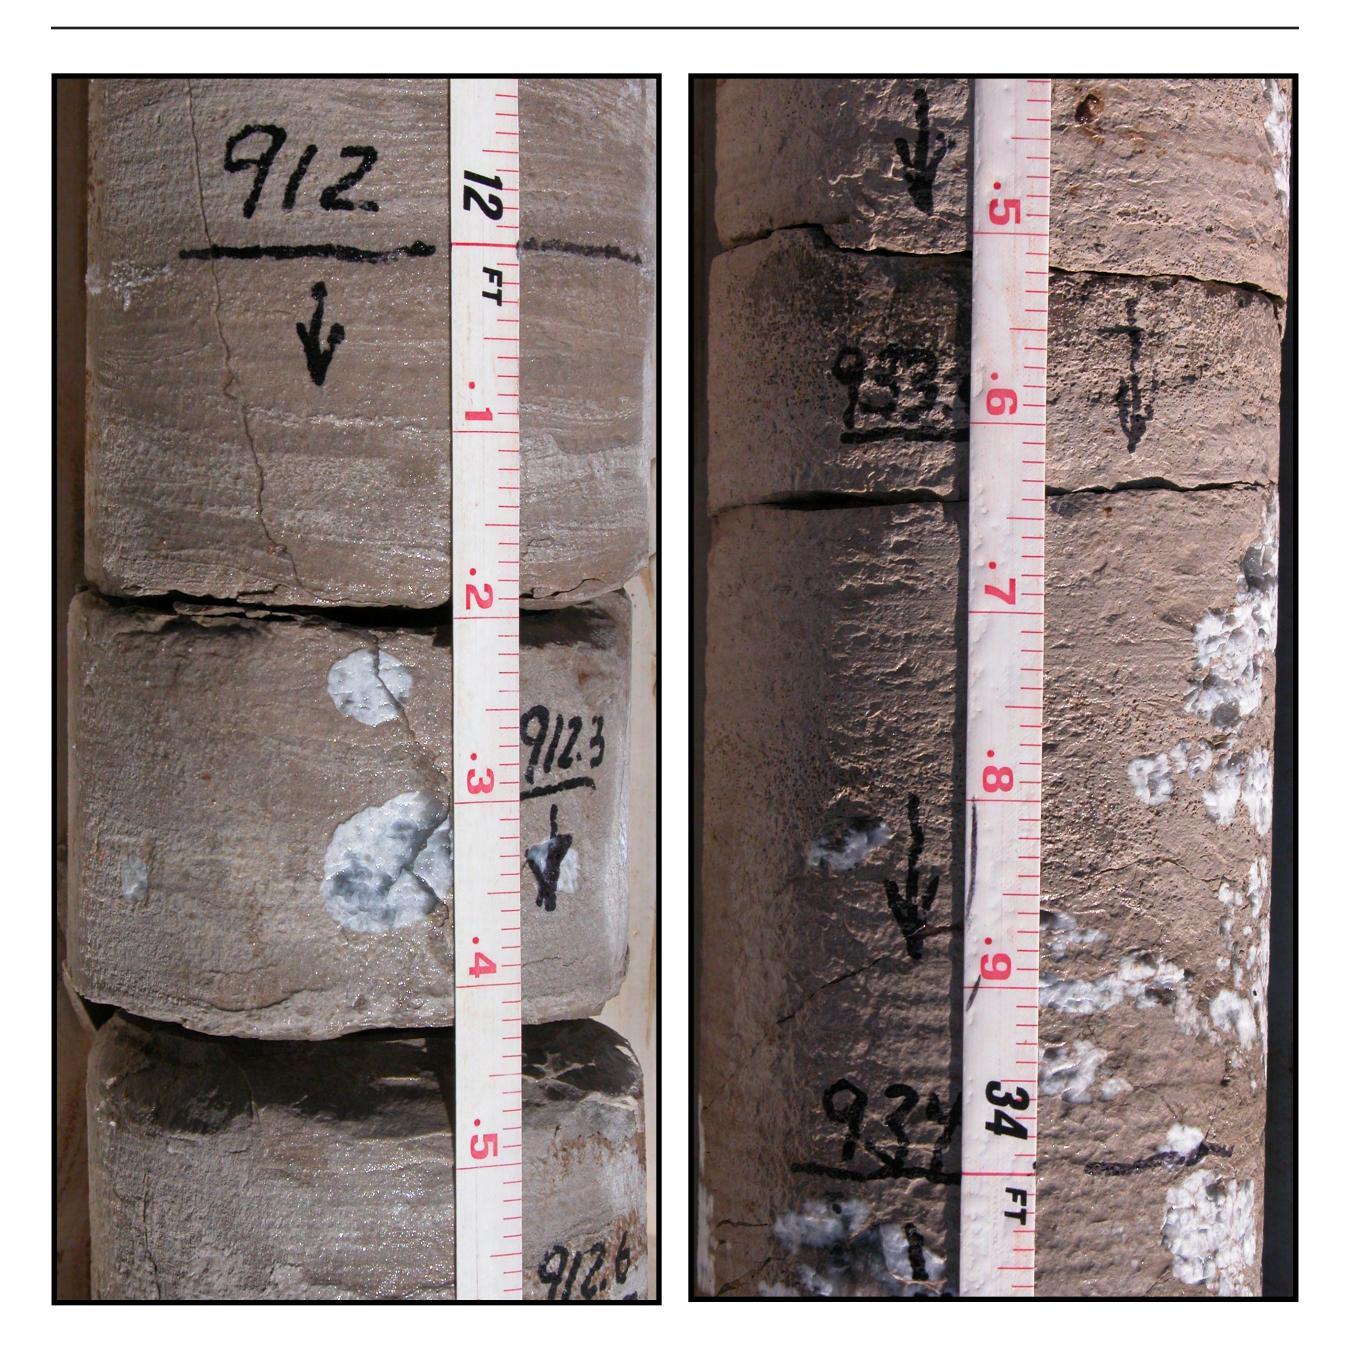
Core photographs of Culebra Dolomite from SNL-15 representing middle (left) and lower (right) portions of the member, which has very low permeability. V

across. Photographs by Dennis Powers on 6/5/2005. These photographs are not referred to in the text.

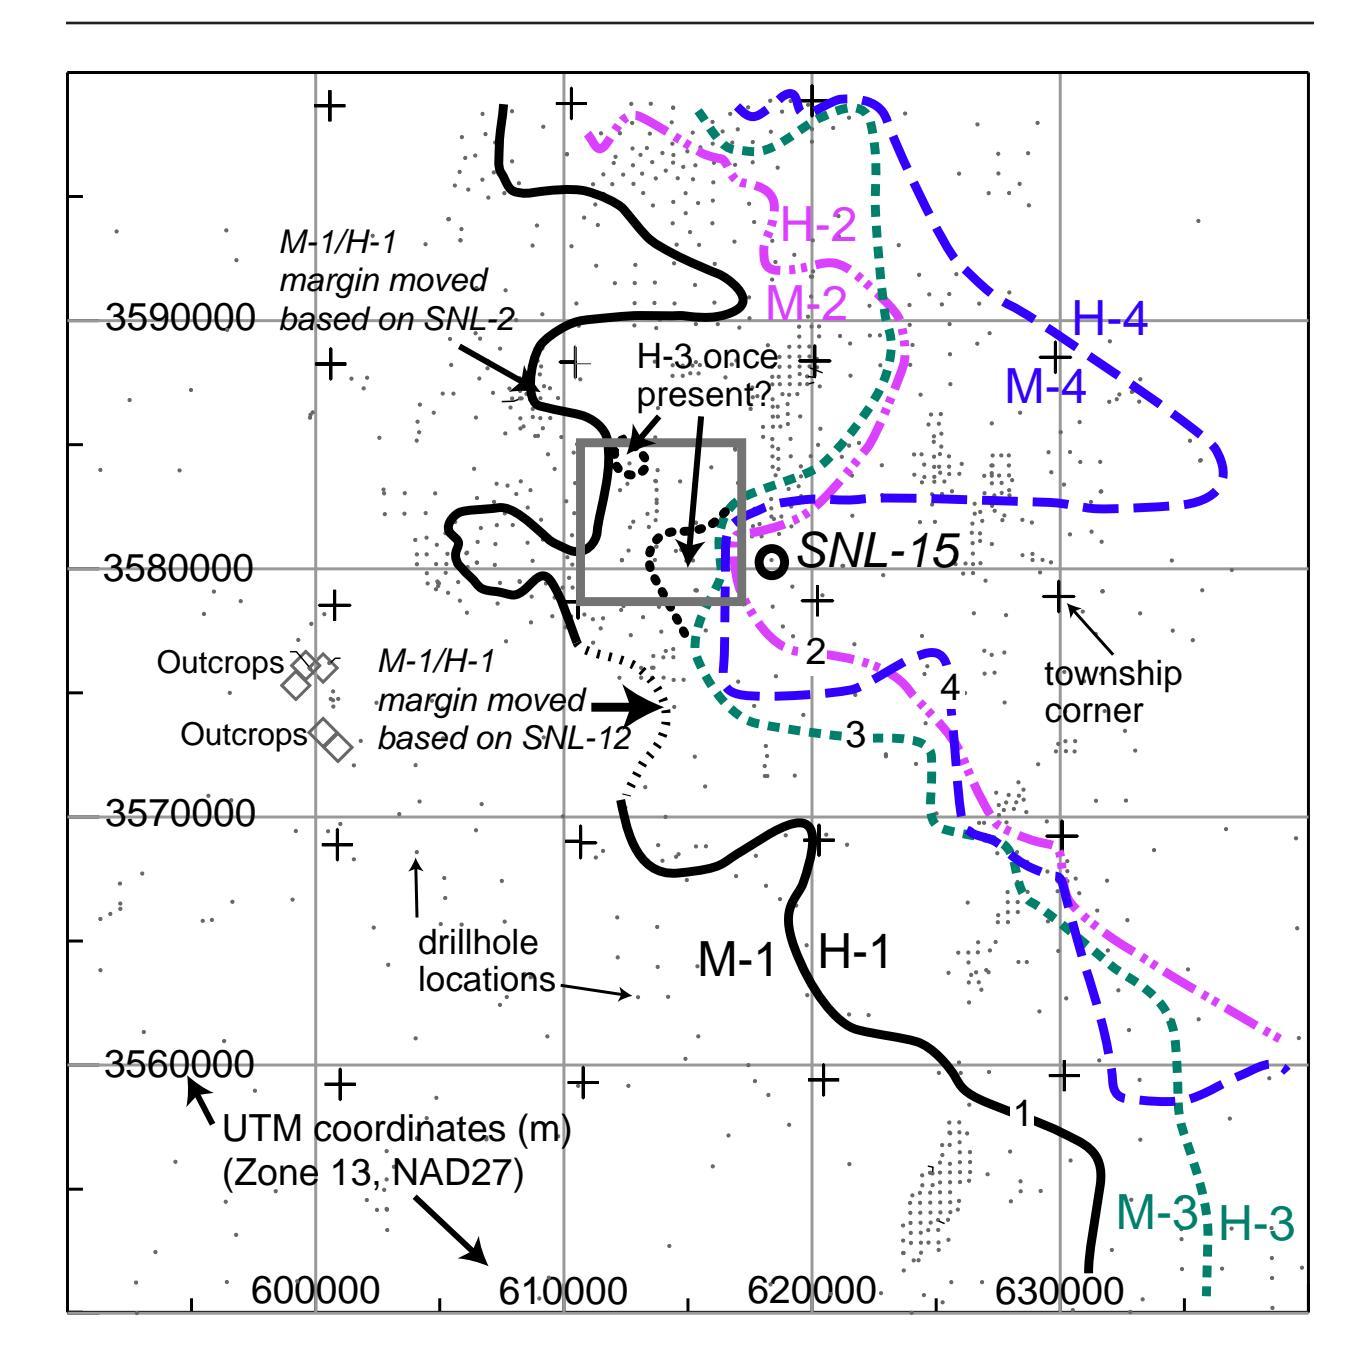
Figure 4-1. Rustler Halite Margins Near SNL-15. Halite is present east of the margins shown. SNL-15 was located in an area where Culebra transmissivity was expected to be low and halite is

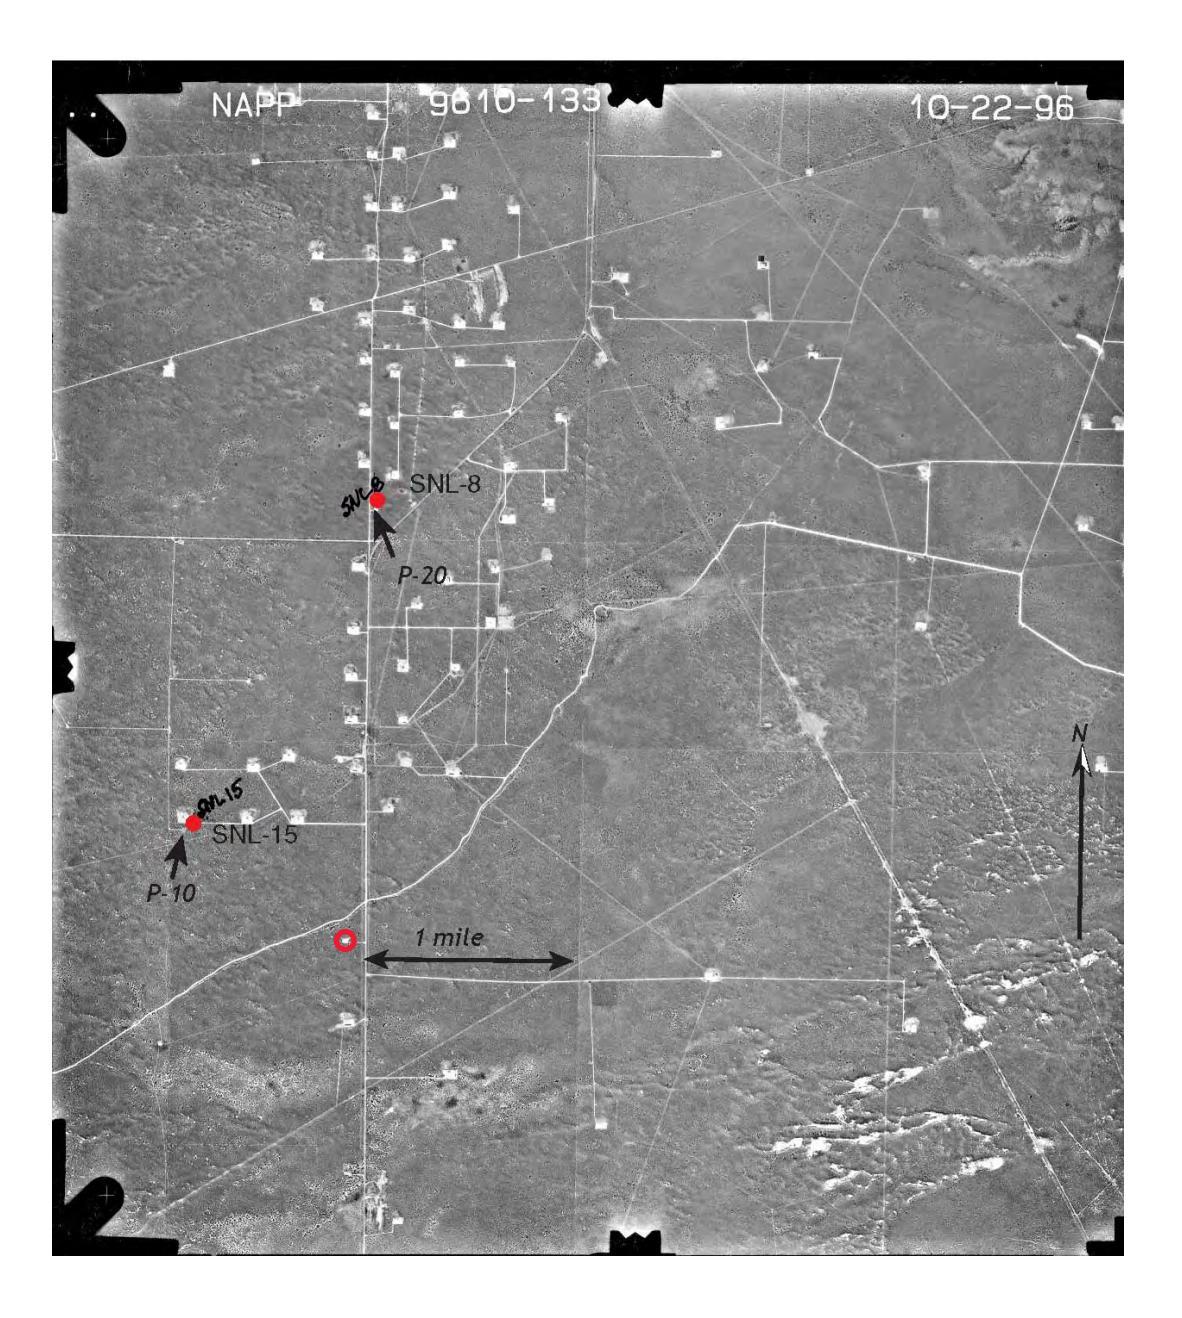
Aerial photograph showing locations of SNL-8 and SNL-15.

Note that SNL-15 was relocated to the P-18 drillpad after this memorandum; red

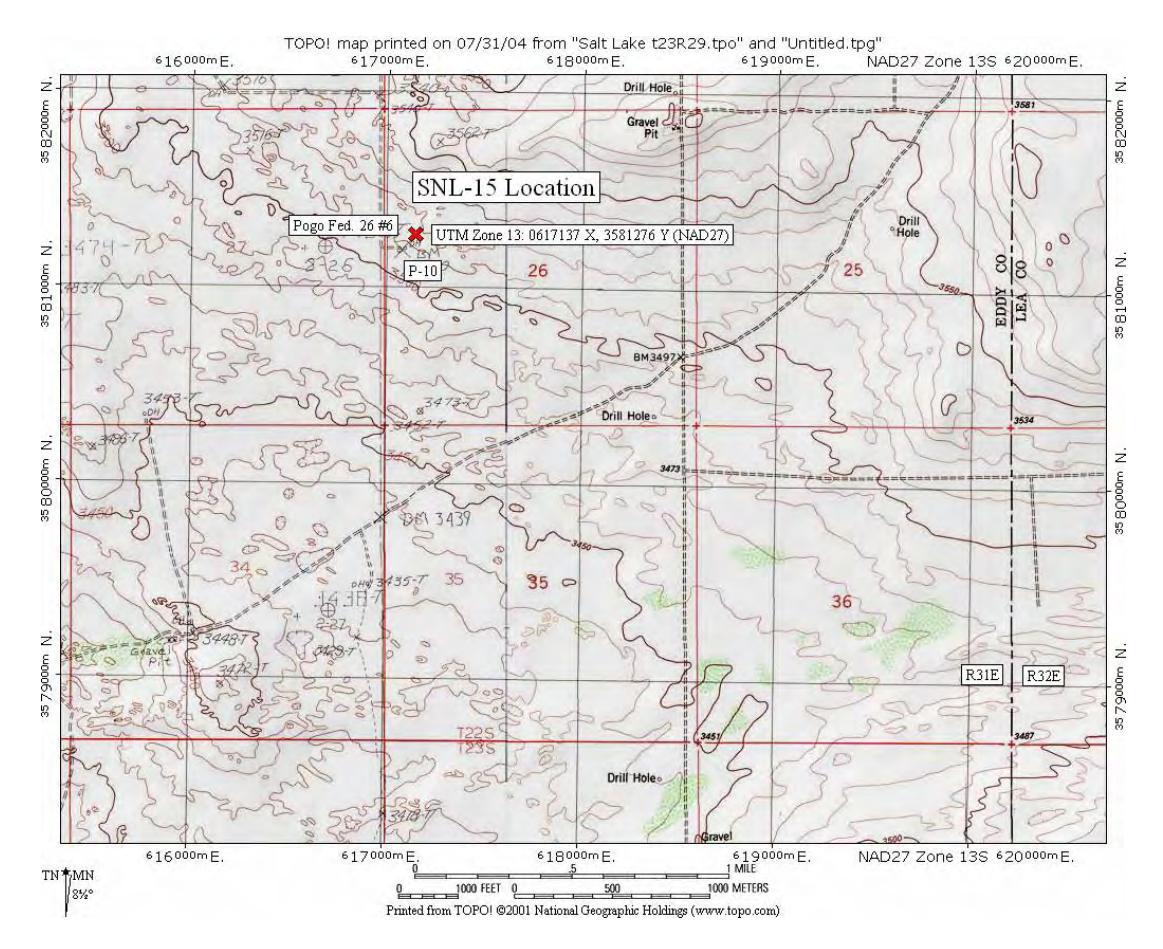
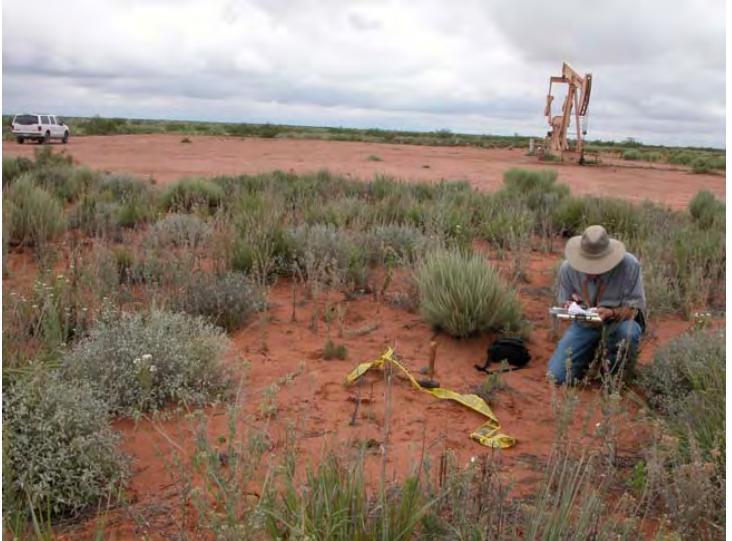
Topographic map of SNL-15 location and photograph showing adjacent pad for oil well. WIPP Waste Handling building is on horizon just left of the pump jack.
