RE: Remediation Plan Nash Draw 8 Federal SWD Battery #1 XTO Energy, Inc. Remediation Permit Number 2RP-5007 Eddy County, New Mexico

LT Environmental, Inc. (LTE), on behalf of XTO Energy, Inc. (XTO), is submitting this summary of initial excavation activities and subsequent plan for additional excavation and closure sampling to confirm the remediation of impacted soil at the Nash Draw 8 Federal Salt Water Disposal (SWD) Battery #1 (Site). The Site is located in the northwest corner of the southwest corner, Section 8, Township 24 South, Range 30 East, in Eddy County, New Mexico (Figure 1).

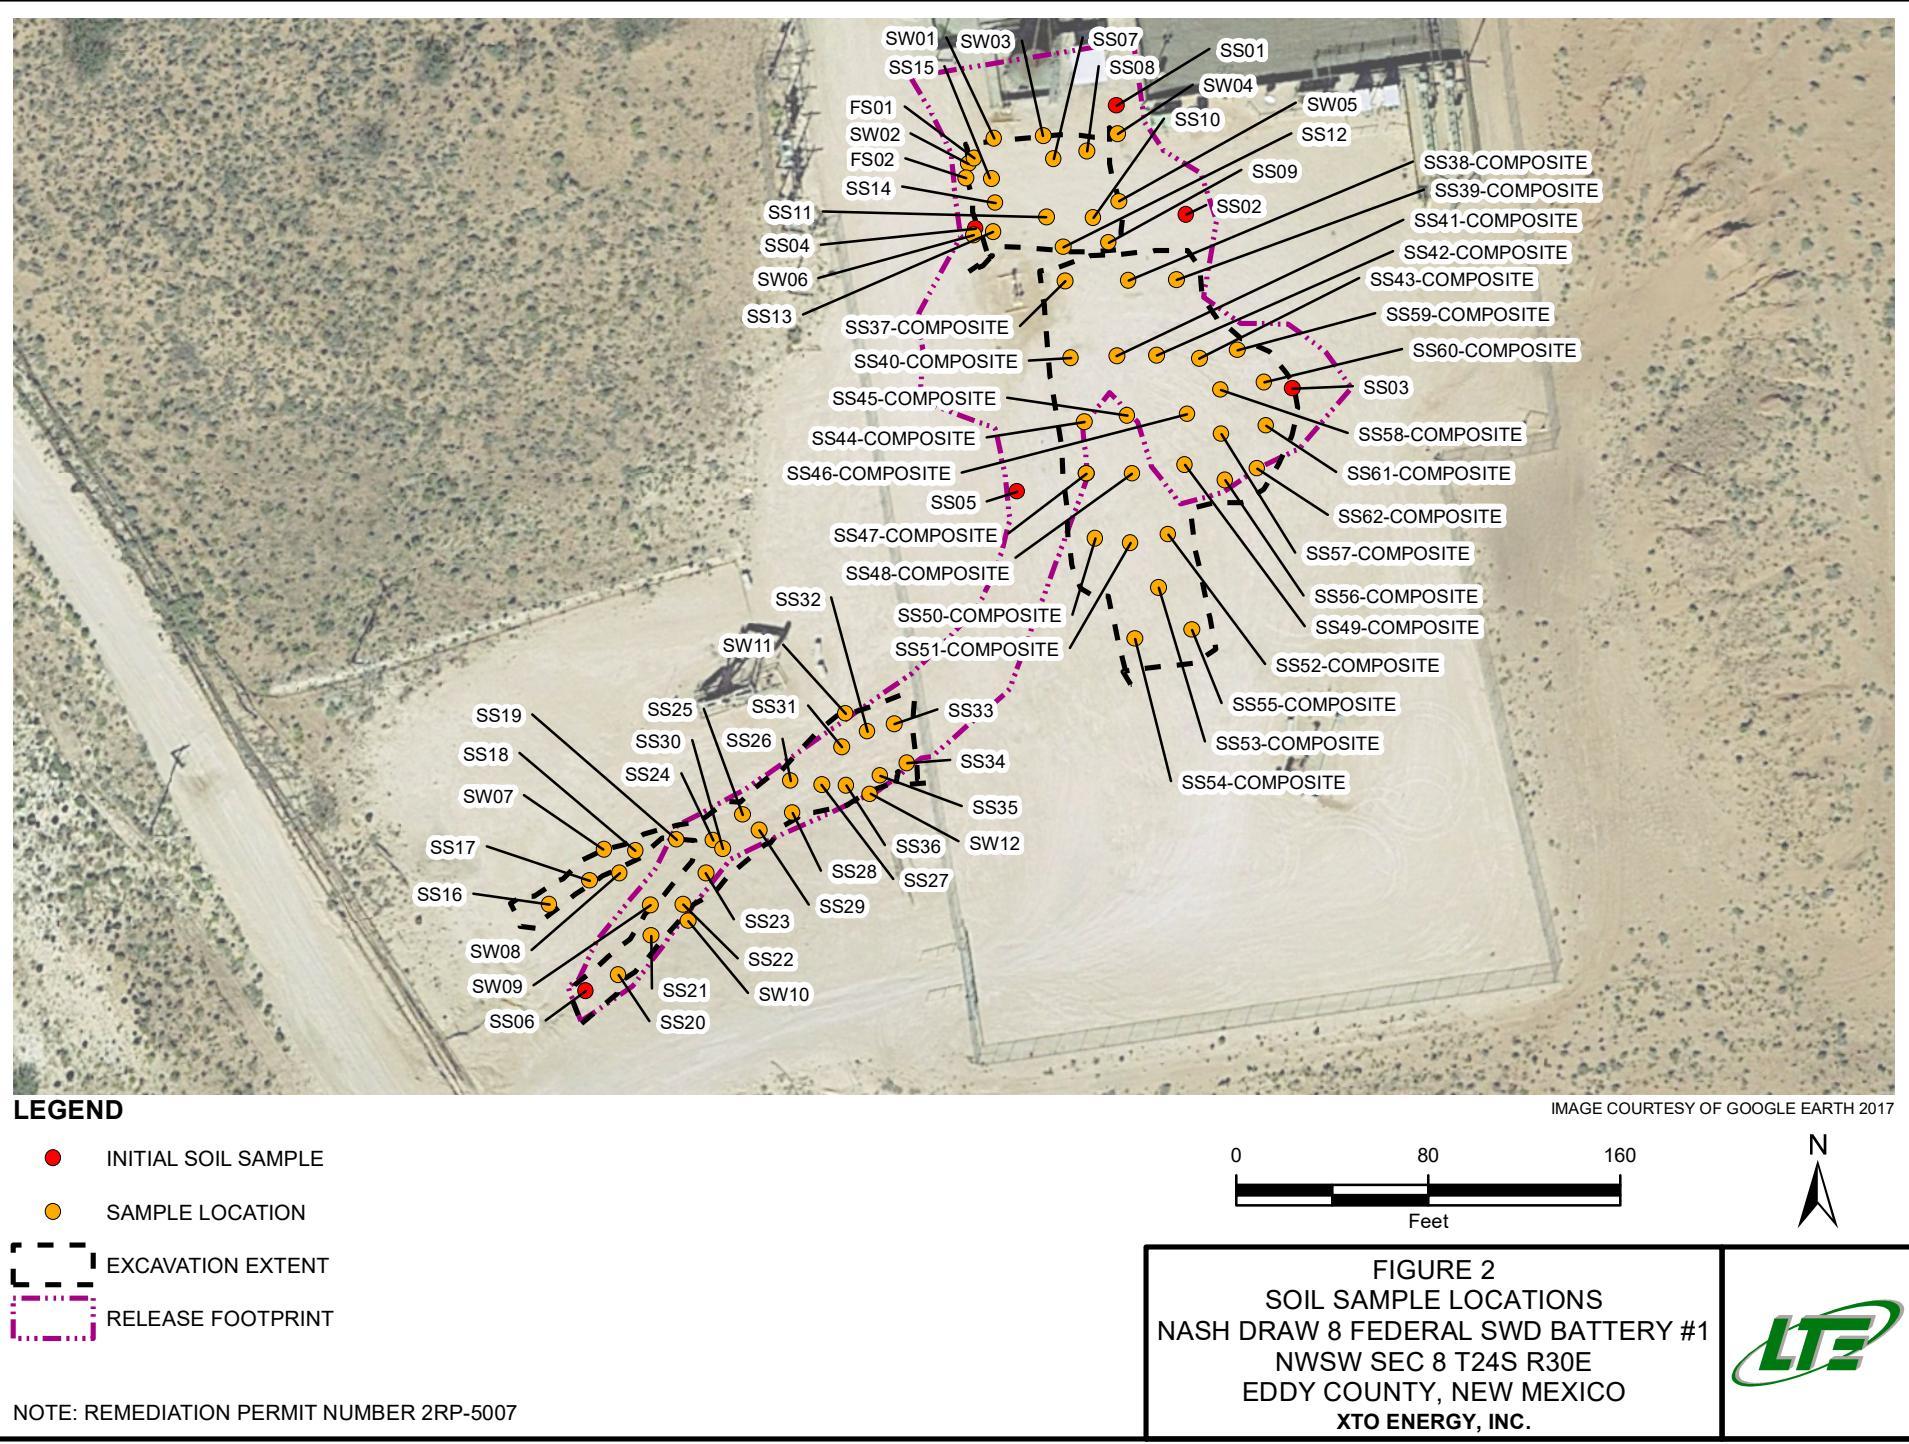
P:\XTO Energy\GIS\MXD\012918153_NASH DRAW 8 SWD\012918153_FIG02_SITE_2018.mxd

The release covered an area of approximately 29,702 square feet at the well pad and flowed from the release area in the northern portion of the Site to the southwestern portion of the Site (Figure 2). Free-standing fluid was recovered using a vacuum truck. As a result, approximately 4 bbls of crude oil and 276 bbls of produced water were recovered from the Site. Six initial surface soil samples (SS01 through SS06) were collected across the area of the release. The soil sample locations were selected based on visual indications of impacted soil from the release and on information provided on the initial C-141 Form. Based on the laboratory analytical results from initial soil sampling, excavation of impacted soil was initiated: one to the north where the initial release occurred, in the south area at the extent of the release, and in the central portion of the release area (Figure 2). As a result, approximately 760 cubic yards total of impacted material has been removed. XTO initially elected to apply a composite sampling protocol as indicated in 19.15.29.12.D where each is not representative of more than 200 square feet. However, this resulted in 76 samples for the existing excavations and will require an additional 200 for the estimated remaining excavation.

Based on the areal extent of the release area, initial soil sampling results, and confirmation soil sampling results, approximately 13,650 square feet of impacted area have not yet been excavated at this time. LTE proposes to continue excavating the remaining portions of impacted soil from the release areas to be compliant with the most stringent Table 1 action levels. Due to the size of the anticipated excavation and in referencing *Guidance on Choosing a Sampling Design for Environmental Data Collection for Use in Developing a Quality Assurance Project Plan*, United States Environmental Protection Agency (EPA) QA/G-5S, December 2002, LTE proposes to continue with a composite sampling protocol, but increase the representative area sampled. The composite sampling protocol will consist of dividing each 1,000 square foot area of the sidewalls and floor of the excavation into five equal areas. Five aliquots of equal volume will be collected from each area. The aliquots will be deposited into a one-gallon resealable bag, thoroughly homogenized by mixing, and placed into a laboratory-supplied 4-ounce sampling jar. Sidewall samples will not be collected if sidewalls are less than two feet deep. In those instances, floor
