Soil Assessment Report

Avalon Compressor Station Release 2RP-4848 Eddy County, New Mexico

ETC Texas Pipeline, LTD.

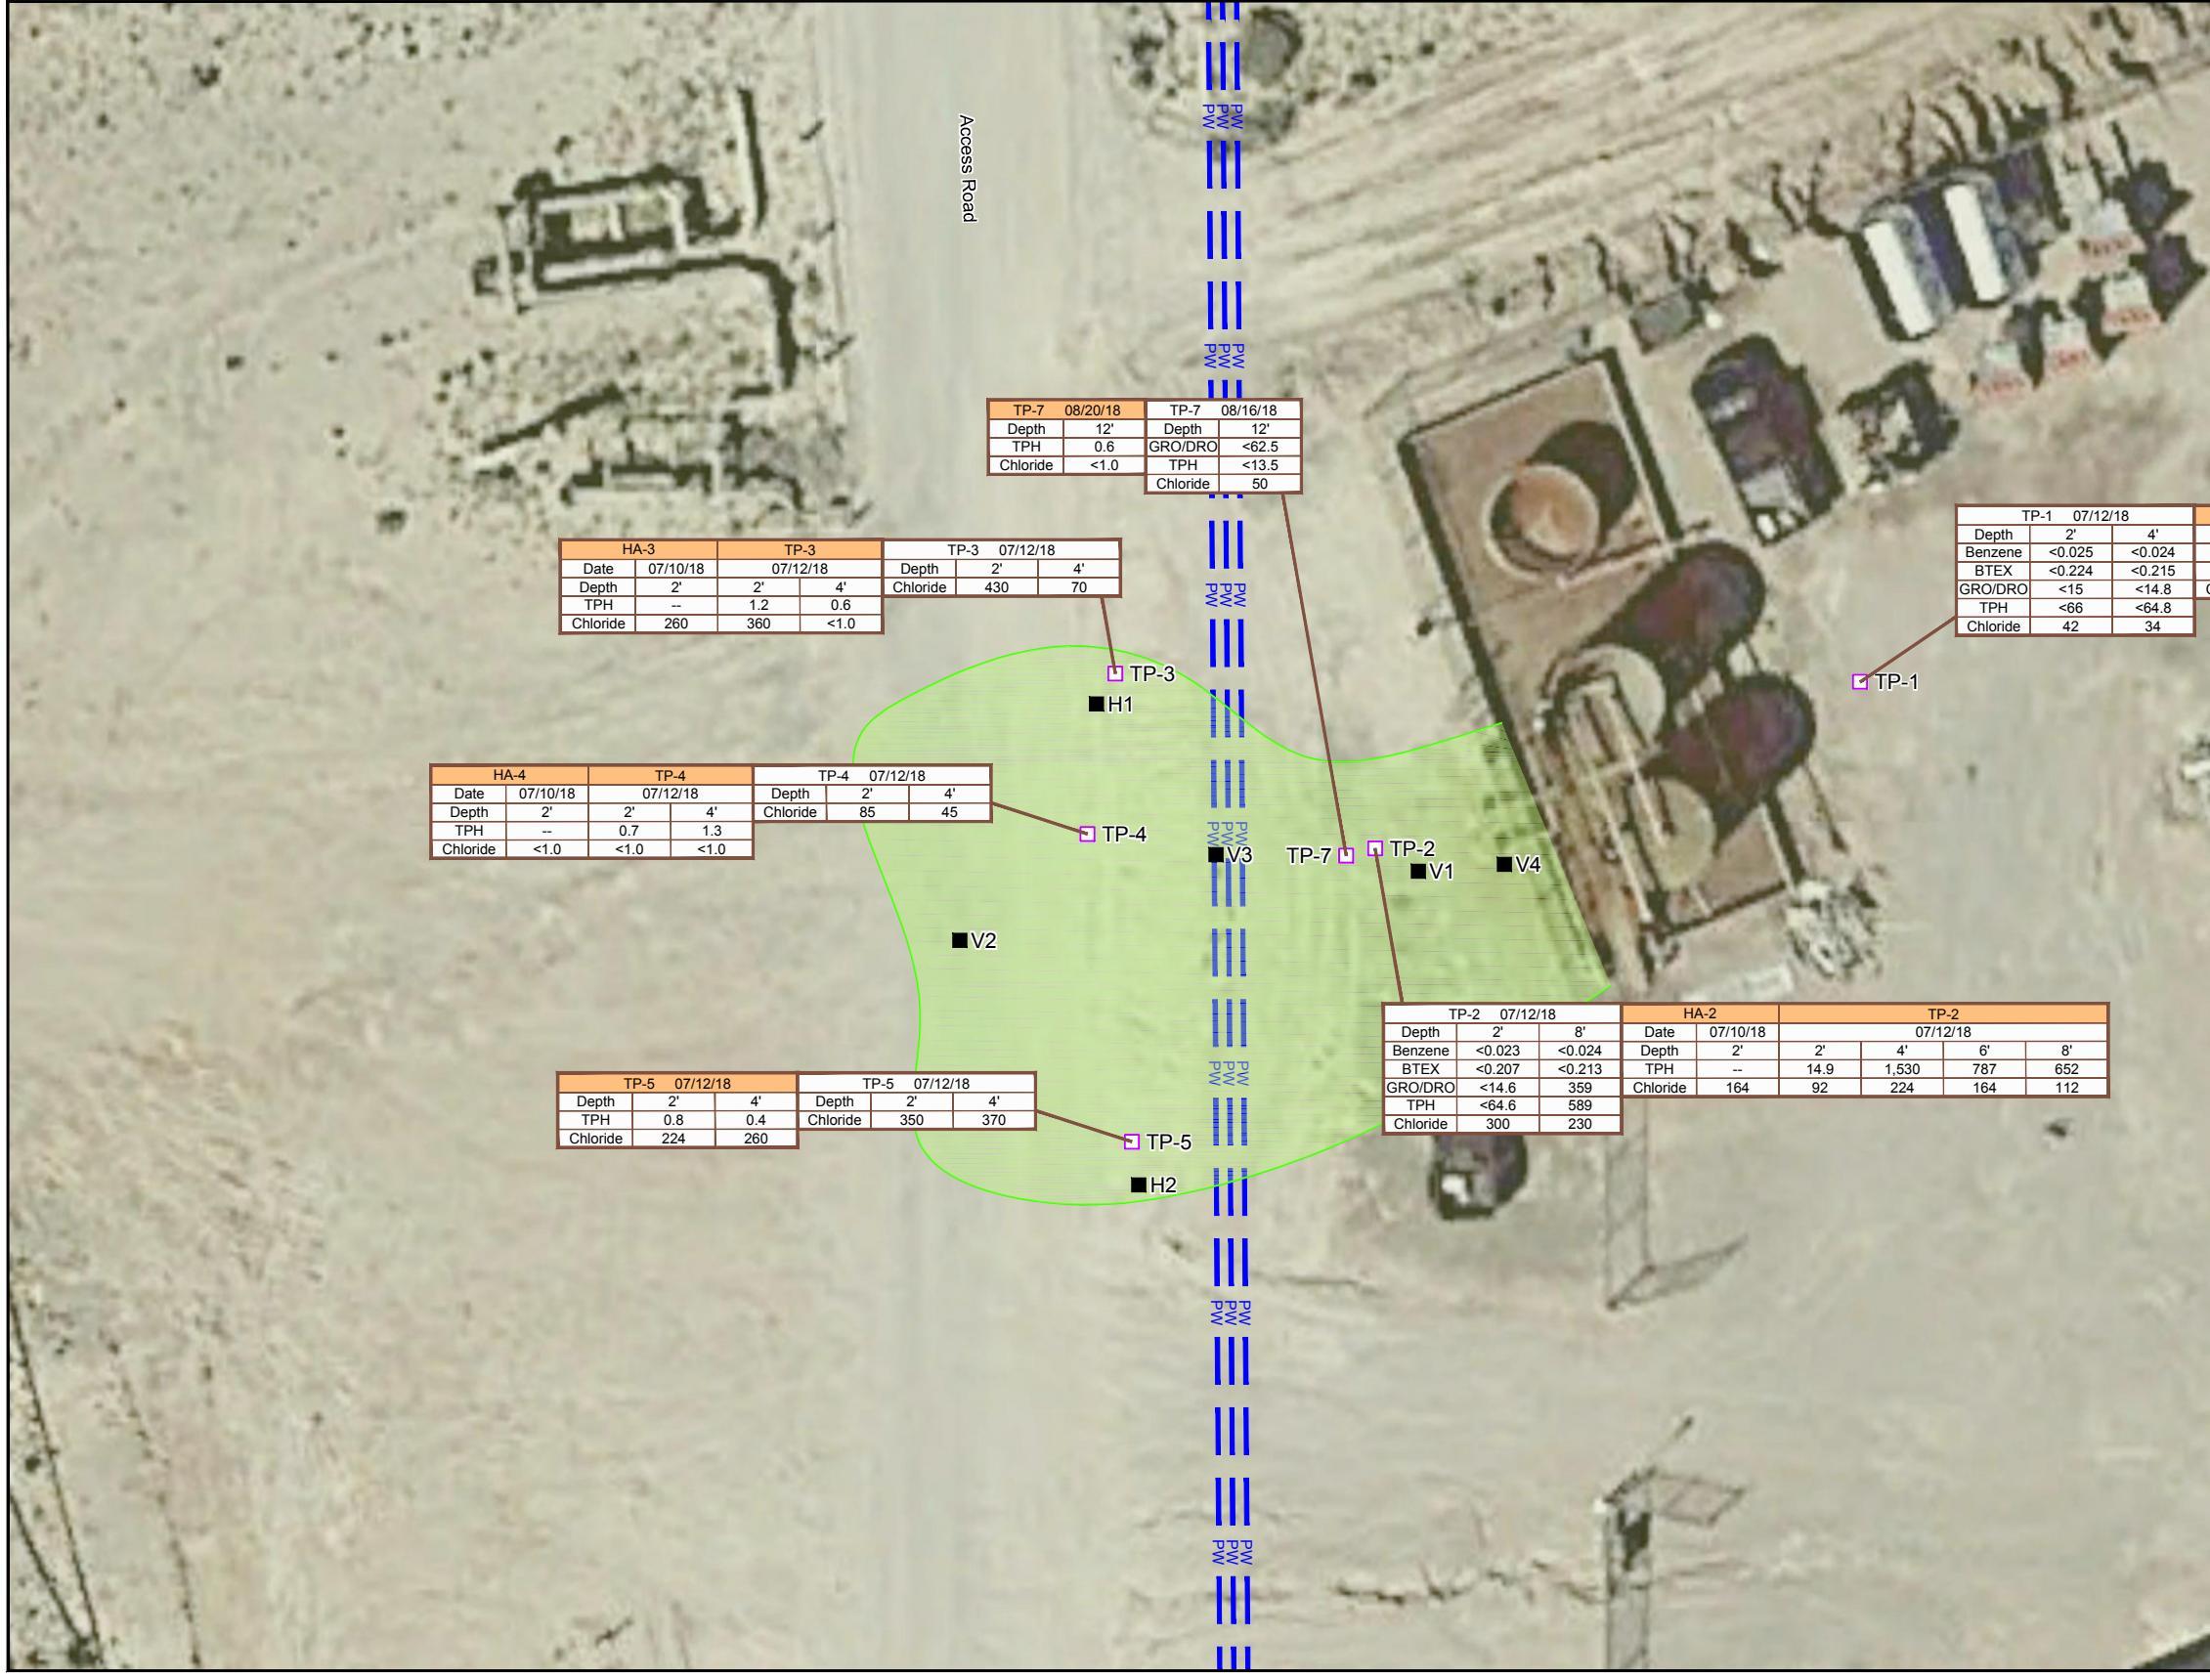
Figure 2 Sample Location Map

Analytical results are summarized in Table 1 and the distribution of analytical results is presented in map view on Figure 2.

- Soil analytical results for chloride, benzene, and total BTEX in soil samples were below the NMOCD screening criteria (600, 10, and 50 mg/kg, respectively) with the exception of the surface soil samples (V1 through V4, H1 4" and H2 4" at 4 to 6 inches) collected by ETC.
- TPH was detected above the NMOCD screening criteria for total TPH (100 mg/kg) within all of the ETC surface samples (V1 through V4, H1 4" and H2 4" - at 4 to 6 inches) and TP-2 at a depth of 8 feet bgs (589 mg/kg). However, the soil sample analyzed from TP-7 directly adjacent at 12 feet bgs did not report TPH above reporting limits.

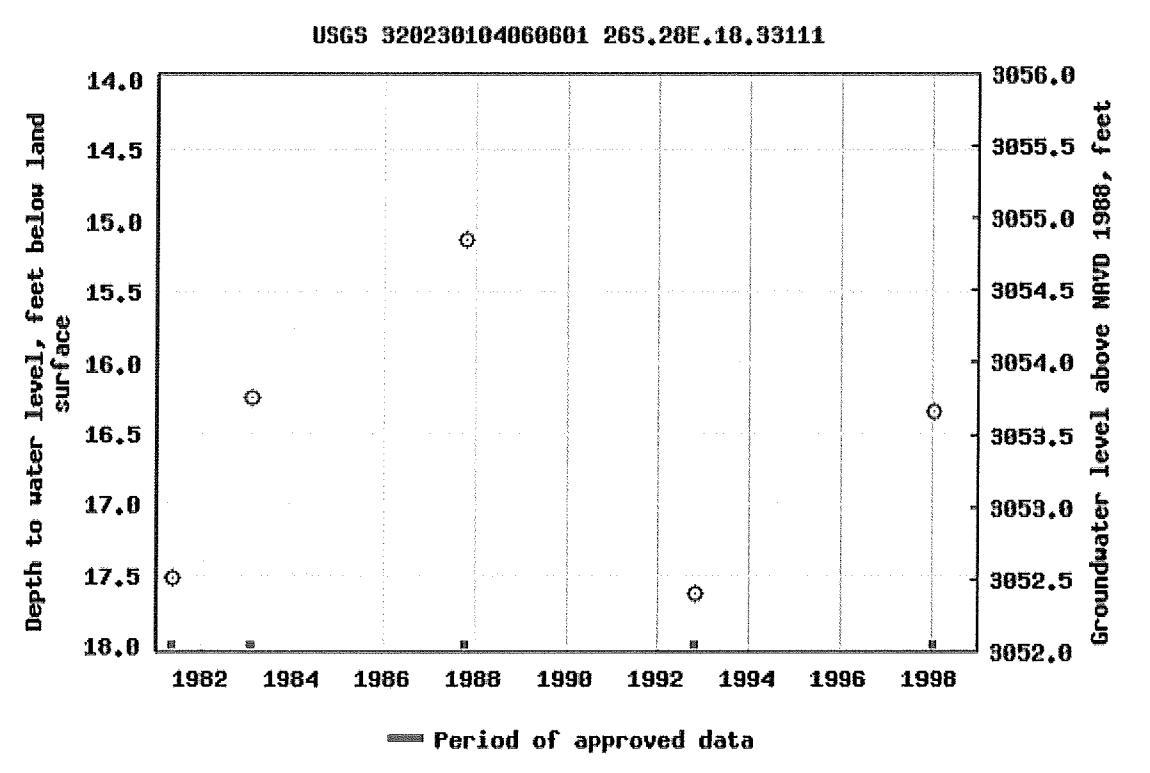
USGS 320230104060601 26S.28E.18.33111

Eddy County, New Mexico Hydrologic Unit Code --Latitude 32°02'30", Longitude 104°06'06" NAD27 Land-surface elevation 3,070 feet above NAVD88 This well is completed in the Castile Gypsum (312CSTL) local aquifer.

Localized depth to groundwater was estimated at a depth of approximately 15 to 20 feet below ground surface (bgs) based on depth to water records available on the United States Geological Survey (USGS) National Water System Information map. The nearest well to the site is approximately 1.38 miles to the west. Well records showing groundwater measurement data are included in Appendix A. Information available from various sources including the Petroleum Recovery Research Center (PRRC) Mapping Portal and the United States Geological Survey (USGS) Current Water Database for the Nation concludes:

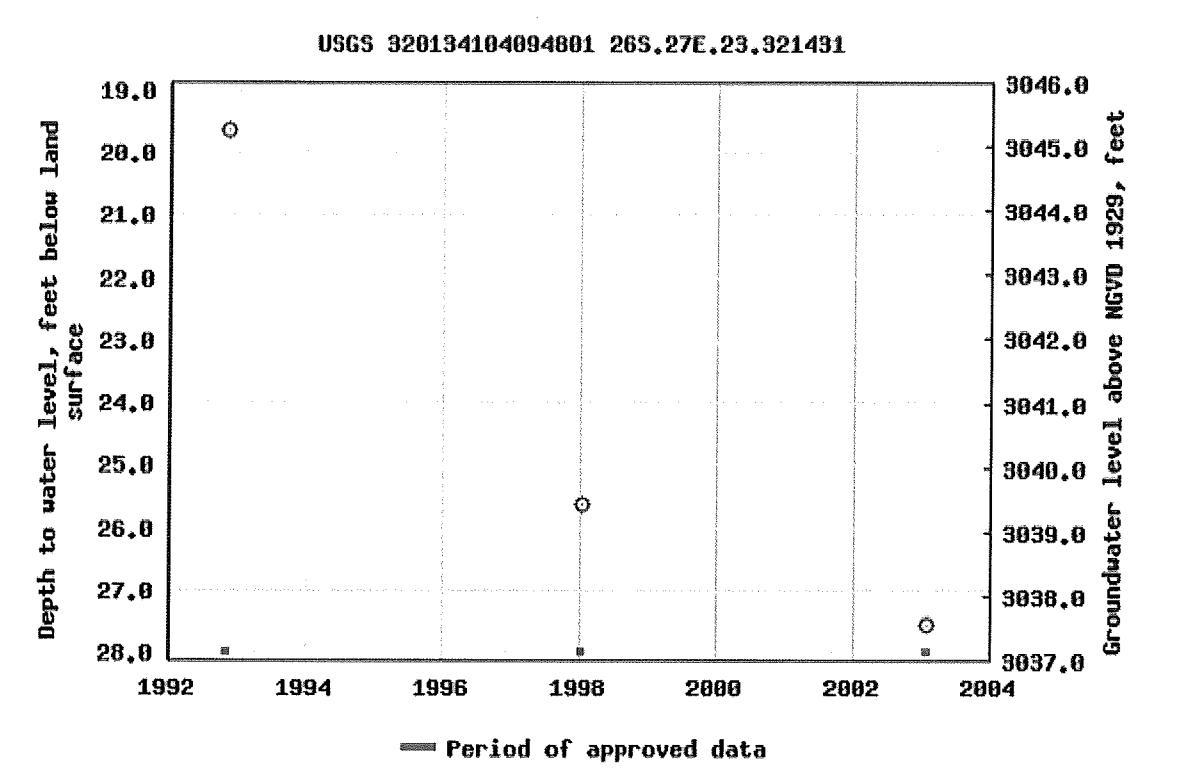
USGS 320134104094801 26S.27E.23.321431

Eddy County, New Mexico Hydrologic Unit Code 13060011 Latitude 32°01'34", Longitude 104°09'48" NAD27 Land-surface elevation 3,065 feet above NGVD29 This well is completed in the Bell Canyon Formation (313BLCN) local aquifer.
