#### Re: Closure Request SRO State Com #065 Remediation Permit Number 2RP-5362 Eddy County, New Mexico

GHD Services, Inc. (GHD), on behalf of COG Operating, LLC (COG), respectfully submits this Site Closure Report to the New Mexico Oil Conservation Division (NMOCD) District II office for the Remediation Permit Number 2RP-5362. This Site Closure Report provides documentation detailing delineation, soil sampling, remediation and restoration activities at the SRO State Com #065 (Site) located in SW/NW quarter (Unit Letter E) of Section 10, T-26-S, R-38E on surface lands owned by the State of New Mexico. The Site is located in Eddy County, approximately 26 miles south/southeast of Carlsbad, New Mexico and GPS coordinates for the Site are 32.05840 N, -104.08295 W (Figure 1).

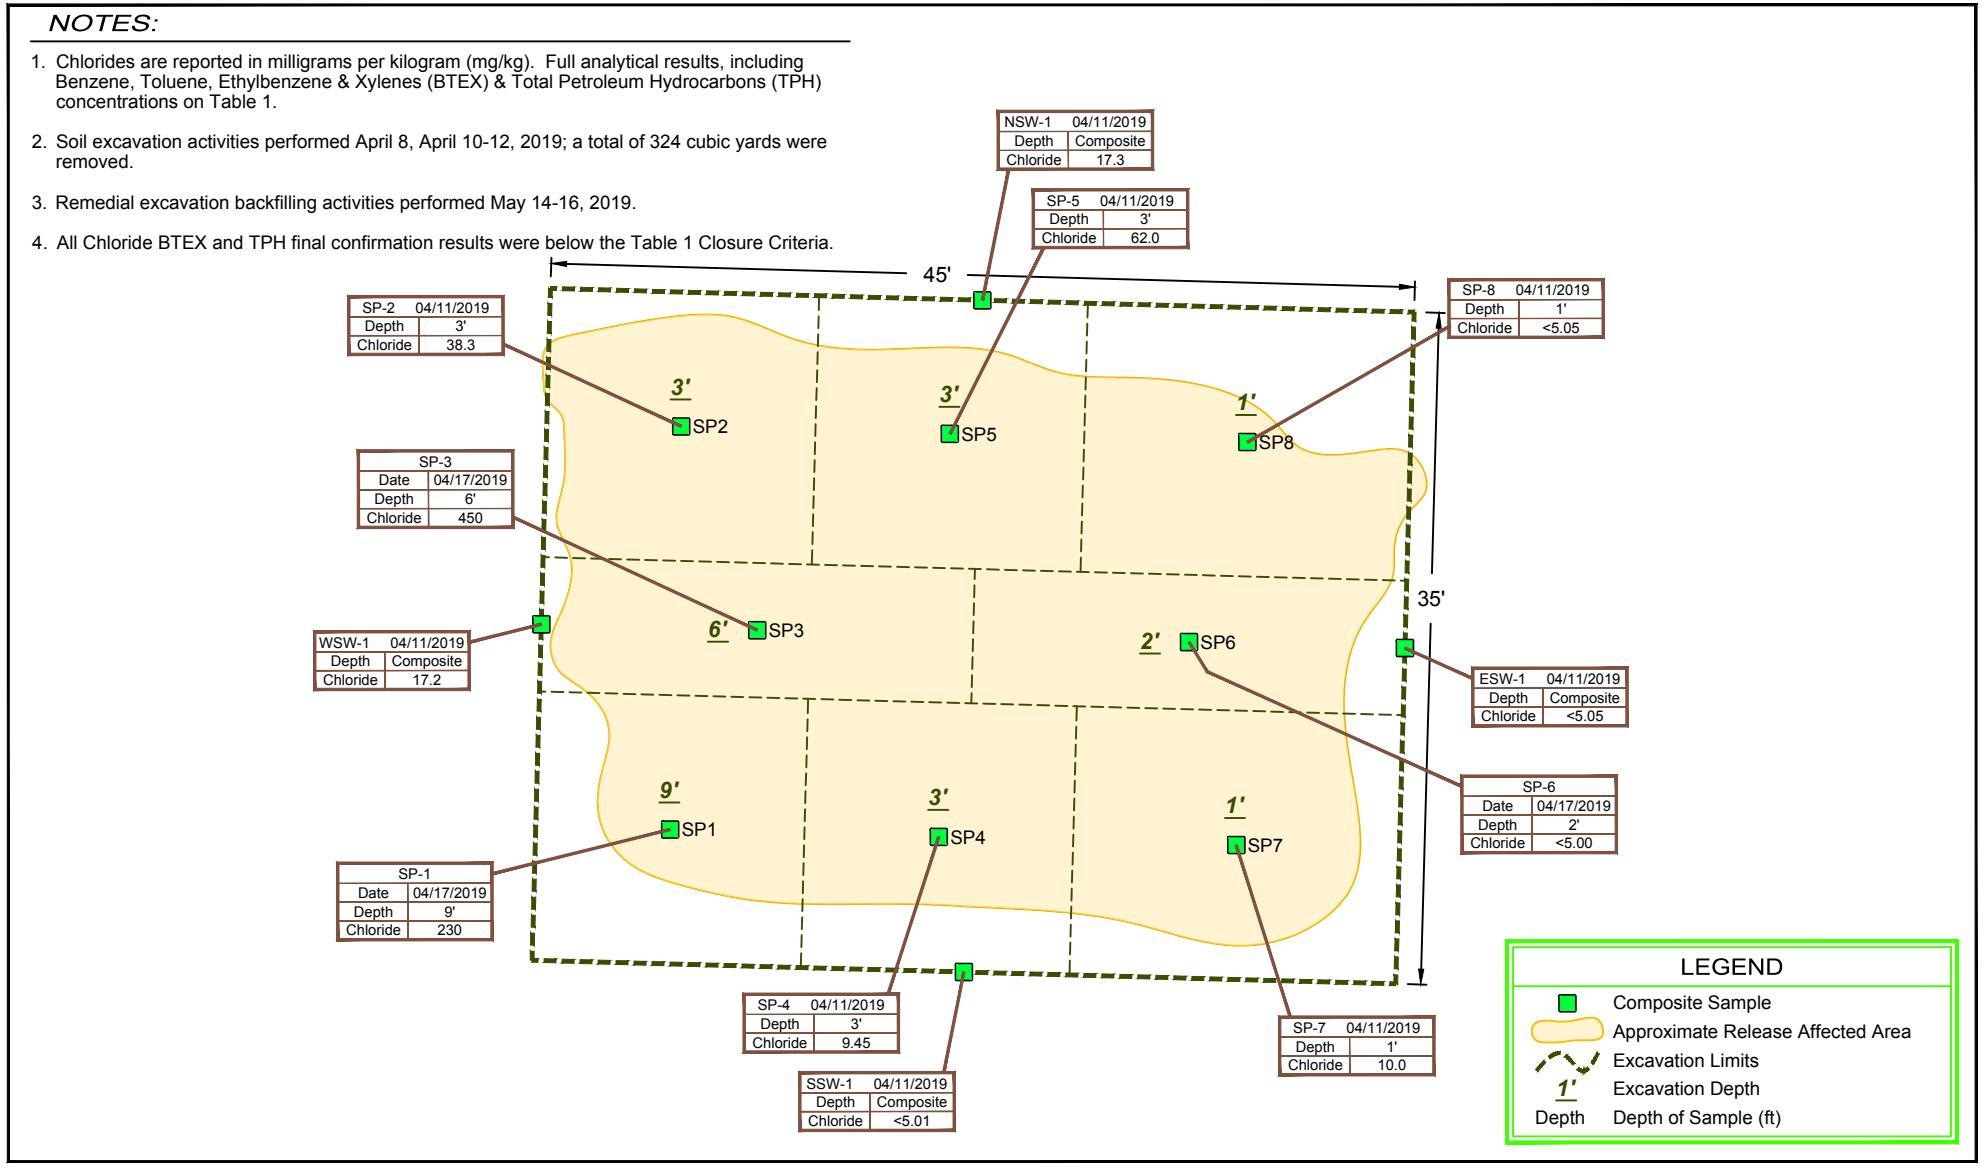
### **FIGURE 2**

The horizontal and vertical excavation extents, sample locations and final confirmation analytical results are shown in Figure 2 – Site Detail and Analytical Results Map and summarized on Table 1- Soil Analytical Data Summary – Confirmation Sampling. Laboratory analytical reports are included in Appendix D.

## SITE DETAIL AND ANALYTICAL RESULTS MAP

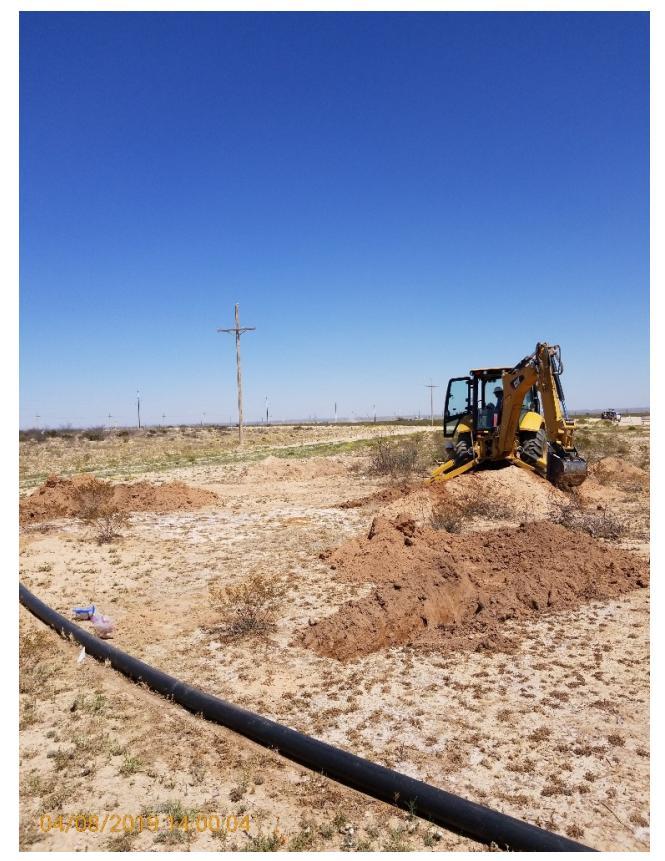
Photo 1 – View of test pit activity to a depth of 3 feet bgs dated April 8, 2019.

Under the direction of COG, GHD and COG's contractor Culberson Construction Energy Services (CCI) mobilized to the Site on April 8, 2019 to assess the nature and extent of the produced water release. Test pits were excavated in the direct vicinity of the release to a depth of approximately three feet. Using visual and Hach® chloride QuanTab® test strips field-screening methods, soil conditions indicated that the depth of impacts varied.

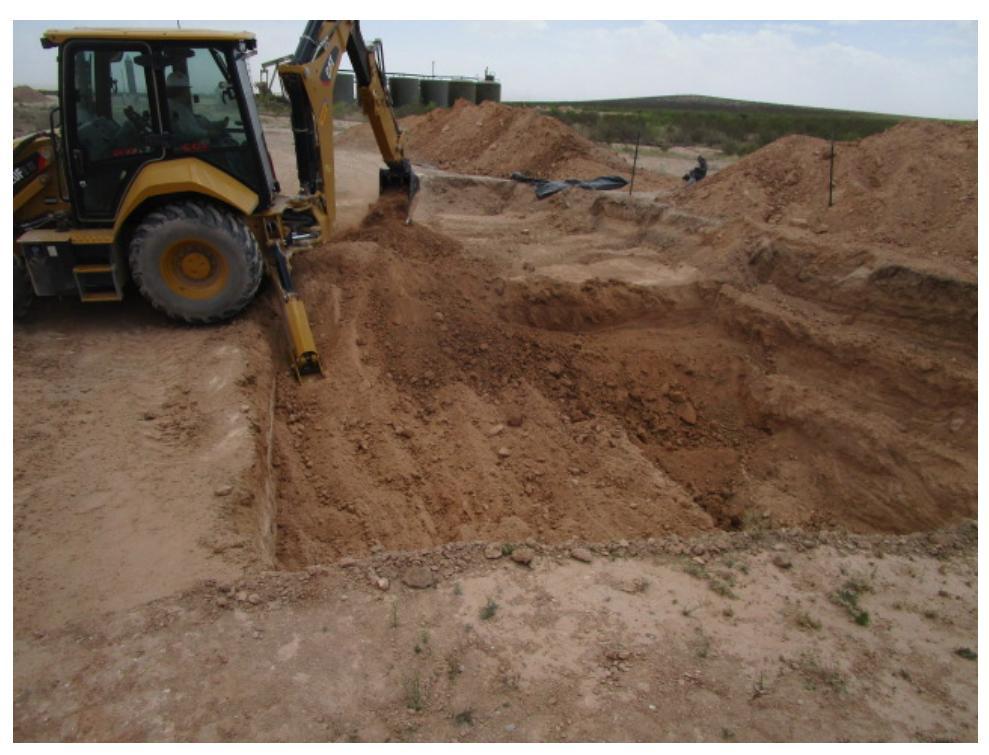
Photo 2 – View of excavating activities dated April 10, 2019.

Between April 10 and 12, 2019, soil excavation activities were performed with the purpose of excavating impacted soils and the collecting horizontal and vertical delineation soil samples below the closure criteria established for the release site. Impacted soils were removed systemically using a backhoe, with a CCI spotter and GHD site supervisor directing the soil removal operations. The depth of excavation ranged from approximately one foot to seven feet bgs. The boundaries of the excavation measured 45 feet x 35 feet.

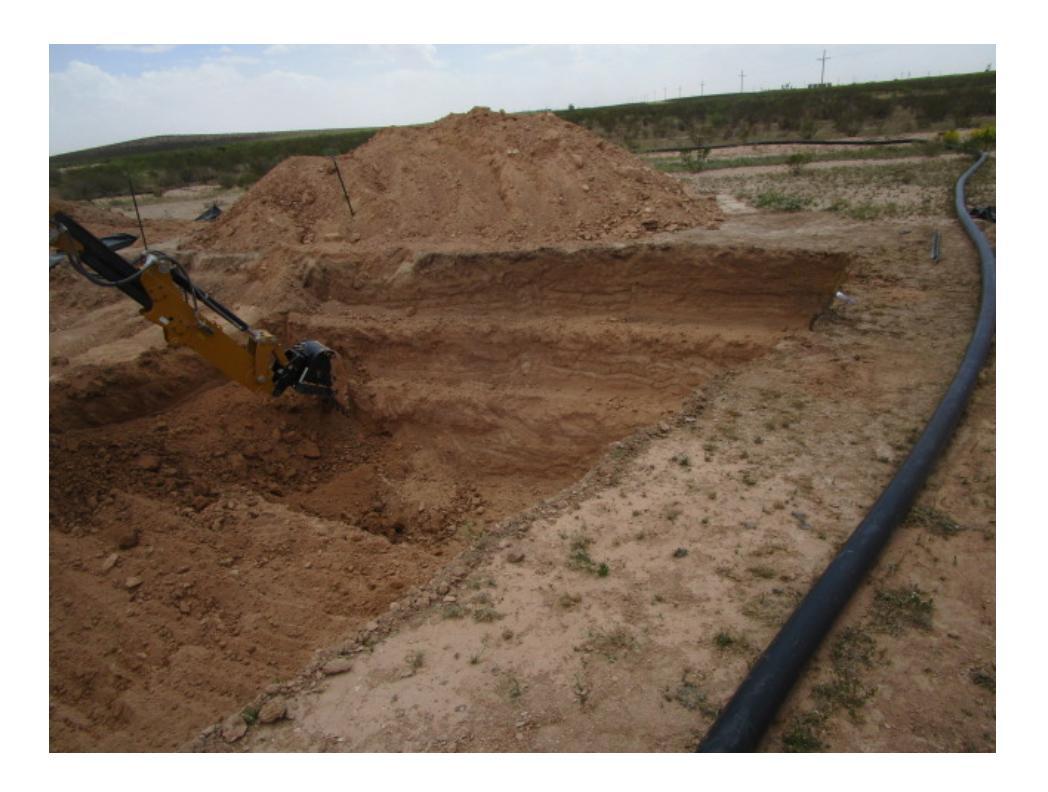
Photo 3 – View of excavation facing southwest dated April 11, 2019. Excavation floor varies in depth.

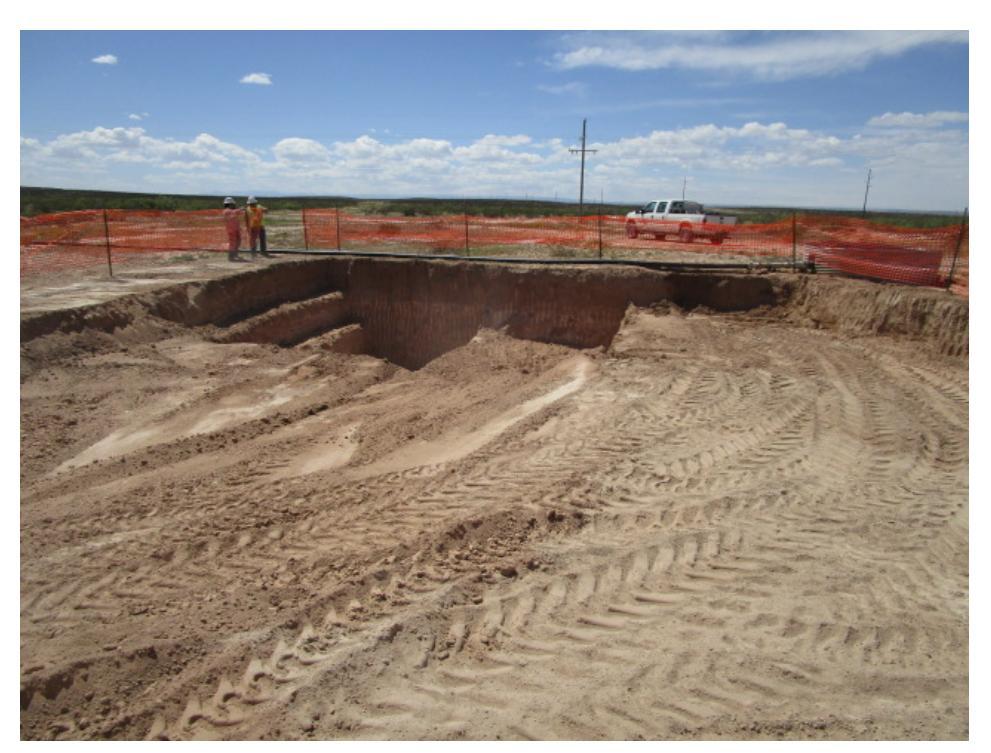
Photo 4 – View of excavation facing west dated April 11, 2019. Excavation floor varies in depth

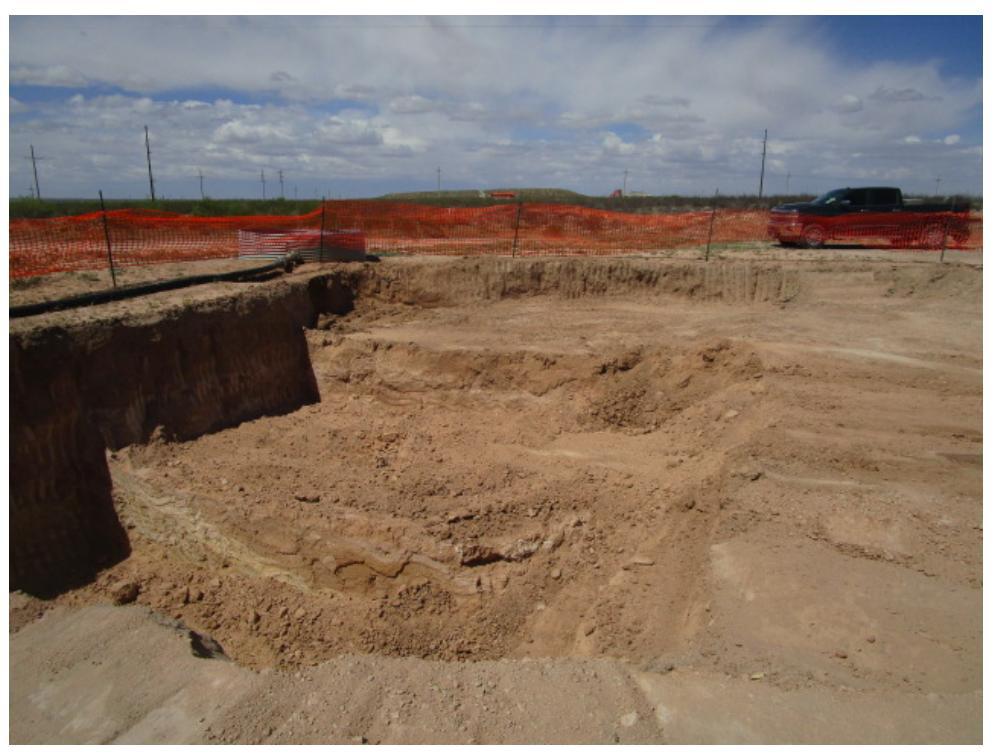
Photo 5 – View of excavation facing north dated April 11, 2019. Excavation floor varies in depth.

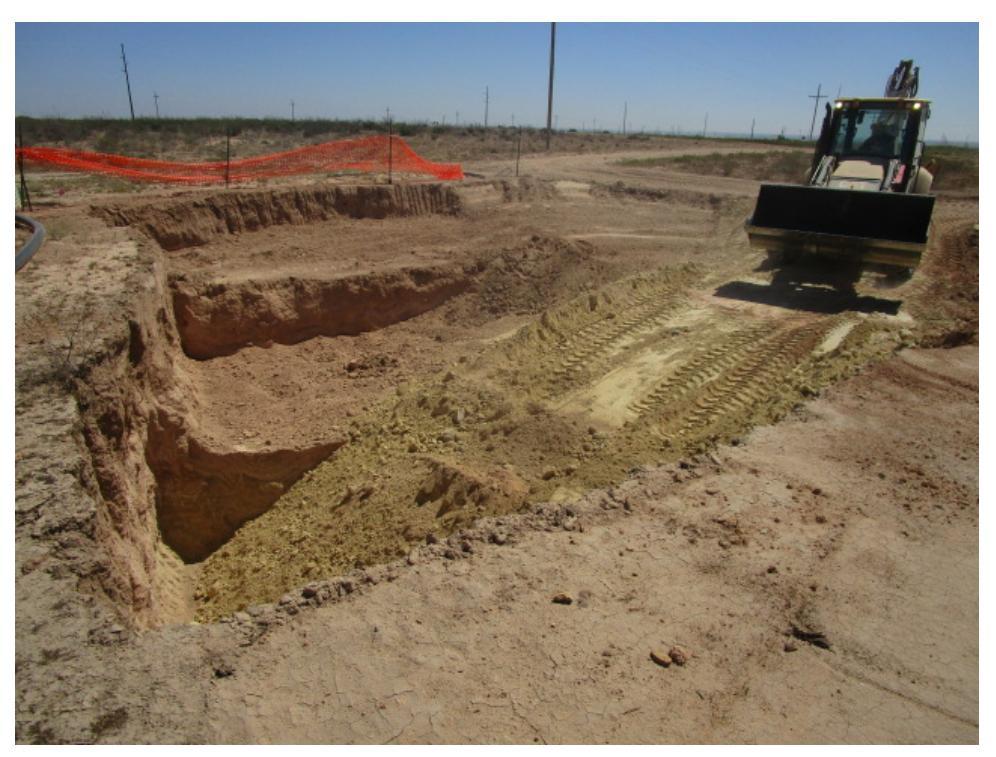
Photo 6 – View during backfilling activities dated May 14, 2019.

Approximately 324 cubic yards of clean soils were trucked to the Site by Baeza trucking from an offsite COG borrow pit near the Site. Between May 14 through 16, 2019, backfilling activities were performed. Soils were placed and compacted in the remedial excavation by CCI and the new ground surface was graded to match the surrounding topography.

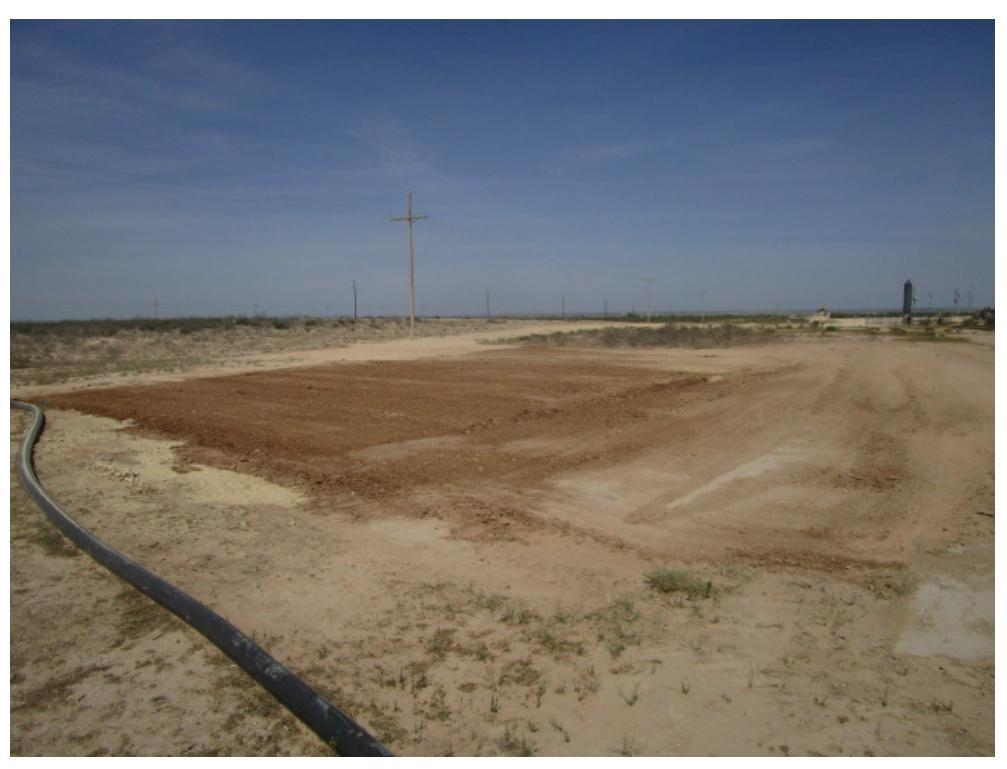
Photo 7 – View following completion of backfilling and final grading activities dated May 16, 2019.
