ConocoPhillips Company San Juan Basin Closure Report

Lease Name: STEWART LS 8N API No.: 30-045-35330

In accordance with Rule 19.15.17.13 NMAC the following information describes the closure of the temporary pit referenced above. All proper documentation regarding closure activities is being included with the C-144. The temporary pit for this location was constructed and location drilled before June 16, 2008 (effective date for Rule 19.15.17). While closure of the temporary pit did fall within the rule some dates for submittals are after the rig release date.

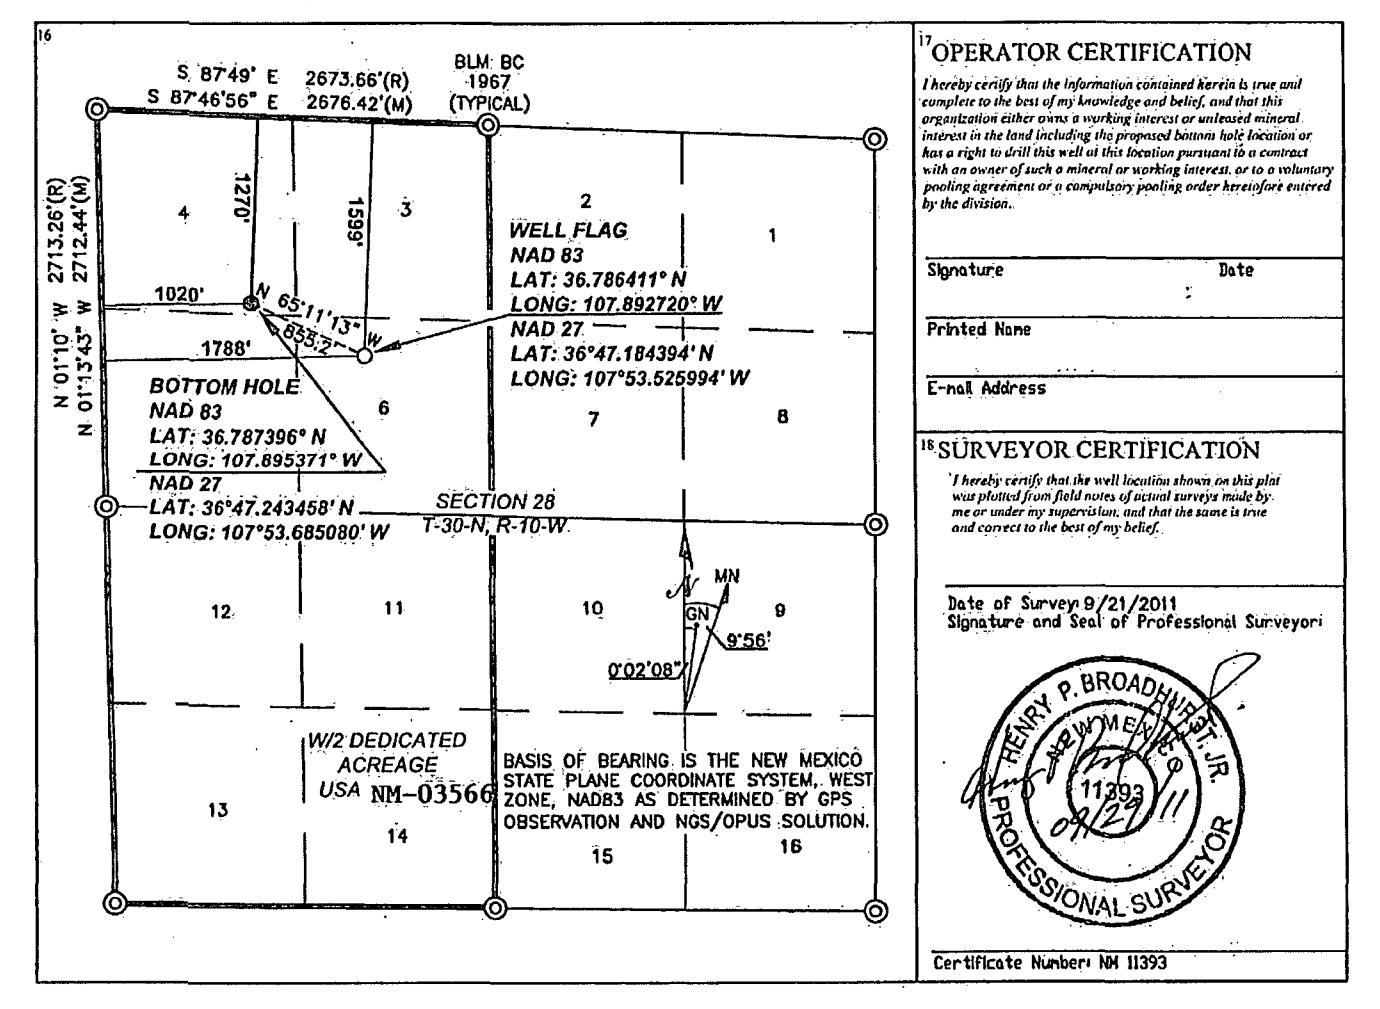
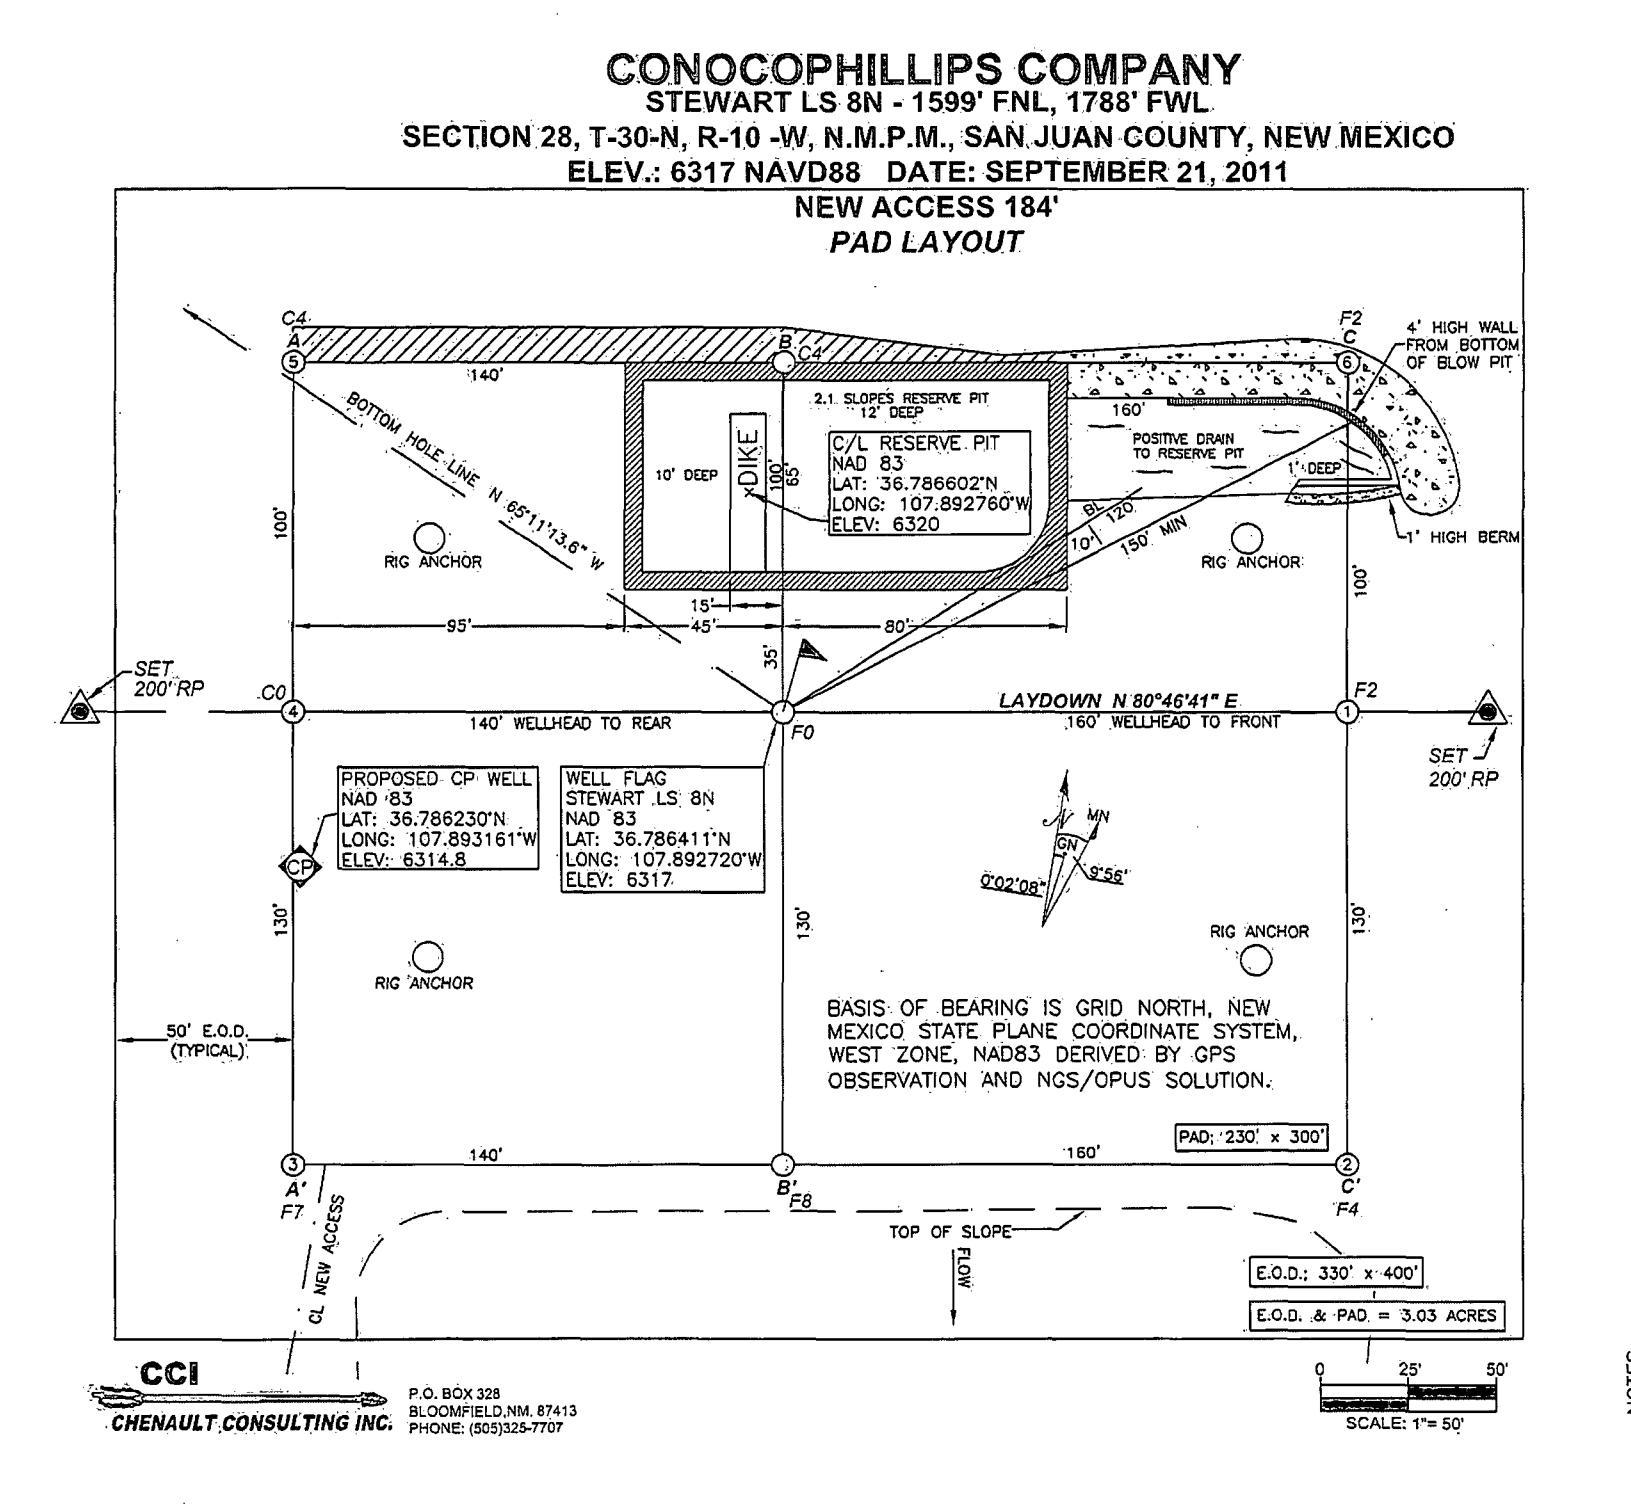
WELL LOCATION AND ACREAGE DEDICATION PLAT

- SHALLOW SIDE). SIDE (OVERFLOW-3' WIDE AND 1' ABOVE **ÁBOVE DEEP** ŝ TO BE DIKE ЫТ RESERVE <u>.</u>-
- HEREIN ARE, PROJECTED DEPICTED CUT Ö TOP SLOPE AND Ч TOE THΕ 5.
- UNMARKED' BURIED (2) WORKING DAYS ିତ PIPELINES MARKED OR I LEAST TWO (LOCATION OF ANY M ACCESS ROAD AT IN UNDERGROUND PAD AND OR FOR WELL IT LUABLE NOTIFY O S C.C.I. SURVEYS IS NOT CONTRACTOR SHOULD N PIPELINES OR CABLES (ŝ

PRIOR TO CONSTRUCTION.
