## **Remediation Summary and Closure Request**

FAE II Operating, LLC Moberly #12 Lea County, New Mexico Unit Letter "H", Section 20, Township 26 South, Range 37 East Latitude 32.030548 North, Longitude 103.178436 West NMOCD Incident # nAPP2313635015

December 2023

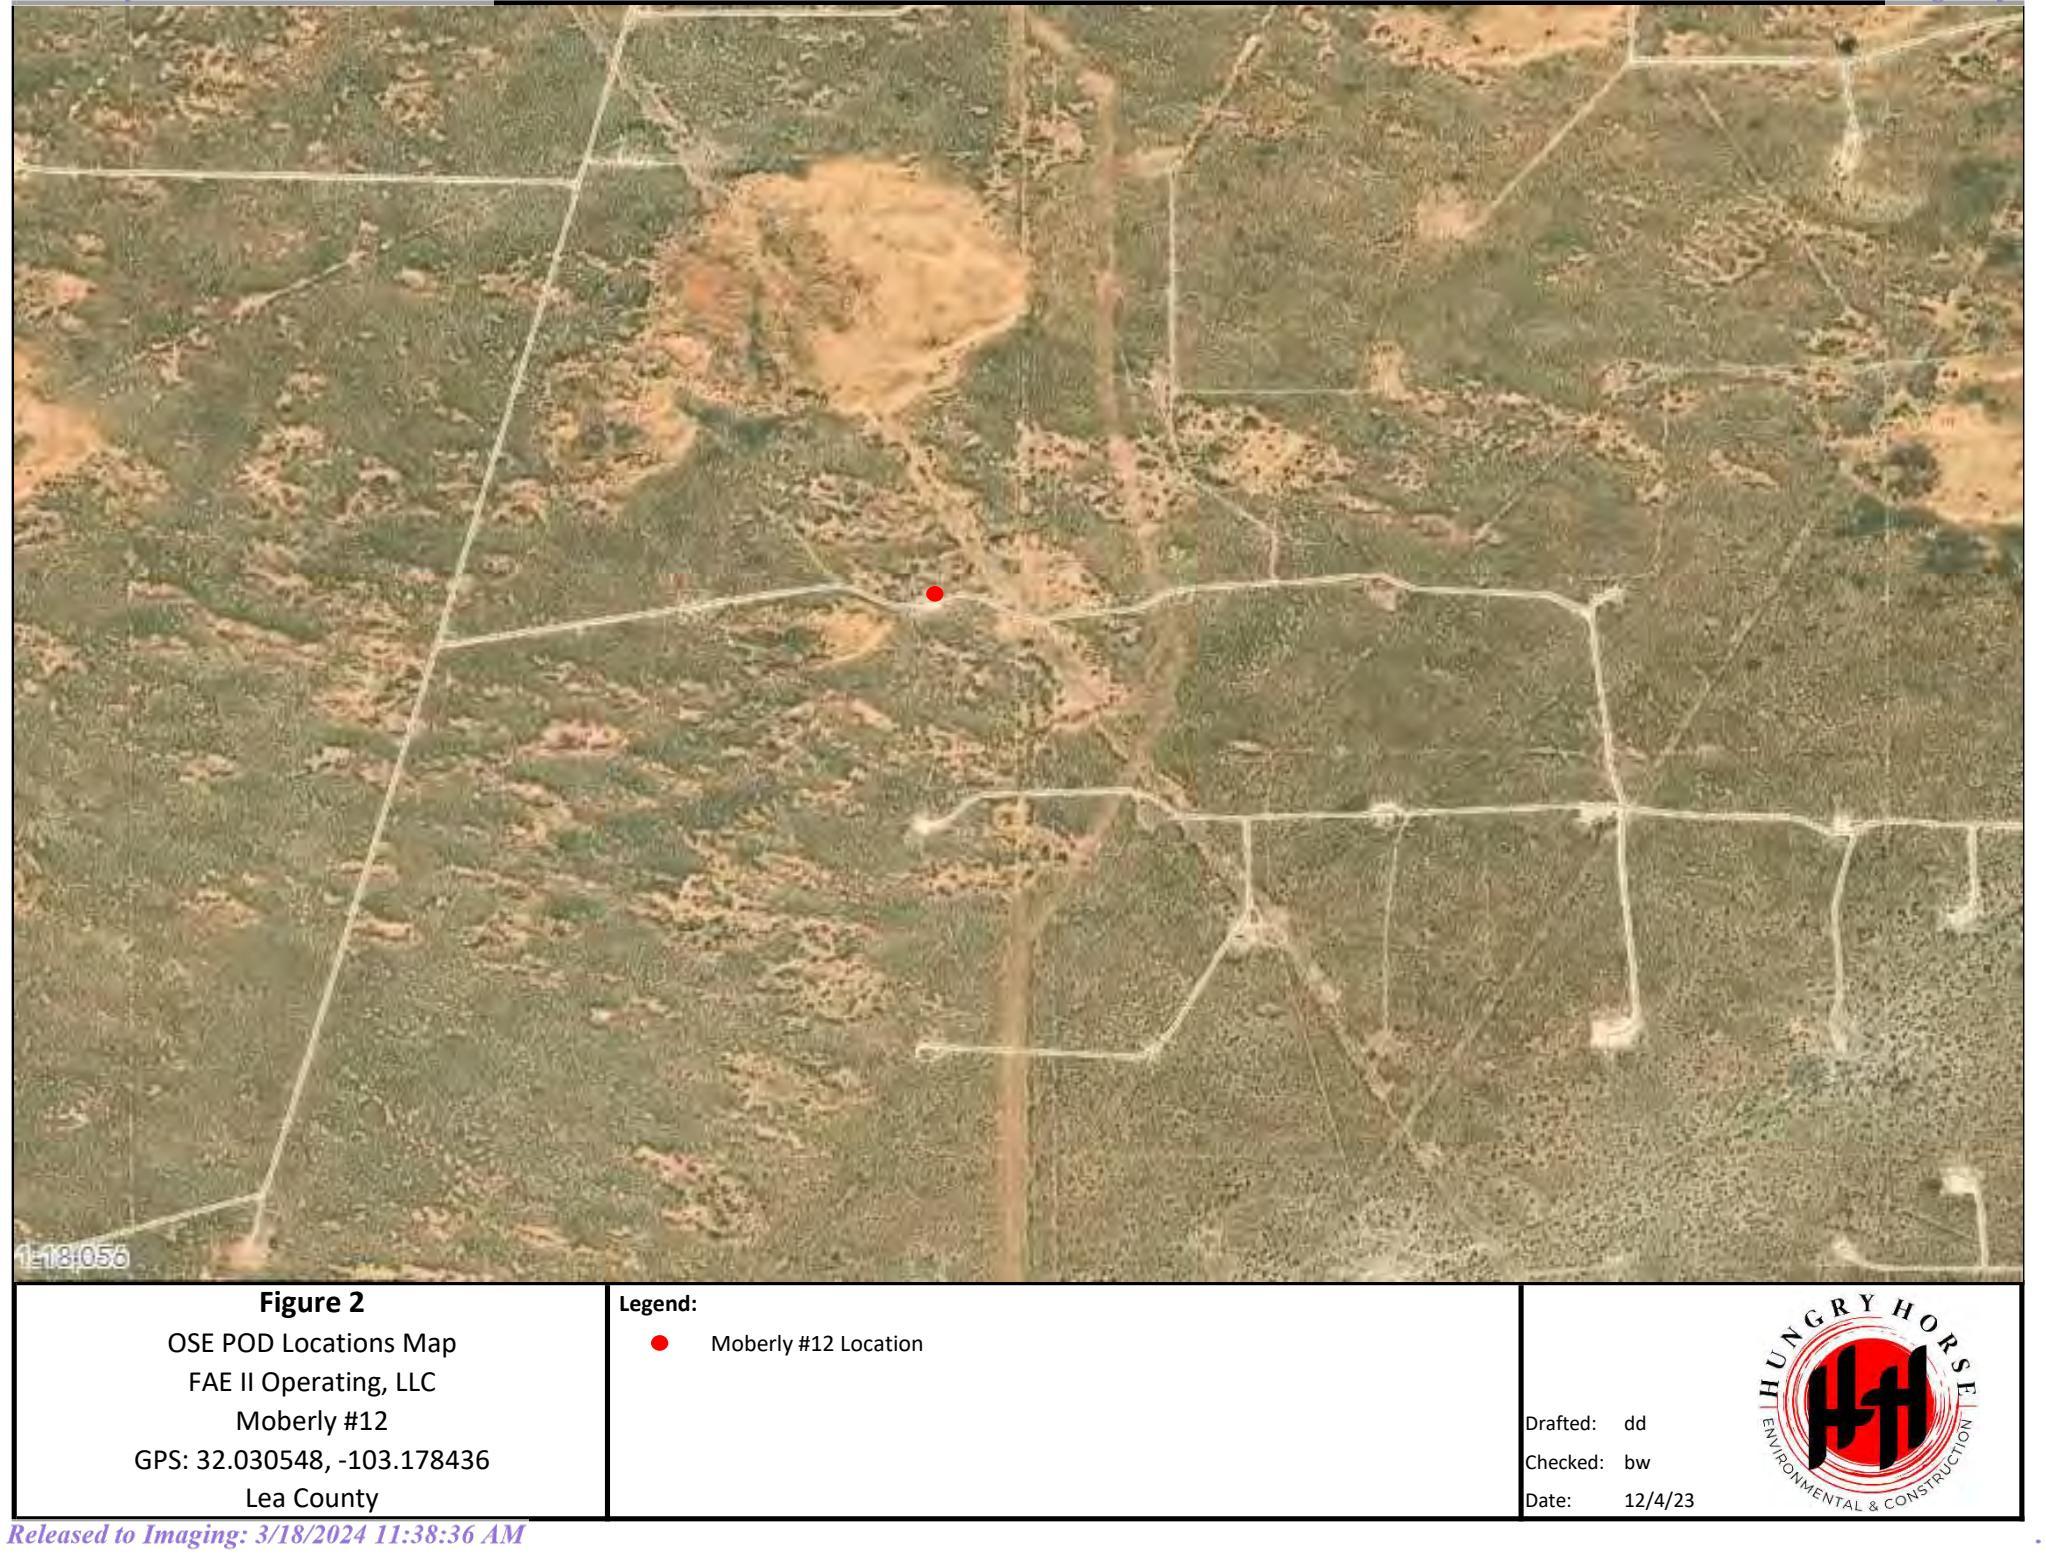
A search of the New Mexico Office of the State Engineer (NMOSE) and United States Geological Survey (USGS) groundwater databases was completed in an effort to determine the horizontal distance to known water sources within a half mile radius of the Release Site. Approximate depth to groundwater was determined using maintained and published water well data. Karst mapping indicates the site is located in a Karst designated area. Karst and Wetland Maps are provided as Attachment I. Depth to groundwater information is provided as Attachment V and the results are depicted on Figures 2 & 3.

One water well was located in the vicinity of the release area. USGS well 320204103093501 was located 1.09 miles northeast of the location. Gauging in 2001 indicated depth to water of approximately 92.46 feet bgs. However, as the release occurred within a Karst designated area, the site was remediated according to the strictest NMOCD Closure Criteria. Utilizing this information, the NMOCD Closure Criteria for the Site were determined as follows:

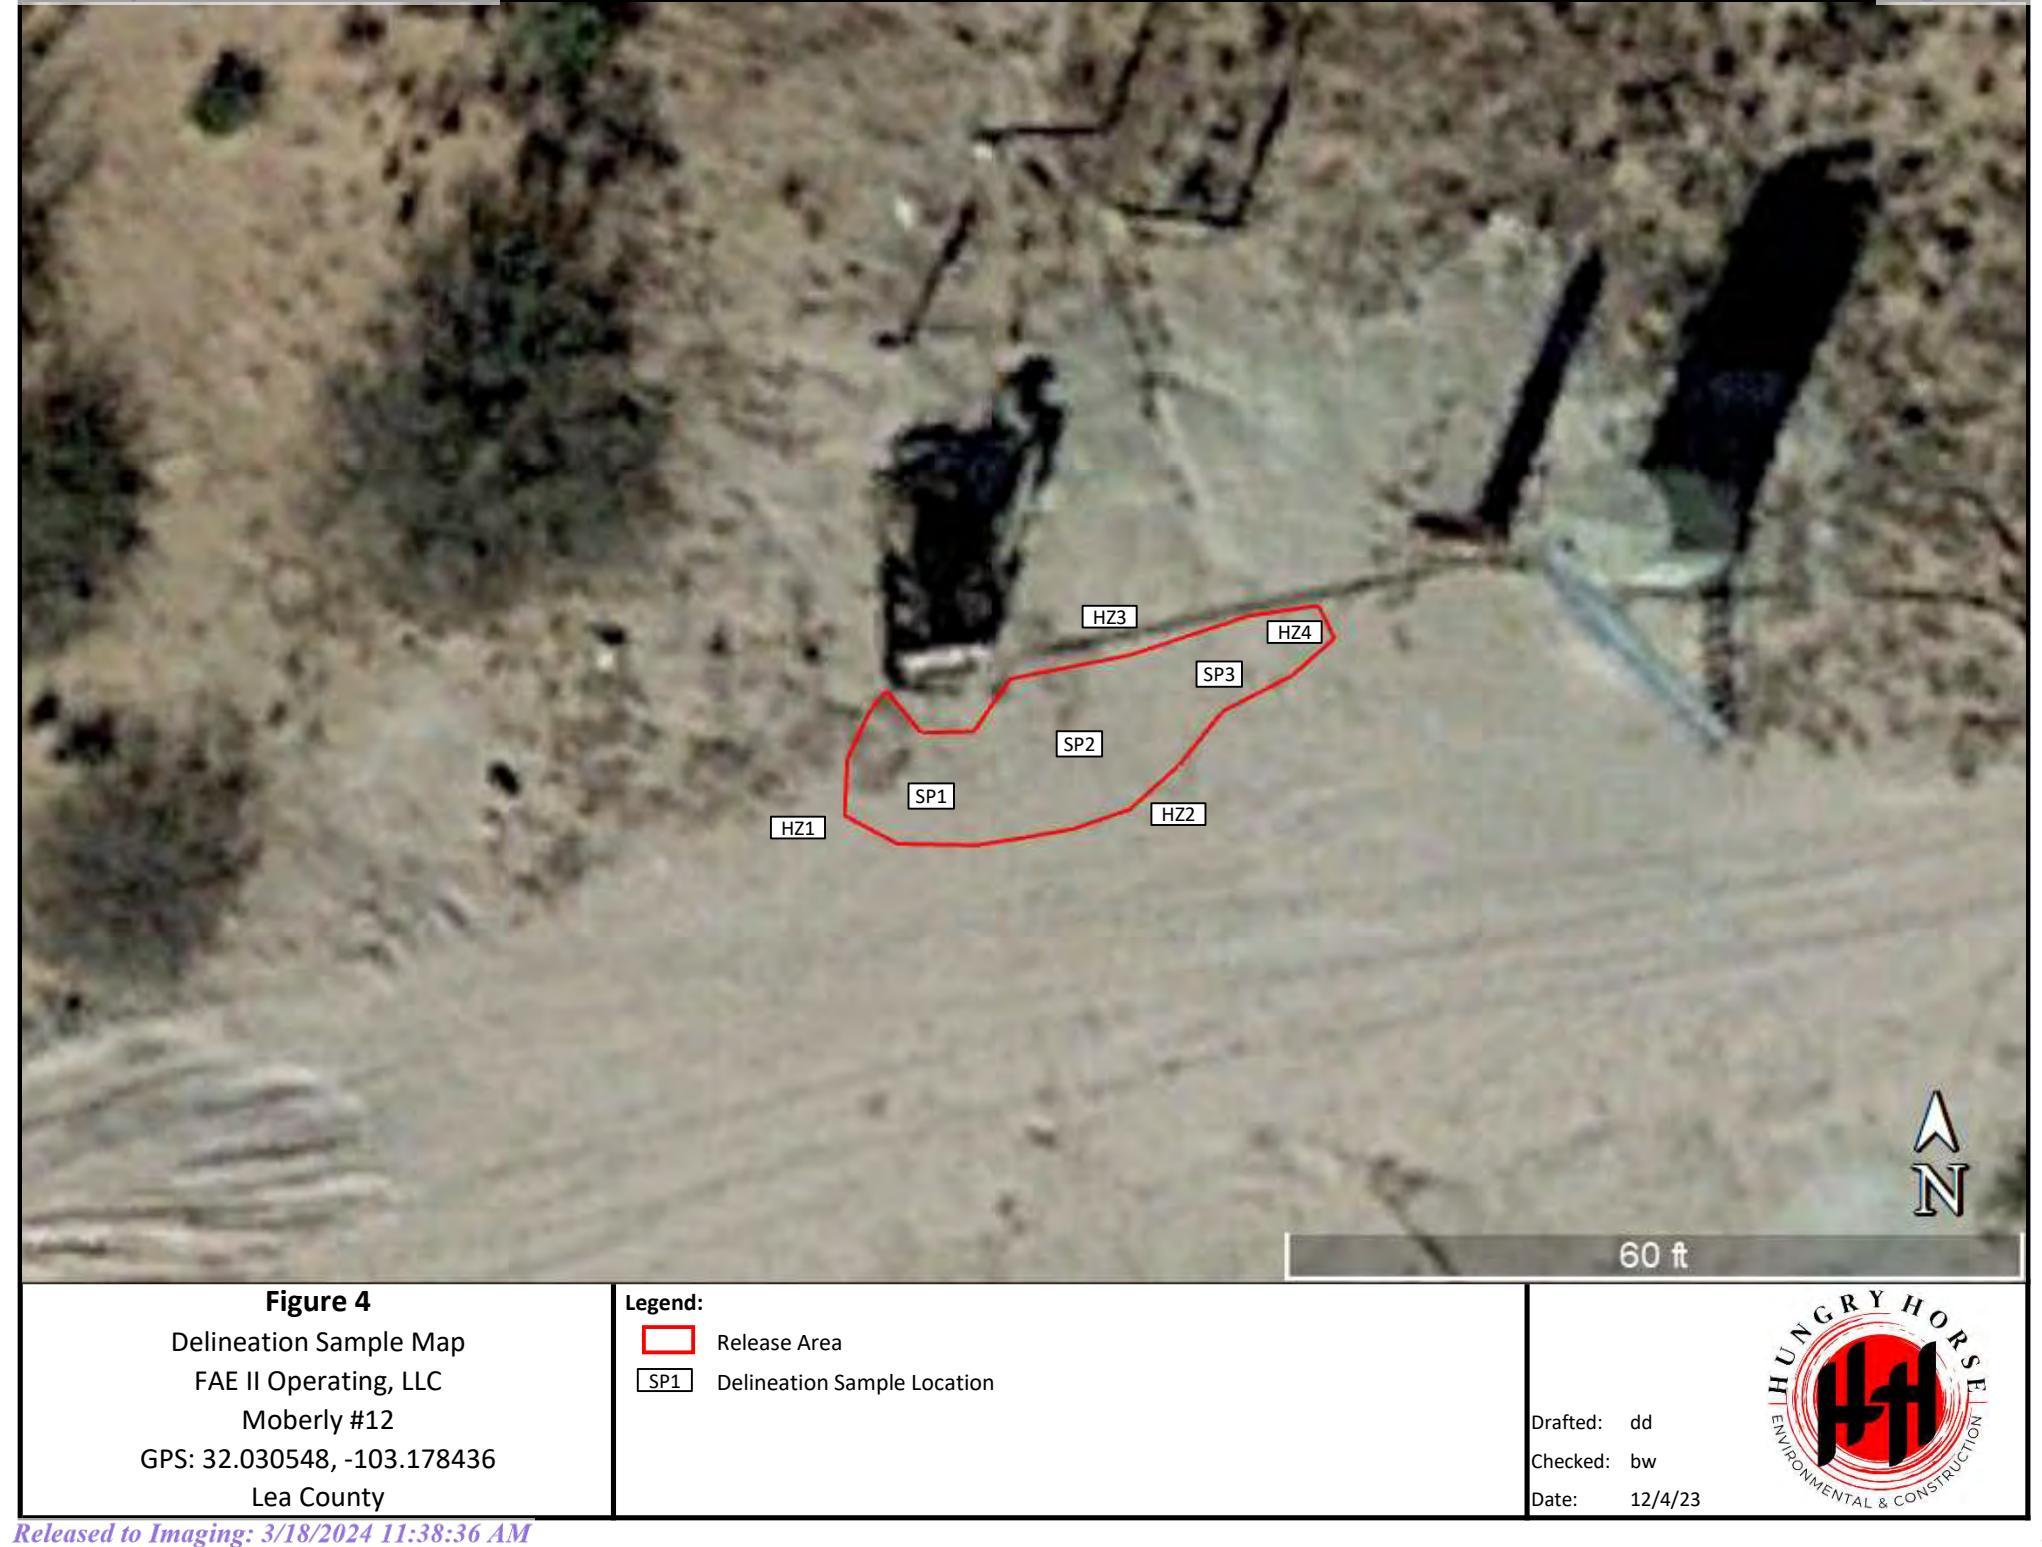
On October 12, 2023, Hungry Horse conducted an initial site assessment consisting of photographing, mapping, and sampling the release area. During sampling, hand augered test bores were advanced throughout the affected area in an effort to determine the vertical extent of contamination. These sample locations are identified by SP designation. On October 19, 2023, hand augered sample bores were advanced along the outside edges of the affected area in an effort to determine the horizontal extent of contamination. These sample locations are identified by HZ designation. During the advancement of the hand augered sample bores, soil samples were collected and field screened for the presence of chloride concentrations utilizing a Hach Quantab<sup>®</sup> chloride test kit.

Based on field observations and field test data noted above and provided in Attachment IV, thirteen representative soil samples were selected for laboratory analysis. Delineation soil samples SP1 through SP3, HZ1 through HZ4, were submitted to the laboratory for analysis of BTEX, TPH, and chloride. Laboratory analytical results indicated contaminant concentrations were below the NMOCD Closure Criteria in each of the submitted samples, with the exception of SP1 at Surface, SP3 at one-foot bgs, and HZ4 at Surface and one-foot bgs, which exhibited TPH and/or chloride concentrations in excess of NMOCD Closure Criteria.

A Delineation Sample Map and Excavation Sample Map are provided as Figure 4 and Figure 5, respectively. A Summary of Soil Sample Laboratory Analytical Results is provided as Table 1 and Laboratory Analytical Reports are provided as Attachment VI.

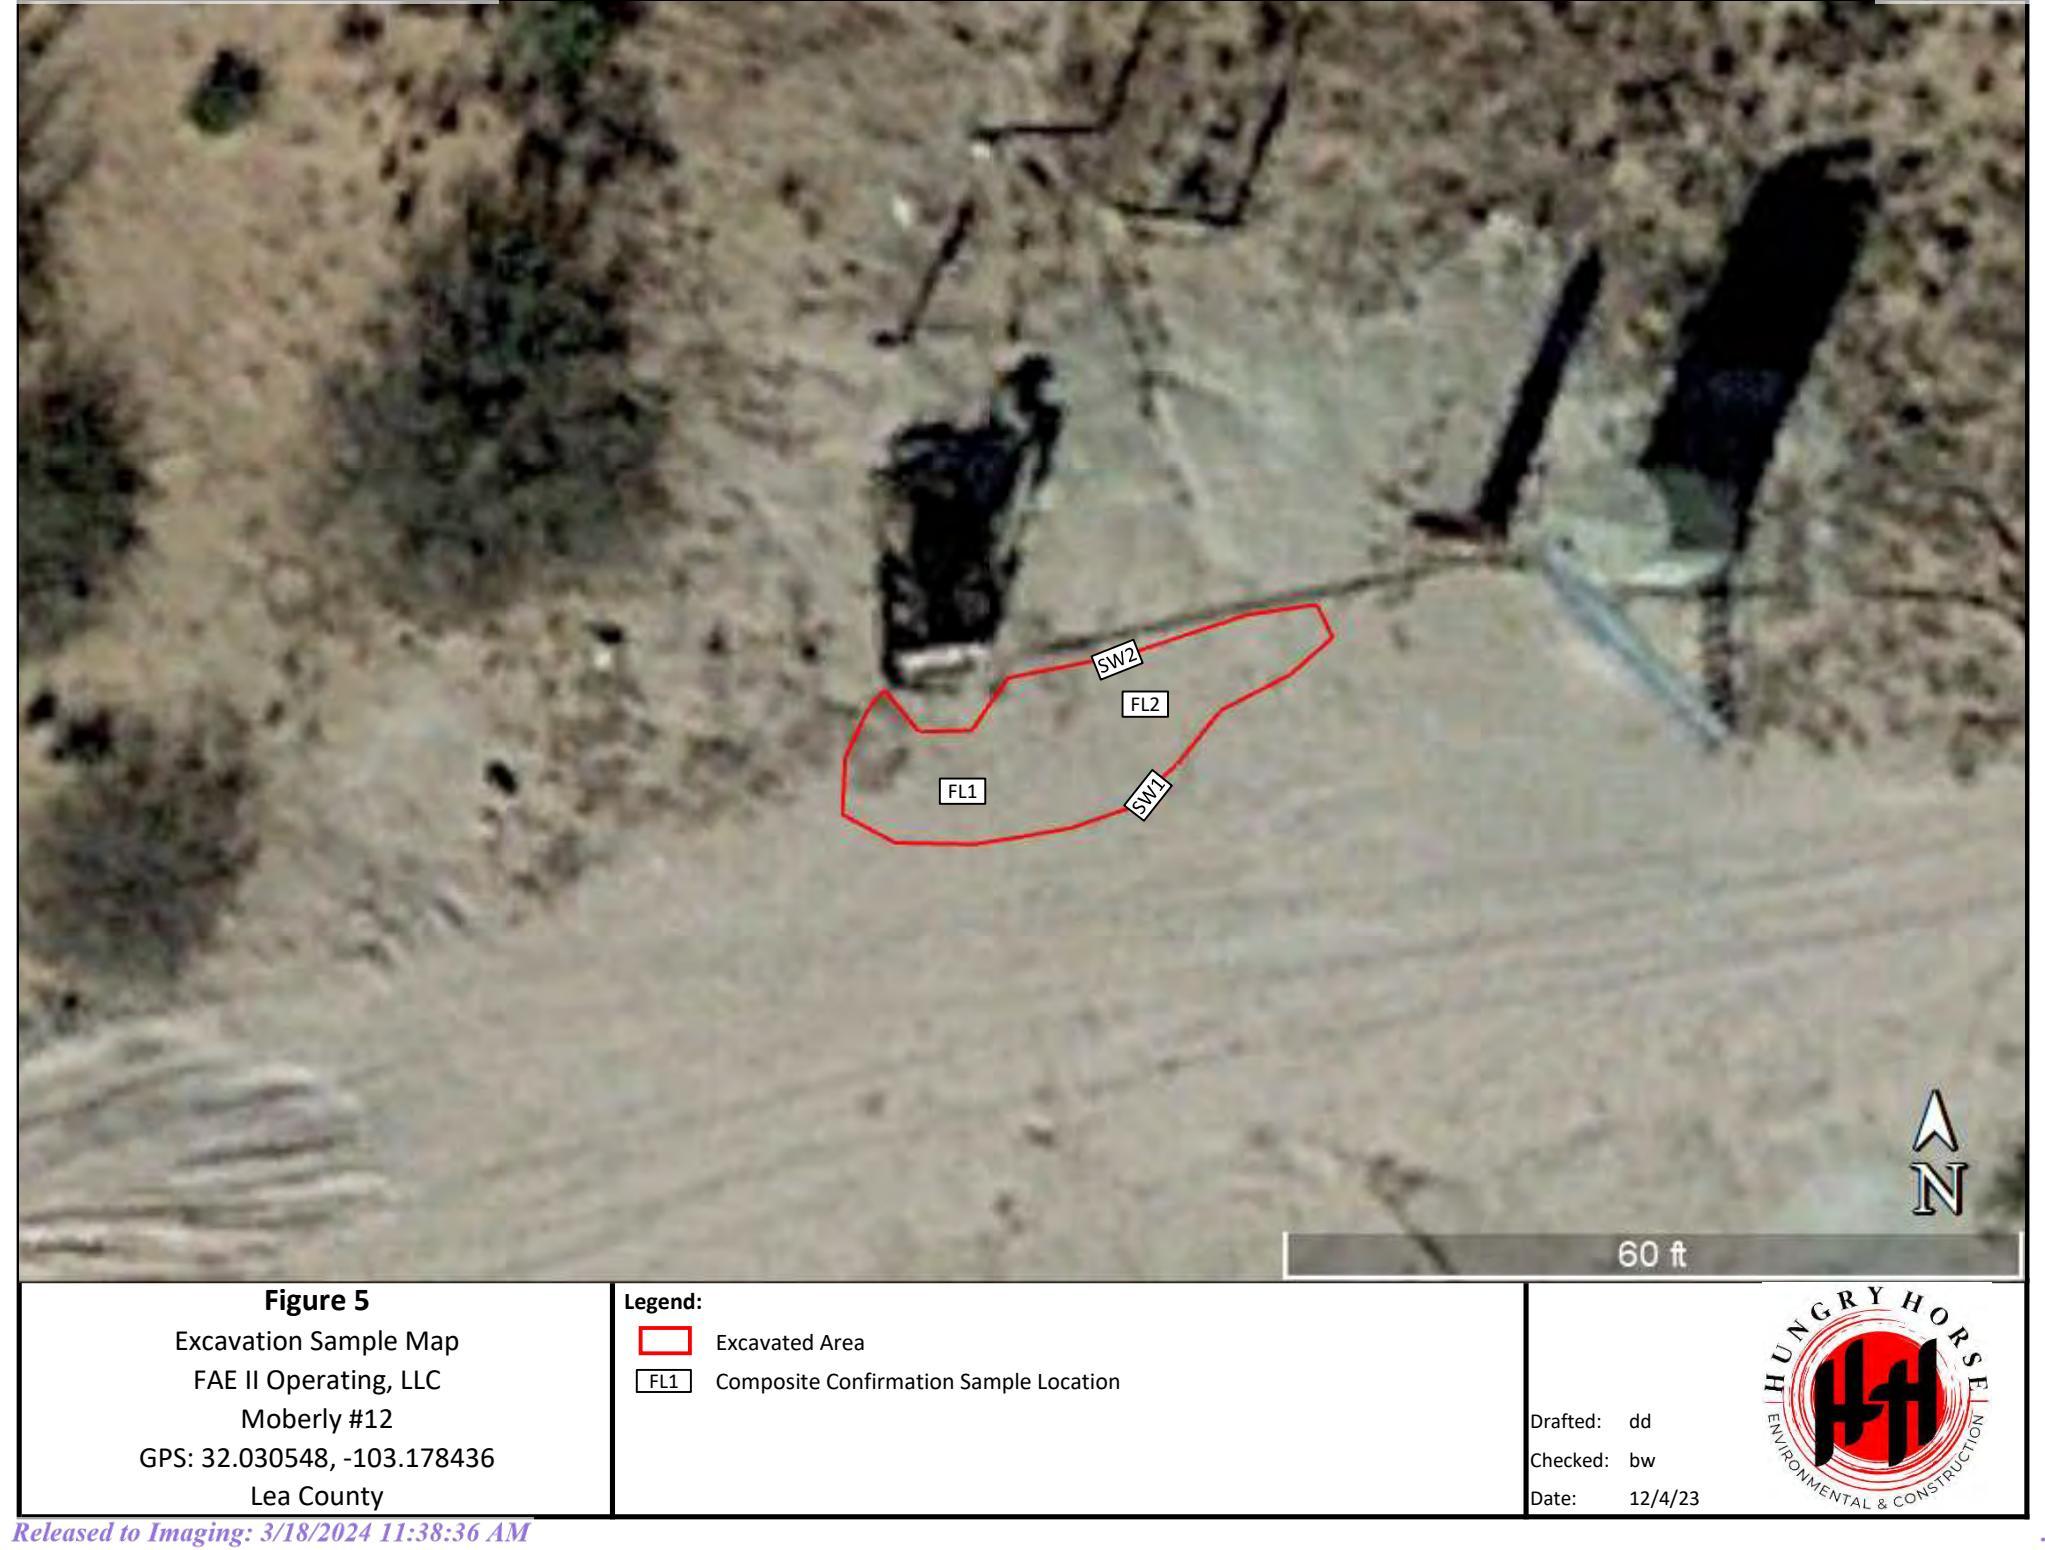
On November 9, 2023, the release area was excavated to a depth ranging from one to five feet bgs. Excavated contaminated soil was temporarily stockpiled onsite, atop plastic, before transport to an NMOCD approved disposal facility.

On December 1, 2023, four composite confirmation soil samples were collected from the excavation floor and sidewalls, every 200 square feet and every 50 linear feet, respectively. Soil samples FL1, FL2, SW1, and SW2, were submitted to the laboratory for analysis of BTEX, TPH, and chloride. Laboratory analytical results indicated contaminant concentrations were below the NMOCD Closure Criteria in each of the submitted samples.

The excavated area measured approximately four hundred square feet. During remediation activities approximately 50 cubic yards of impacted soil were excavated and hauled to an NMOCD approved disposal facility.
