## QUARTERLY MONITORING REPORT 4th Quarter, 1993

## AMOCO PRODUCTION CORPORATION SAN JUAN GRAVEL A-1 PRODUCTION TANK PIT AREA

Project: 92140

QUARTERLY MONITORING REPORT 4th QUARTER, 1993 AMOCO PRODUCTION CORPORATION SAN JUAN GRAVEL A-1 - TANK BATTERY PRODUCTION TANK PIT AREA SE/4, SE/4 (P) SECTION 21, T29N, R13W, NMPM FARMINGTON, SAN JUAN COUNTY, NEW MEXICO

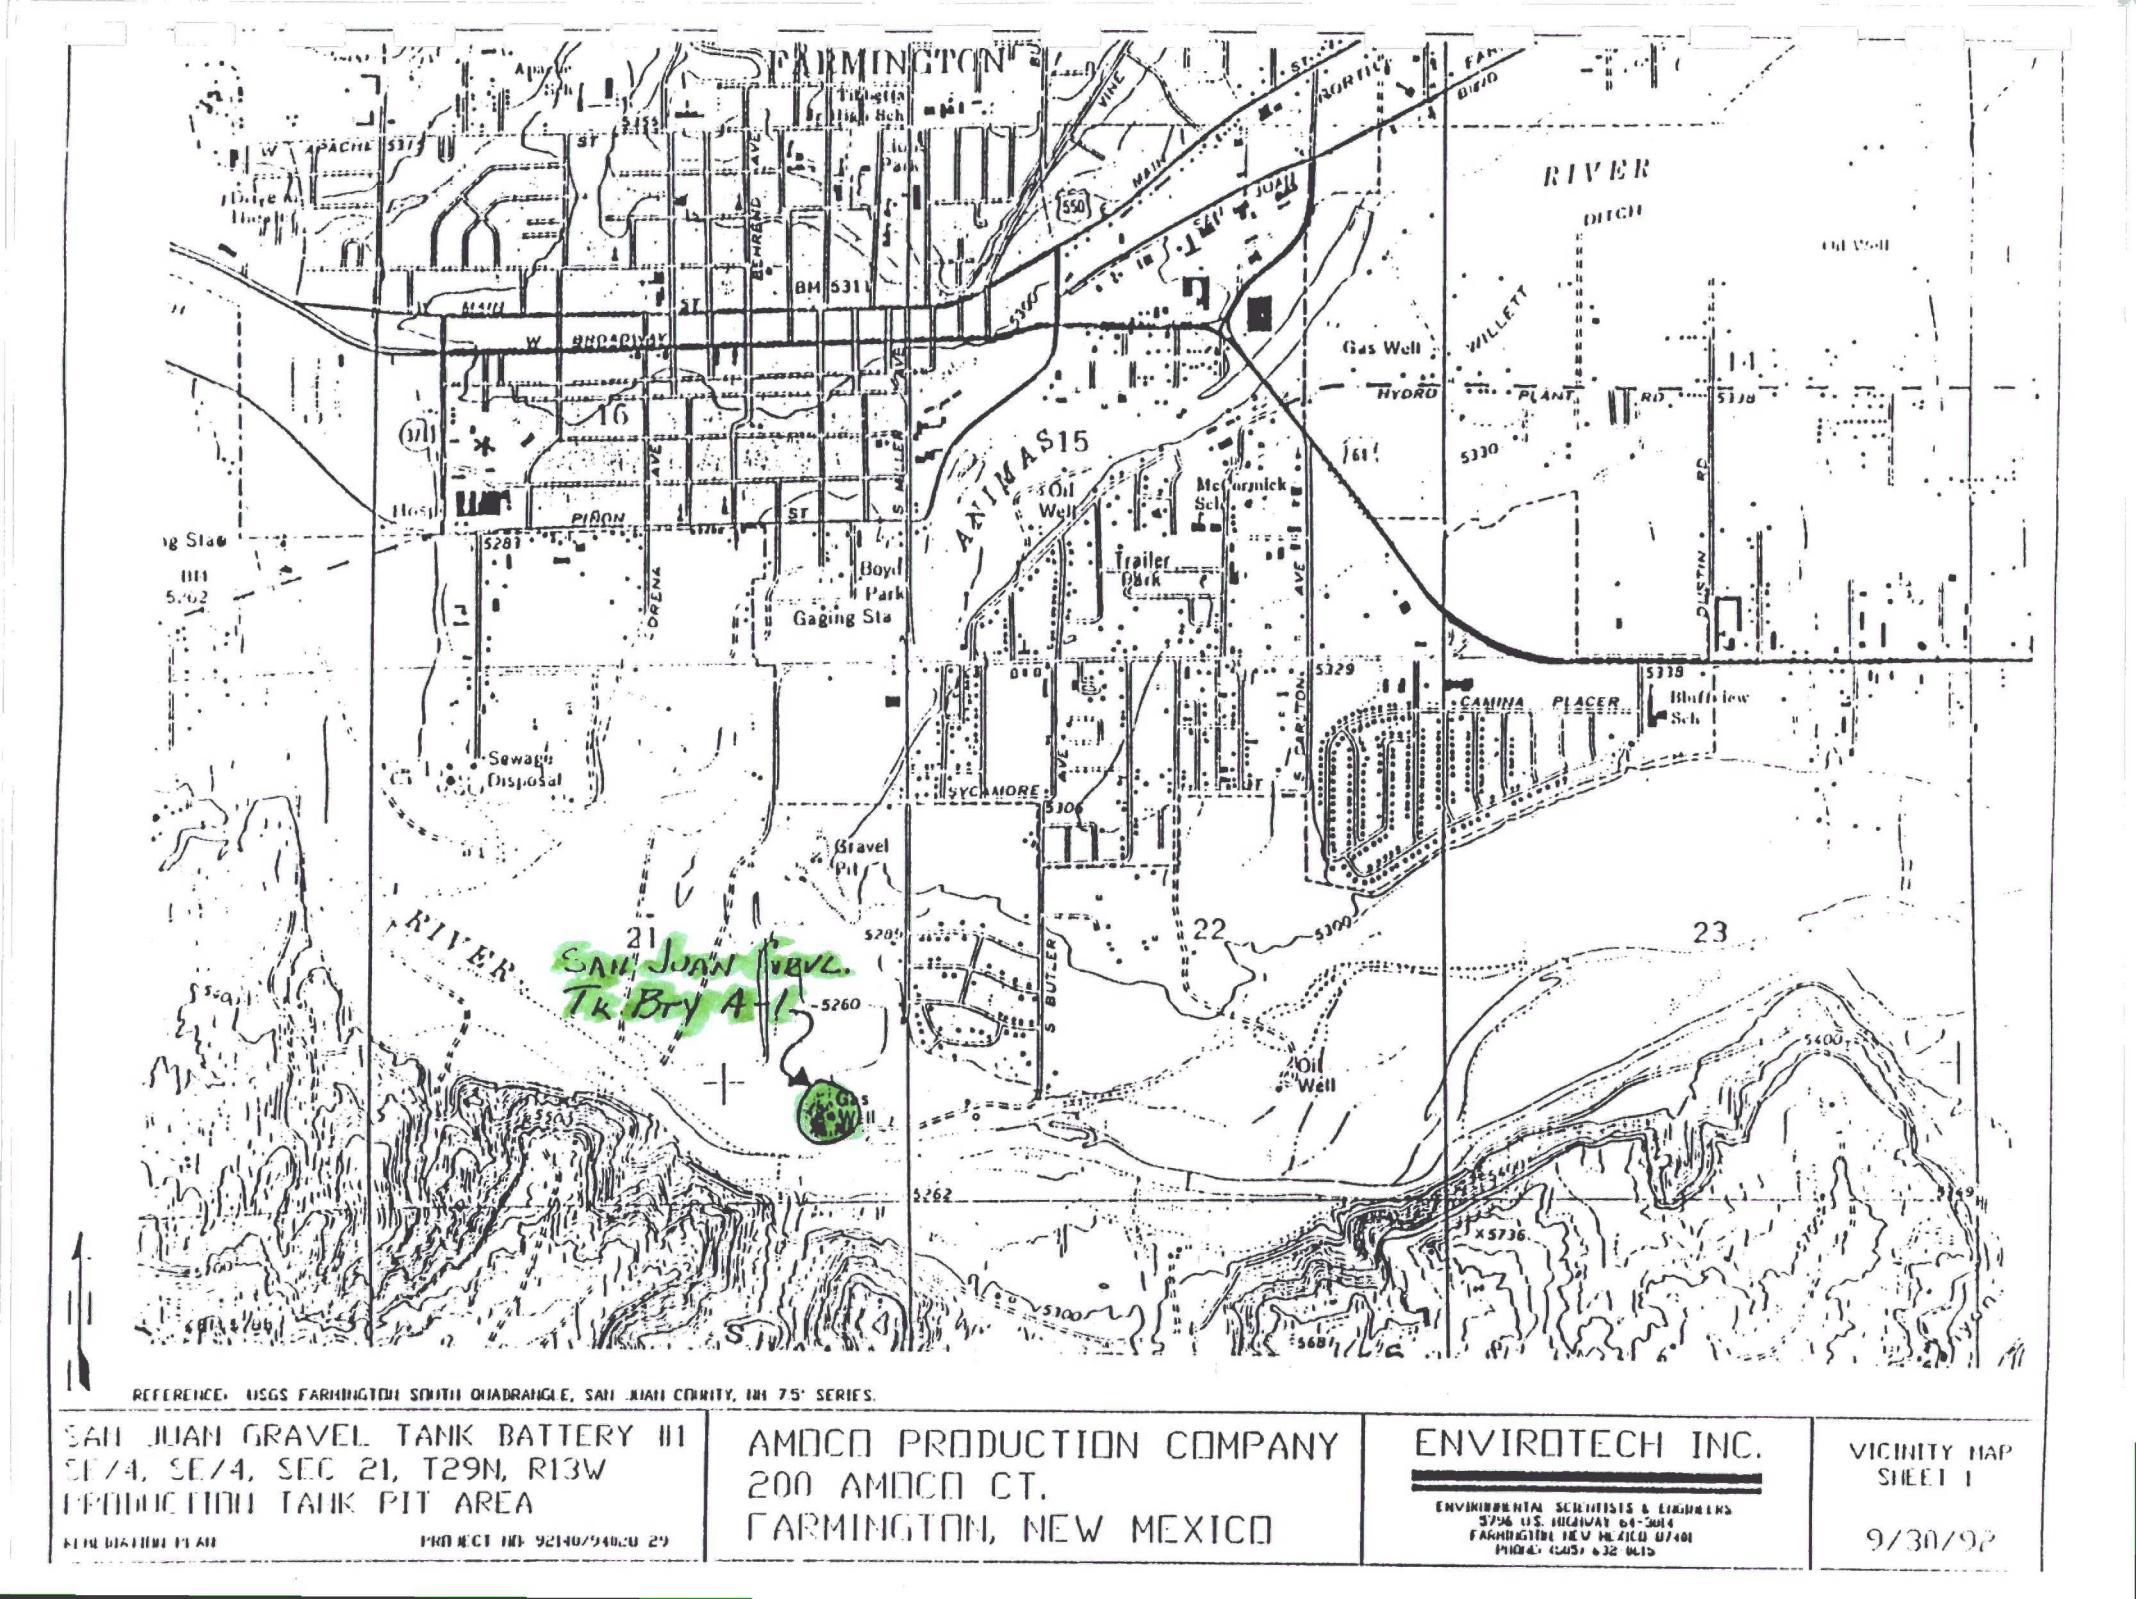
APPENDIX	A	Vicinity M	lap			
		Site Diagr	cam with	groundwater	contour	elevations

Based upon groundwater elevation measurements taken on November 19, 1993, the groundwater flow direction appears to be towards the southwest (refer to Site Diagram - Appendix A). Measurements taken on July 6, 1993 indicated west-southwest trend. It should be noted that the water level has dropped approximately one half of a foot since the July 6, 1993 sampling event.

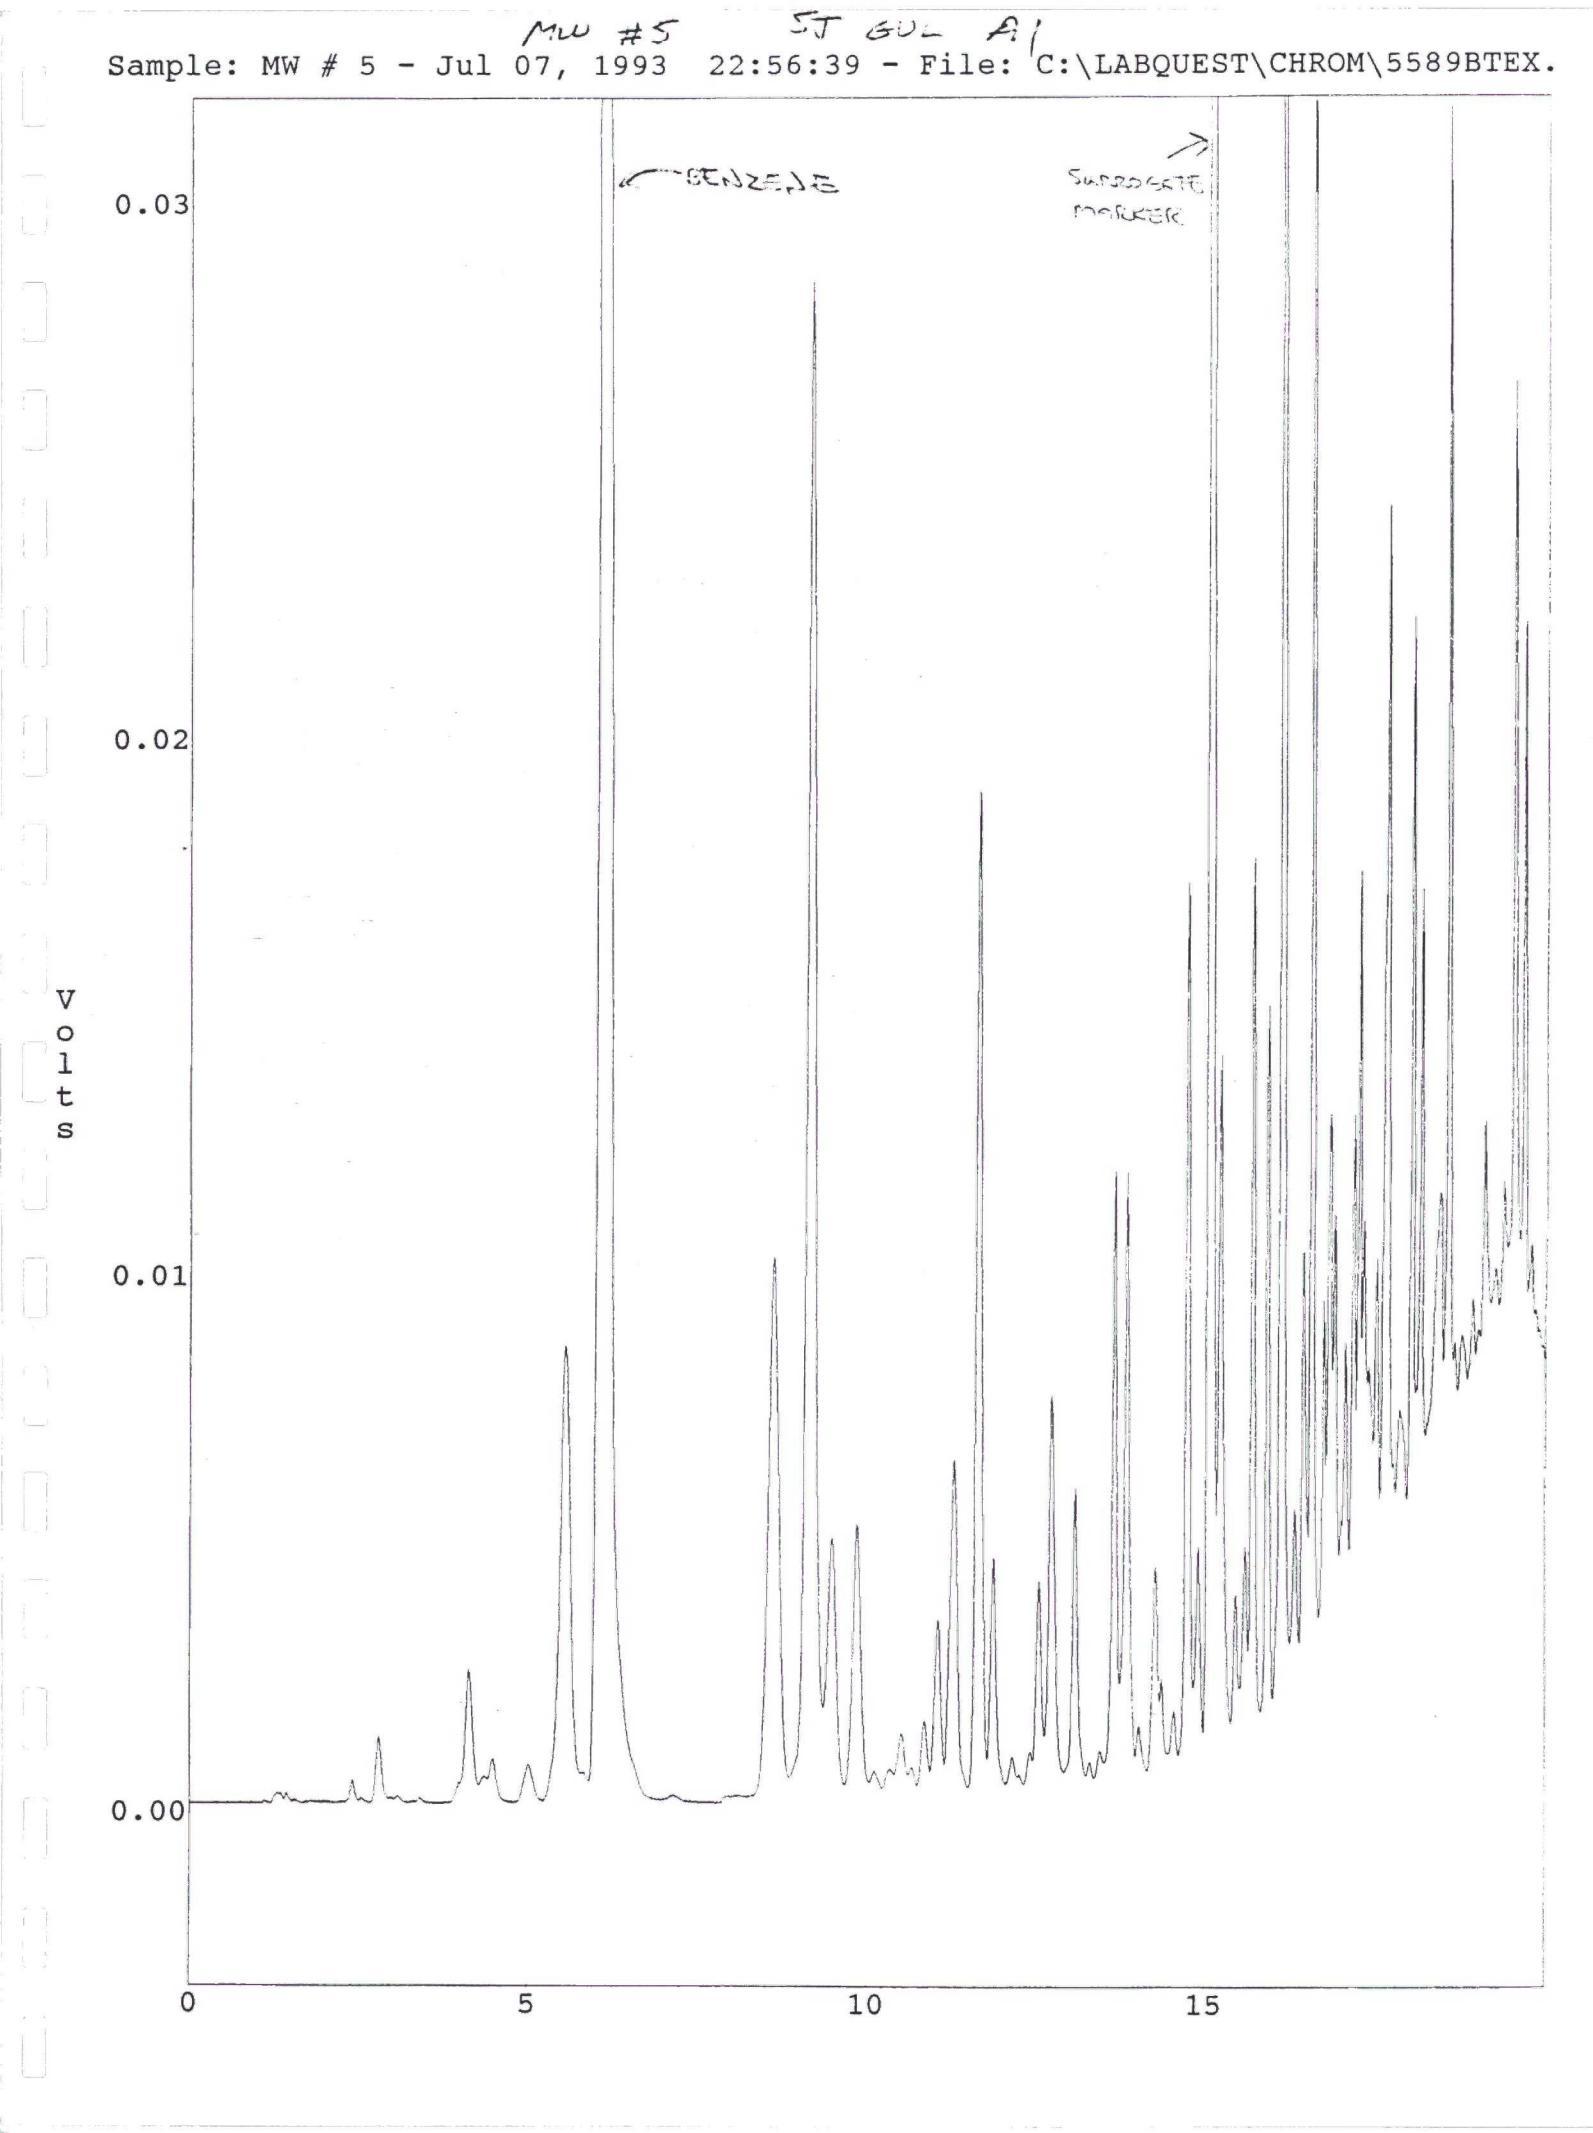
APPENDIX B Laboratory Analyses Monitor Well # 5 Gas Chromatogram Laboratory QA/QC Documentation Chain-Of-Custody Records DECEMBER 1993

The laboratory analysis conducted during this sampling event indicates that monitor well #5 does not have a benzene level (0.4 parts per billion) exceeding regulatory standards. Monitor well #5 is located in the proximity of the plume center. The sampling event conducted on July 6, 1993 had recorded a benzene concentration of 229 ppb. Two postulations toward this dramatic decrease are; 1) microbial activity within the proximity of monitor well #5 has increased on a order of magnitude in order to dissolve the lighter hydrocarbon components, and/or 2) the system may have collected the lighter hydrocarbons, but not the medium to heavy hydrocarbons components (review laboratory gas chromatogram -Appendix B).
