WORKPLANS

R. T. HICKS CONSULTANTS, LTD.

RE: Investigation Characterization Plan Vacuum Salt Water Disposal System: F-25 EOL, L-26 Vent NMOCD Case #s: Not Yet Assigned T17S, R35E, Section 25 and 26

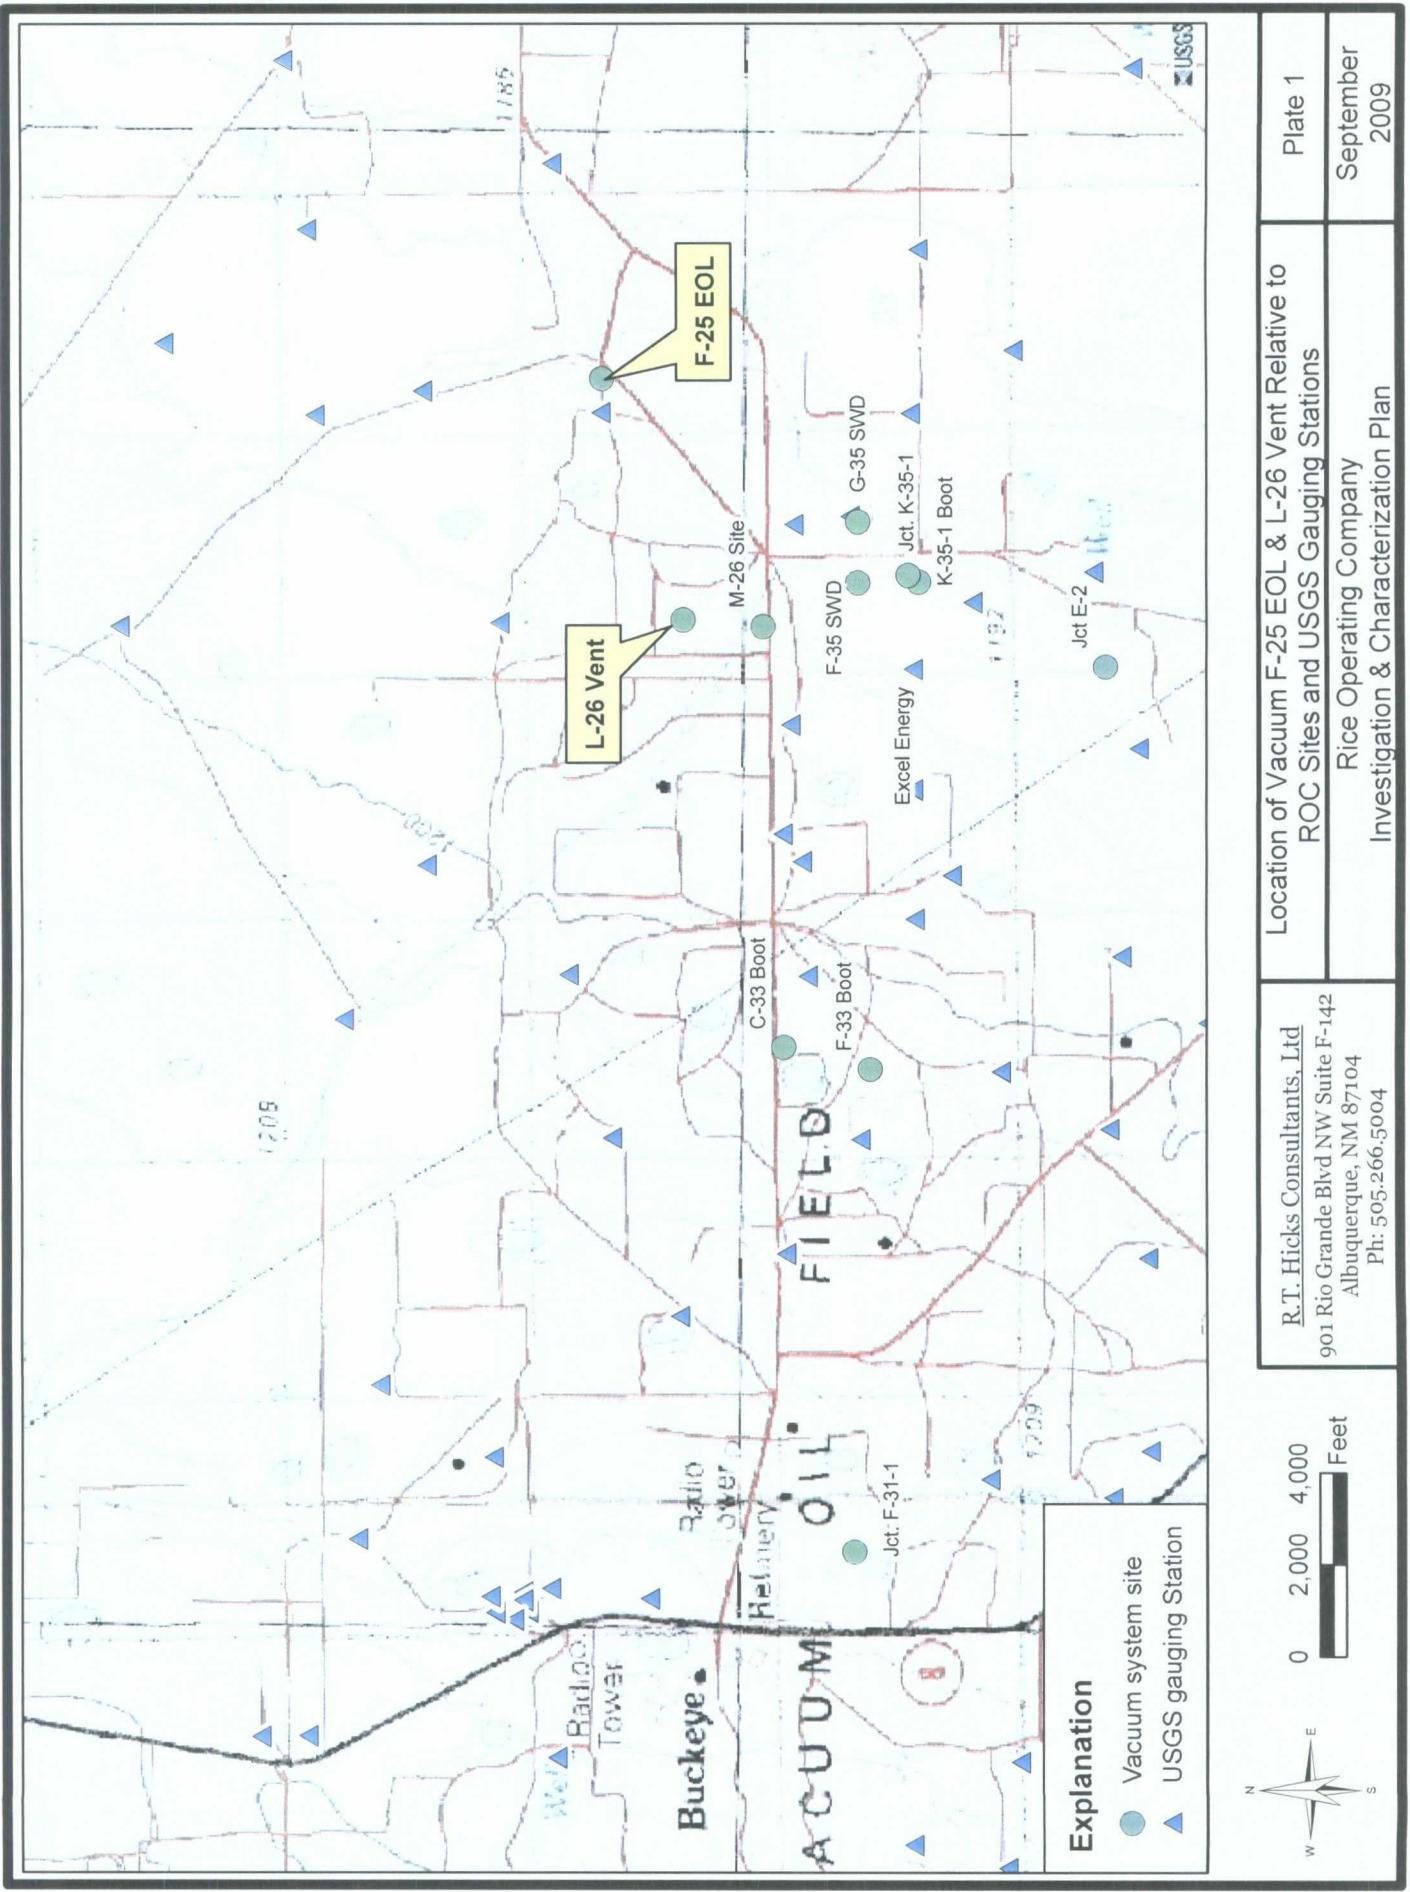
On behalf of Rice Operating Company (ROC), R.T. Hicks Consultants, Ltd. is pleased to submit this Investigation Characterization Plan (ICP) for the above- referenced sites within the Vacuum Salt Water Disposal System. Plate 1 is a map showing the sites relative to major roads in the area, nearby ROC sites and nearby USGS monitoring wells. GPS coordinates for the site are approximately: N32° 48.479, W103° 24.917 (F-25 EOL) and N32° 48.199, W103° 25.945 (L-26).

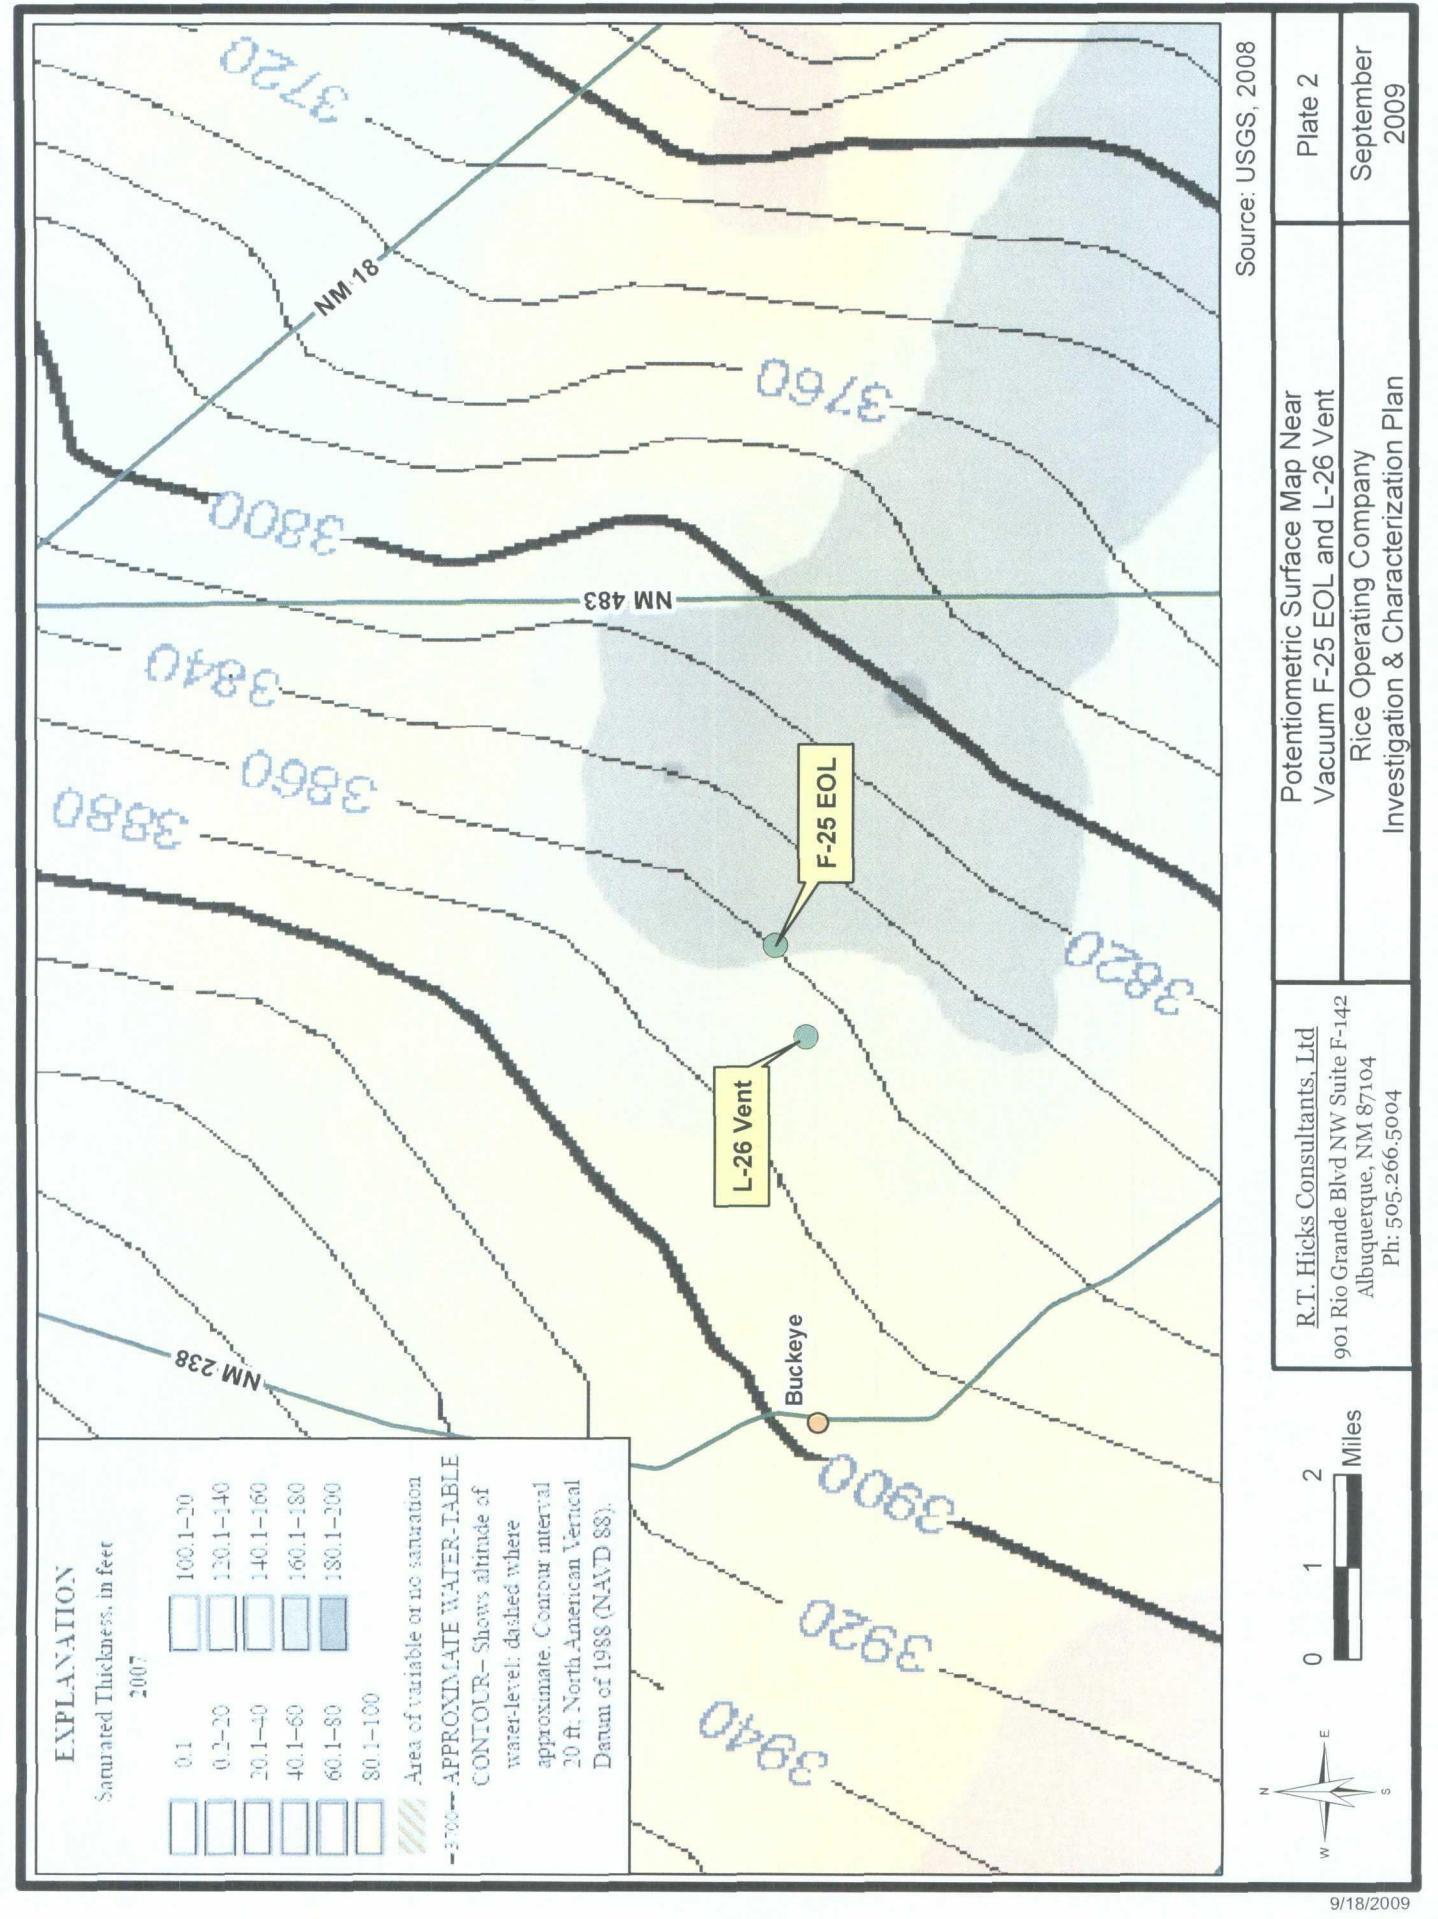
S:/PROJECTS/ROC/VACUUM_F25_EOL/PLATESICP/USGS_POT.MXD

4. If warranted, we will install one monitor well to evaluate possible ground water impact. Plate 2 presents a potentiometric surface map for the site area.
