CLOSURE

BD F-2 EOL

Unit F, Section 2, T22S, R36E

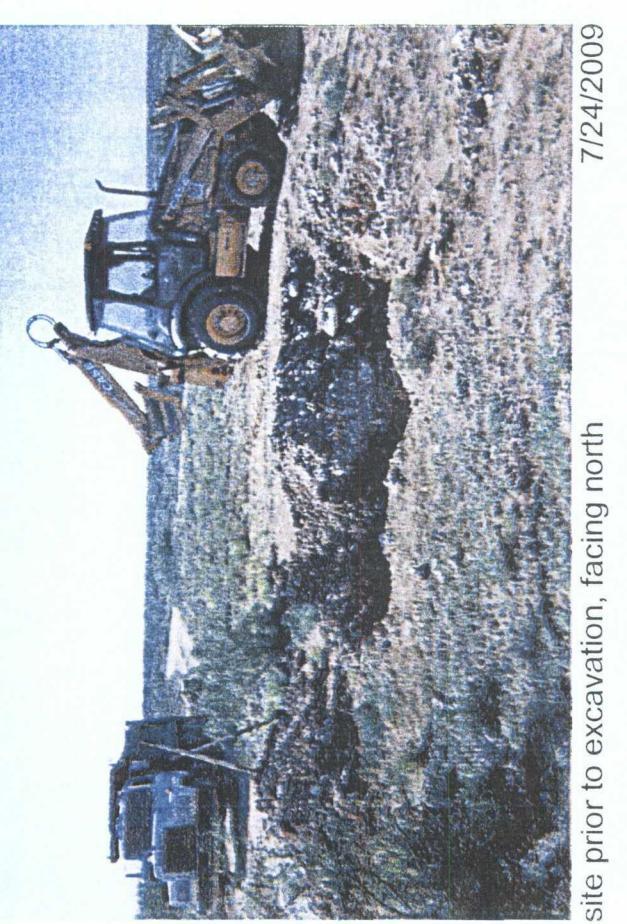
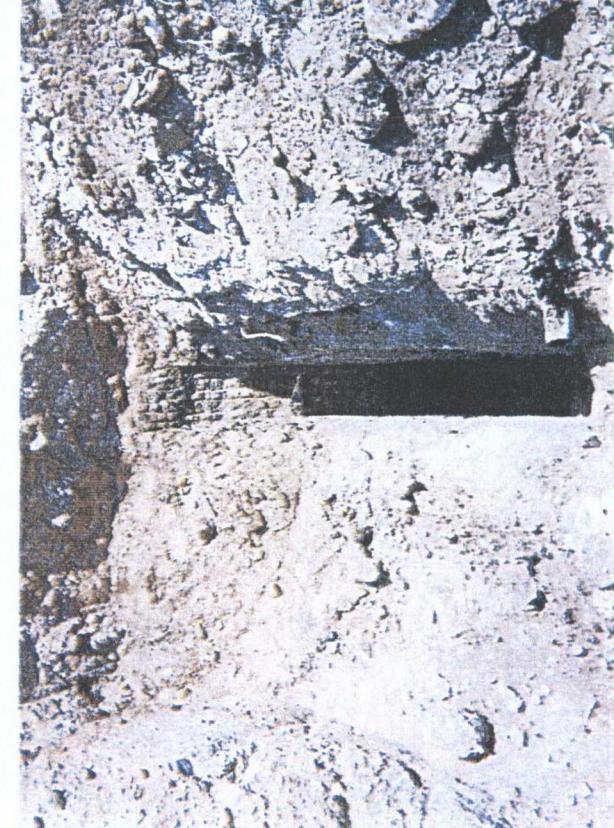
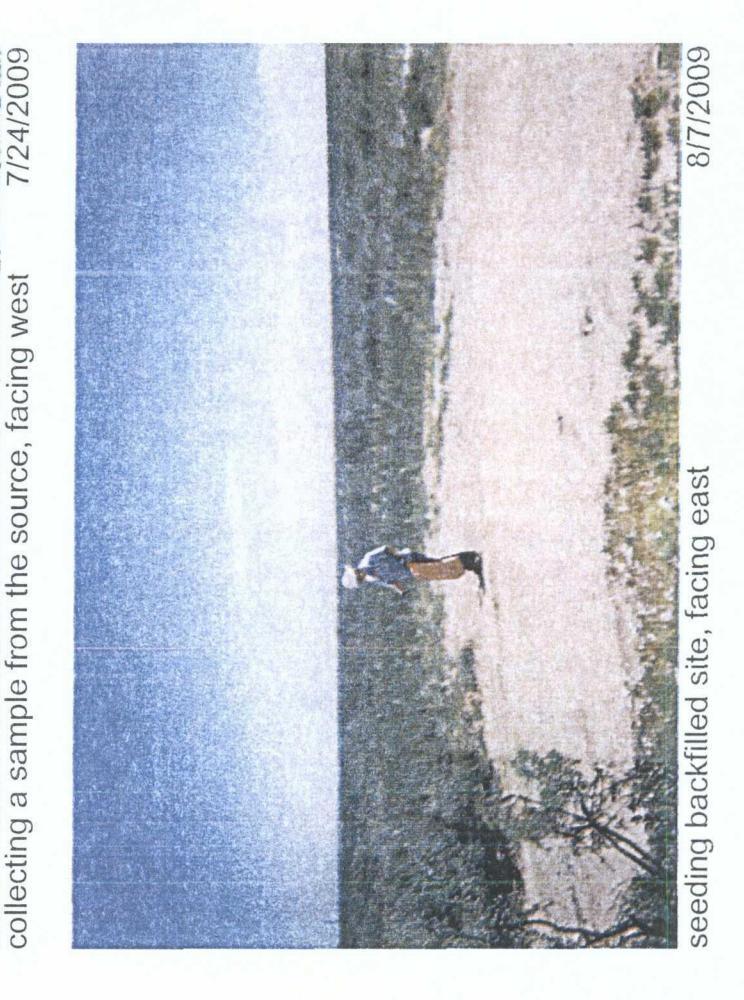
7/24/2009

final excavation, facing north

SOURCE 8' GRAB	SOURCE 8' GRAB 8.5 <10.0 593 <16 background 6"					6"	210		
							Vortical	4'	238
General Description	of Remedi	al Action:	This junction	n was eliminat	ed during the	9	delineation	5'	124
pipeline replacement/upgrade program. After the former junction box was removed, an trench at the 6' 119							119		
investigation was conducted using a backhoe to collect soil samples at regular intervals junction 7' 11							119		
creating a 2x6x8-ft deep excavation. Chloride field tests yielded concentrations similar to 8' 149							149		
that of the background. (Drganic vapo	ors were mea	asured using	a PID, which	yielded low				I,
concentrations. The deep	pest sample	, 8 ft BGS, w	as sent to a	commercial la	aboratory for	analysis	of chloride and TF	PH, which yiel	ded low
concentrations. The exca	avated soil w	as returned	to the excava	ation to groun	d surface and	d contour	ed to the surround	ding area. Or	ı 8/7/2009,

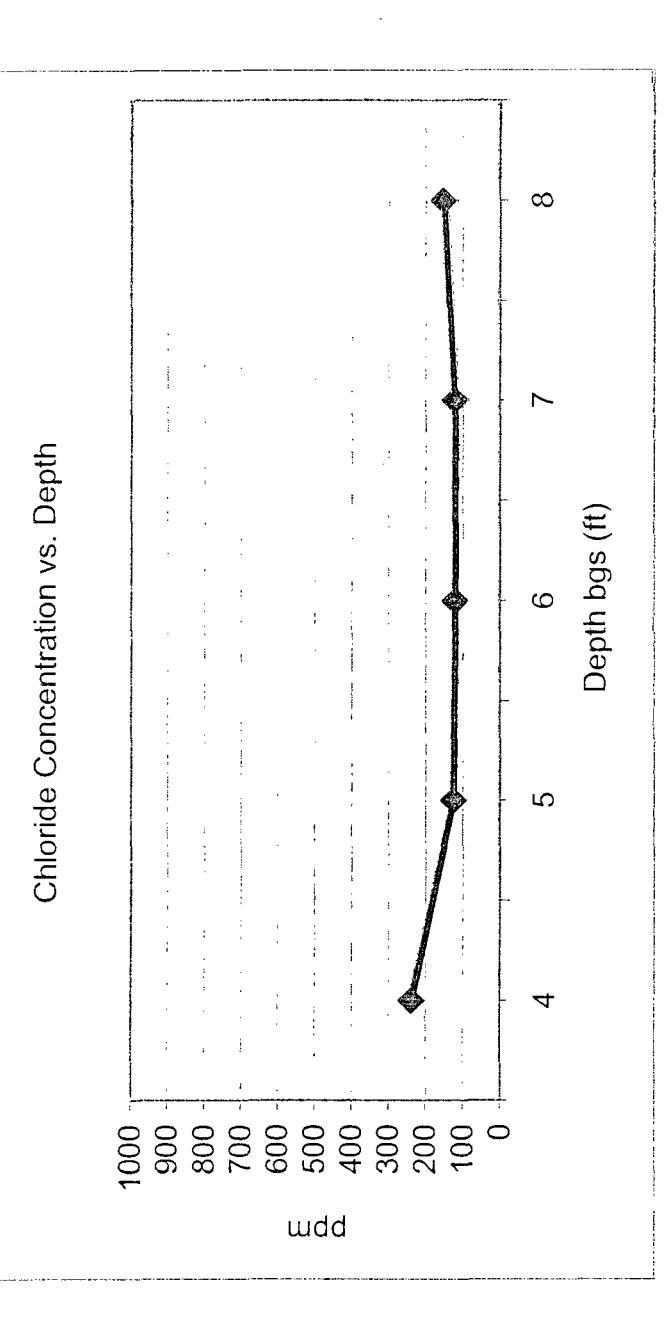
CHLORIDE CONCENTRATION CURVE

Backhoe samples at the junction (source)

Groundwater = 130 ft
