Details of bop testSamedan Oil CorporationFannin #110/6/73Contractor:W E K Drlg.Rig 2Test by Yellow Jacket Tools and Services, Inc.

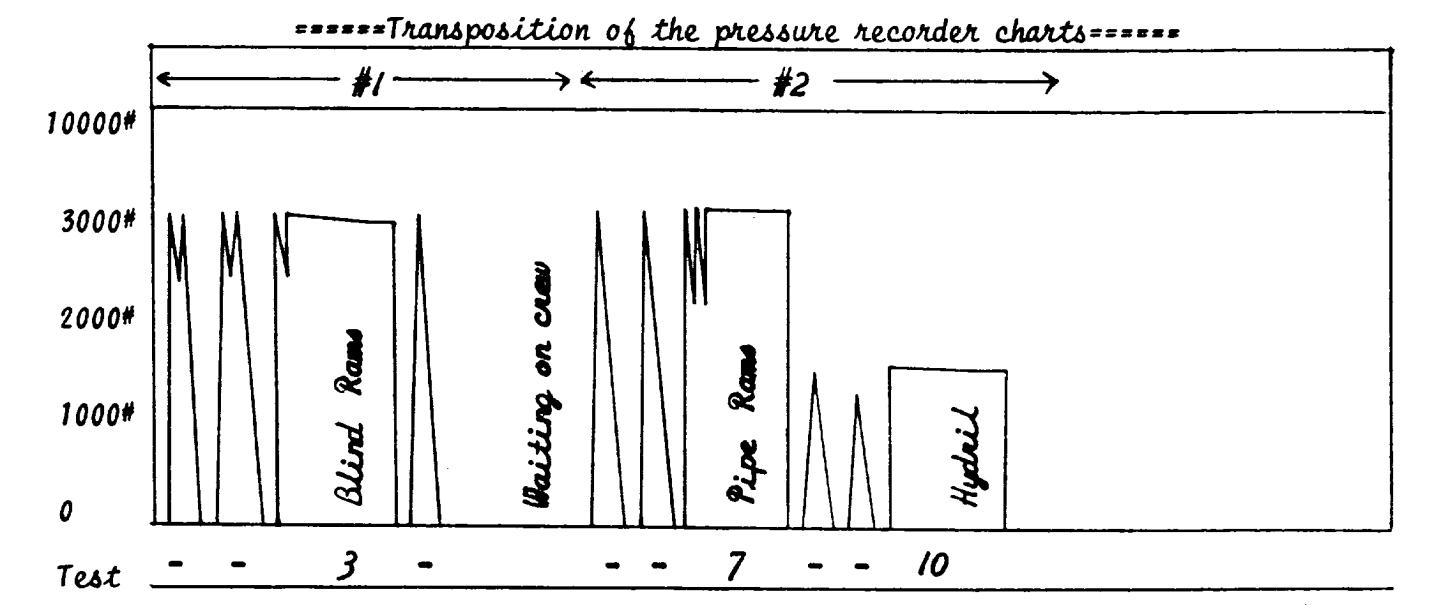
The above is a transposition of the pressure recorder charts covering test to the blowout control equipment in service on your well drilling in the Artesia Area, Hobbs District, New Mexico. Test was made with test plug landed in casing head with the following test results:

TESTING: Blind Rams with value closed off stack on kill line and all values closed off choke-manifold cross - pressure applied thru test entry of bull plug off tee on chokeline.

- Test #1 Pressured to 3000# with loss of pressure; repressured to 3000# with loss of pressure. Volume pump went out. Replaced.
- Test #2 Repeated test. Pressured to 3000# with loss of pressure; repressured to 3000# with <u>leak to thread connection of wing value</u> <u>off manifold cross (pipe rack side</u>). Tightened.
- Test #3 Repeated test. Pressured to 3000# with loss of pressure; repressured to 3000# with loss of approximately 200# during first
