Executive Summary EnerVest Jack B-2 & 3 Remediation Project 1PR-2541

ENERVEST JAL WEST LEAK 1RP-2541

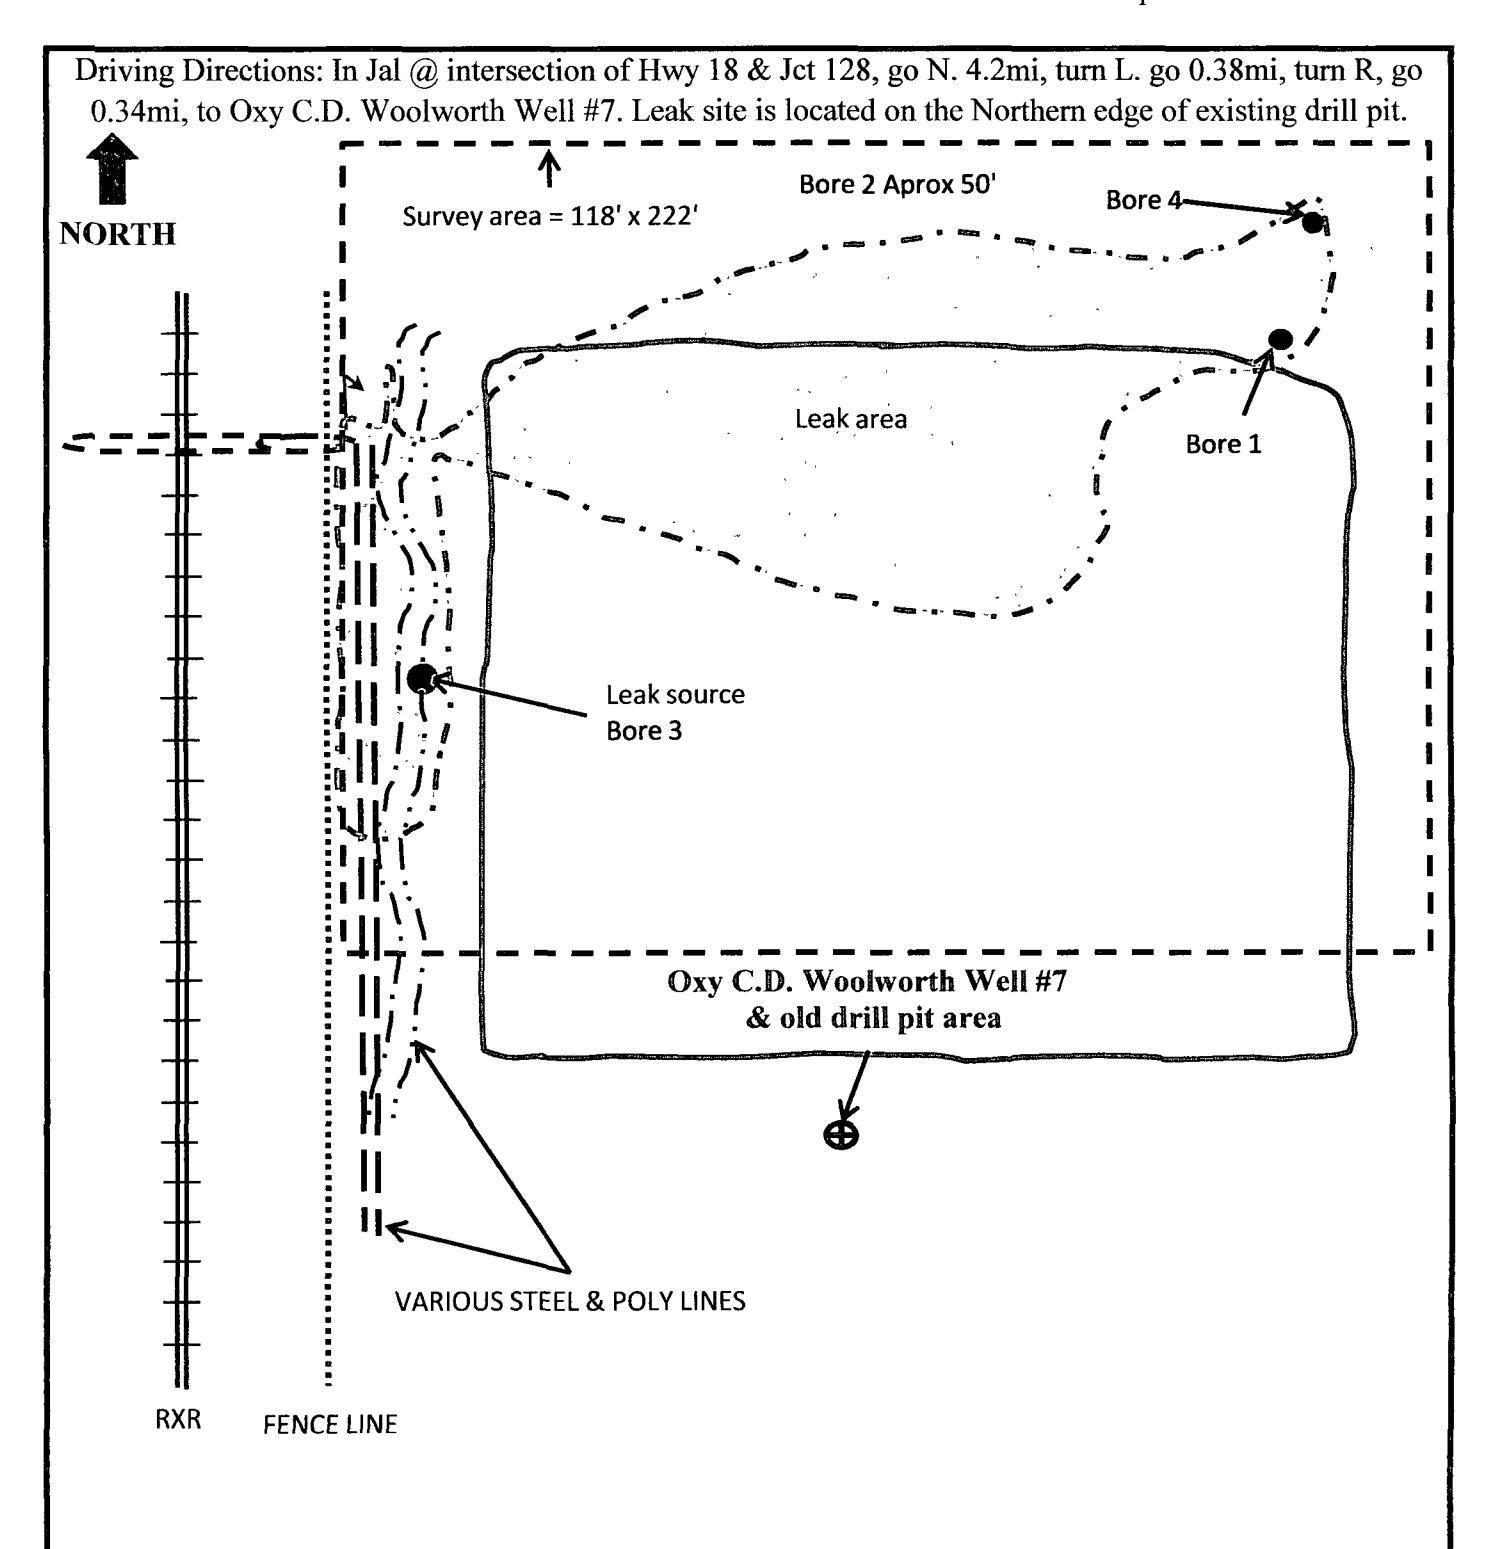
ENERVEST JAL WEST LEAK NW/SE UL/J SEC30 - T24S - R37E GPS LAT & LON NAD27 (DECIMAL) N32.16897350 / W103.20043950 DTW: 100' > 120' BGS Texaco / Chevron 2005 water data map
