Re: Shiner Bock 1 Federal Com #1
30-015-42015
Unit H, Section 02, T17S-R31E
Eddy Co., NM

COG Operating LLC would like to submit for your consideration the enclosed work plan for the above captioned well. The plan is in response to a release that occurred December 18, 2014.

Release Notification and Corrective Action

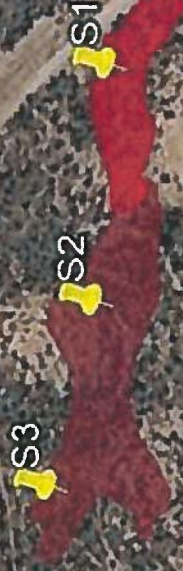
Shiner Bock 1 Federal Com #1

Initial soil samples were taken on 2/6/2015. TPH and BTEX were tested at a depth of 1' for each of the sample points with results concluding non-detect. Chloride concentration in one sampling area (S1) were elevated, therefore samples were taken at 2', 3', and 4'. These results indicated concentrations favorable for surface reclamation. Sample points 2 and 3 showed chloride concentration favorable for vegetation regrowth. (See attached site diagram).

S1	CI-
1'	11,300
2'	176
3'	272
4'	80
S2	CI-
1'	304
2'	32
3'	112
4'	ND
S3	CI-
1'	96
2'	ND
3'	80
4'	ND

- Excavation of S1 to a depth of approximately 1.5'. The excavation area would be approximately 620 square feet and would be backfilled with like material.
- S2 and S3 do not require any further remediation as chloride concentrations are favorable for vegetation regrowth.
