## **Beach Exploration, Inc.**

EQU #24 Location Spill  
Unit C, Sec 11, T-19-S R-29-E

### **Remediation Plan**

December 20, 2016

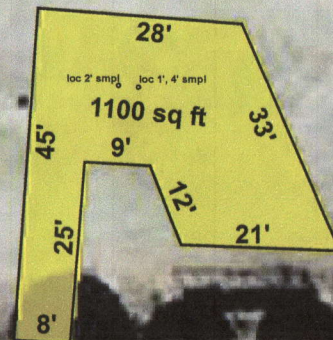
EQU #24

**Spill Delineation**  
(Based on Original Photos)

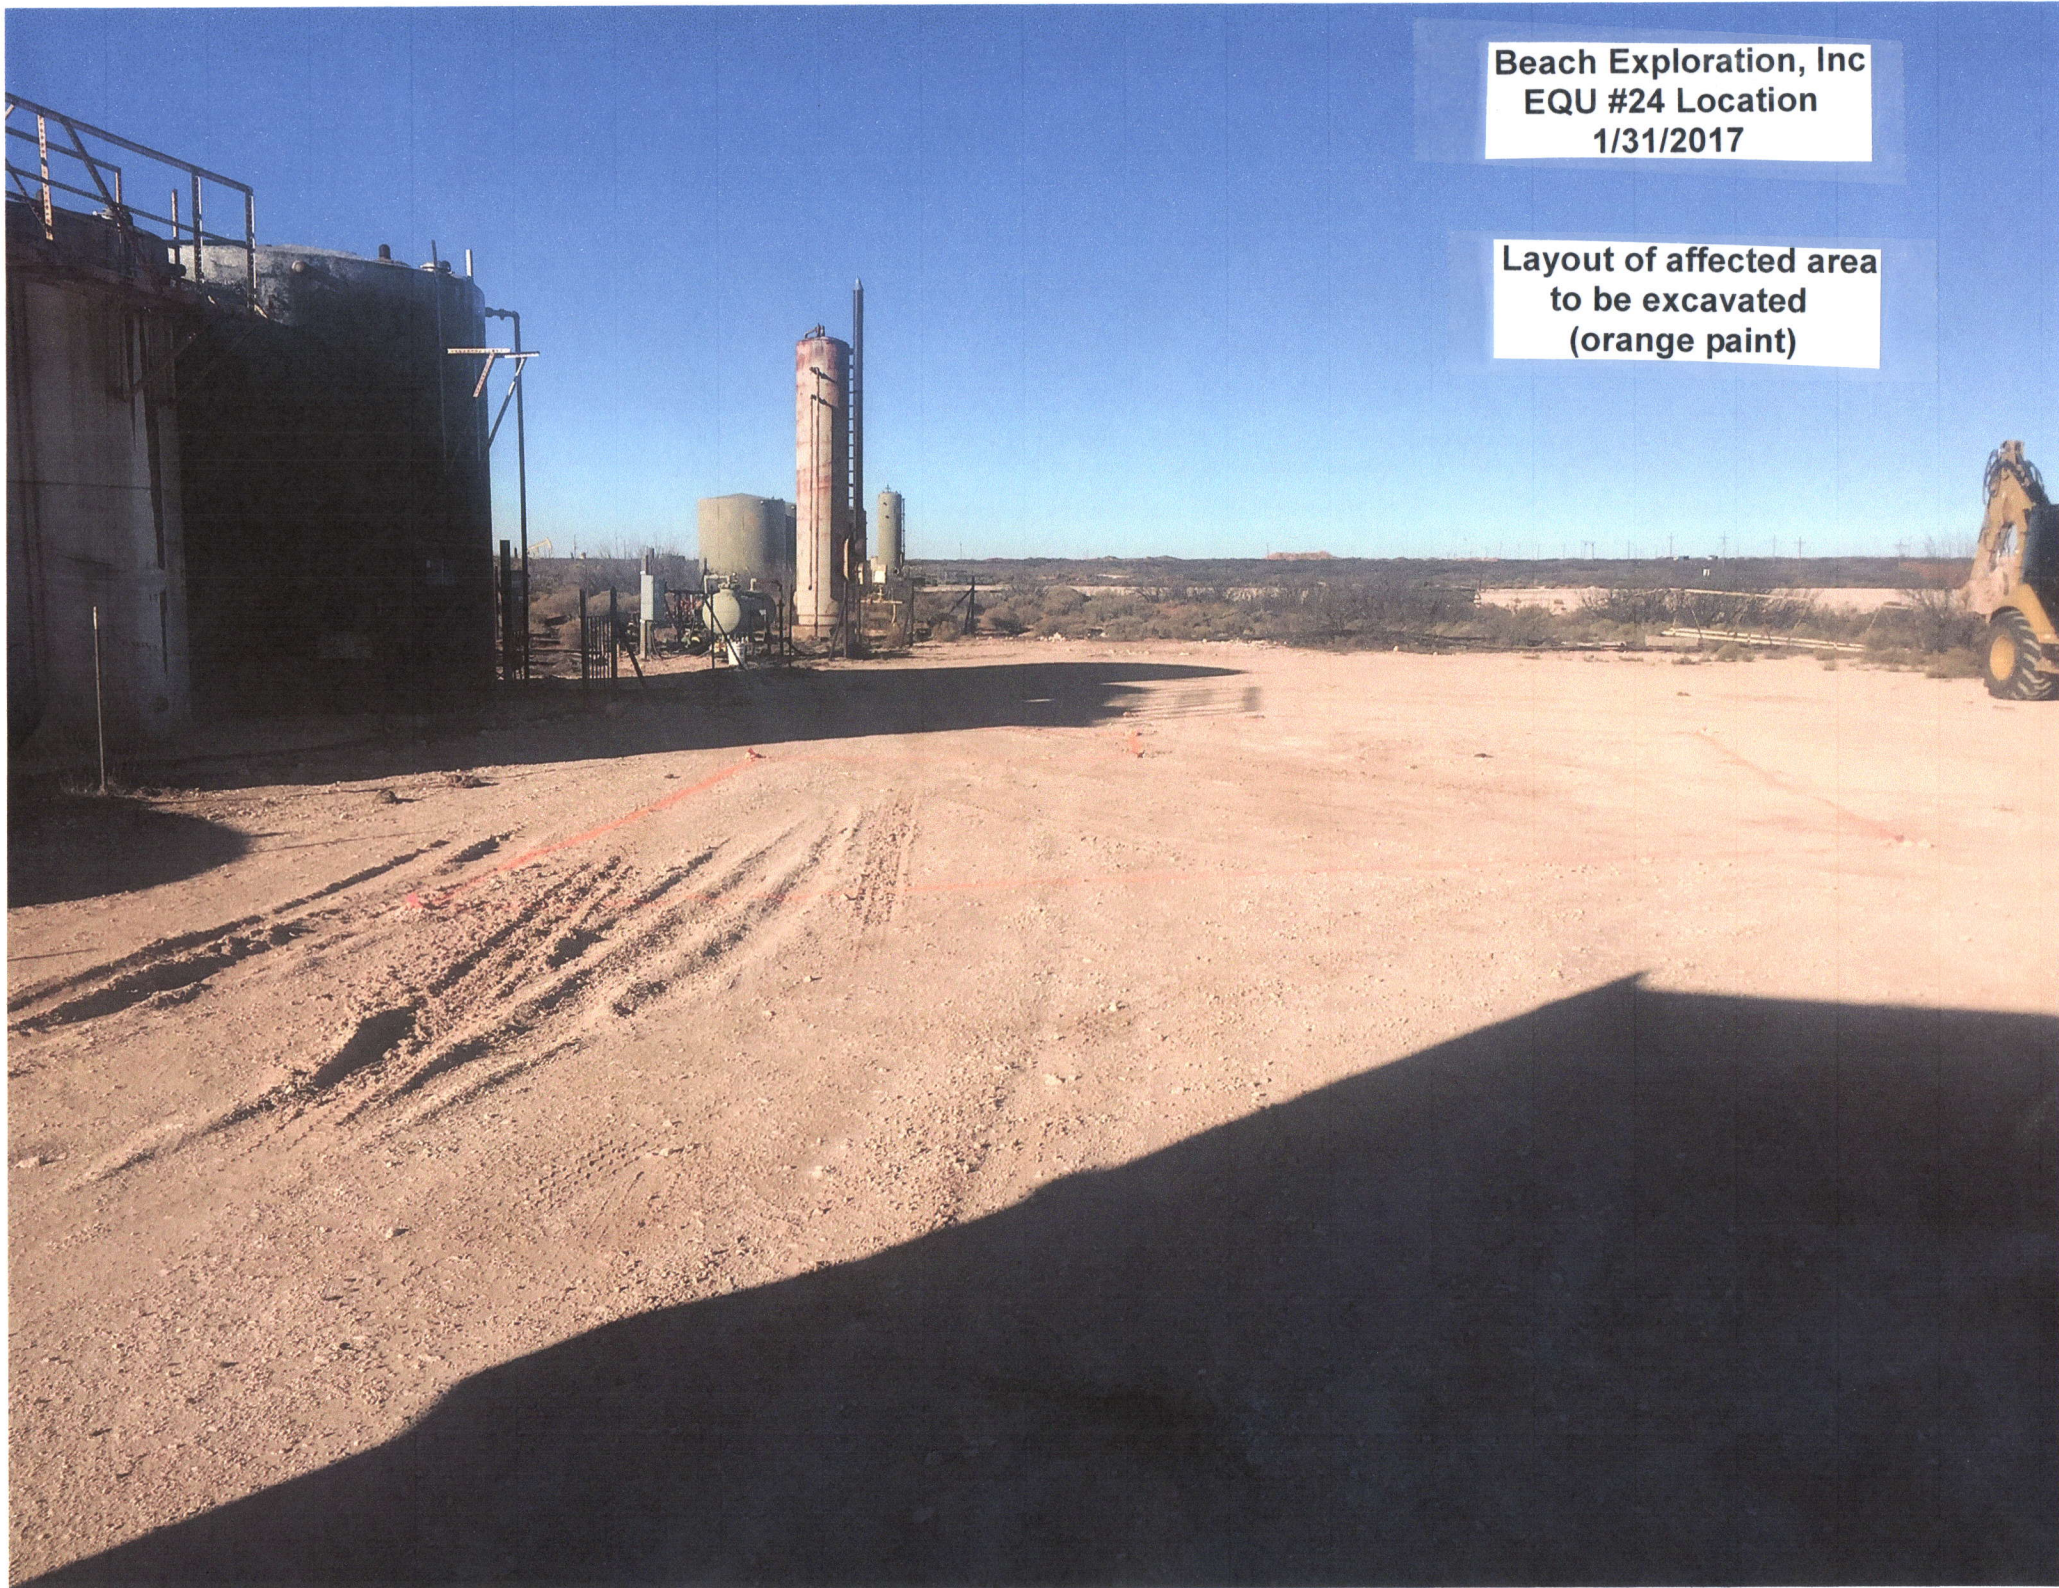
**Beach Exploration, Inc  
EQU #24 Location  
1/31/2017**

**Layout of affected area  
to be excavated  
(orange paint)**

Based on the above information, Beach plans to excavate the spill area to 1' and remove the material to an approved site. The area would then be backfilled with clean material and dressed to the original pad.

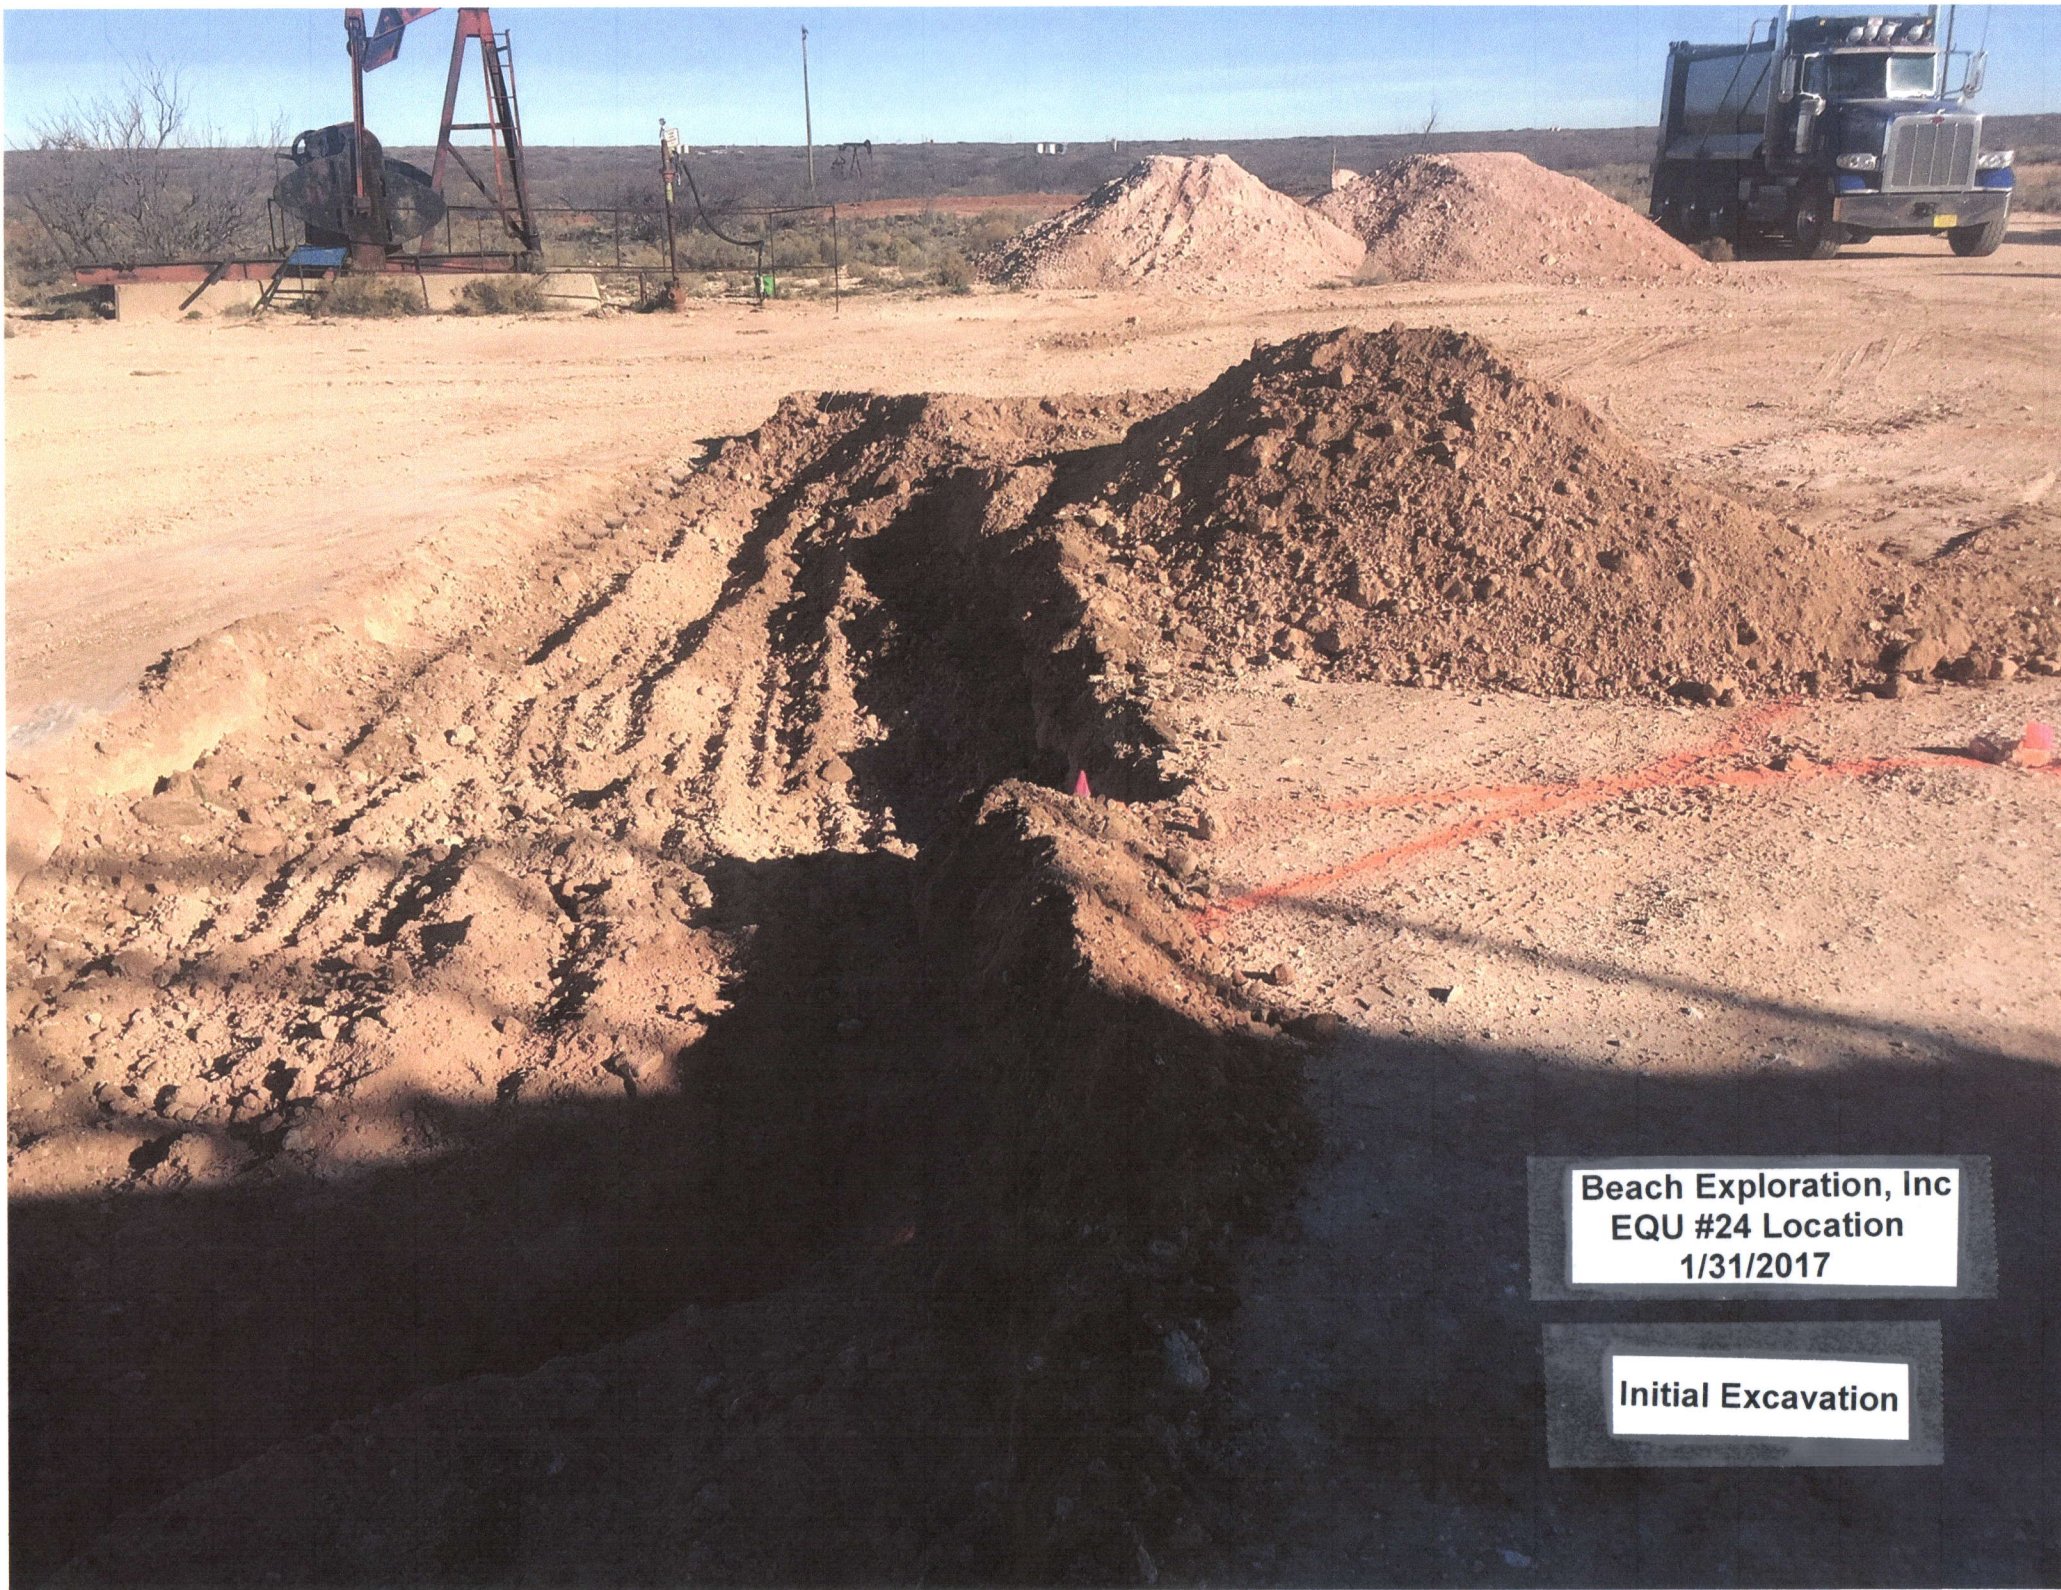
Beach Exploration, Inc  
EQU #24 Location  
1/31/2017

Initial Excavation

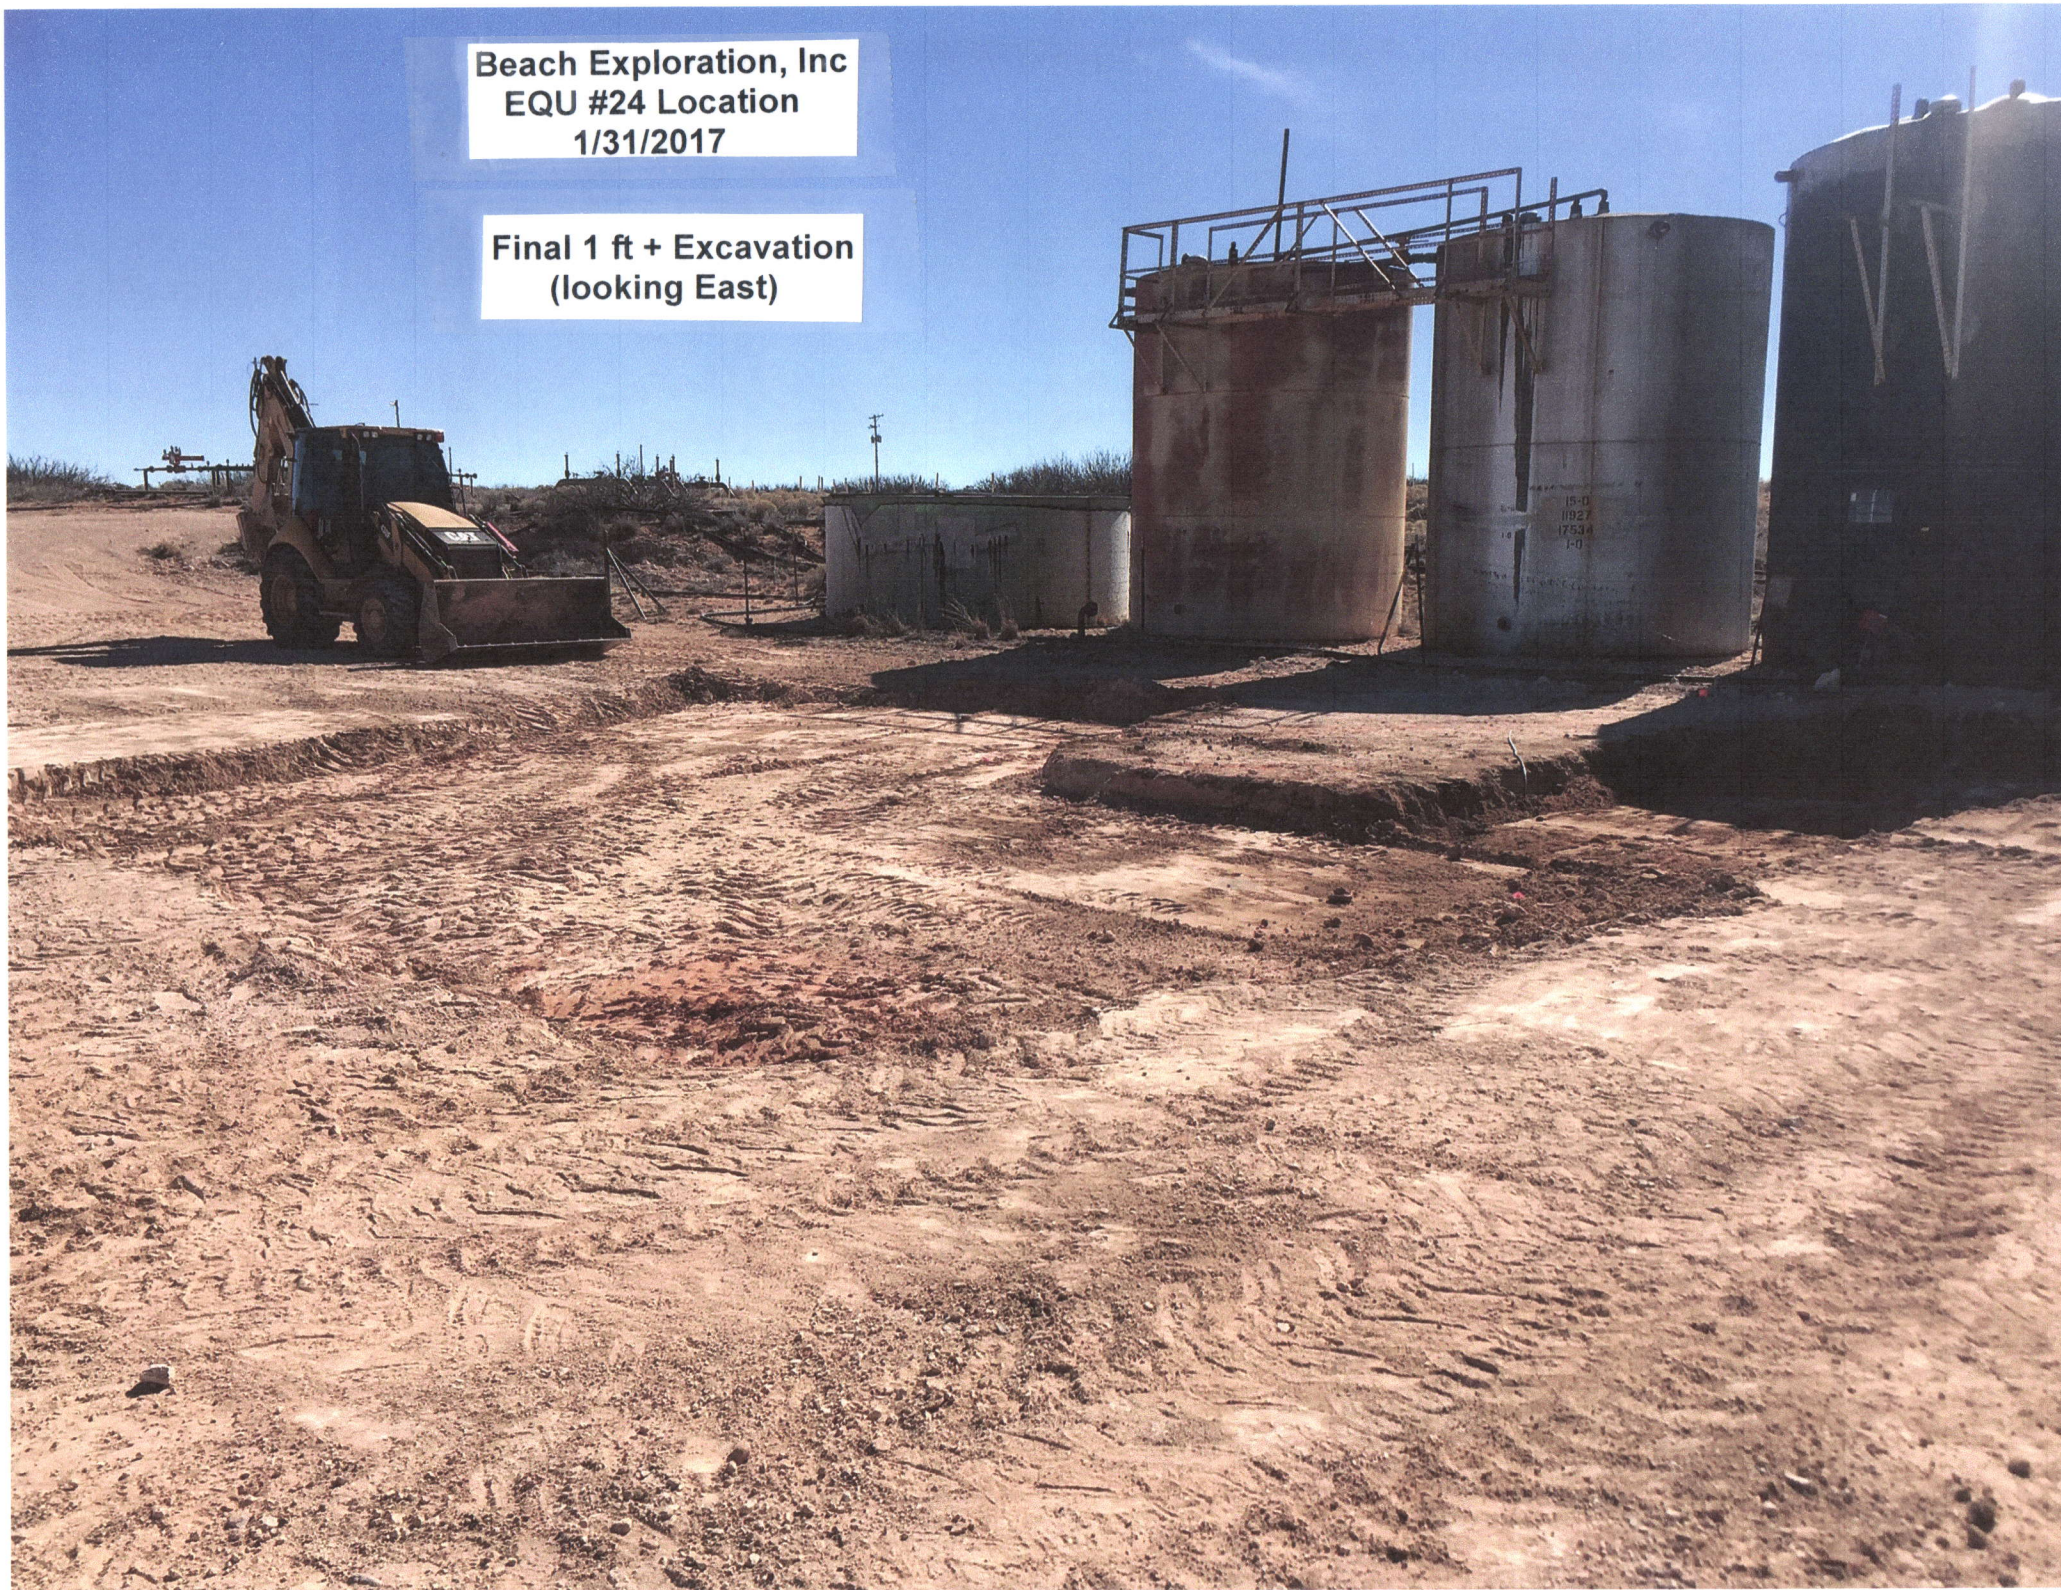
Beach Exploration, Inc  
EQU #24 Location  
1/31/2017

Final 1 ft + Excavation  
(looking East)

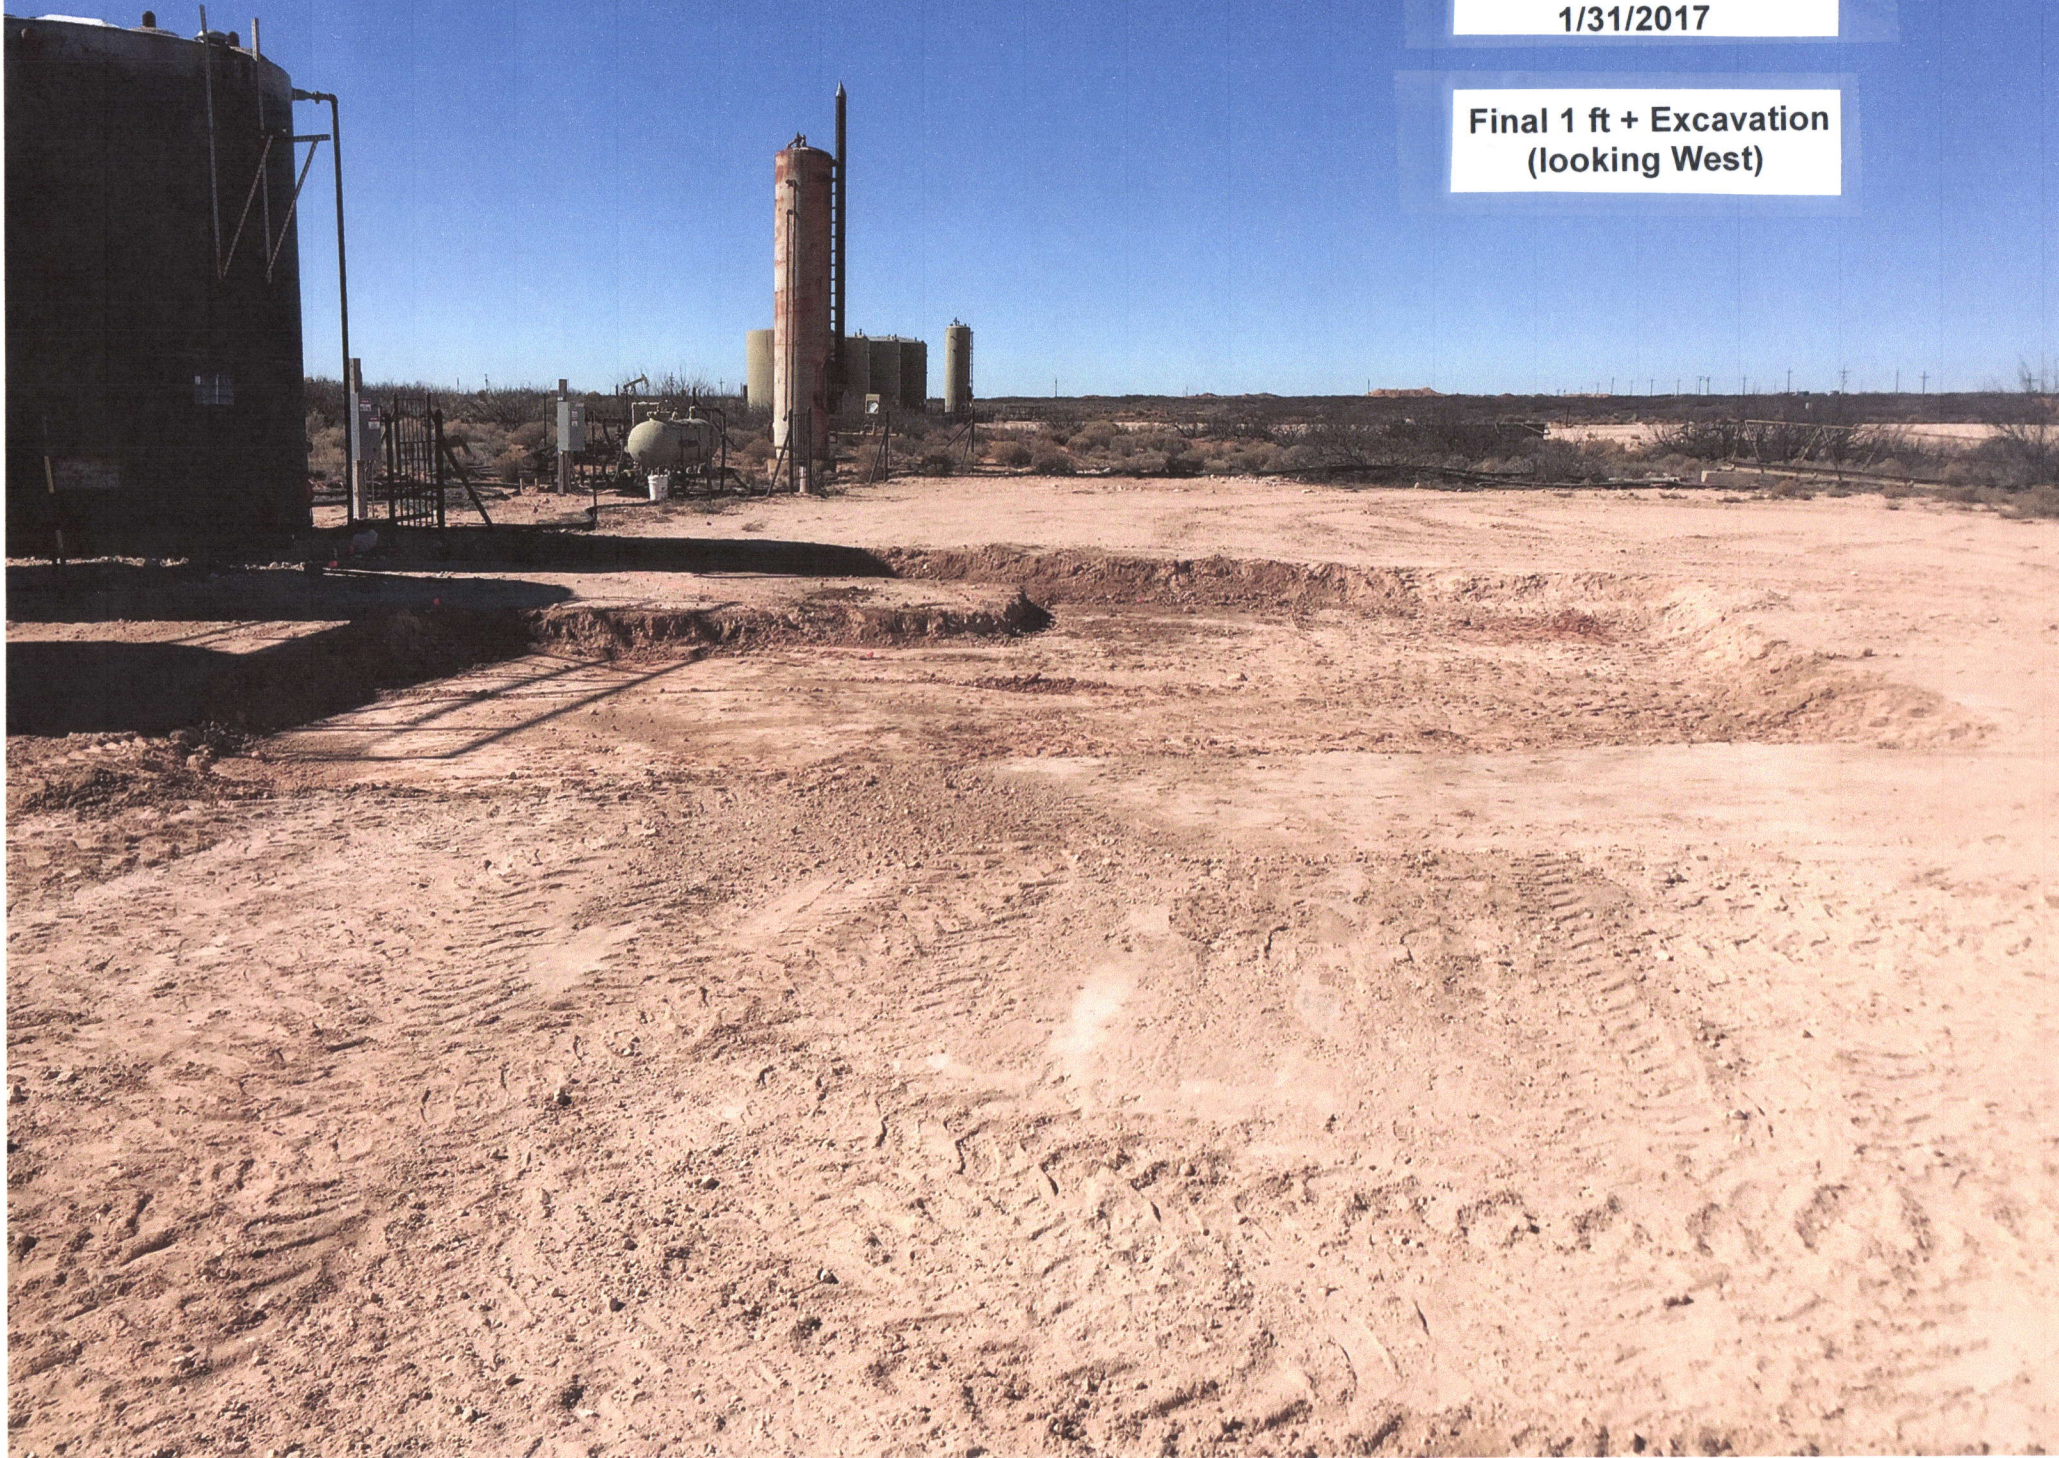
**Beach Exploration, Inc  
EQU #24 Location  
1/31/2017**

**Final 1 ft + Excavation  
(looking West)**

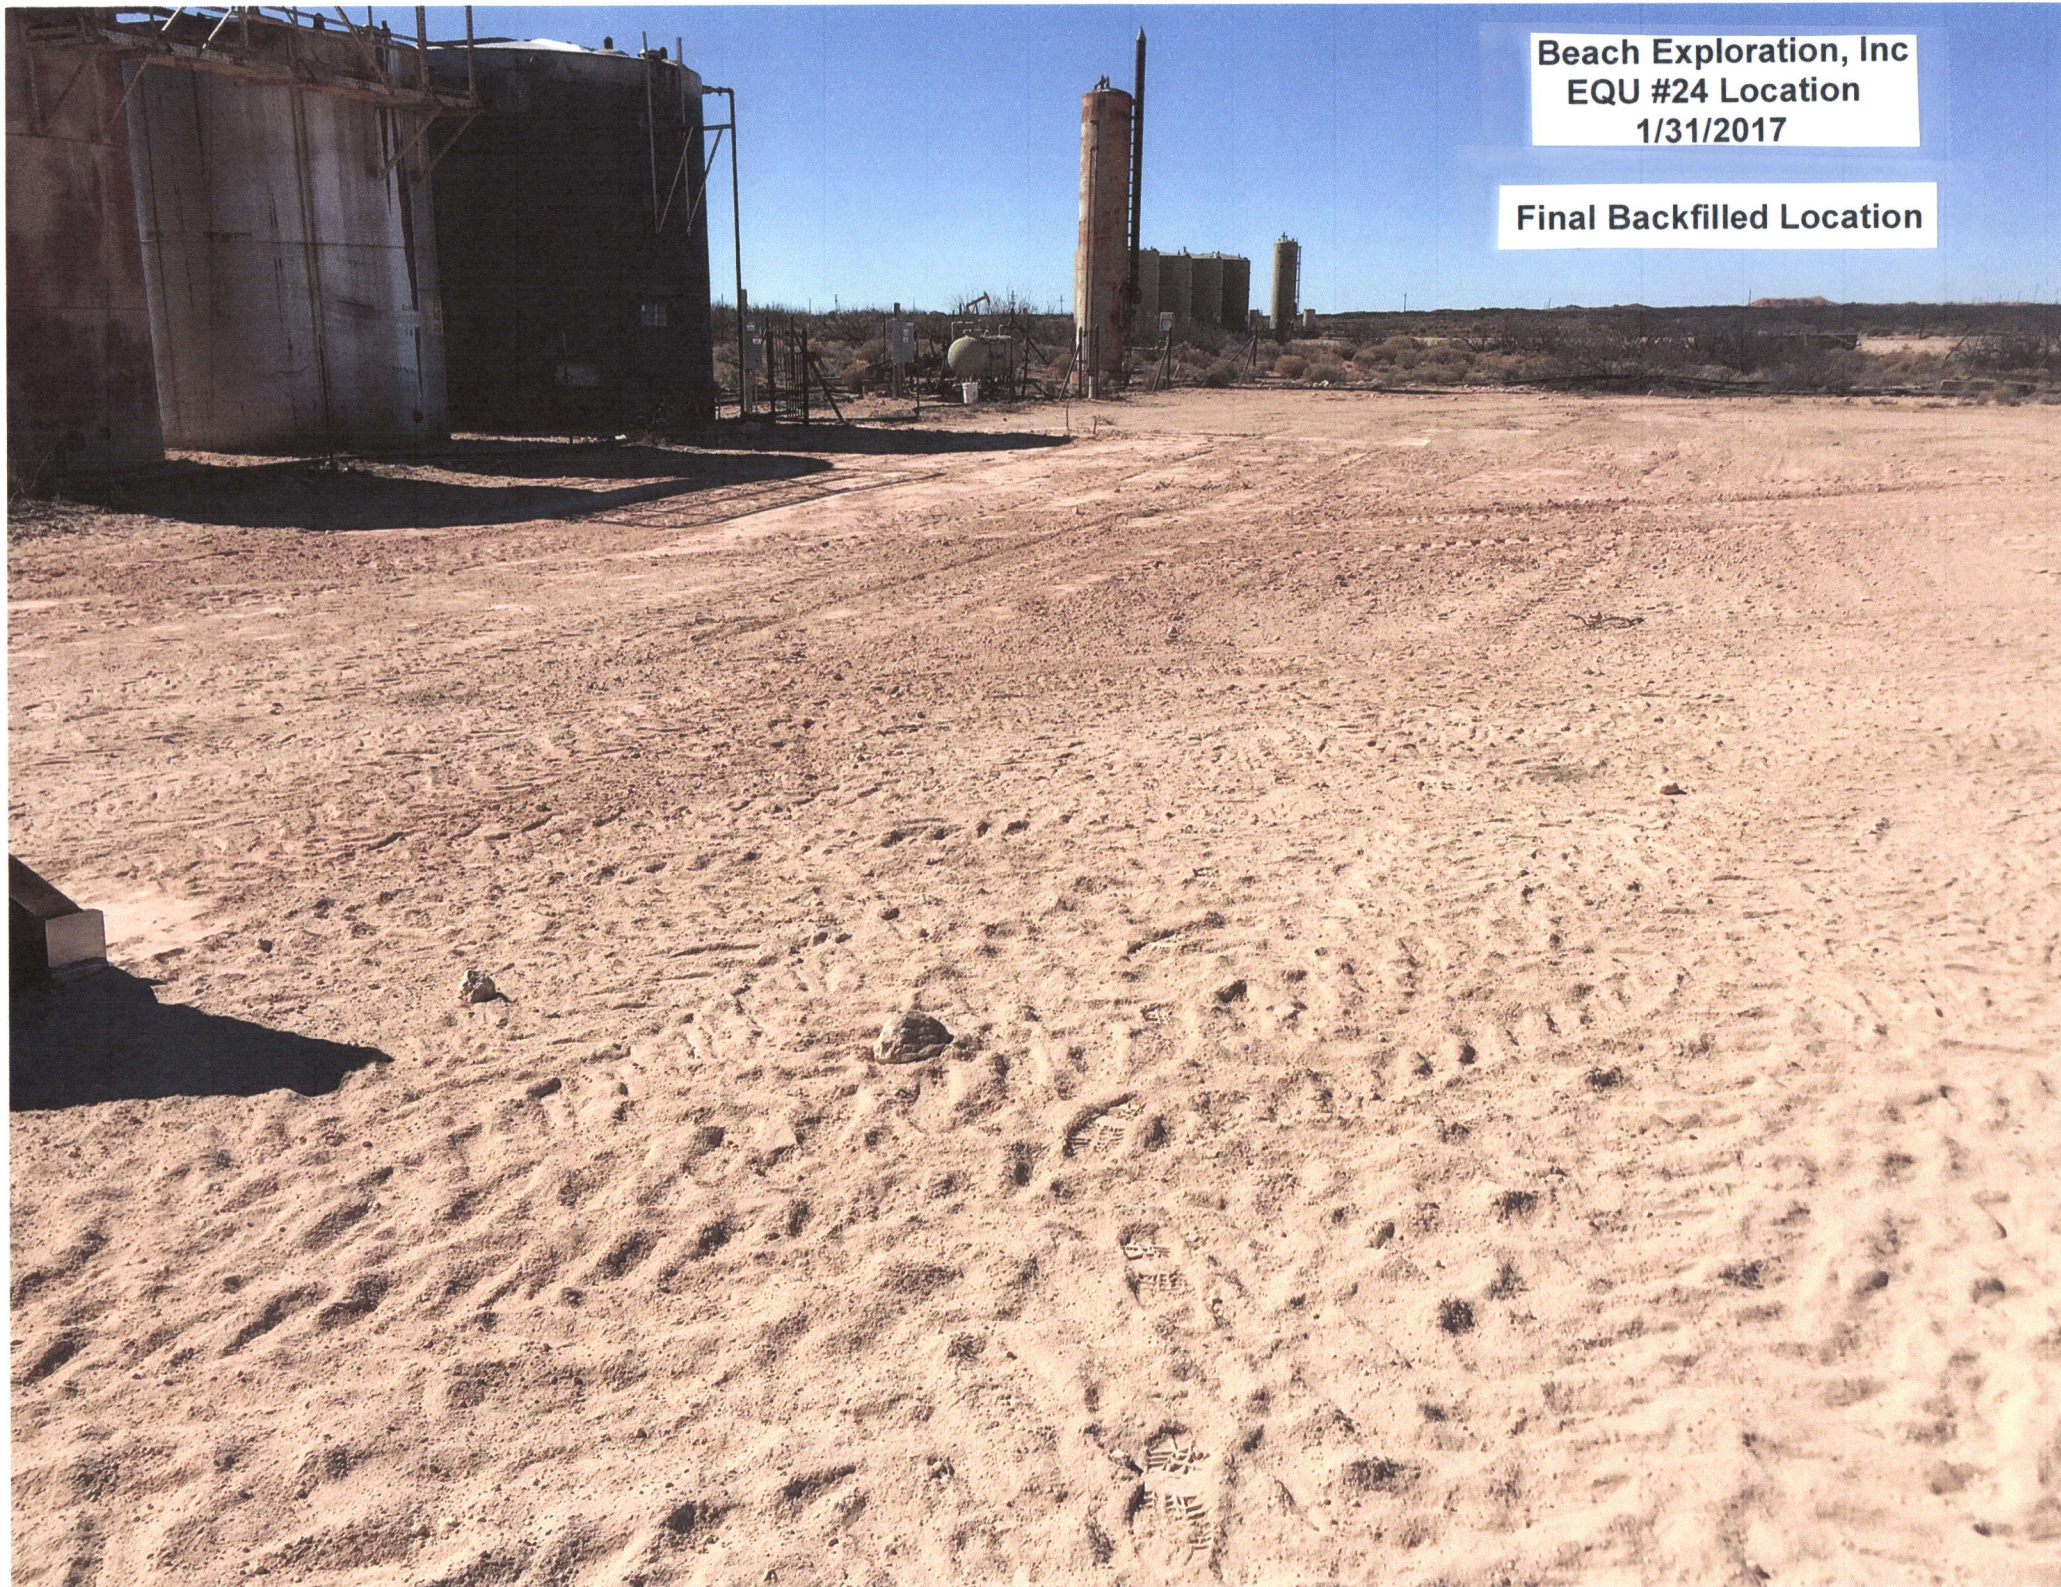
Beach Exploration, Inc  
EQU #24 Location  
1/31/2017

Final Backfilled Location

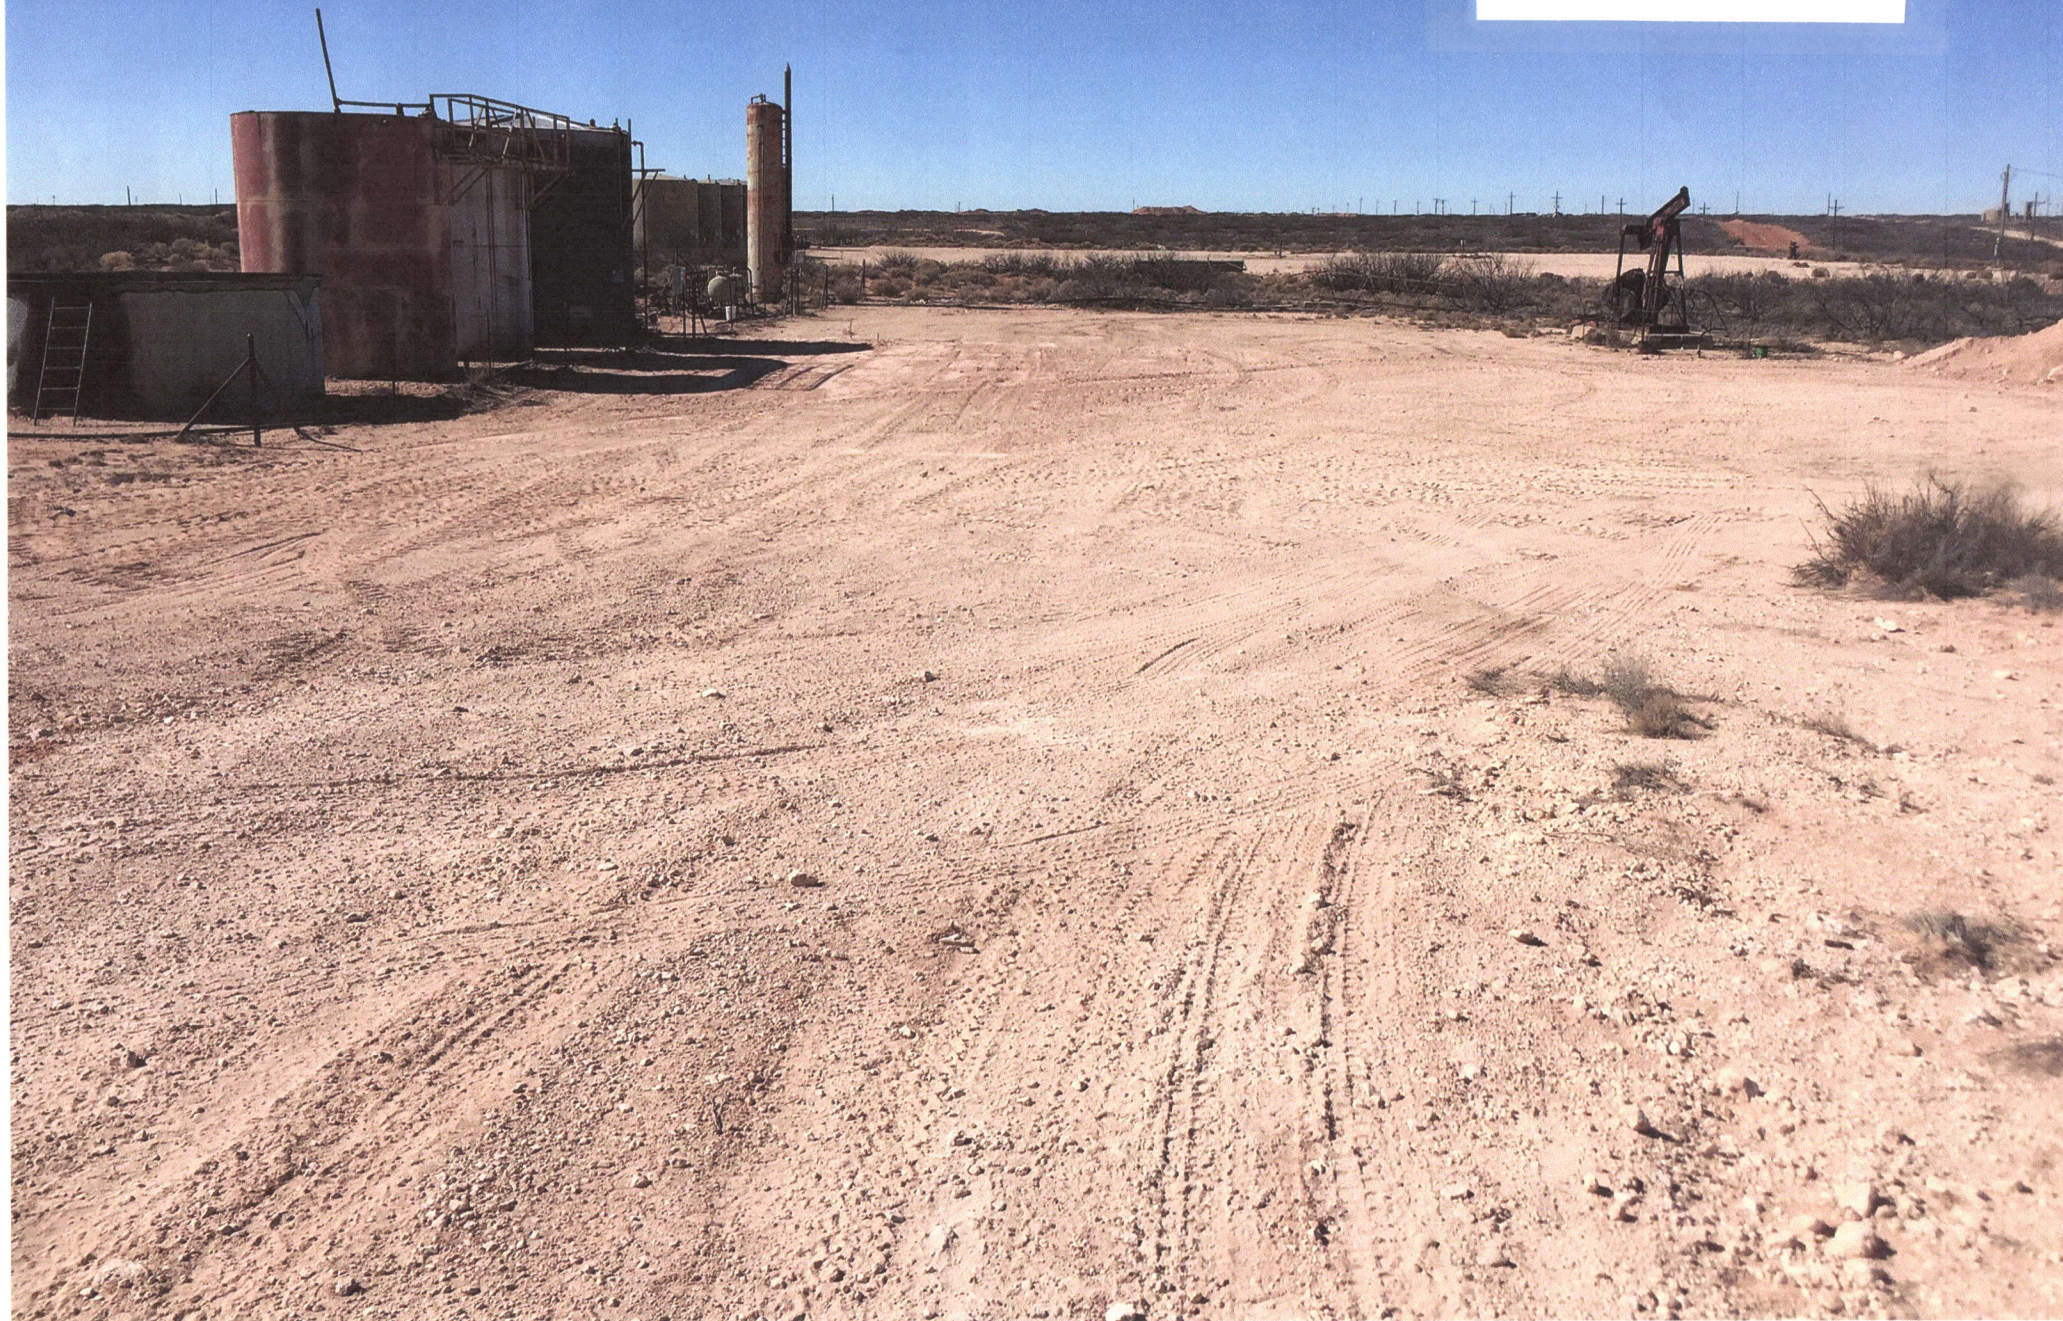
**Beach Exploration, Inc  
EQU #24 Location  
1/31/2017**

**Final Backfilled Location**
