## **APACHE CORPORATION INTERIM RECLAMATION**

B 440 FEDERAL #8; S.27, T17S, R29E; 505/S & 1025/E; 30-015-41524; NMLC-028775A

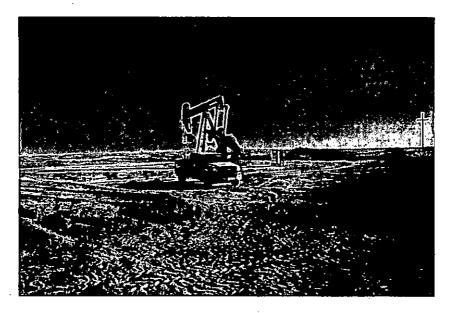
OVERVIEW OF WELL PAD-PUMPJACK FACING ROAD ENTRANCE FOR EASY SET UP FOR WORKOVER.
