Release Notification

Project #17035-0129
NMOCD Incident # nCS1932436155

RE: BGT Closure and Release Closure Report for the Jicarilla 122-2 Well Site Located in Section 4, Township 25N, Range 4W, San Juan County New Mexico

**SITE PHOTOGRAPHY
DJR OPERATING
JICARILLA APACHE 122-2
SECTION 4, TOWNSHIP 25N, RANGE 4W
RIO ARRIBA COUNTY, NEW MEXICO
PROJECT # 17035-0129
INCIDENT #NCS1932436155**

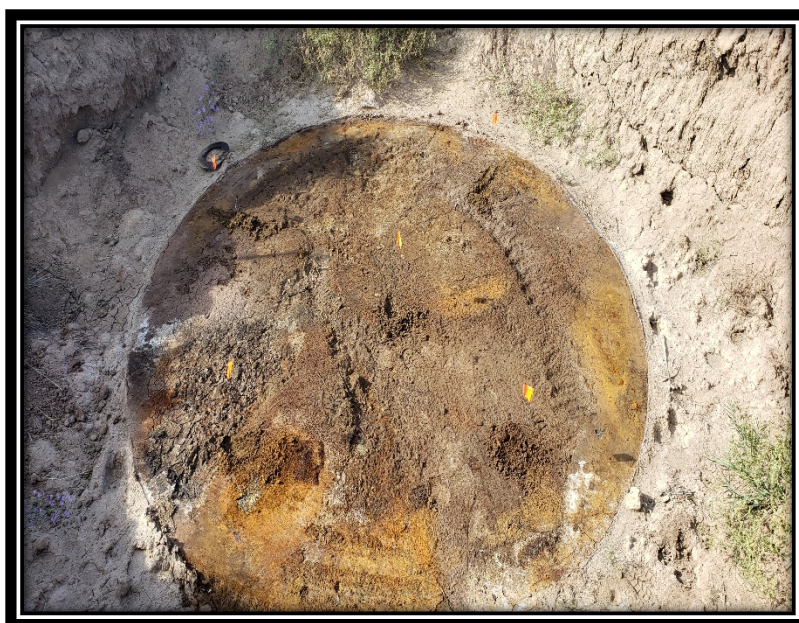
Picture 2: Sample Points Below BGT

On October 8, 2019, DJR personnel removed the BGT and Envirotech personnel collected a five-point composite confirmation soil sample from beneath the former location of the BGT. BGT removal and sampling activities were witnessed by Mr. Hobson Sandoval, Jicarilla Apache Nation Oil and Gas (JOGA) representative.

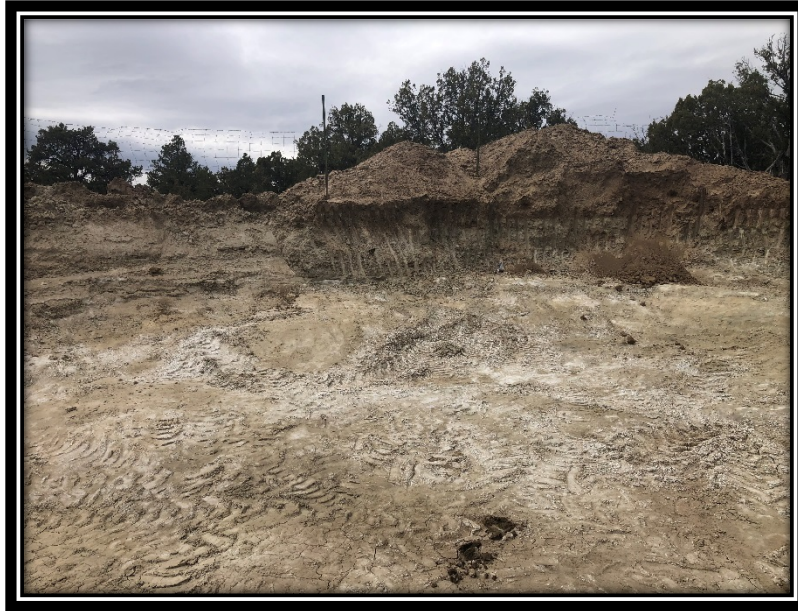
Picture 3: View of Excavation West Wall

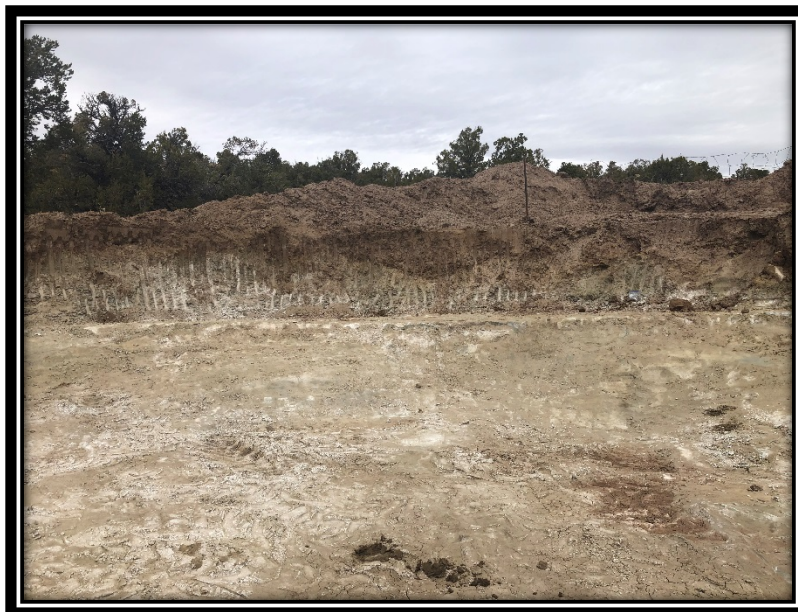
Picture 4: View of Excavation North Wall

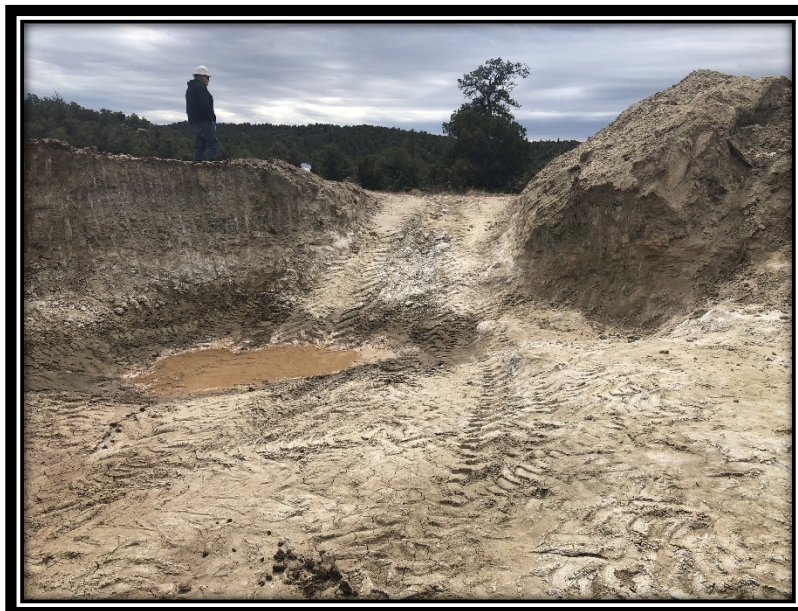
Picture 6: View of Excavation South Wall

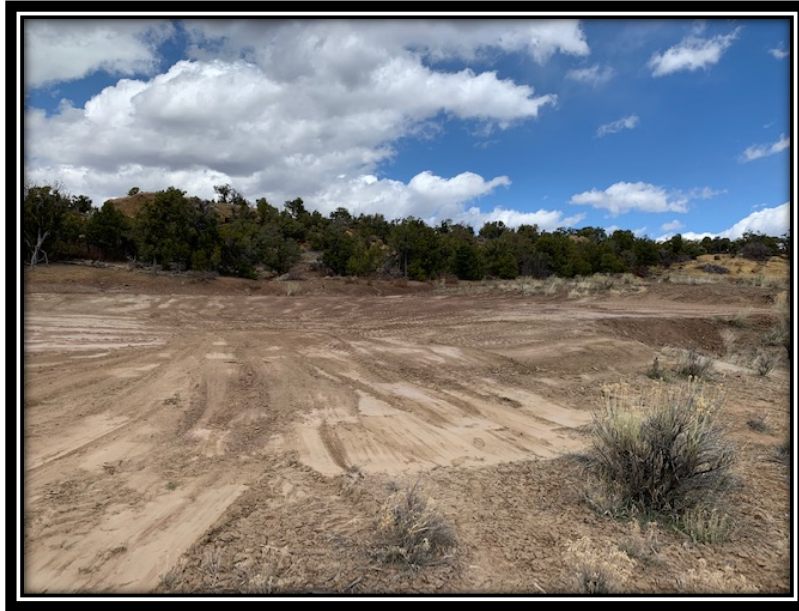
Picture 9: View of Backfilled and Recontoured Area (View 1)

After the application of the potassium permanganate solution, DJR personnel backfilled the excavation with clean backfill and recontoured the area to match pre-existing conditions on April 7, 2020. The area was reseeded on April 8, 2020, with the approved Jicarilla Mesa seed mixture. Potassium permanganate application and backfilling activities are documented in the attached **Site Photography**.

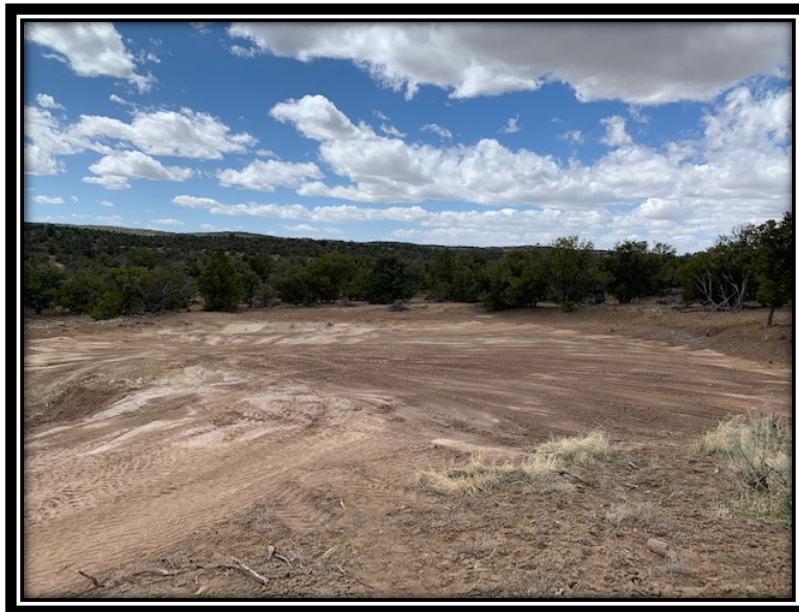
Picture 10: View of Backfilled and Recontoured Area (View 2)
