**PIT REMEDIATION AND CLOSURE REPORT**

Facility Or: SJ 29-6 #21 A

Location: SJ 29-6 UNIT #21A

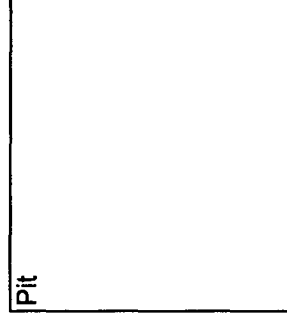
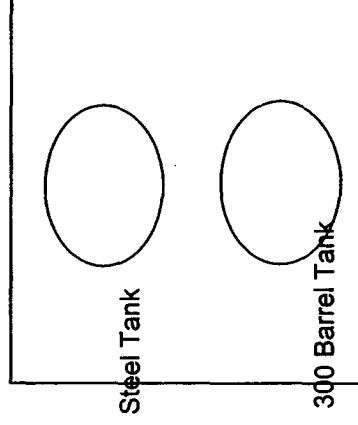
Site Diagram:

Final Pit: Sample location Soil sample collected from center of pit with hand probe

Sample depth 3-feet below pit bottom

Well Head

Dehydrator

Pit

Meter House

Steel Tank

300 Barrel Tank
