**PIT REMEDIATION AND CLOSURE REPORT**

Operator: ConocoPhillips Telephone: 505-599-3400

Facility Or: SJ 29-6 # 62  
Well Name

Location: Unit or Qtr/Qtr Sec A Sec 04 T 29 N R 6 W County Rio Arriba

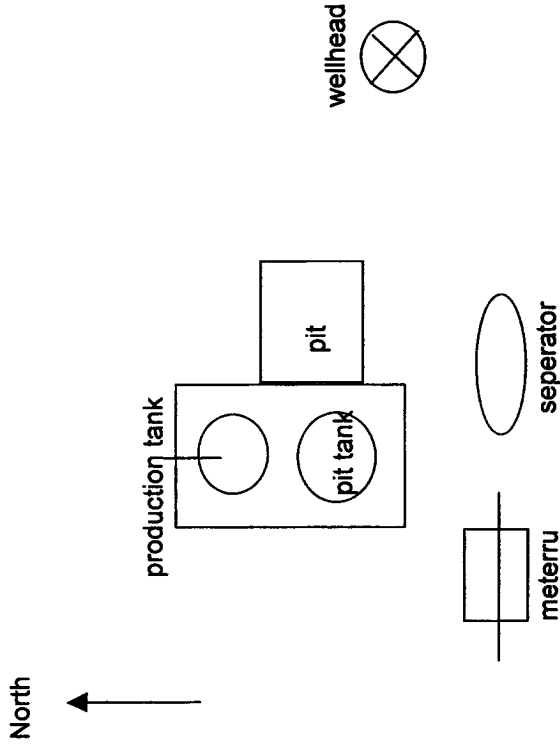
Site Diagram:

Final Pit: Sample location Soil sample collected from center of pit with hand probe

Sample depth 3-feet below pit bottom

Initial size: 30x25x3 deep

Final Size: 30x25x3 deep
