**PIT REMEDIATION AND CLOSURE REPORT**

Operator: ConocoPhillips Company Telephone: (505) 599-3400

Facility Or: Campbell Fed #5 API #: 30-045-06307  
Well Name

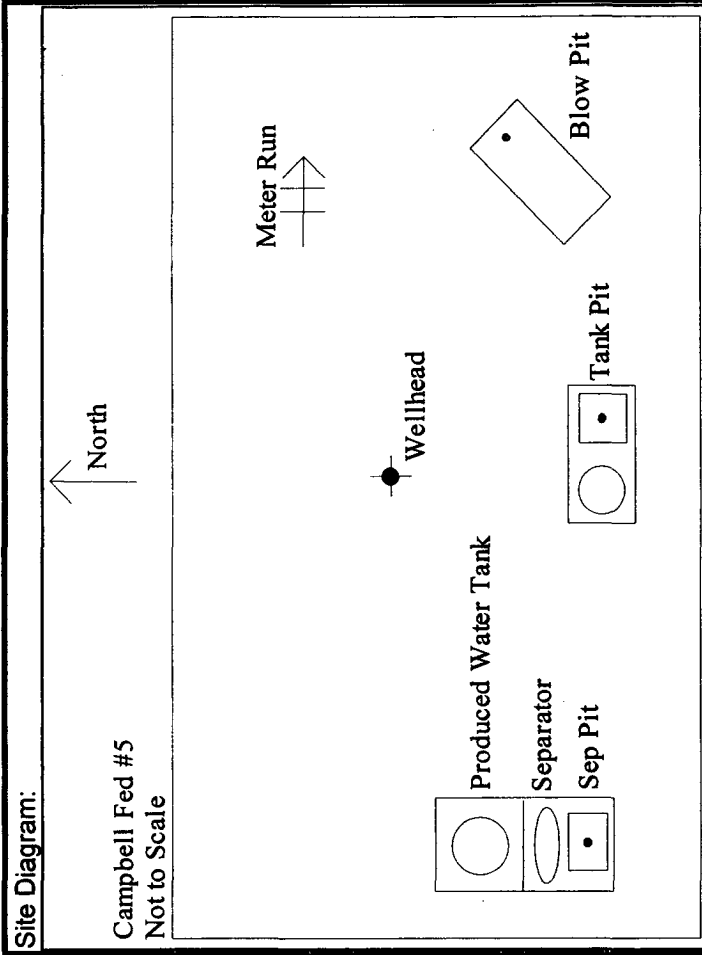
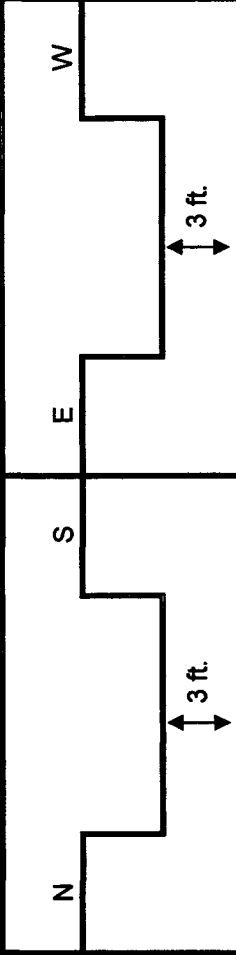
Not to Scale

| Sample ID | Description | OVM Reading |
|---|---|---|
| 1 | sep pit | 3469 ppm 3' below pit bottom |
| 2 | tank pit | 33.8 ppm 3' below pit bottom |
| 3 | blowdown pit | 2.7 ppm 3' below north end of pit bottom |

Comments: sep pit - odor & staining at 3', saturated soil due to proximity to NAPI field.  
tank pit - no odor or staining  
blowdown pit - no odor or staining
