Burlington Resources Oil Gas Company, LP San Juan Basin Below Grade Tank Closure Report

Lease Name: San Juan 32-9 Unit60

API No.: 3004511270

Below Grade Tank Closure Report

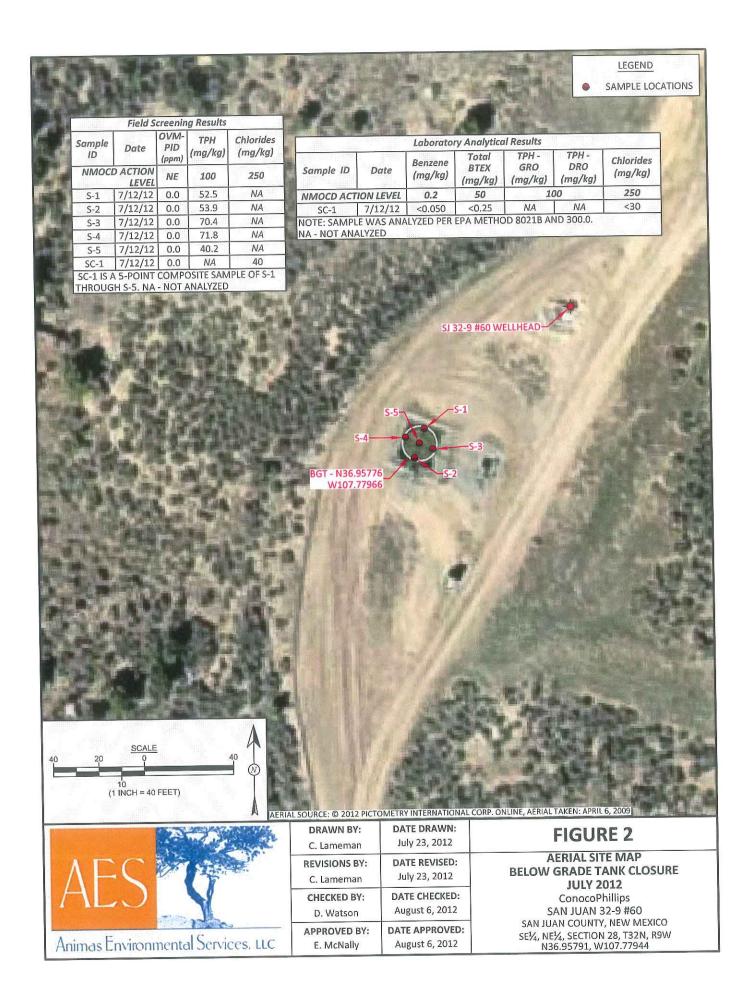
On July 12, 2012, AES personnel conducted field screening and collected five soil samples (S-1 through S-5) and one 5-point composite (SC-1) from below the BGT. Soil samples S-1 through S-5 were collected from approximately 0.5 feet below the former BGT for field screening of volatile organic compounds (VOCs), total petroleum hydrocarbon (TPH), and chlorides. Soil sample SC-1 was submitted for confirmation laboratory analysis. Soil sample locations are included on Figure 2.

Field screening for VOCs via OVM showed readings of 0.0 ppm in all samples (S-1 through S-5 and SC-1). Field TPH concentrations ranged from 40.2 mg/kg in S-5 up to 71.8 mg/kg in S-4. The field chloride concentration was 40 mg/kg in SC-1. Field screening results are summarized in Table 1 and presented on Figure 2. The AES Field Screening Report is attached.

Laboratory analytical results showed that the benzene and total BTEX concentrations in SC-1 were less than 0.050 mg/kg and less than 0.25 mg/kg, respectively. The laboratory chloride concentration was below the laboratory detection limit of 30 mg/kg. Laboratory analytical results are summarized in Table 2 and included on Figure 2. Laboratory analytical reports are attached.
