Pit, Below-Grade Tank, or
Proposed Alternative Method Permit or Closure Plan Application

1.
Operator: Burlington Resources OGRID #: 14538
Address: PO BOX 4289, Farmington, NM 87499
Facility or well name: Huerfanito Unit 79M
API Number: 30-045-28948 OCD Permit Number: _____
U/L or Qtr/Qtr J (NWSE) Section 26 Township 27N Range 09W County: San Juan
Center of Proposed Design: Latitude 36.54375 °N Longitude -107.75468 °W NAD: ☐ 1927 ☒ 1983
Surface Owner: ☒ Federal ☐ State ☐ Private ☐ Tribal Trust or Indian Allotment

Burlington Resources Oil Gas Company, LP
San Juan Basin
Below Grade Tank Closure Report
(Without Reclamation)

Lease Name: HUERFANITO UNIT 79M

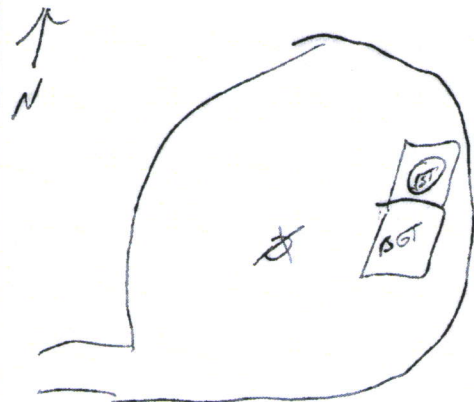
PROFILE

LOCATION: NAME: Hardsito (HBr) WELL #: 79M TEMP PIT: PERMANENT PIT: BGT: XLEGAL ADD: UNIT: P SEC: 26 TWP: 27N RNG: 9W PM: NMQTR/FOOTAGE: 1150 FSL + 1180 FGL CNTY: San Juan ST: NMEXCAVATION APPROX: NA FT. X NA FT. X NA FT. DEEP CUBIC YARDAGE:DISPOSAL FACILITY: NA REMEDIATION METHOD: NALAND OWNER: API: 3004506120 BGT / PIT VOLUME:CONSTRUCTION MATERIAL: Steel DOUBLE-WALLED, WITH LEAK DETECTION: NALOCATION APPROXIMATELY: 91 FT. East FROM WELLHEADDEPTH TO GROUNDWATER: 40'

FIELD CHLORIDES RESULTS
