Pit, Below-Grade Tank, or
Proposed Alternative Method Permit or Closure Plan Application

**ConocoPhillips Company
San Juan Basin
Below Grade Tank Closure Report**

Lease Name: Chaco Plant 28

API No.: 30-045-22156

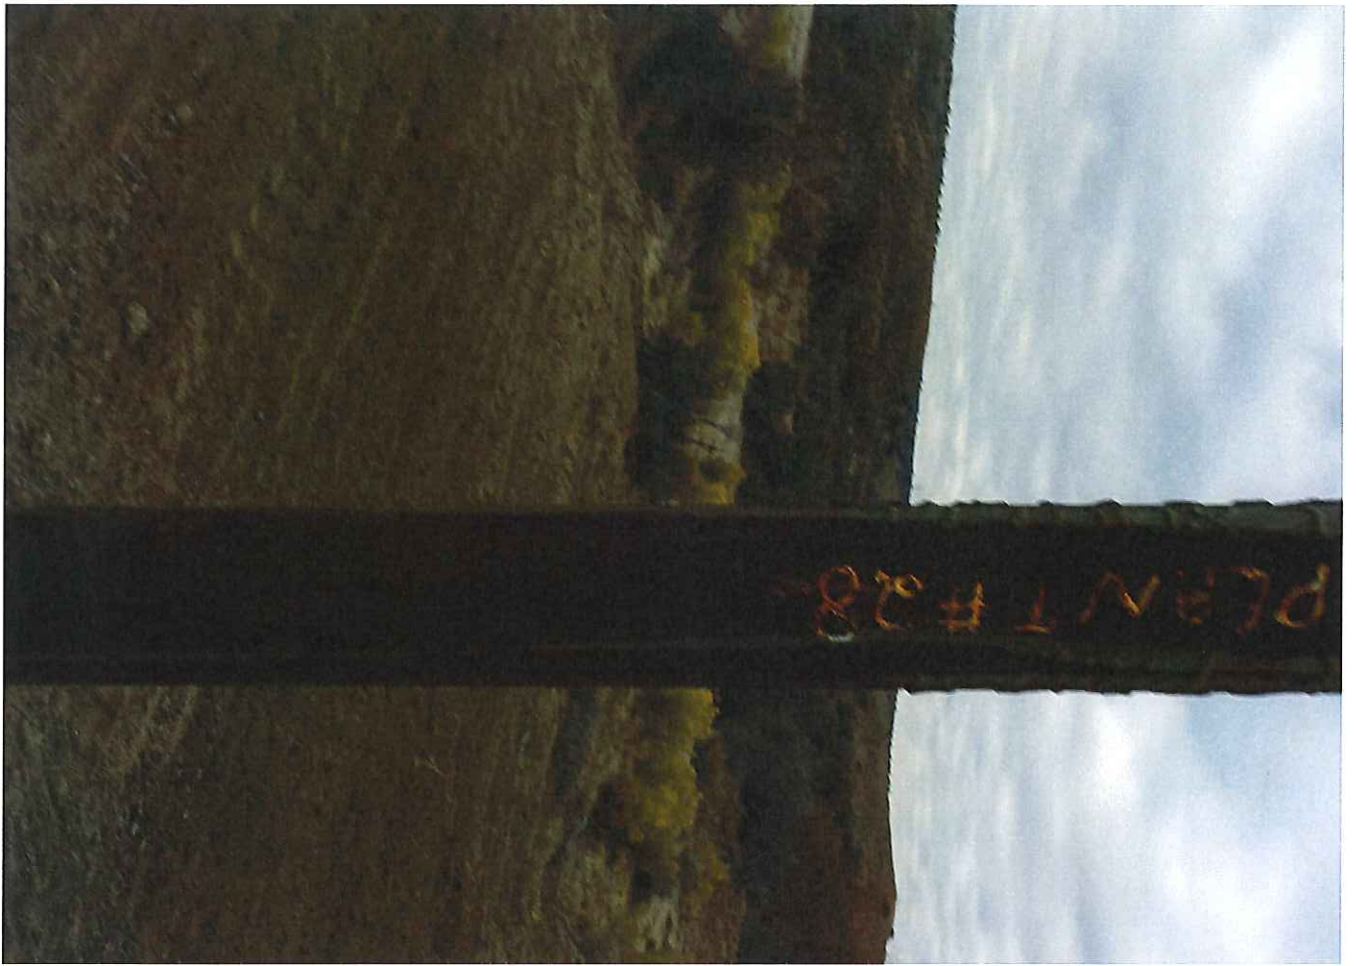
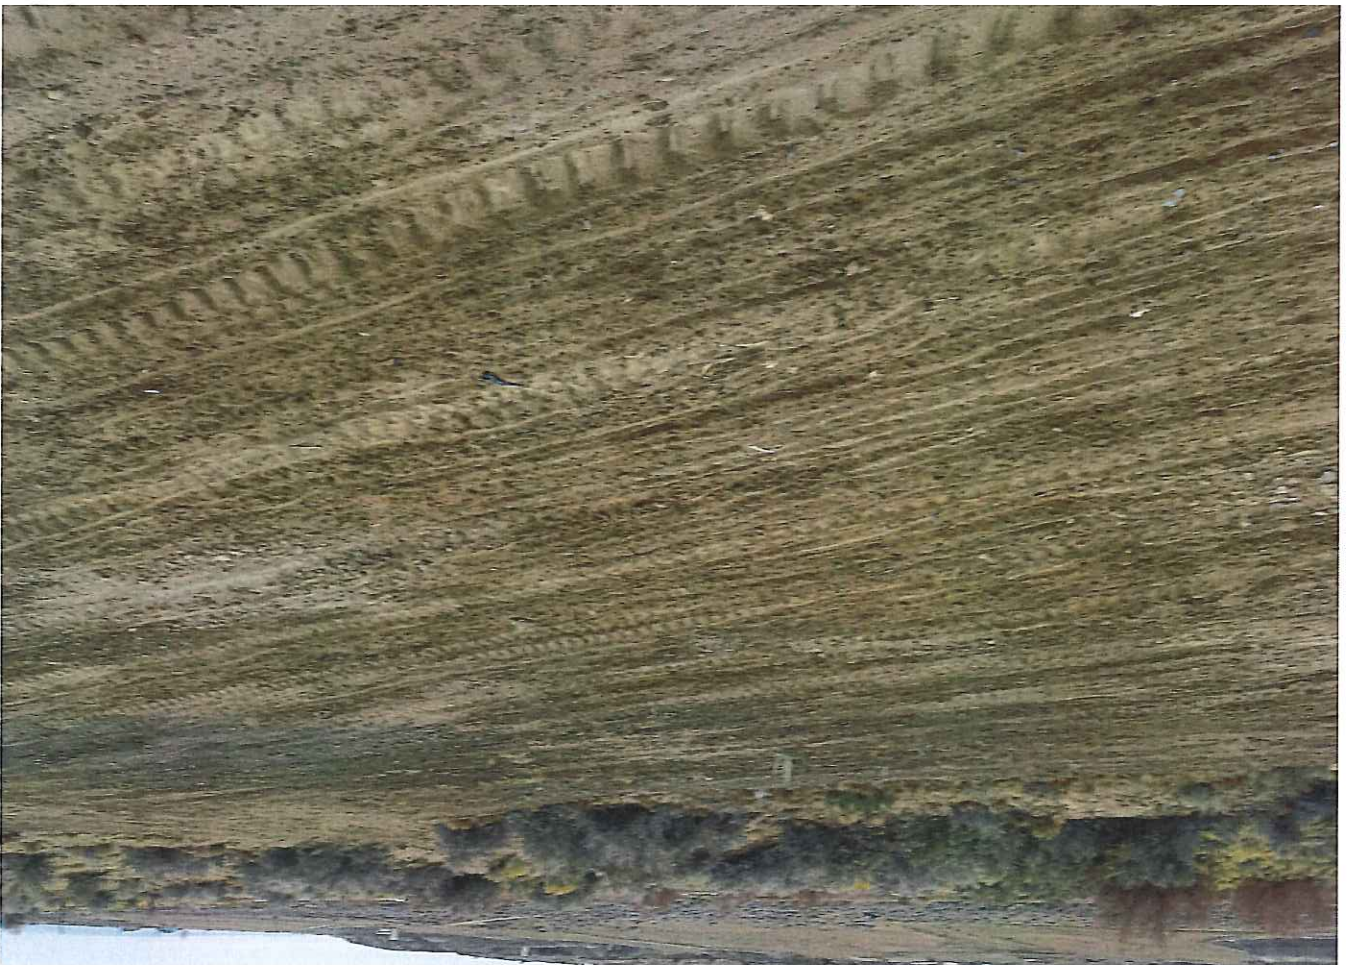
- ☒ Proof of Closure Notice (surface owner and division)
- ☐ Proof of Deed Notice (required for on-site closure for private land only)
- ☐ Plot Plan (for on-site closures and temporary pits)
- ☒ Confirmation Sampling Analytical Results (if applicable)
- ☐ Waste Material Sampling Analytical Results (required for on-site closure)
- ☐ Disposal Facility Name and Permit Number
- ☒ Soil Backfilling and Cover Installation
- ☒ Re-vegetation Application Rates and Seeding Technique
- ☒ Site Reclamation (Photo Documentation)

The below-grade tank area passed all requirements of Paragraph (4) of Subsection E of 19.15.17.13 NMAC and was backfilled with compacted, non-waste containing, earthen material.
